DPST-81-375

June 5, 1981

DURABILITY OF SRP WASTE GLASS - EFFECTS
OF PRESSURE AND FORMATION OF SURFACE LAYERS

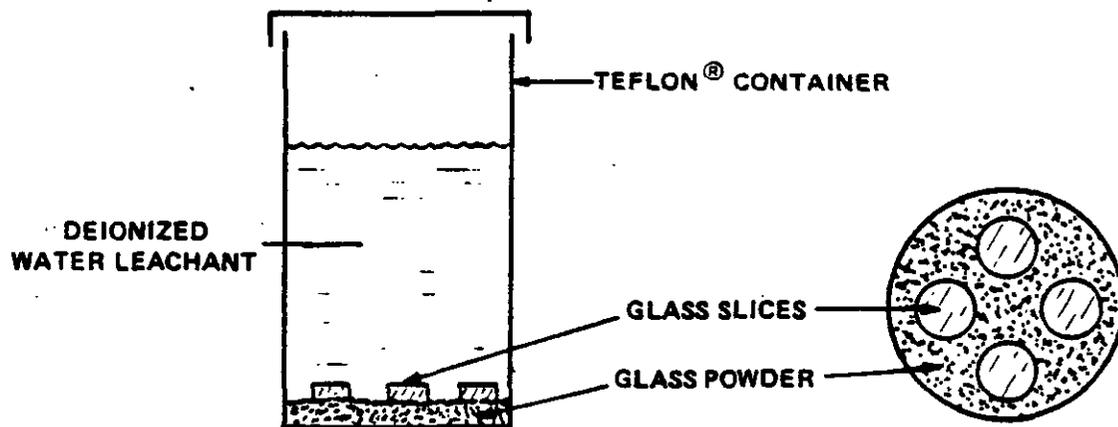
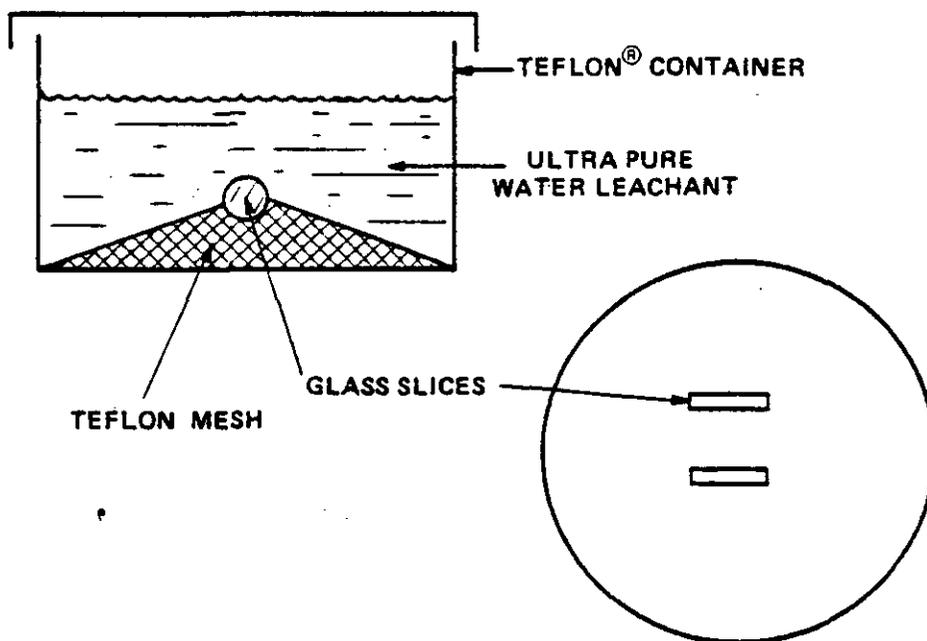
FIGURE 1
EXPERIMENTAL UNITS

TP-3
SA/V = 10/1 cm⁻¹

Samples at 90°C/14.7 psi & 90°C/1000 psi

TP-4
SA/V = 1/10 cm⁻¹

Samples at 90°C/14.7 psi & 90°C/1500 psi

Two sets of tests were completed. All experiments involved leaching waste glass in deionized water for one month using a waste glass composition designated TDS/131, as shown in Tables 1 and 2. The first set of tests, TP-3, studied the corrosion of TDS/131 waste glass at 90°C/14.7 psi and 90°C/1000 psi. A relatively high glass surface area to volume of leachant (SA/V) of 10:1 cm⁻¹ was used. In order to accomplish this ratio and accelerate reactions, both glass powder and as-cut slices were used with distilled water in each test.

The second set of tests, TP-4, was conducted at 90°C/14.7 psi and 90°C/1500 psi. These experiments reflected improvements over TP-3 including (a) use of acid washed Teflon® vessels, (b) ultrapure water, (c) slices mounted on edge with no powders involved, (d) individually prepared 600 grit surfaces, and (e) a SA/V ratio of 1:10 cm⁻¹. An oven was used for the 90°C/14.7 psi samples while an autoclave was used in all high pressure experiments. The experimental units and conditions of TP-3 and TP-4 are depicted in Figure 1. Intercomparisons were made of leachability data within TP-3 and also TP-4 as a function of pressure. However, because of the different conditions used in the two sets of tests, direct comparisons between data from TP-3 and TP-4 were not attempted.

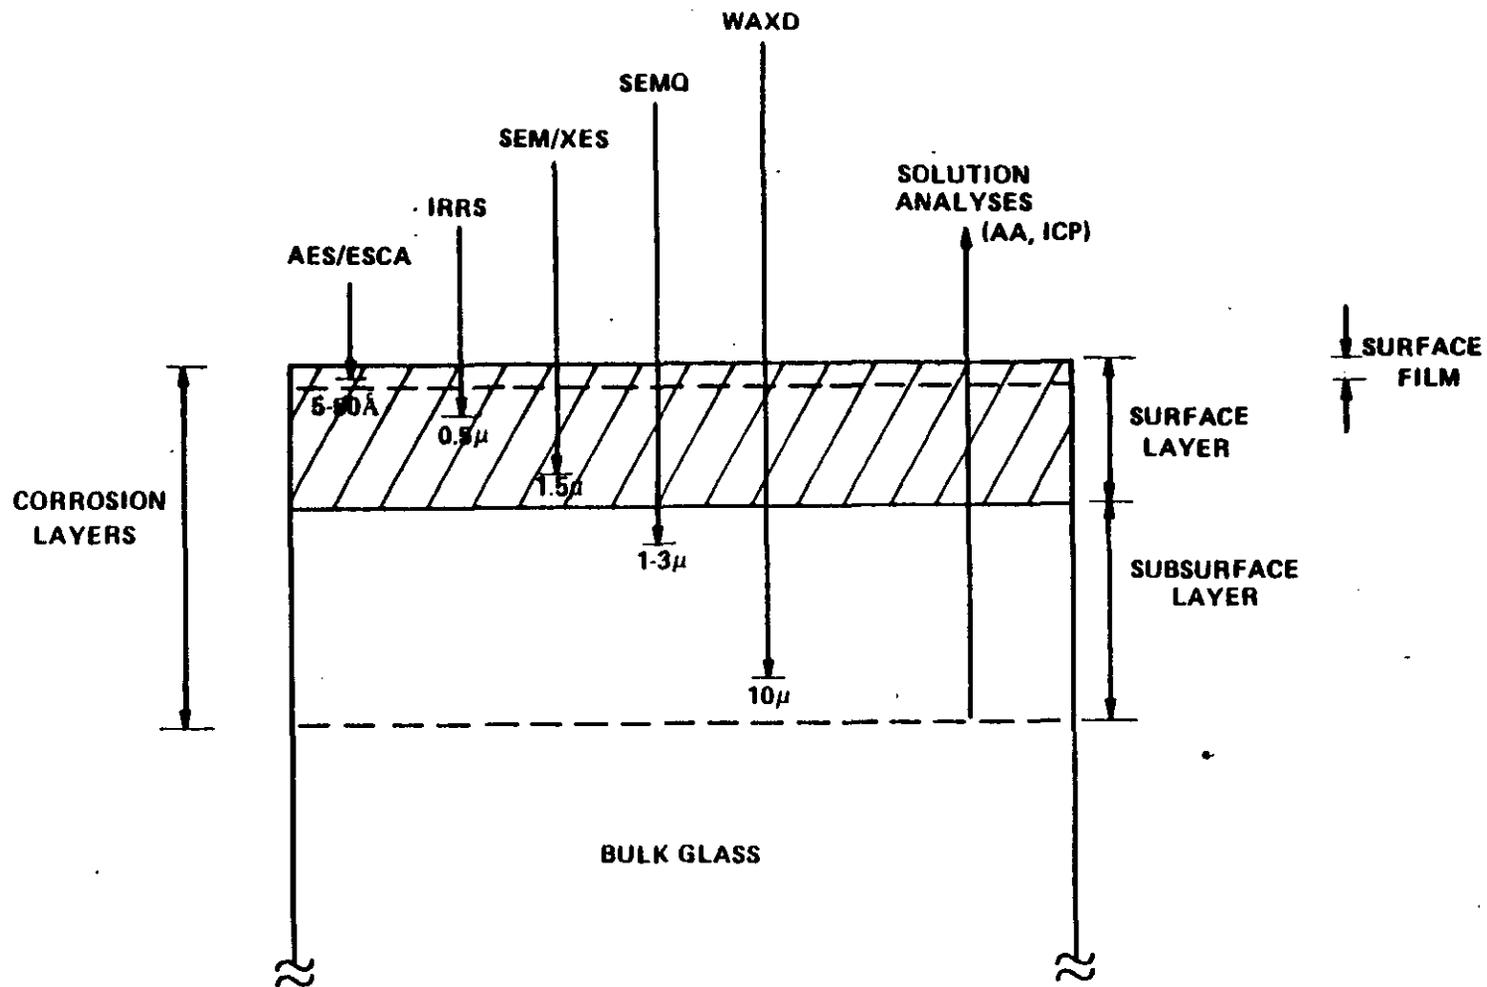
FIGURE 2
ANALYSES OF CORROSION LAYERS*

*Beam penetration generally increases with voltage (kV) and decreases with increasing sample density (ρ) and average atomic number (Z). The surface layer most likely has different Z and ρ than the bulk glass so the estimated range of penetration given is approximate.

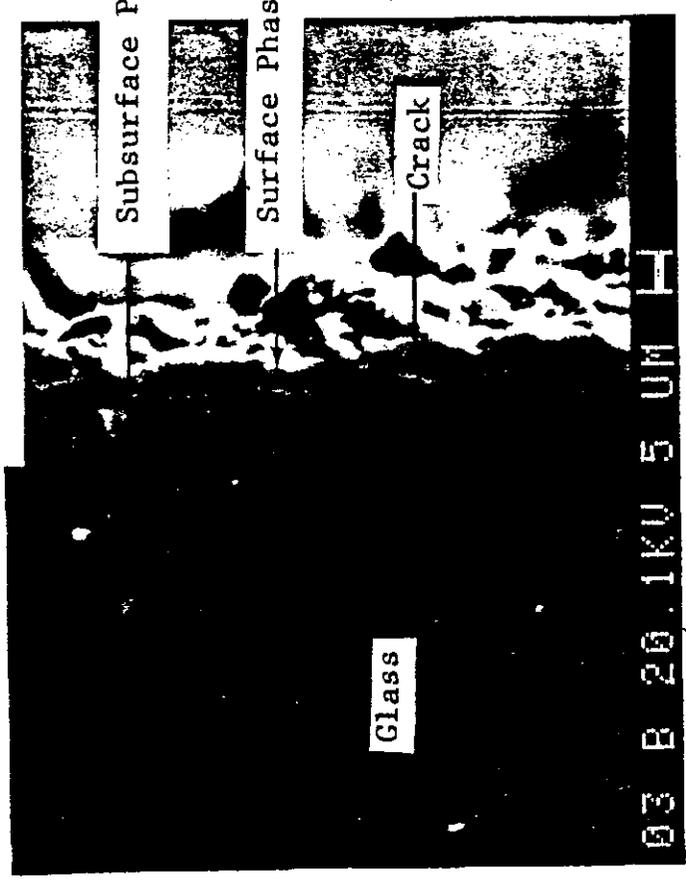
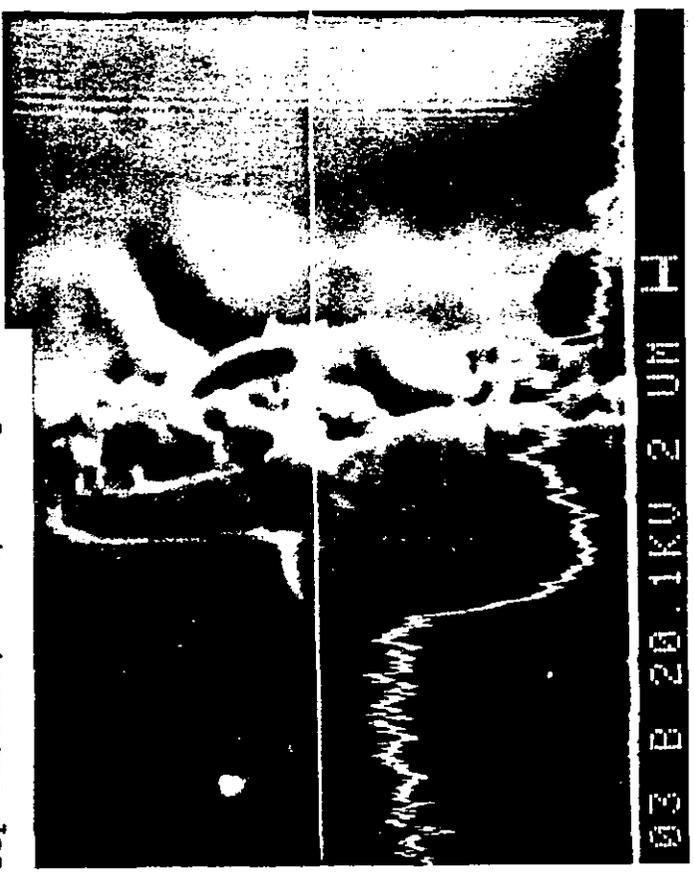
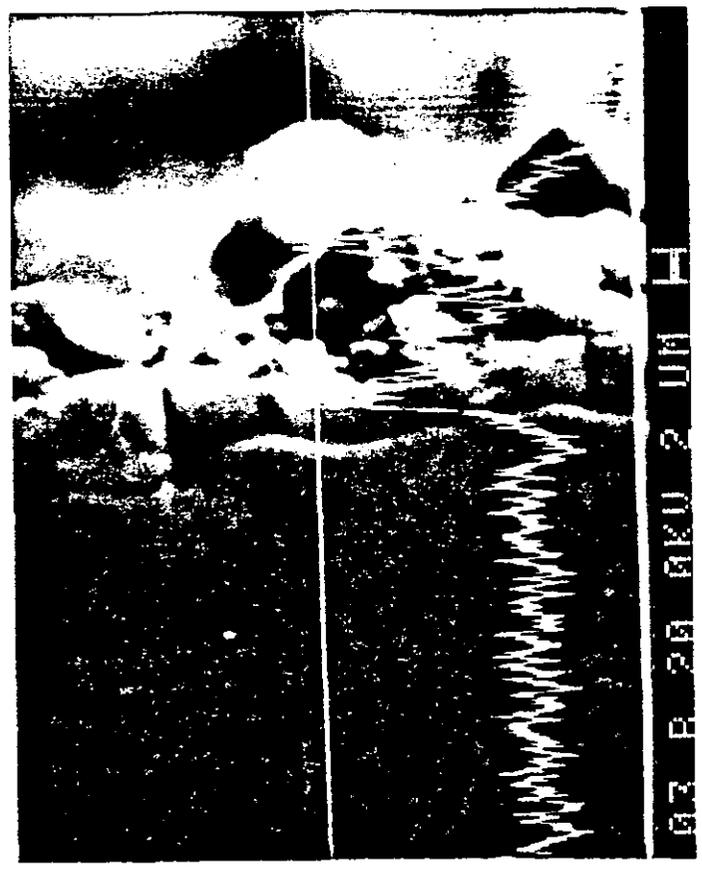
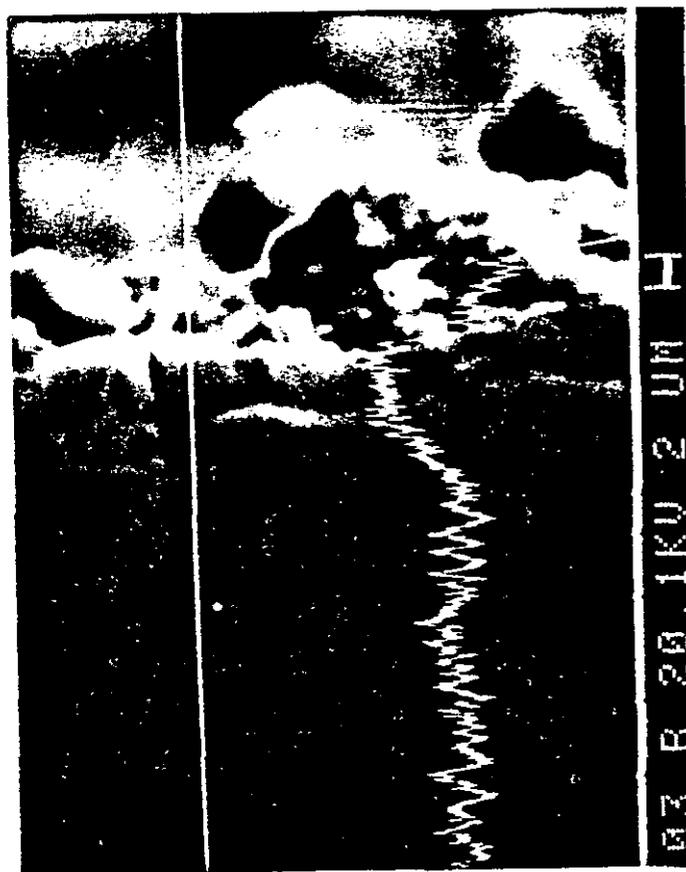
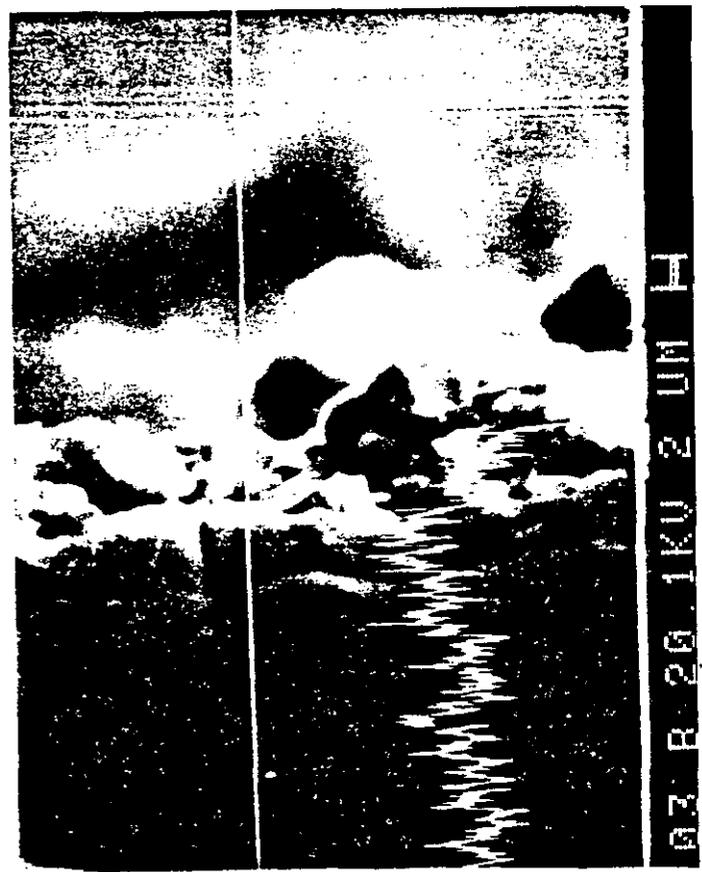
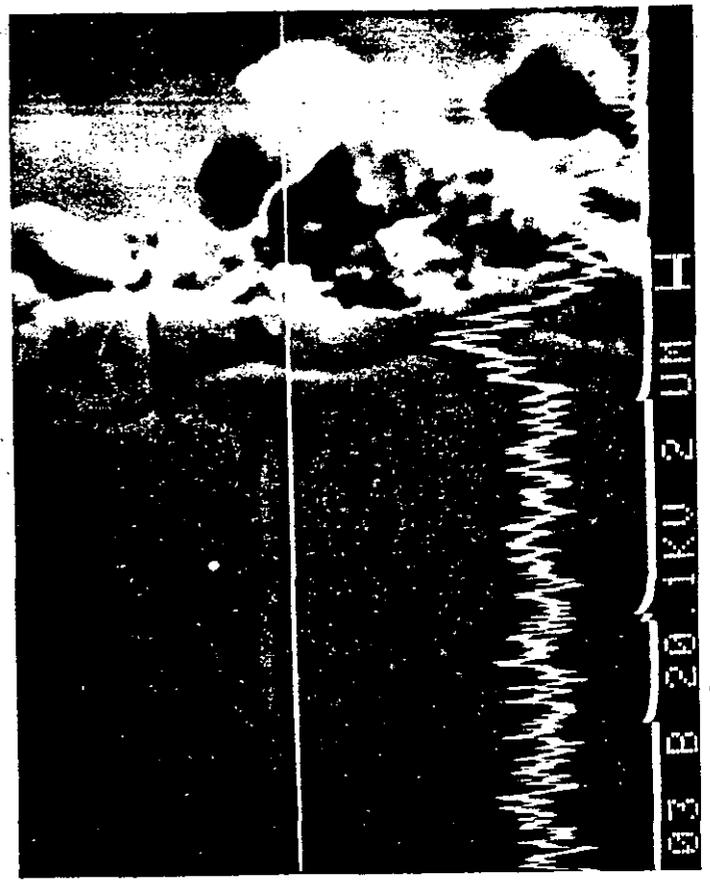
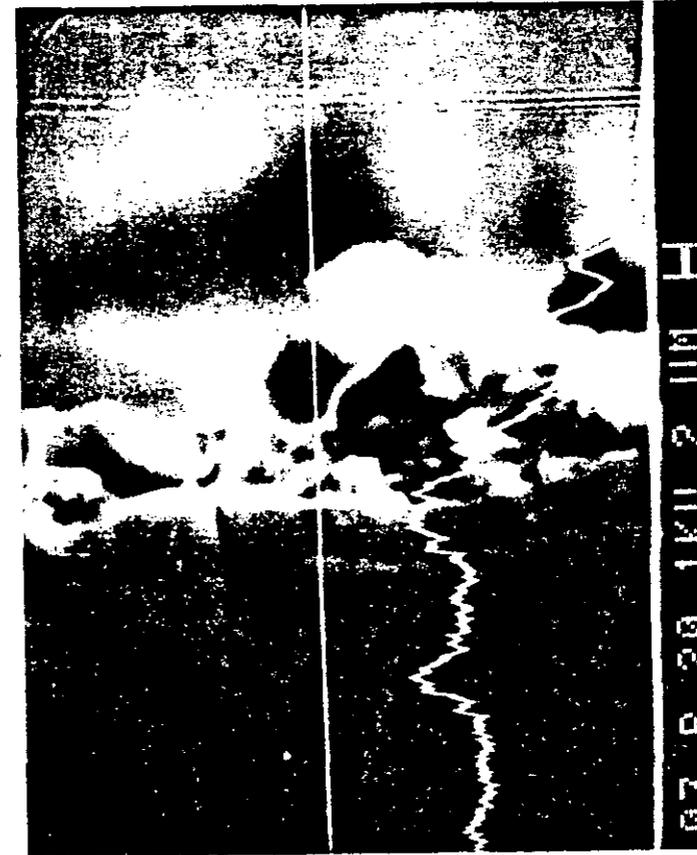
FIGURE 5. Cross Section of Top Surface, 90°C/14.7 psi

Leached Surface Layers

Na Profile

Mg Profile

Ca Profile

Fe Profile

Ni Profile

Mn Profile

Ti Profile

SEMQ analyses showed the surfaces to be composed of two distinct layers. Surface layers were depleted in Na and enriched in Mg, Fe, Mn and Ni relative to the bulk glass. Subsurface layers were depleted in Mg and Na and enriched in Ca, Fe, Mn, Ni, Ti, Al and Si relative to the bulk glass. Cracks extended through these surface layers into the glass.

Elemental x-ray intensity profiles of cross sections of the deposited film and bottom surfaces of the 14.7 and 1000 psi samples are shown in Figure 5 through 7. Wide angle x-ray diffraction of the surfaces of the leached glasses revealed no crystalline phases.

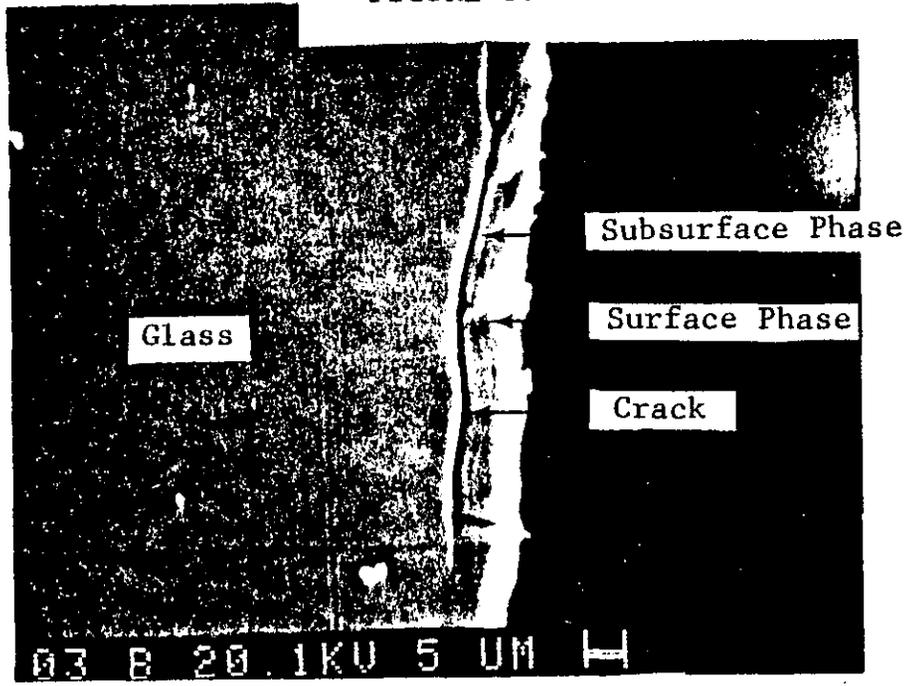
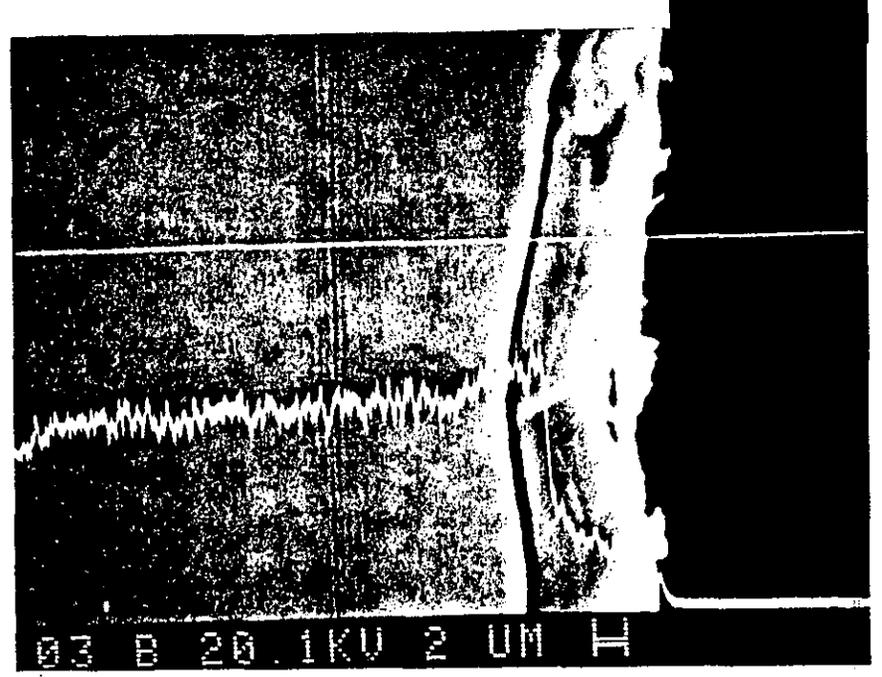
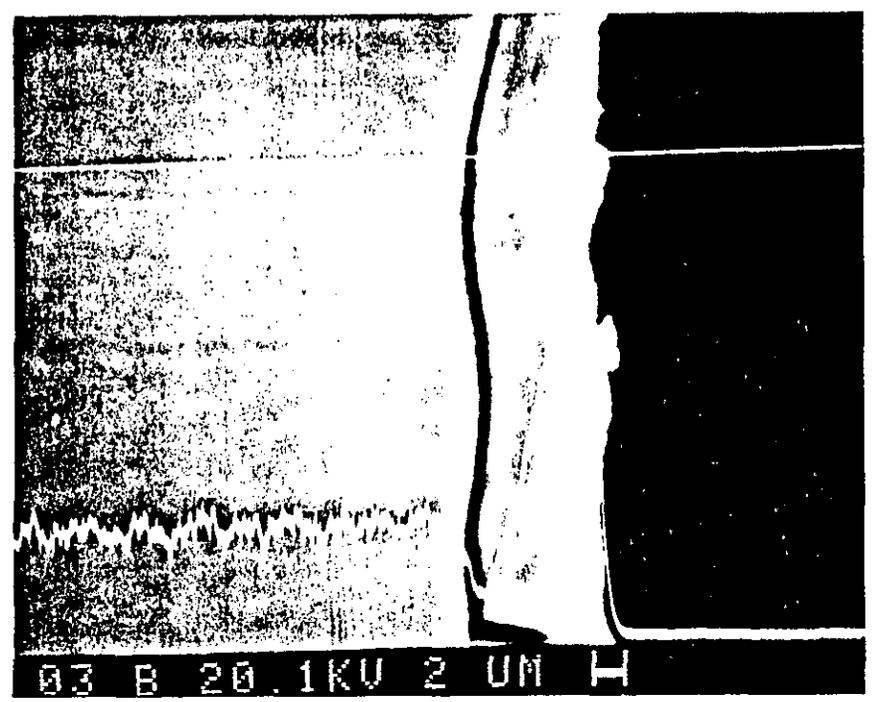
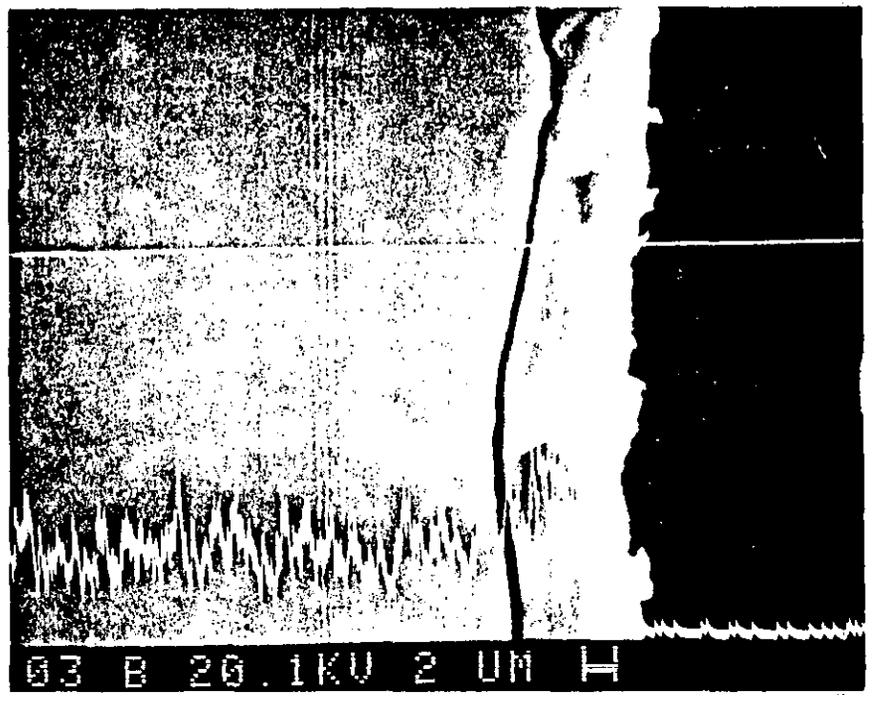
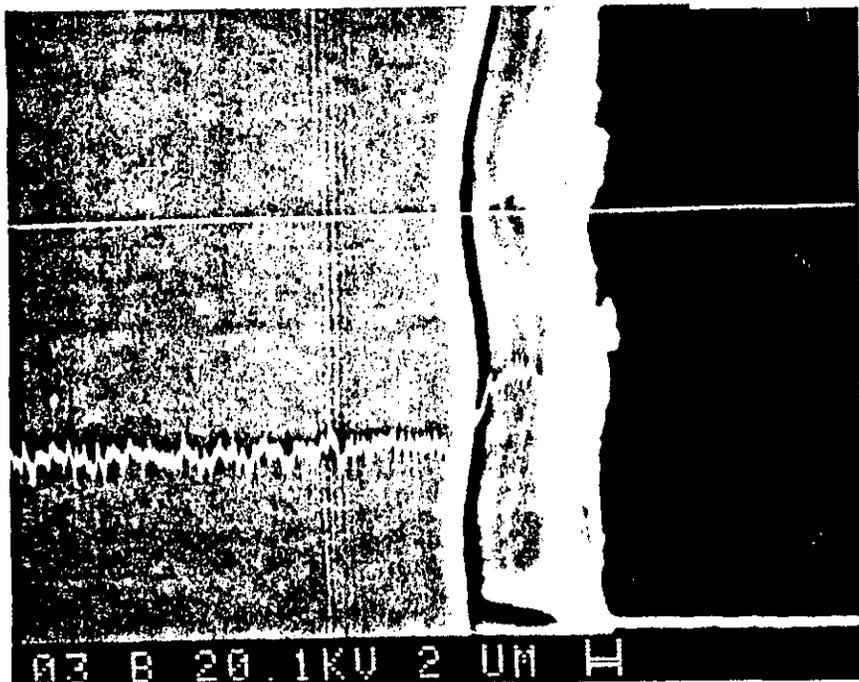
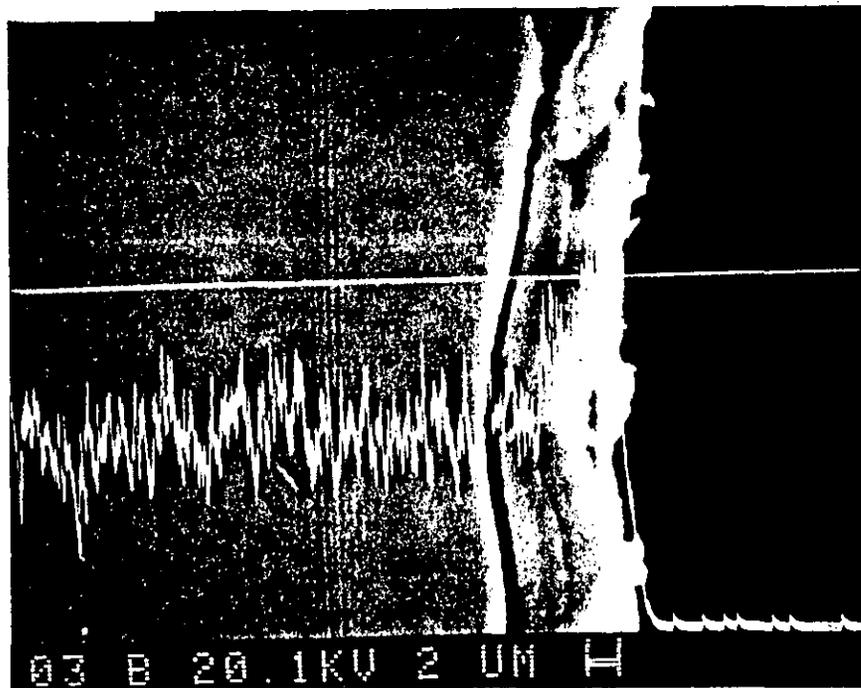
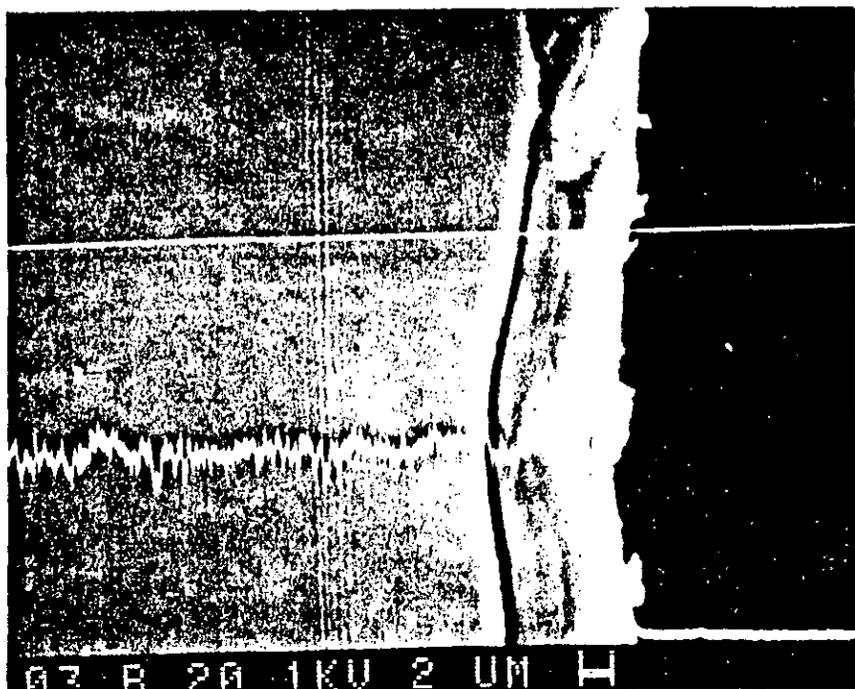
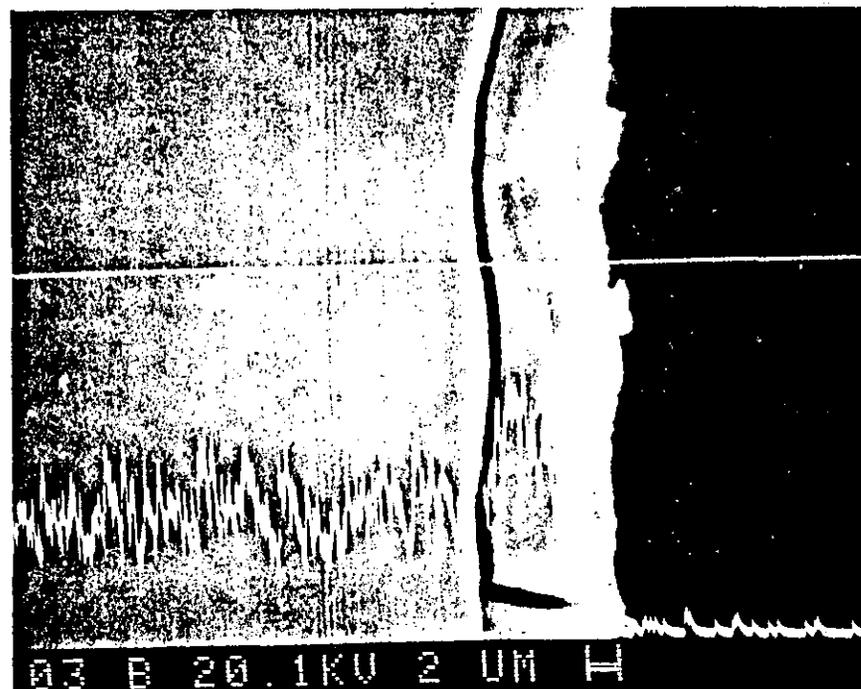
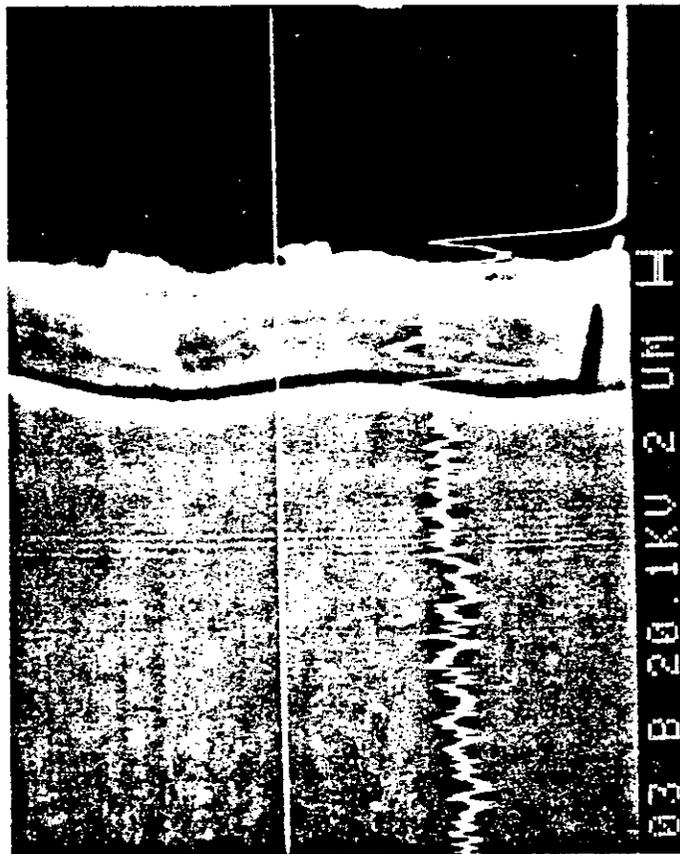
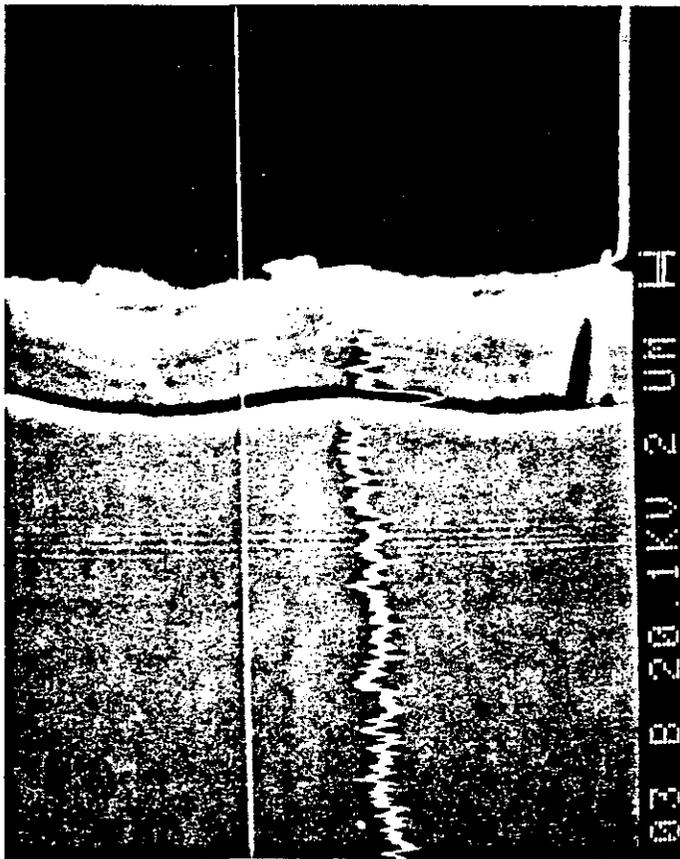
FIGURE 6. TP-3 - Cross Section of Bottom Surface, 90°C/14.7 psi

Leached Surface Layers

Na Profile

Mg Profile

Ca Profile

Fe Profile

Ni Profile

Mn Profile

Ti Profile

Al Profile

Si Profile

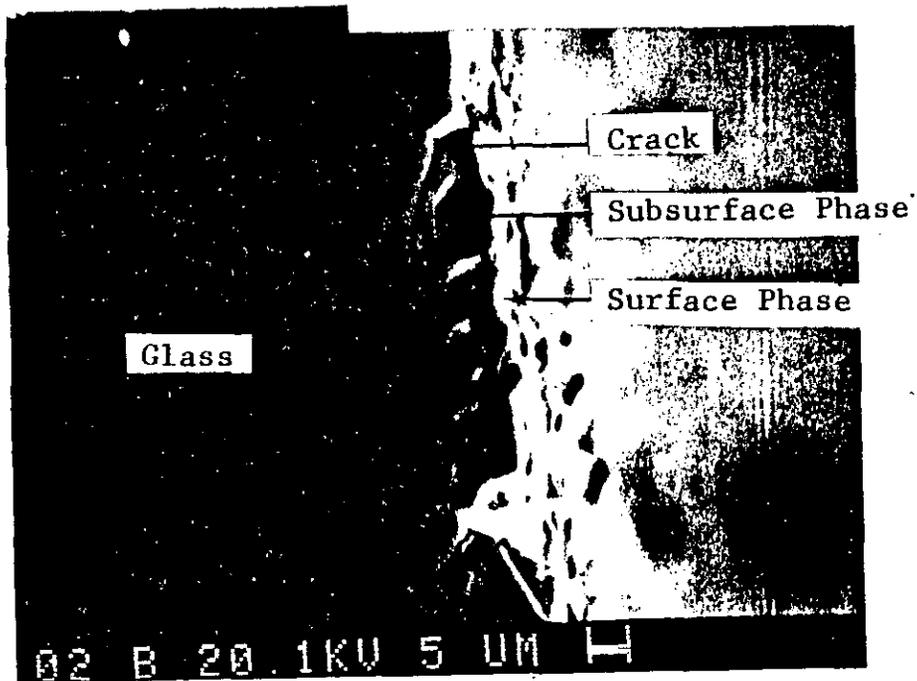
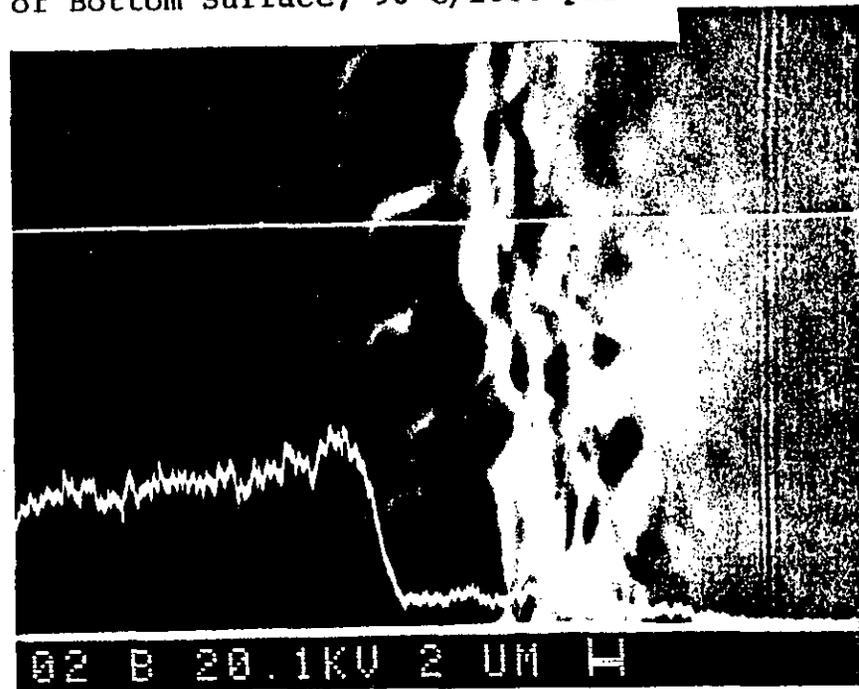
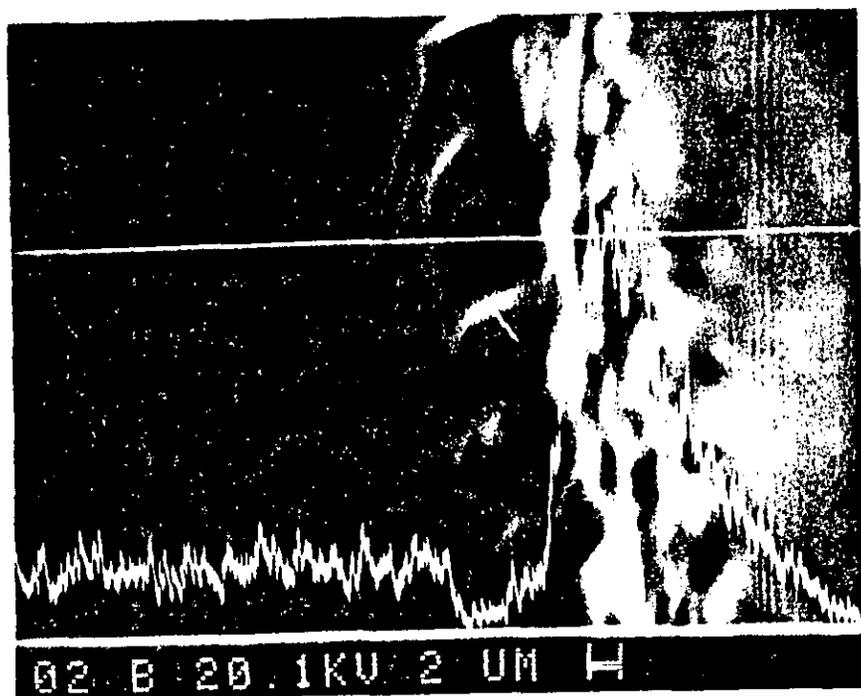
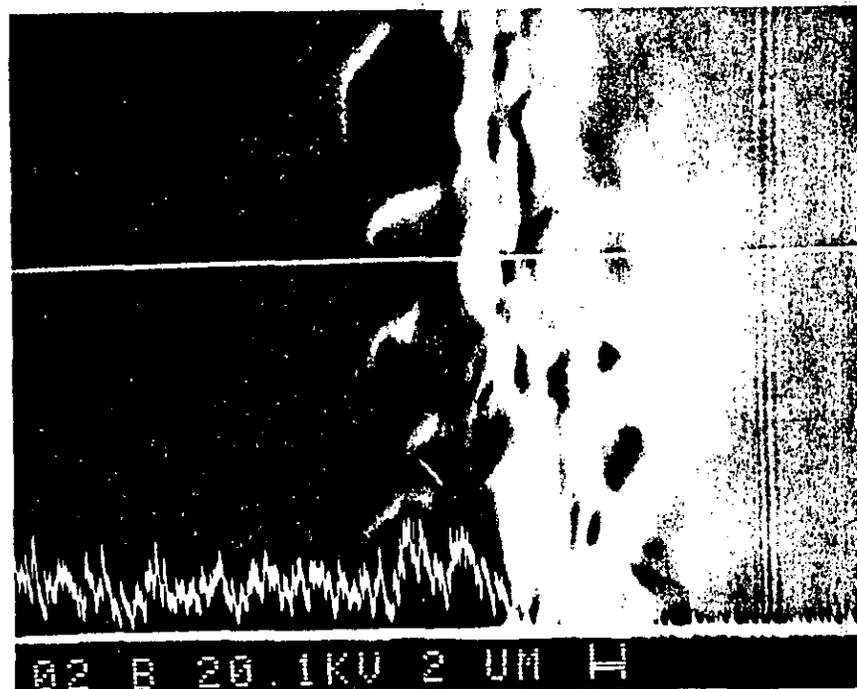
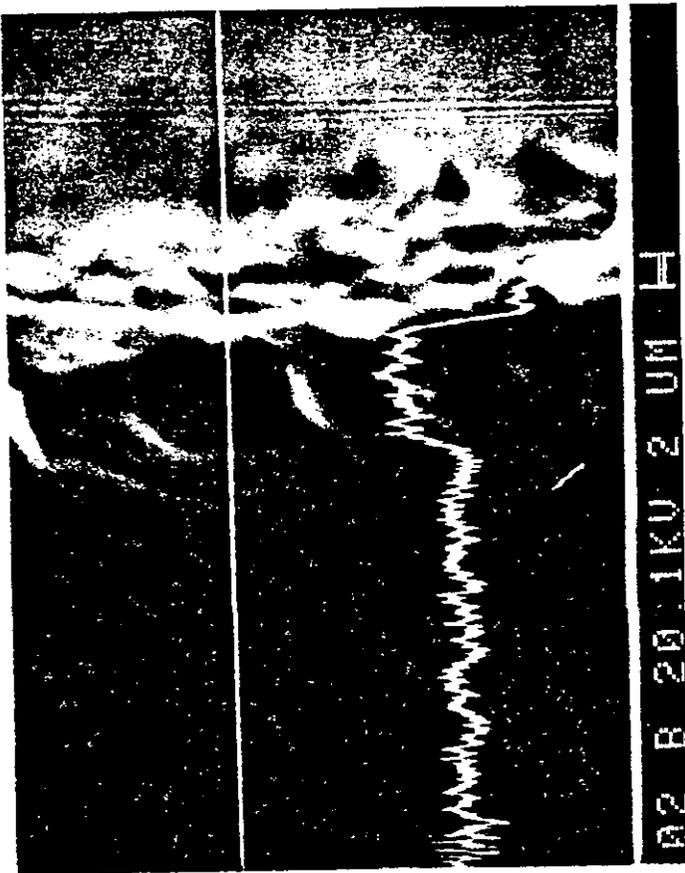
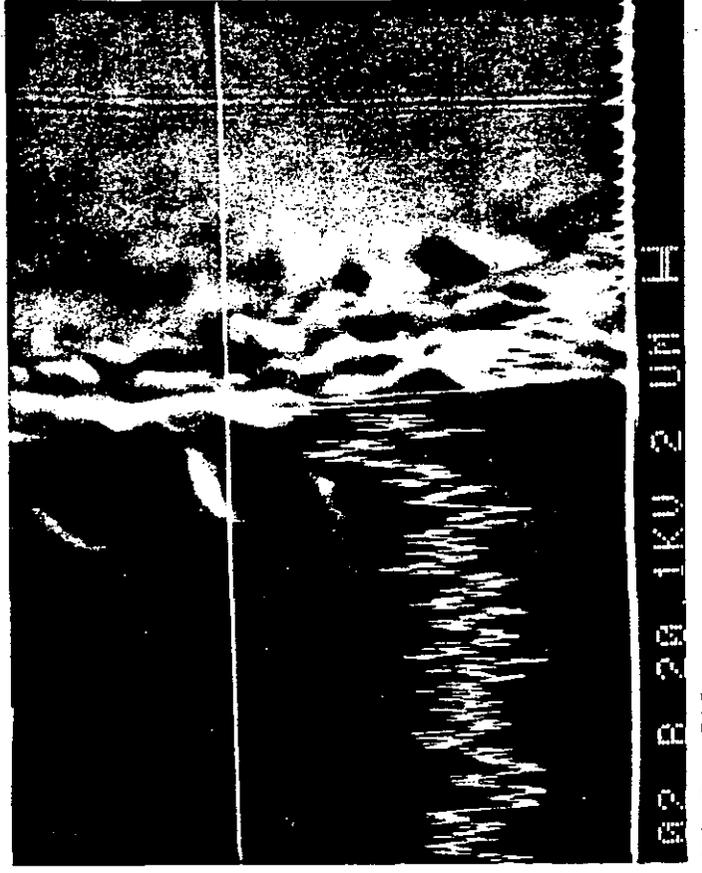
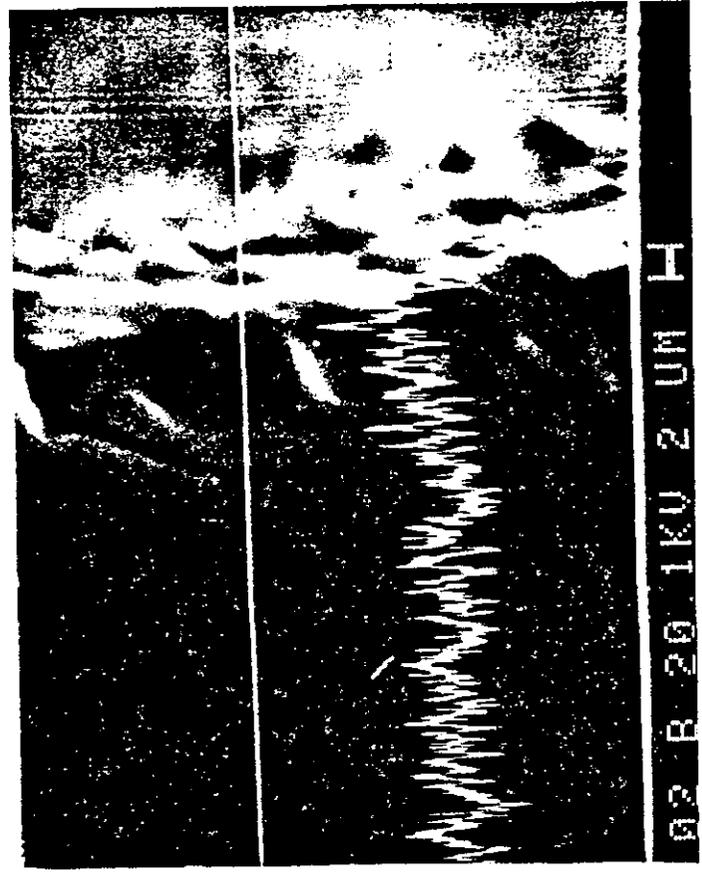
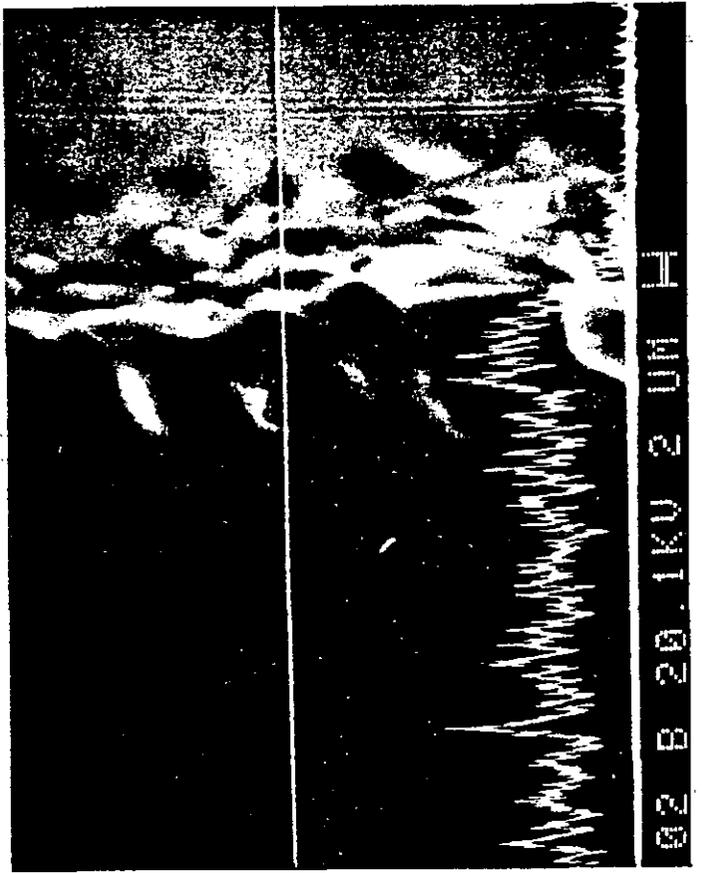
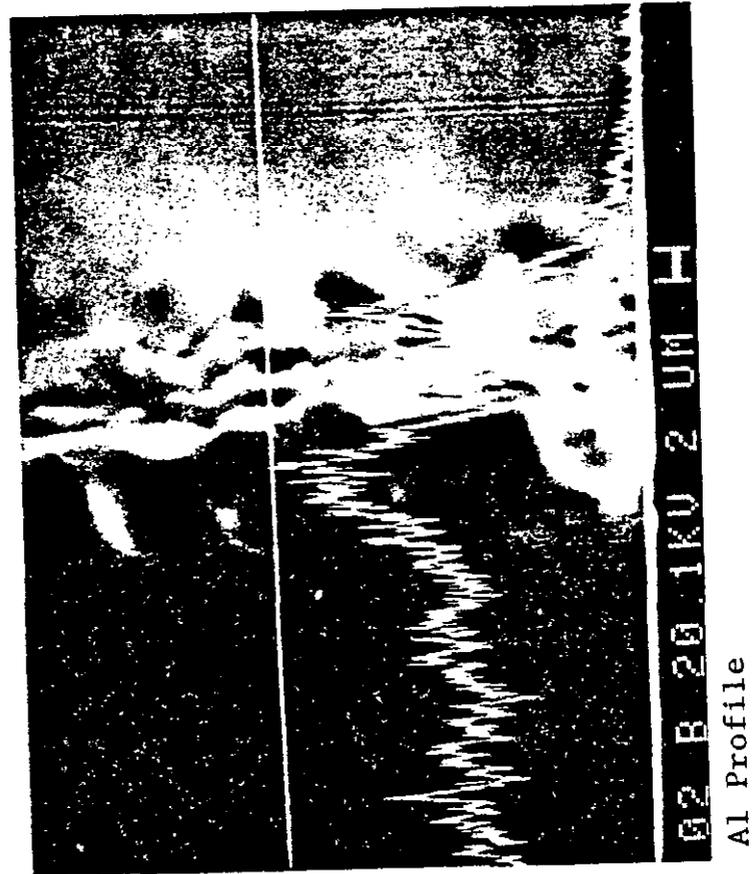
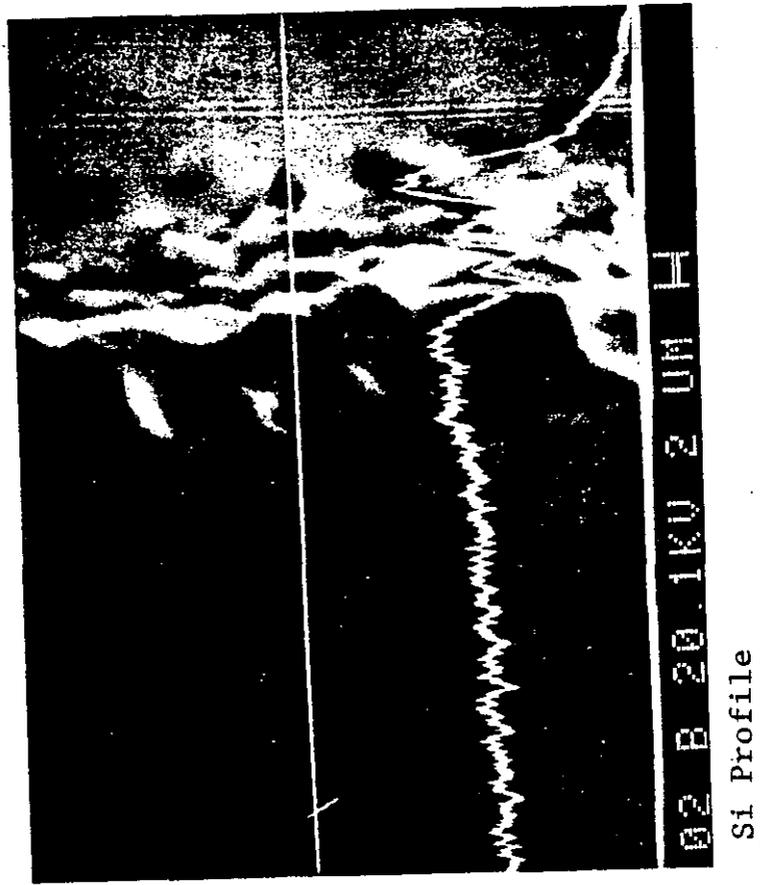
FIGURE 7. TP-3 - Cross Section of Bottom Surface, 90°C/1000 psi

Leached Surface Layers

Na Profile

Mg Profile

Ca Profile

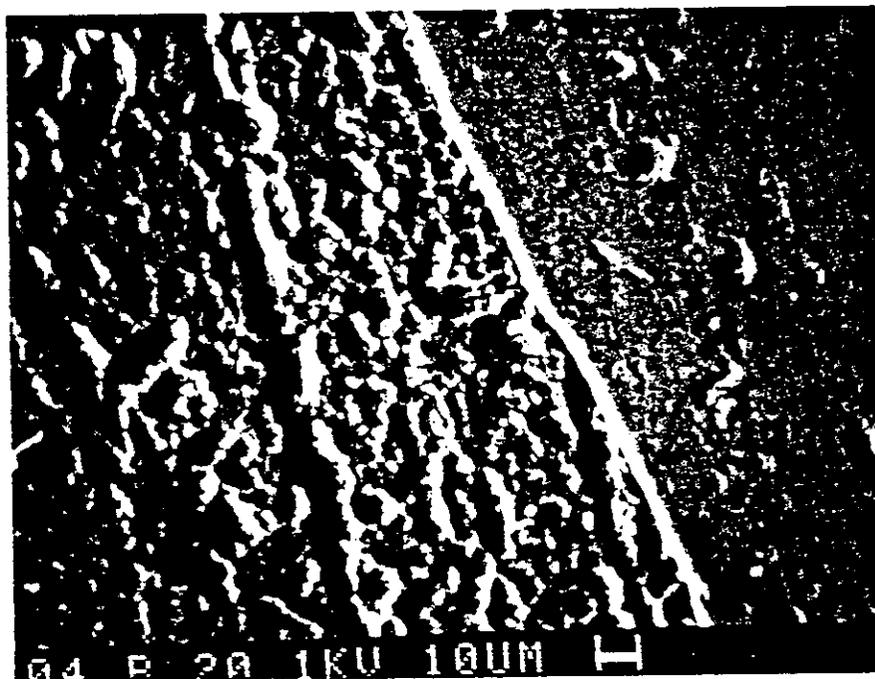
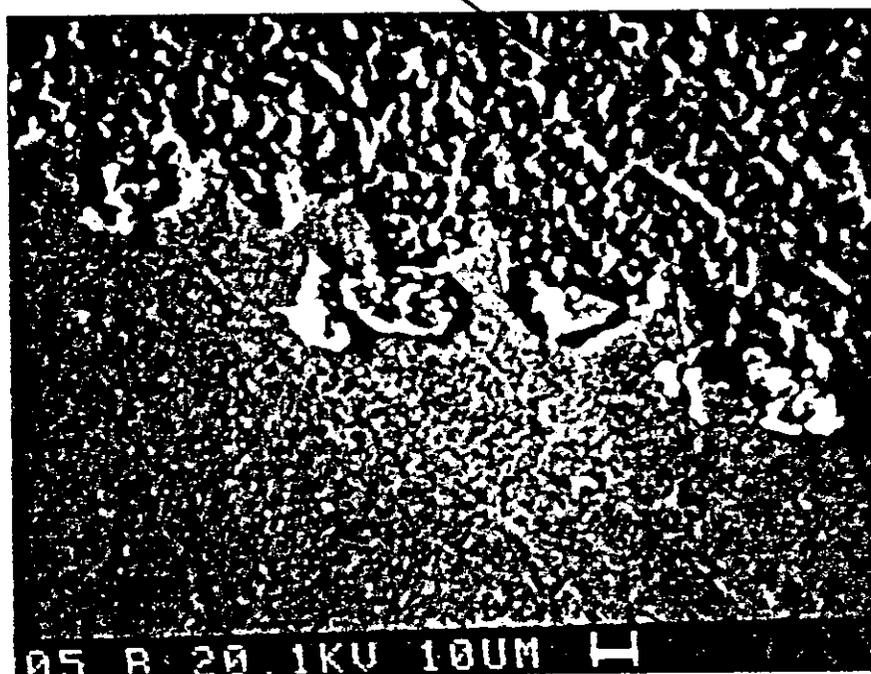
FIGURE 8. Glass Surface Layers of TP-4

Surface
Film

Glass
Under Film

90°C/14.7 psi

90°C/1500 psi

The surfaces of the 14.7 and 1500 psi waste glass slices contained thinner leached zones than in the previous experiments. IRRS spectroscopy defined a corrosion or leached zone of about 5.6 μ for the 14.7 psi sample and only 1.8 μ for the 1500 psi specimen. SEMQ analyses showed the leached glass surfaces had only single surface layers but these layers were composed of at least two distinct phases. No brown deposit was observed. (No glass powders were used in TP-4 experiments.) A significant difference existed in the morphologies of the surfaces of the two specimens. The surface layer of the 14.7 psi sample was hard and very brittle and flaked off easily. There was extensive cracking between this layer and the glass beneath. In contrast, the surface layer of the 1500 psi sample was a gold colored film that appeared to be very adherent to the glass but could be scraped off. These surface layers and the glass surfaces below the layers are shown in Figure 8.
