DPST-81-375

June 5, 1981

DURABILITY OF SRP WASTE GLASS - EFFECTS
OF PRESSURE AND FORMATION OF SURFACE LAYERS

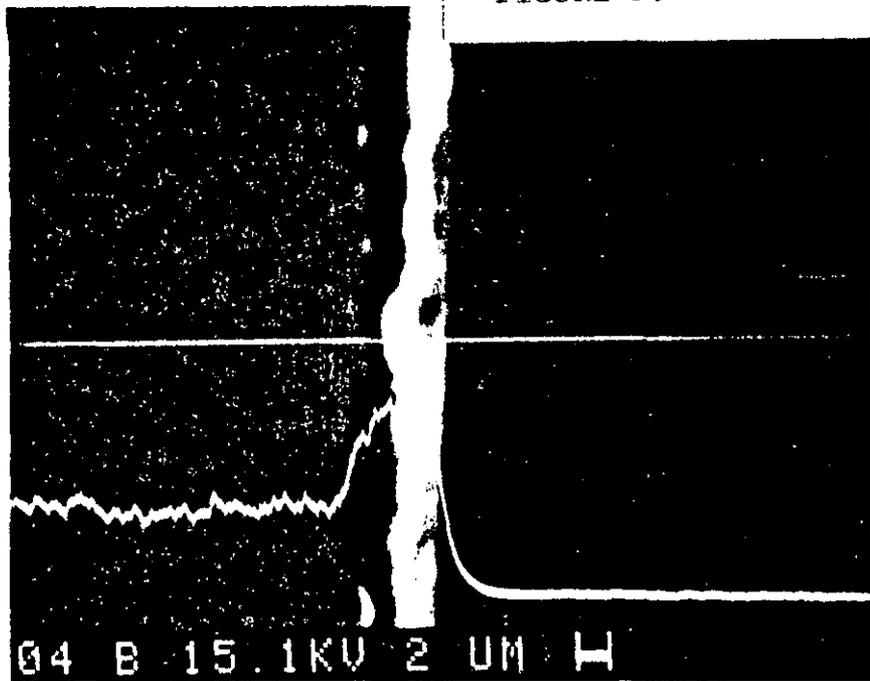
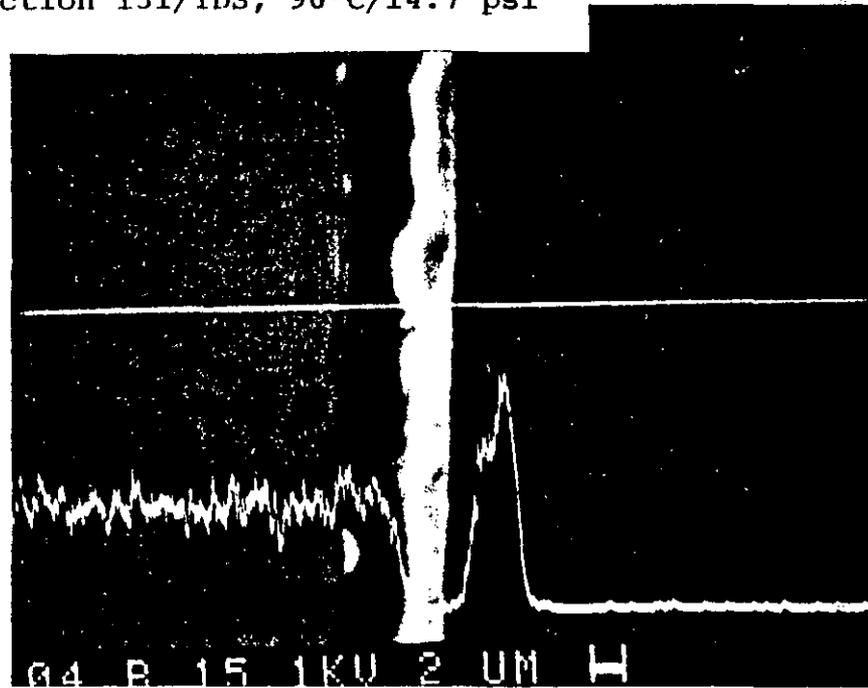
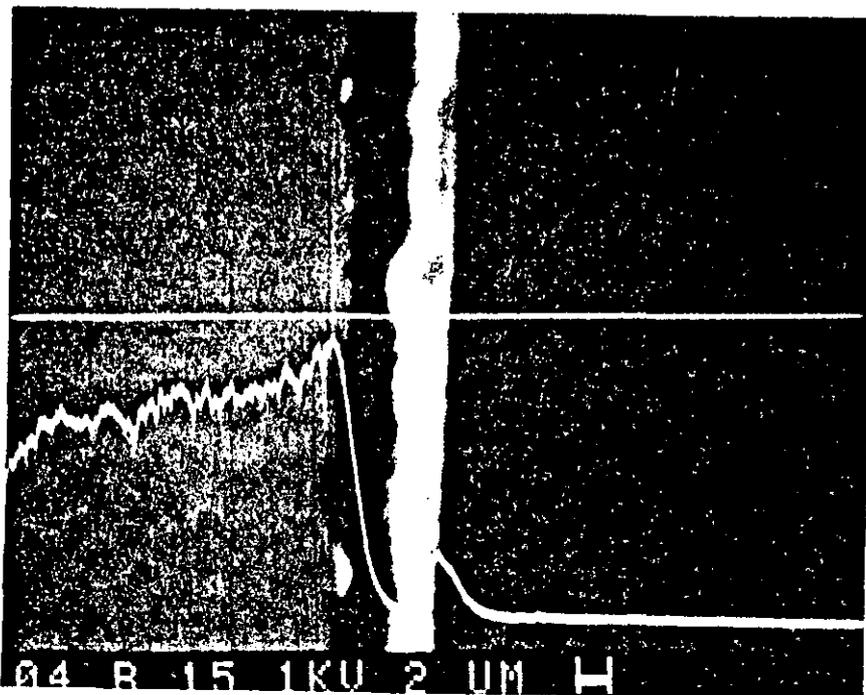
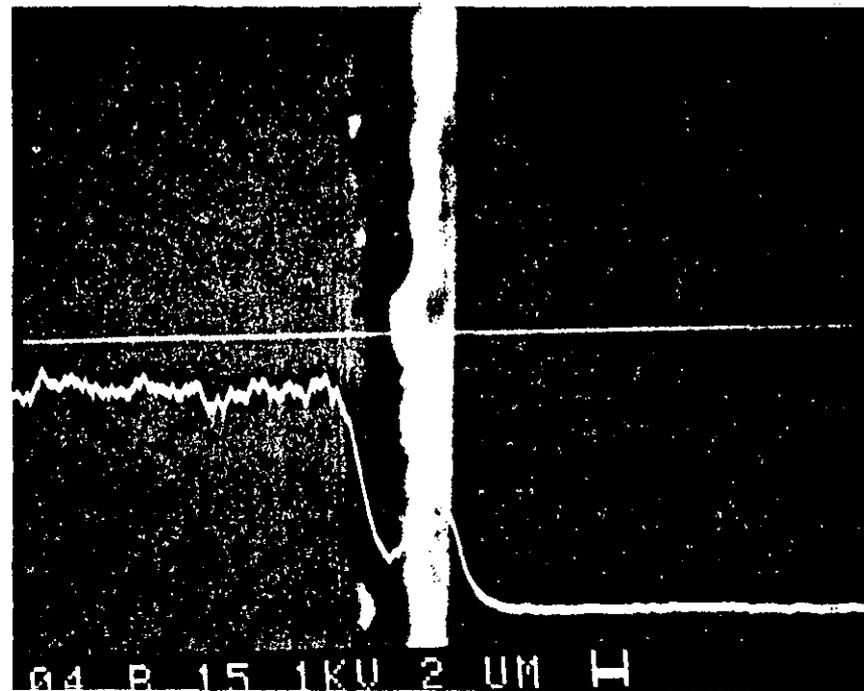
FIGURE 9. TP-4 - Cross Section 131/TDS, 90°C/14.7 psi

Fe Profile

Mg Profile

Na Profile

Si Profile

The leached layer was examined in more detail by SEMQ. Consistent with the previous experiments, the surface layer was again very depleted in Na and slightly depleted in Si. Also noted was a greater than 200% increase in Fe content in the surface layer compared to the bulk glass. The surface layers of both the 14.7 and 1500 psi samples were also generally enriched in Ca, Ti, La, Mn, Ni, Mg and Zr (Table 7). Glass surfaces exposed where the surface flaked off of the 14.7 psi sample and where the surface layer was scraped off of the 1500 psi sample were slightly enriched in Fe and Si and slightly depleted in Na relative to the bulk glass. Elemental x-ray intensity profiles

of the surfaces of the 14.7 and 1500 psi samples are shown in Figures 9 and 10.

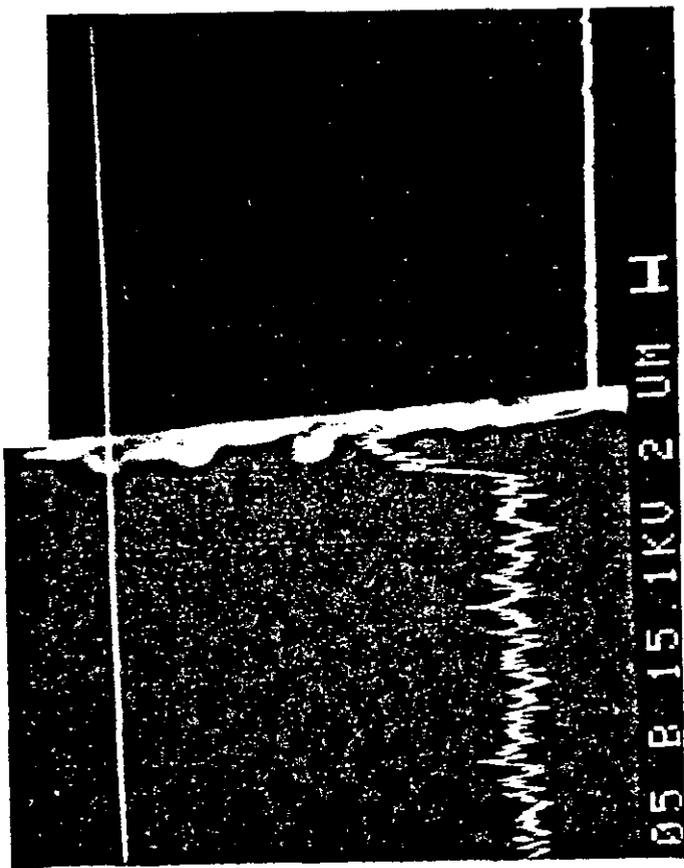
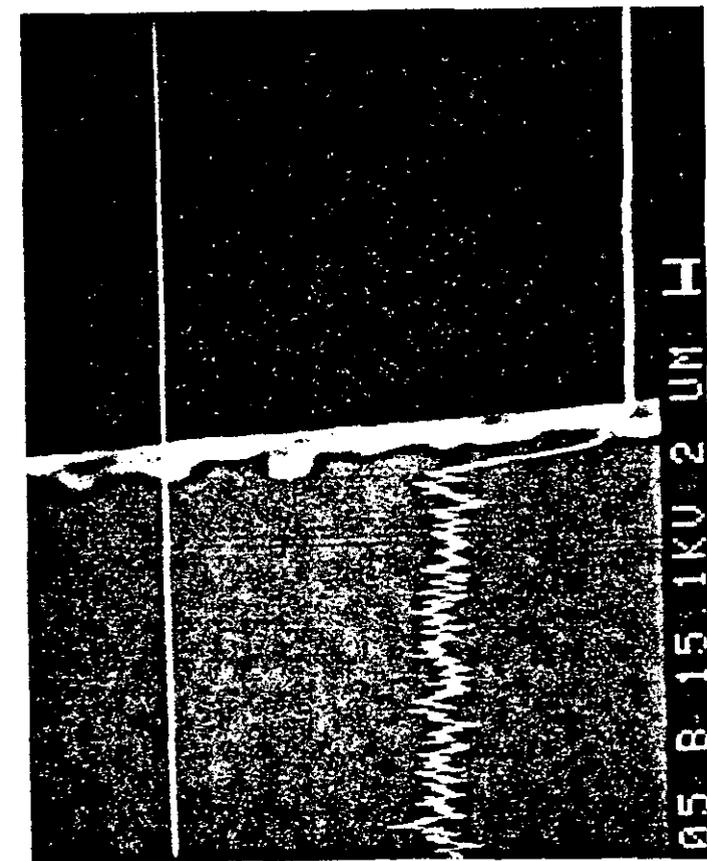
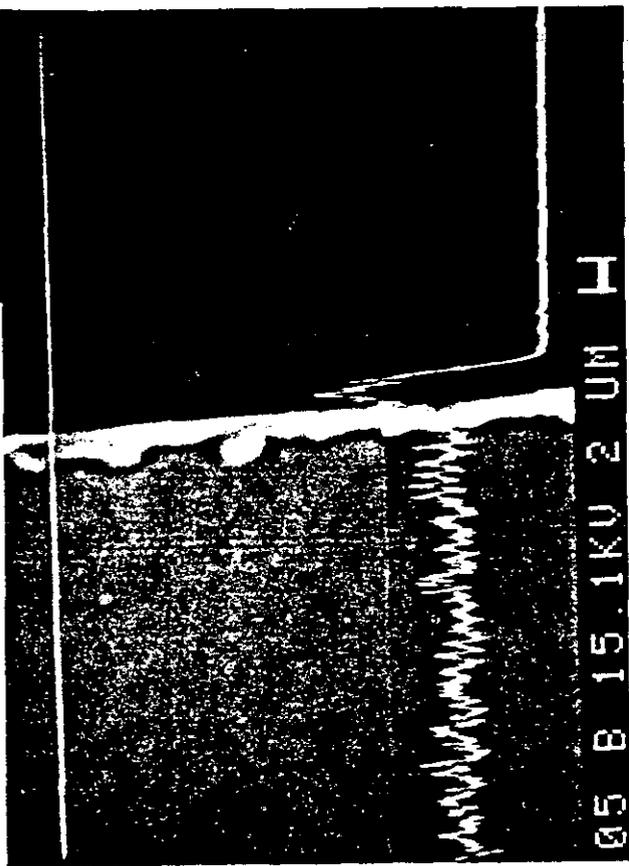
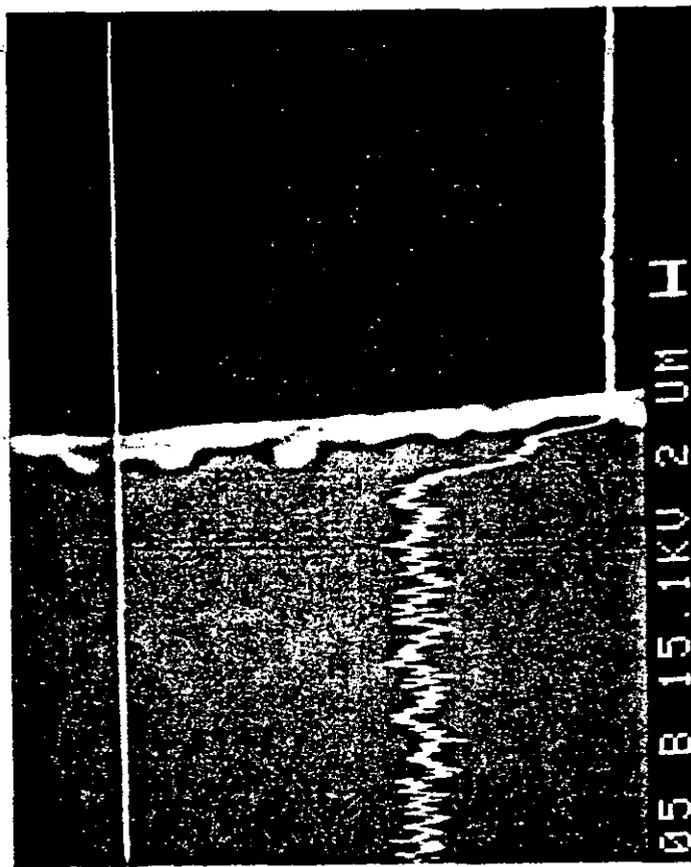
FIGURE 10. Cross Section 131/TDS, 90°C/1500 psi

Fe Profile

Na Profile

Mg Profile

Si Profile
