CRADA Final Report
for
CRADA number ORNL95-0375

IMPROVED MATERIALS FOR USE
AS COMPONENTS IN KRAFT BLACK
LIQUOR RECOVERY BOILERS

J. R. Keiser
G. A. Aramayo
G. M. Goodwin
P. J. Maziasz
Oak Ridge National Laboratory

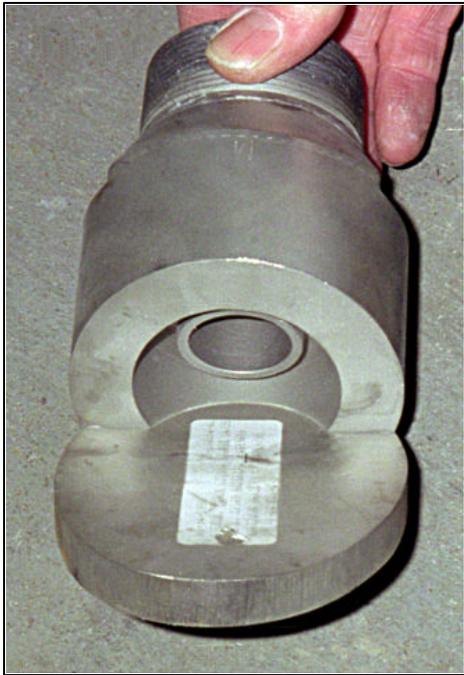
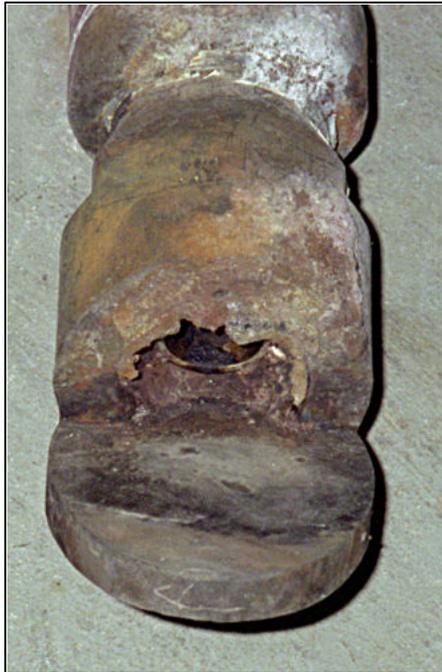
Fig. 1 Splash plate type liquor nozzles a) unexposed and b) degraded.

Figure 1a shows a new black liquor splash-plate-type nozzle while Fig. 1b shows a degraded one which has lost the majority of the barrel and a portion of the splash plate surface due to corrosion and/or erosion. For this study, splash-plate-type nozzles were prepared with new parts and with parts that had seen some service, i.e. a repair approach. In both cases, approximately 4.8 mm (3/16 in.) of the top surface of the splash plate was machined away and replaced by two layers of gas tungsten arc (GTA) iron aluminide weld metal, each about 3.2 mm (1/8 in.) thick. The top surface was then machined bringing the part back to its original thickness. The leading edge of the nozzle barrel was also overlaid with a single layer of iron aluminide weld metal. A second type of nozzle, a swirl-cone type, was overlaid with iron aluminide using both new and post-service parts. The leading edges of the cones were removed and replaced with GTA weld metal as were the outlet orifices. The parts were then machined back to the original dimensions. Both types of liquor nozzles, like those shown in Fig. 2, were installed in mills in North America.

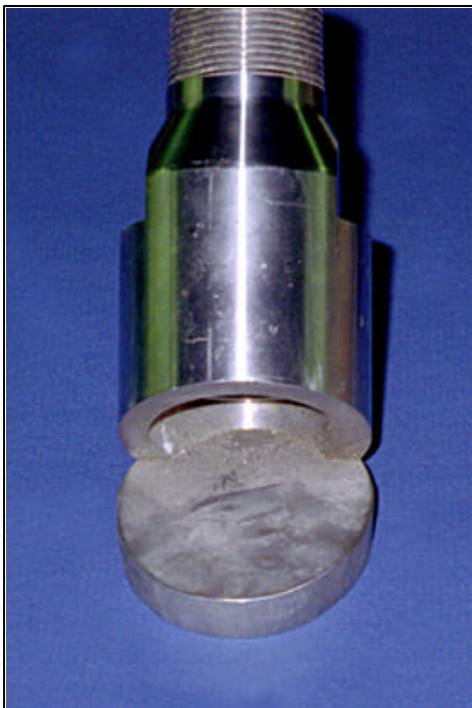
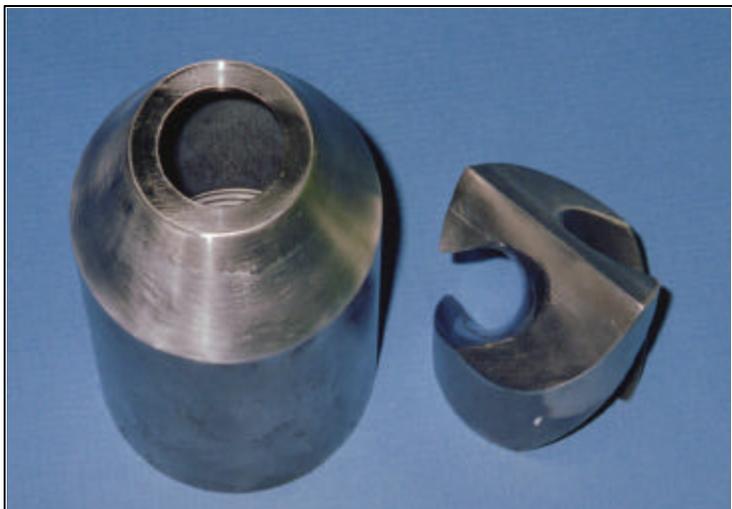
Fig. 2 Splash plate and swirl type liquor nozzles after application of iron aluminide. steel plate and then overlaid with a pad of iron aluminide weld metal. The plates were installed in a mill in the south central U.S. and their performance monitored by periodic visual examinations by mill personnel.

Experience with the iron aluminide liquor nozzles and liquor port linings showed that the iron aluminide did not provide good corrosion resistance. Apparently, molten salts drip on and splash on the nozzles and linings, and these salts are so aggressive that the aluminide is corroded at an unacceptably high rate. Consequently, it was concluded that the corrosion resistance of iron aluminide was not sufficient to give satisfactory service under the molten salt conditions experienced by liquor nozzles and port linings of a black liquor recovery boiler.

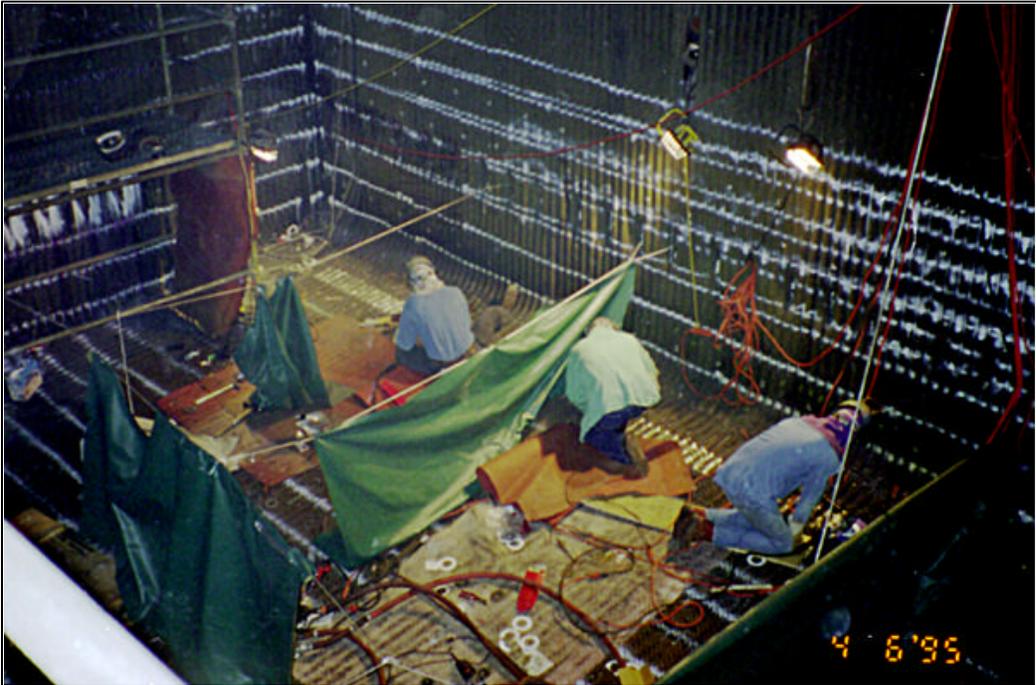
Fig. 3 Weld overlay being applied to floor tubes of Columbus, MS, recovery boiler.

The Weyerhaeuser mill in Columbus, MS is one where this floor tube thinning was observed. Consequently, arrangements were made to have a weld overlay applied to a short length of the floor tubes near the front wall during the April, 1995 shutdown. The lower boiler during application of the weld overlay is shown in Fig. 3. During subsequent shutdowns, visual inspections of the overlaid floor tubes were made, and, after a year's exposure, a few short sections were removed for metallographic examination. Figure 4 shows a section of the weld overlaid floor tubes after a year's exposure. Residual stress measurements were not made in tube sections that were removed because removal of the sections from the floor relieved most of the stresses that were developed during the overlay process. However, the deformation of the weld-overlaid floor tubes suggested that significant stresses were developed in the tubes as a result of the application of the weld overlay.

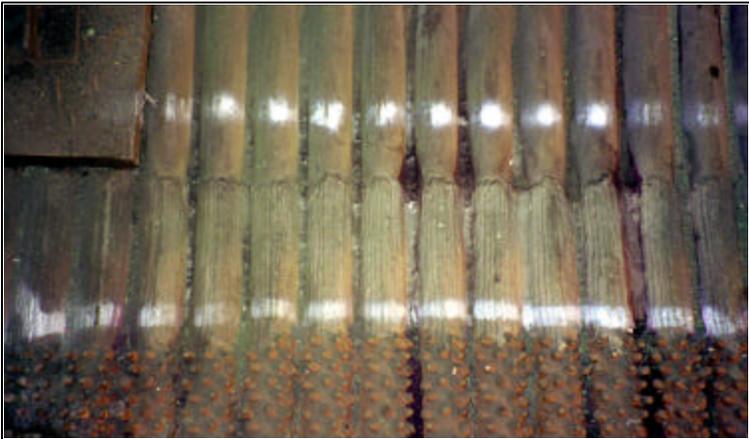
Fig. 4 Section of weld overlay floor tube.

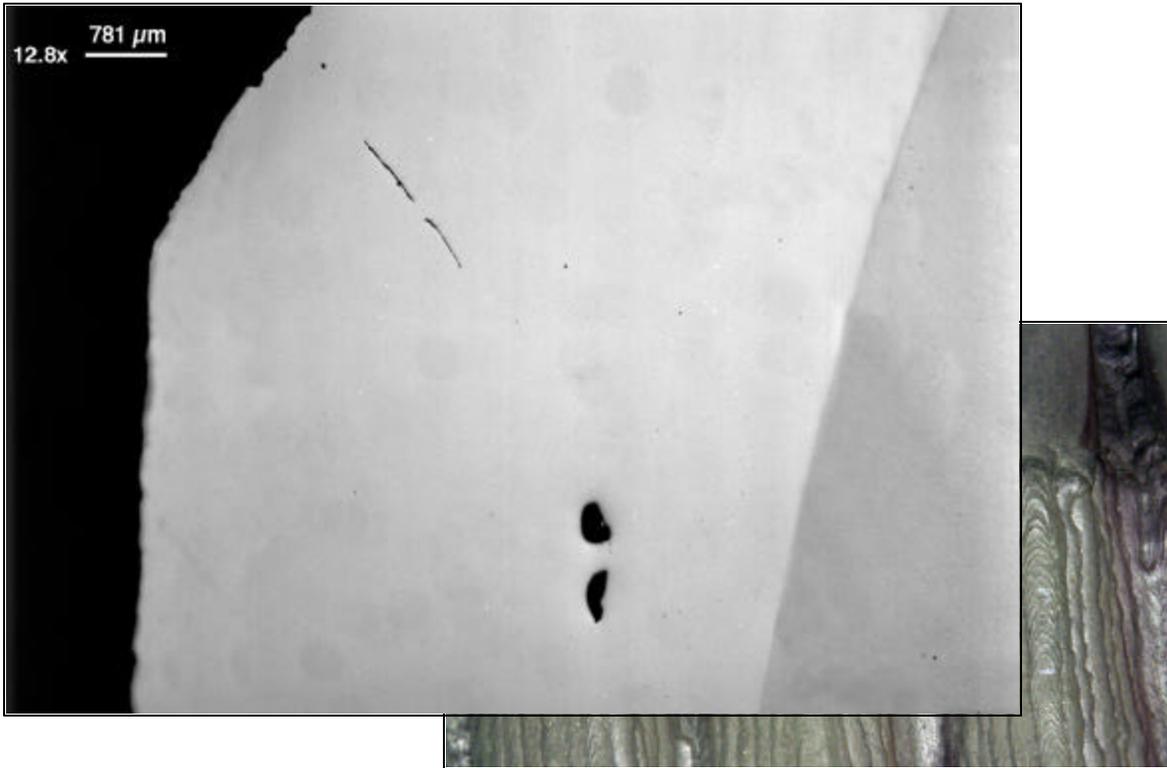
Fig. 5 Cross section of weld overlaid tube showing lack of fusion and porosity.

Cross sections were taken from the weld overlaid tubes that had been removed from the floor, and these sections were examined metallographically. Results of the examination showed that field application of the weld metal resulted in less than ideal quality. The weld surface showed some significant irregularities, and some porosity was evident. An example is shown in Fig. 5. As shown in Fig. 6, the depth of the heat affected zone varied appreciably along the surface which is not unexpected given the difficulties associated with the field application. Despite these shortcomings, the overall appearance and condition suggest that the weld overlay provided the desired protection of the carbon steel tubes.

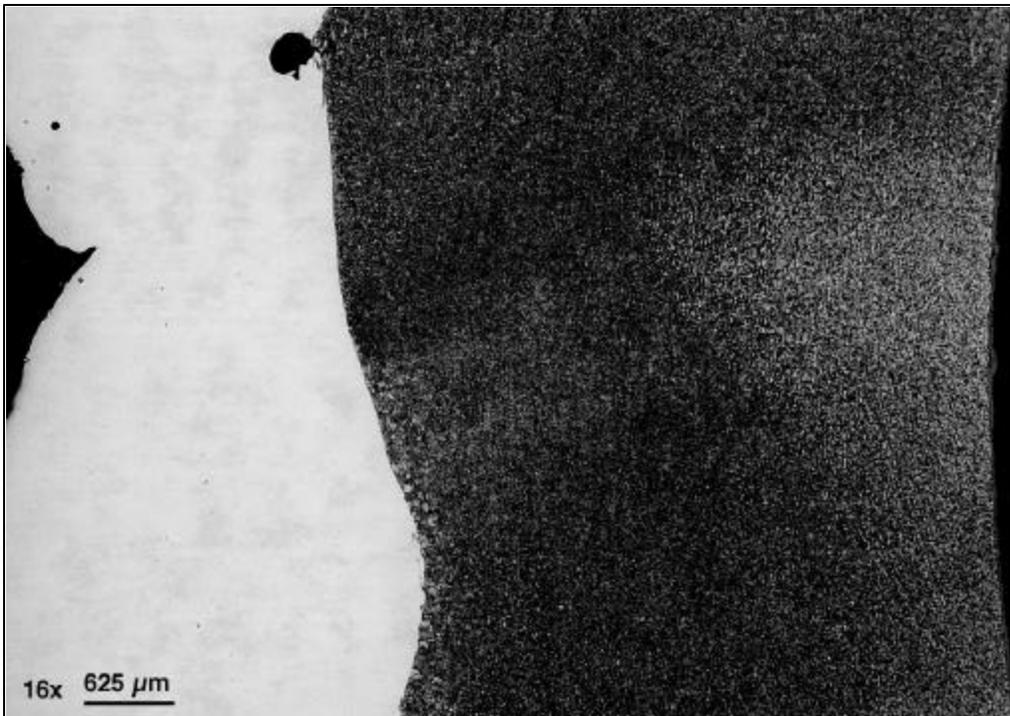
Fig. 6 Etched cross section of weld overlaid tube where darkened areas indicate heat affected zone.

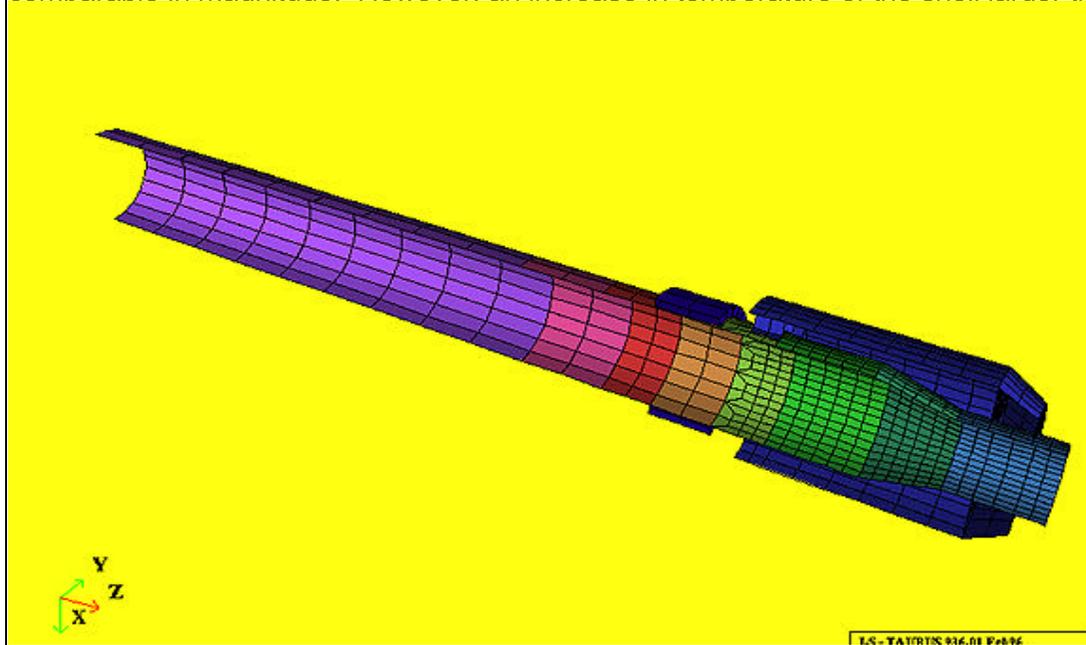
Fig. 7 Finite element model of the lime kiln/cooler configuration.

of refractory brick, insulation, and the structural steel shell. Figure 7 shows the finite element used to describe the lime kiln/cooler configuration. The shell response was determined for two different temperature profiles across the wall of the kiln at the failure location. In addition, the effects of mortar at the brick interfaces and between the brick and insulation were investigated. Lastly, the effects on the lining stability associated with the choice of brick size was studied.

The finite element analysis showed that an increase in the shell deformation decreases system structural stability but must be due to something other than thermal effects. With regard to the interaction between the lime kiln's internal components, an increase in the friction at the brick-to-brick and brick-to-insulation interfaces increases the stability of the system, as does an incremental increase in the bonding strength of the mortar at the brick-to-insulation interface.
