Document Number: SNF-5116, Revision 0

Document Title: Fuel Retrieval Sub-Project Stuck Fuel Station Performance Test Data Report

Abstract: This document provides the test data report for Stuck Fuel Station Performance Testing in support of the Fuel Retrieval Sub-Project. The stuck fuel station was designed to provide a means of cutting open a canister barrel to release fuel elements that are stuck due to bent or swollen fuel, corrosion products, or the presence of debris. Testing confirmed that the cutting system adequately cuts the barrels provided an alternate blade is used.

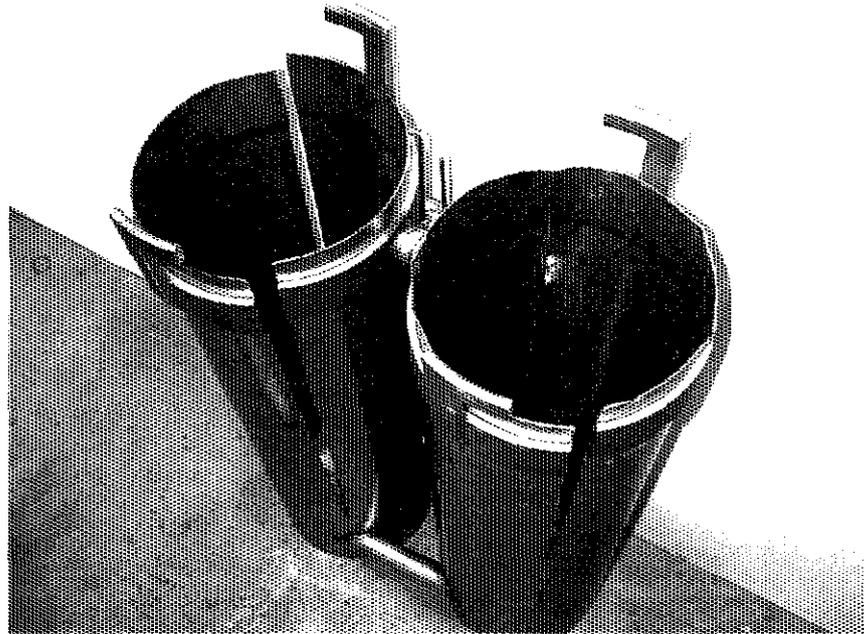
Figure 4. Typical Spread Canister Barrels

Once all four cuts were made, the canister spreading tool was used to spread the cans. The spreader did not engage the barrel lip well, and popped out during operation. The spreader was lined up with the lid brackets and performed much better. The spreader was able to open the cans up to over 8.5 inches. Figure 4 shows typical canister barrels after spreading. See Table B.2 for diameter after spreading data.
