Poster to be presented at the 2002 Gordon Research Conference – Aqueous Corrosion in New London (NH) July 14-19, 2002

## STRESS CORROSION CRACKING BEHAVIOR OF ALLOY 22 IN MULTI-IONIC AQUEOUS ENVIRONMENTS

Kenneth J. King, John C. Estill and Raúl B. Rebak  
Lawrence Livermore National Laboratory, Livermore, CA, 94550

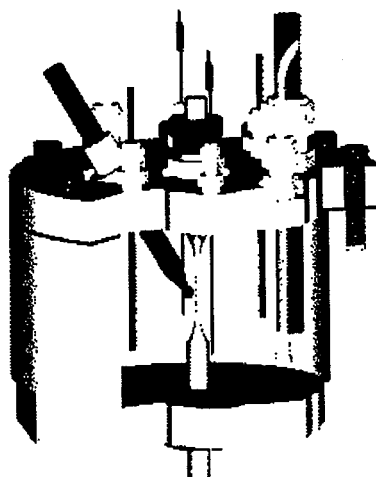
Figure 2: Apparatus Set Up for SSRT Testing

Each specimen was cylindrical, approximately 7.25-inch (184 mm) long and 0.438-inch (11 mm) diameter. The useful gage of the specimens was 1-inch (25.4 mm) long and had a 0.1-inch (2.54 mm) diameter. The slow strain rate tests were conducted at a constant deformation rate of  $1.6 \times 10^{-6} \text{ s}^{-1}$ . The concentration of some testing solutions are given in Table 3. The apparatus set up is shown in Figure 2.

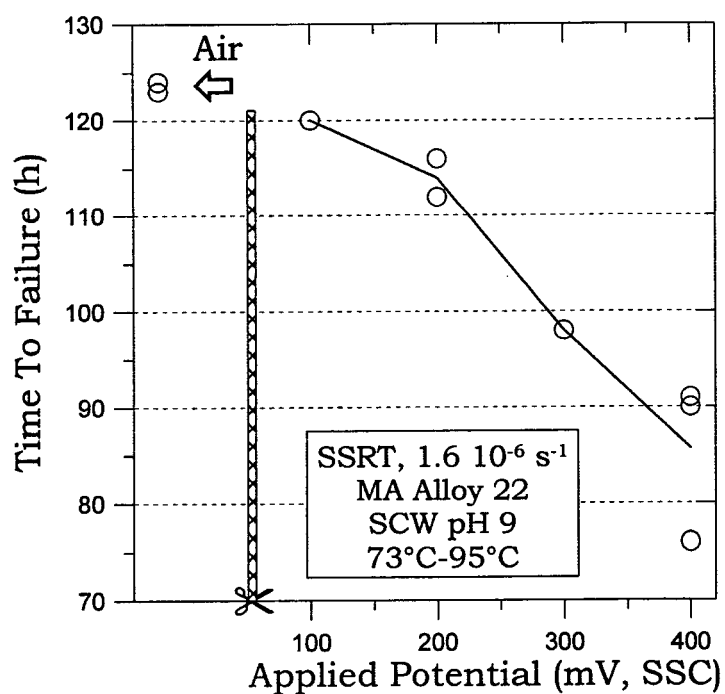
FIGURE 3: Effect of Potential on the time to failure of Alloy 22 in SCW.

Figure 3 shows the time to failure of the strained specimens as a function of the applied potential. Figure 3 shows that the higher the applied potential the lower the time to failure. The lowest time to failure was obtained for the specimens strained at +0.4 V [SSC]. Figure 4 is an SEM image of the fracture end of a specimen strained in air. This shows typical ductile failure with necking before cracking. Figure 5 shows a SEM low magnification image of a specimen strained in SCW at +0.1 V [SSC] and Figure 6 is a larger magnification of the lateral surface of the same specimen. Alloy 22 was not susceptible to cracking at +0.1 V [SSC] since the specimen showed considerable necking before failure (Figure 5) and the lateral surface was free of secondary cracking (Figure 6). Figures 7-8 show the characteristics of a specimen strained in SCW at +0.2 V [SSC]. Figure 7 shows considerable necking before failure; however, Figure 8 shows incipient secondary cracking in the lateral surface. Figure 9 is a low magnification SEM image of a specimen strained in SCW at +0.4 V [SSC] showing that the failure of this specimen occurred with little reduction in area (necking). Figure 9 also shows that there is abundant secondary cracking in the lateral surface. Figure 10 is an SEM image of the fracture surface showing that the environmentally induced cracking was transgranular in nature. Figure 11 is a metallographic cross section of the same specimen showing that

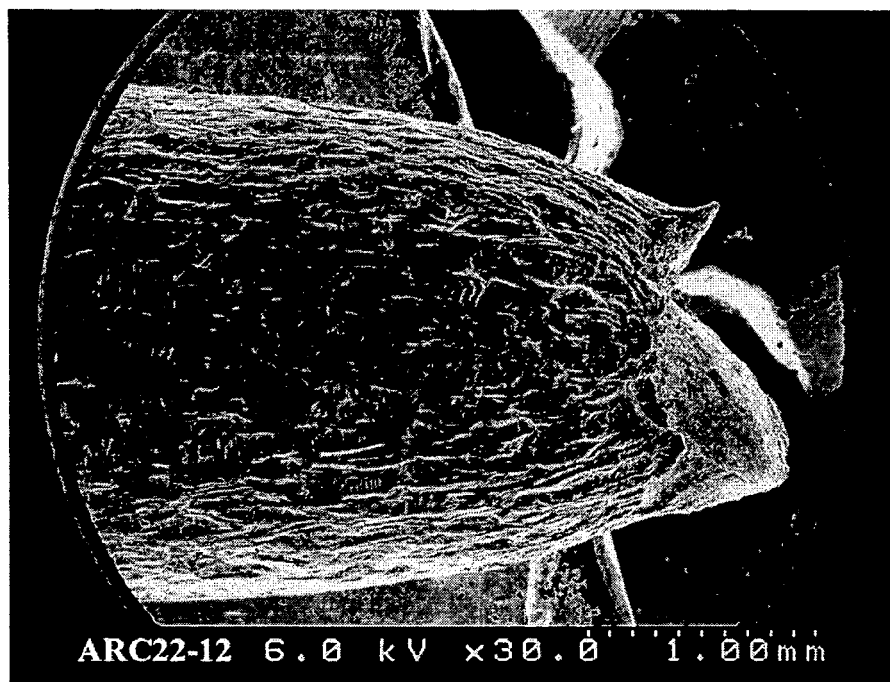
FIGURE 4: Fracture end of specimen strained in air at ambient temperature.  
Magnification X 30.

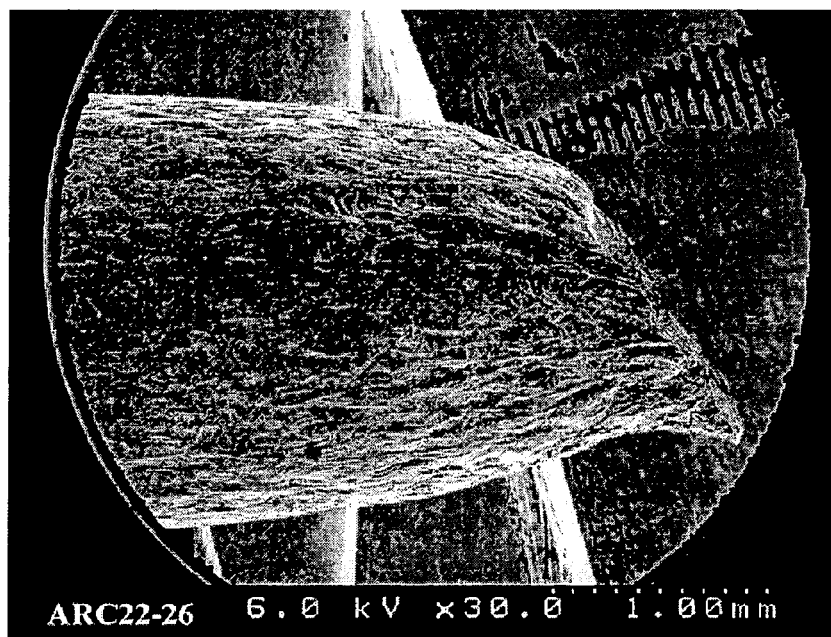
FIGURE 5: Fracture end of specimen strained in SCW at 73°C and +0.1 V.  
Magnification X 30.

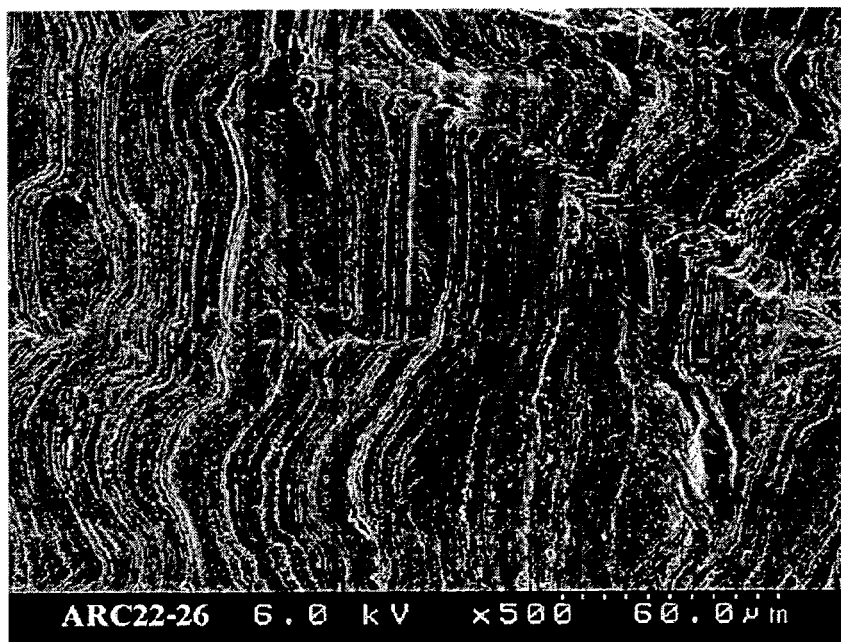
FIGURE 6: Fracture end of specimen strained in SCW at 73°C and +0.1 V.  
Magnification X 500.

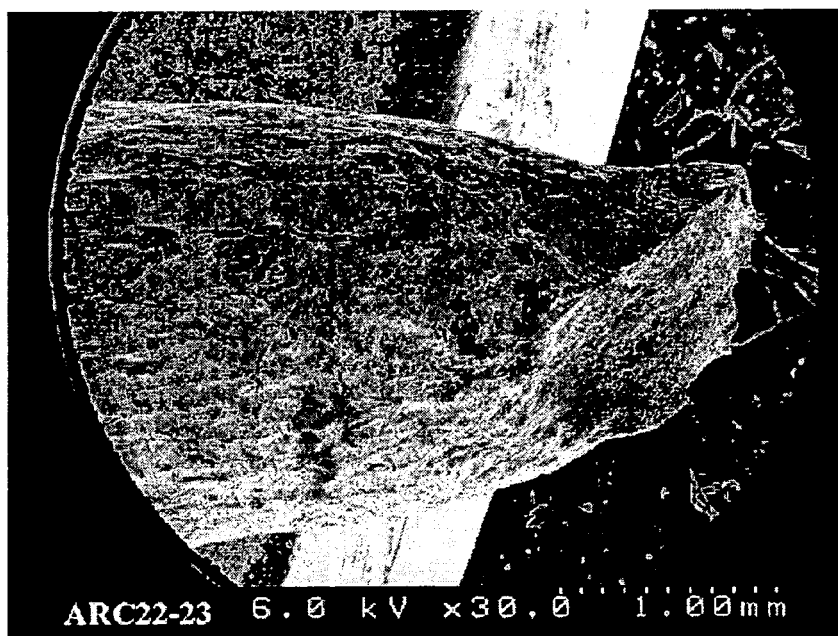
FIGURE 7: Fracture end of specimen strained in SCW at 73°C and +0.2 V.  
Magnification X 30.

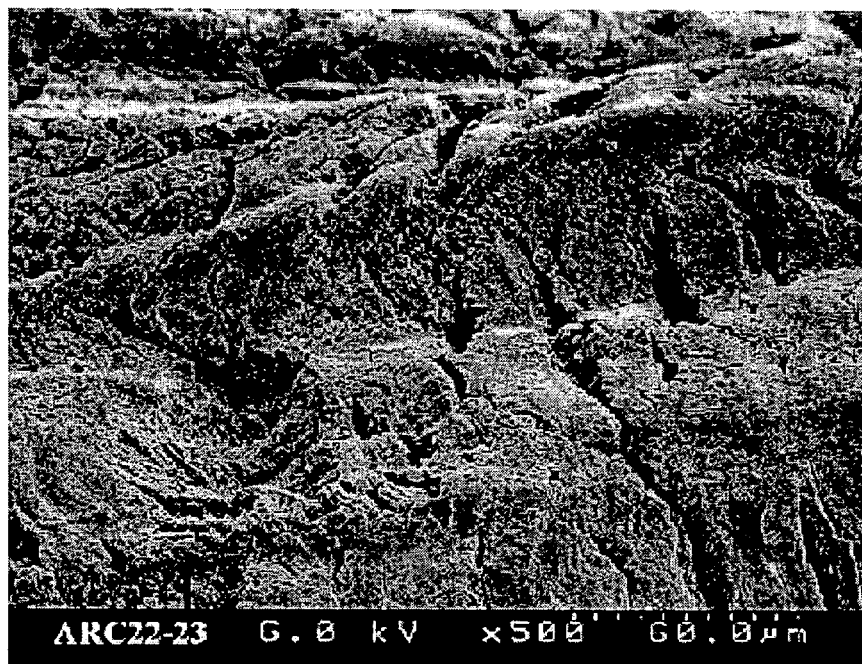
FIGURE 8: Fracture end of specimen strained in SCW at 73°C and +0.2 V.  
Magnification X 500.

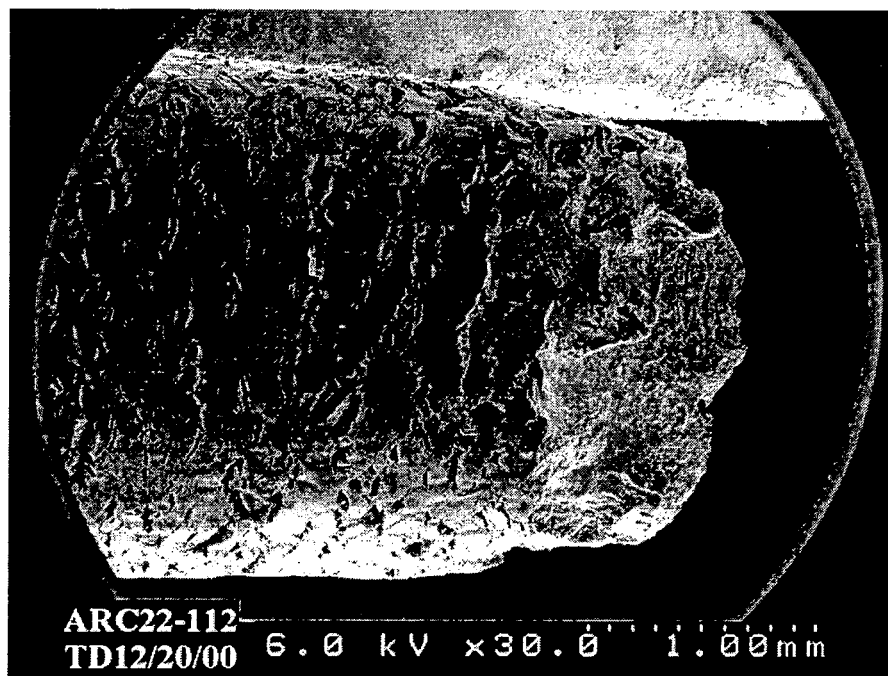
FIGURE 9: Fracture end of specimen strained in SCW at 73°C and +0.4 V.  
Magnification X 30.

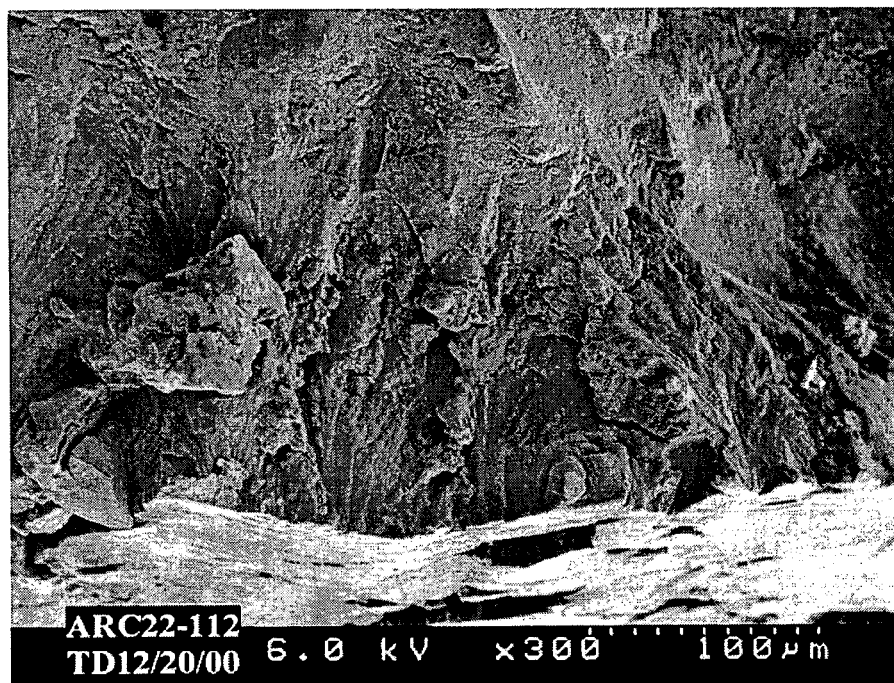
FIGURE 10: Fracture surface of specimen strained in SCW at 73°C and +0.4 V.  
Magnification X 300.

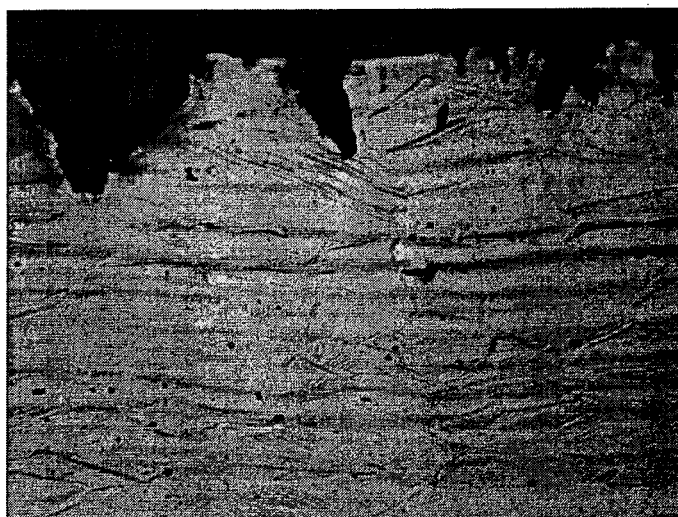
FIGURE 11: Metallographic sectioning of Alloy 22 (112) strained in SCW at 73°C and +0.4 V.  
Magnification X 200.

the EAC cracks are shallow and open, probably because the strain rate was high; not allowing enough time for crack propagation.

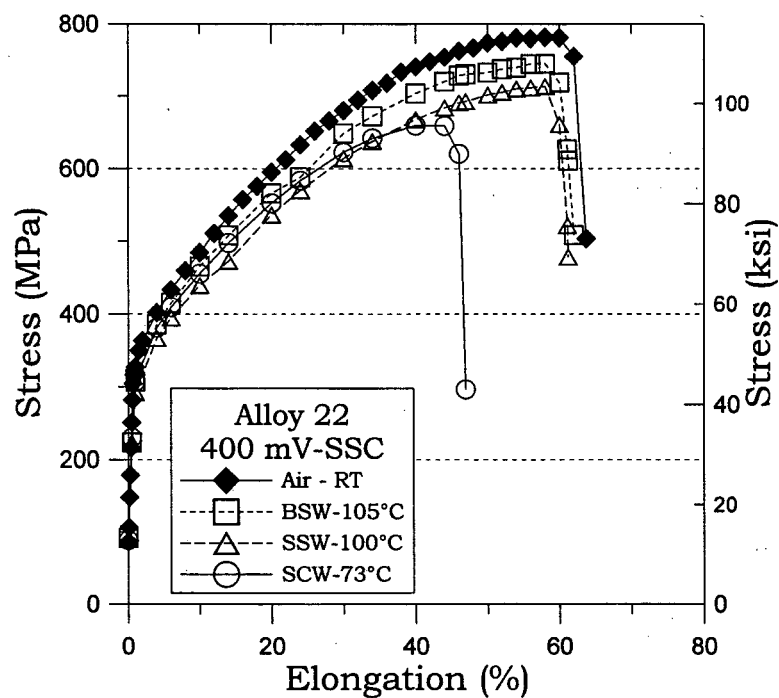
FIGURE 12: Stress-Elongation curves for Alloy 22 specimens strained at +0.4 V.

Figure 12 shows the stress-elongation curves for Alloy 22 specimens strained at 0.4 V in three different electrolyte solutions. Figure 12 shows that Alloy 22 was susceptible to EAC in SCW solution at 73°C but was not susceptible to EAC in basic saturated water (BSW) pH 12 at 105°C or simulated saturated water (SSW) pH 6.7 at 100°C. Table 4 shows that when Alloy 22 was strained in SCW at +0.4 V [SSC] at ambient temperature (25°C), the parameters time to failure, ultimate tensile strength and reduction in area were similar to the same parameters for the specimens strained in air.

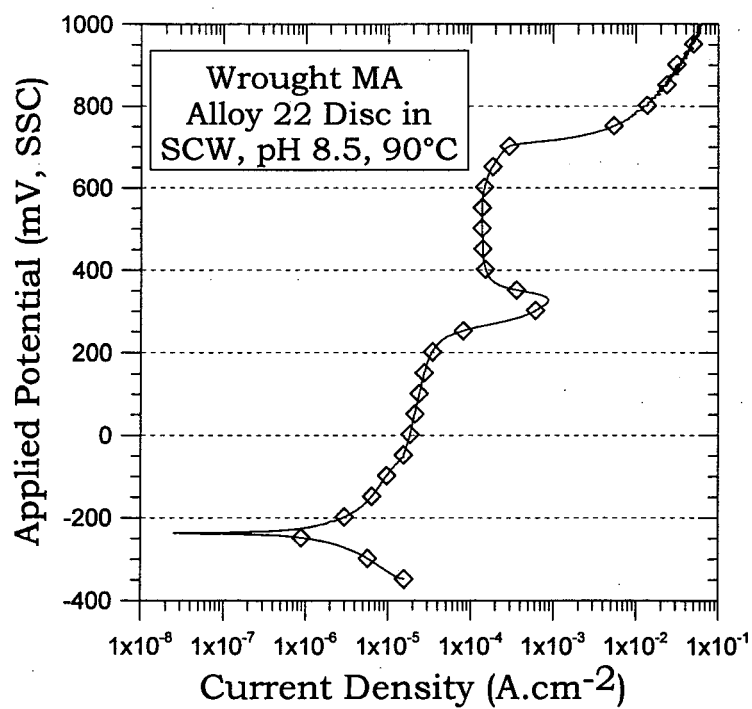
FIGURE 13: Polarization Curve for MA Alloy 22 in SCW at 90°C.

Figure 13 shows the polarization curve for MA Alloy 22 in SCW at 90°C. There is an anodic peak in the potential range between +0.2 to +0.4 V [SSC]. The range of potential for cracking susceptibility of Alloy 22 seems to be associated to the presence of this anodic peak.

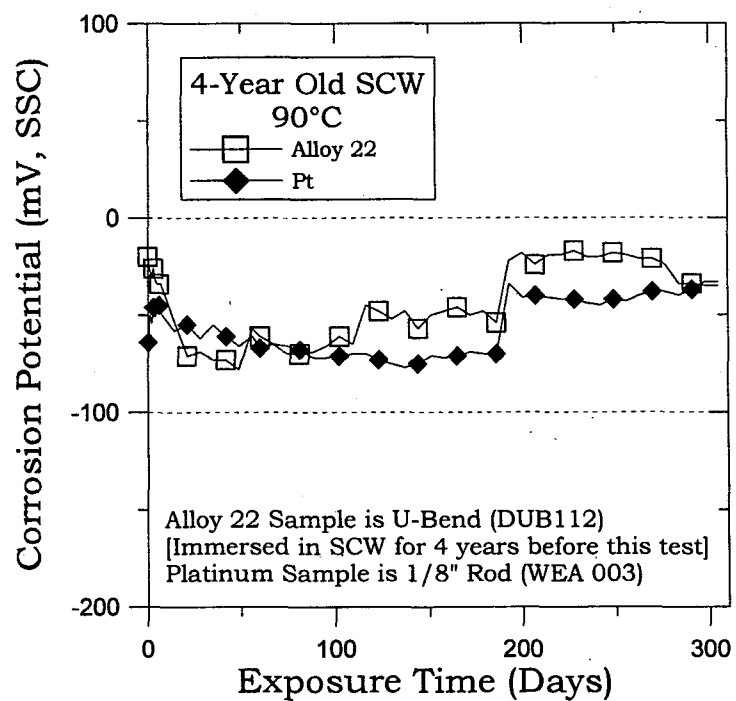
FIGURE 14: Corrosion Potential of Alloy 22 and Platinum in 4-year old SCW solution (from the Long Term Corrosion Test Facility).

Current results show that for MA Alloy 22 to fail by EAC in SCW solution, several conditions are required to be applied simultaneously: (1) A temperature higher than approximately 70°C, (2) A stress level in the order of 600 MPa (two times the level of the yield stress) and (3) Anodic potentials in the order of +0.3 V [SSC]. Therefore, it is unlikely that the actual container would be susceptible to EAC even though it may enter in contact with a SCW type of solution at high temperature. Firstly, because in the design of the waste package it is predicted that the container will be fully annealed to eliminate any residual stress due to welding. Second, because data (Figure 14) shows that the  $E_{\text{corr}}$  of Alloy 22 after more than 5 years immersion in aerated SCW at 90°C remained below 0 V [SSC], that is, at least 0.3 V below the range of potential susceptibility. Table 2 also shows that  $E_{\text{corr}}$  for Alloy 22 in aerated SCW was also below 0 V [SSC].
