**CHARACTERIZATION OF CONDITIONS OF  
NATURAL GAS STORAGE RESERVOIRS AND  
DESIGN AND DEMONSTRATION OF REMEDIAL  
TECHNIQUES FOR DAMAGE MECHANISMS  
FOUND THEREIN**

**ANNUAL TECHNICAL PROGRESS REPORT**

***1 OCTOBER 2001 – 30 SEPTEMBER 2002***

**Schlumberger  
Data and Consulting Services**

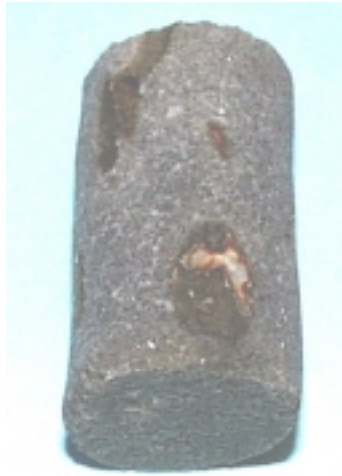
**Figure 2: Photograph of Core #1**

Core #1 (**Fig. 2**) was taken at a depth of 2283.5 feet. The core is a sandstone, dark gray in color, 23.3 mm in diameter and 42 mm long. One end is terminated by a smooth curved surface indicating the sand face of the well. The other end is a broken surface where the core was broken off. Large vugs are present with apparent remnants of calcite fracture filling. Previous acid treatments have apparently dissolved most of the calcite, leaving open spaces.

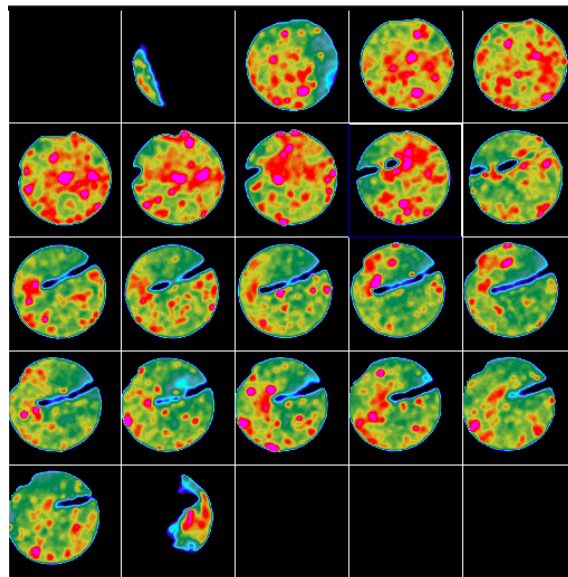
**Figure 3: X-Ray CT Images of Core #1**

The X-ray CT images of Core #1 (**Fig. 3**) are at 2-mm spacing along the core, starting at the well's sand face from left to right. Red indicates high density or atomic number while blue/black represents low density or voids. There is a concentration of high-density material in the first 1.4 mm of rock. An empty fracture is clearly visible starting with the seventh image.

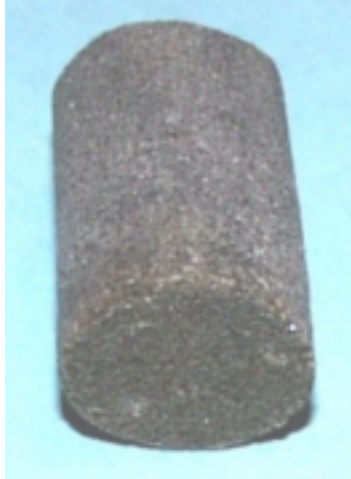
**Figure 4: Photograph of Core #2**

Core #2 (**Fig. 4**) was taken at a depth of 2284 feet. The core is a sandstone, dark gray in color, 23.3 mm in diameter and 37 mm long. One end is terminated by a smooth curved surface indicating the sand face of the well. The other end is a broken surface where the core was broken off. The core appears uniform with no visible vugs or fractures.

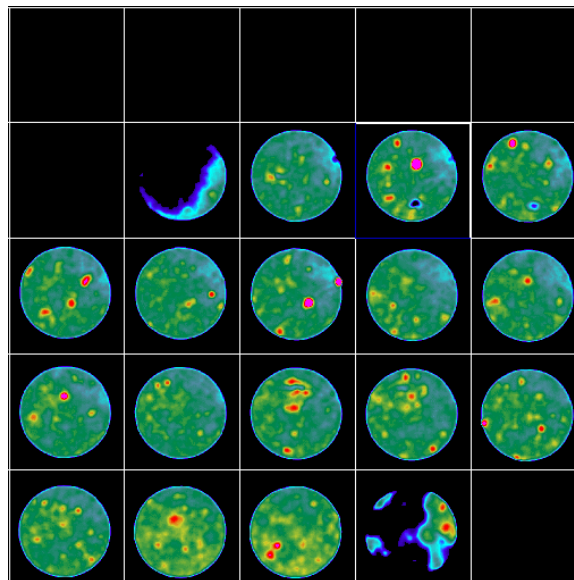
**Figure 5: X-Ray CT Images of Core #2**

The X-ray CT images of Core #2 (**Fig. 5**) are at 2-mm spacing along the core, starting at the well's sand face from left to right. The few red spots indicate high density or atomic number while blue/black represents low density or voids. The rock appears uniform with no evidence of fractures or dissolution features. Overall density appears lower than the core at 2283.5 feet.

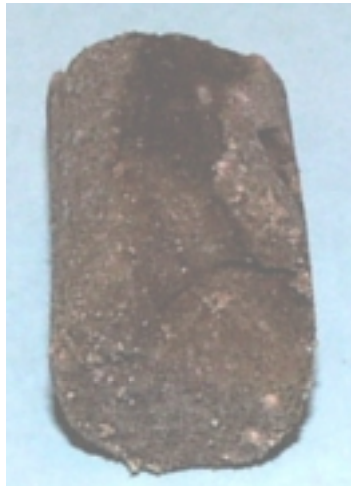
**Figure 6: Photograph of Core #3**

Core #3 (**Fig. 6**) was taken at a depth 2284.5 feet. The core is a sandstone, dark gray to brown in color, 23.4 mm in diameter and 38 mm long. One end is terminated by a smooth curved surface indicating the sand face of the well. The other end is a broken surface where the core was broken off. A major dissolution feature is present on the side of the core along its entire length.

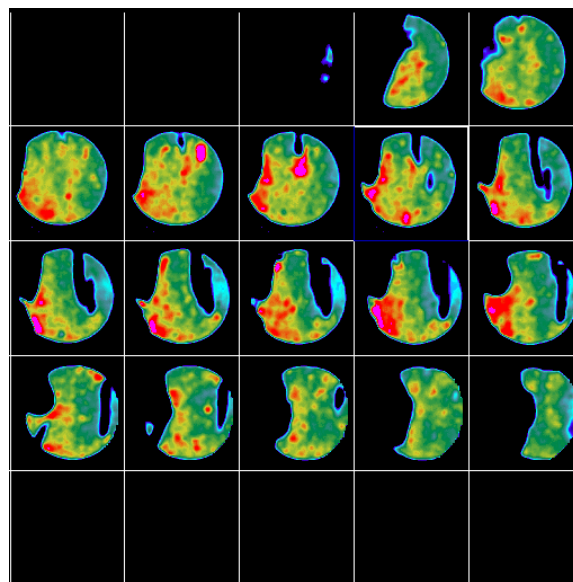
**Figure 7: X-Ray CT Images of Core #3**

The X-ray ct images of Core #3 (**Fig. 7**) are at 2-mm spacing along the core, starting at the well's sand face from left to right. Red areas present in the first 12 slices indicate high density or atomic number while blue/black represents low density or voids. The red areas decrease in portion of the core furthest from the sand face. In addition to the dissolved volume visible in the photo, the scans reveal a second internal void of the same magnitude.

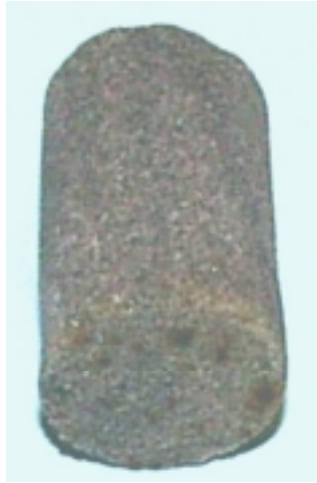
**Figure 8: Photograph of Core #4**

Core #4 (**Fig. 8**) was taken at a Depth 2285 feet. The core is a sandstone, dark gray in color, 23.5 mm in diameter and 41 mm long. One end is terminated by a smooth curved surface indicating the sand face of the well. The other end is a broken surface where the core was broken off.

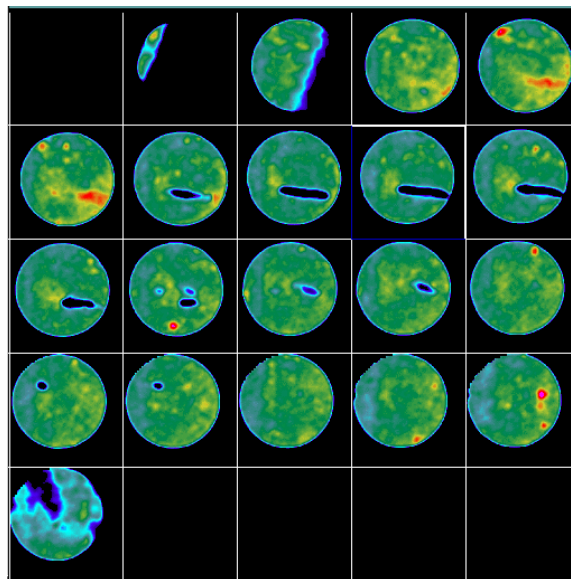
**Figure 9: X-Ray CT Images of Core #4**

The X-ray CT images (**Fig. 9**) of Core #4, again at 2-mm spacing along the core, reveal a hidden empty fracture in the interior starting about 8mm into the core. A high-density (red) feature in the forth and fifth images correspond with the plane of the fracture in subsequent images and may represent the material that was dissolved. In general there is less of the high-density material present in this core. It closely resembles core #2 except for the fracture.

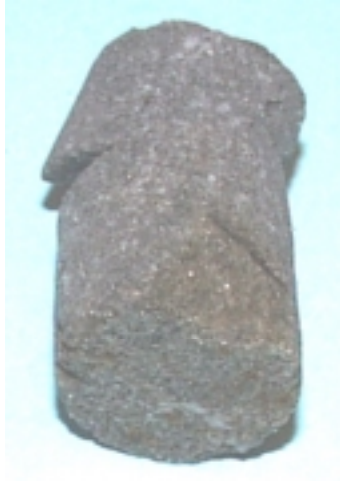
**Figure 10: Photograph of Core #5**

Core #5 was taken at a depth 2285.2 feet. The core is a sandstone, dark gray in color, 23.5 mm in diameter and ~22 mm long. One end is terminated by a smooth curved surface indicating the sand face of the well. The core is fractured and the fracture surfaces do not match. An additional piece is missing from the sand face. The material appears homogenous. No X-ray CT scans were taken

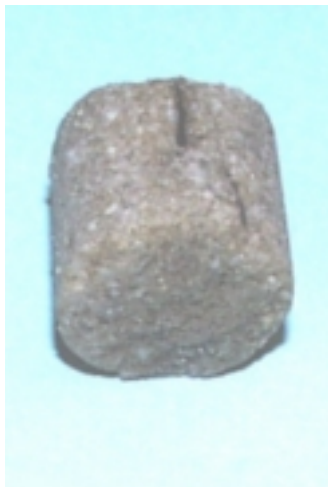
**Figure 11: Photograph of Core #6**

Core #6 (**Fig. 11**) was taken at a depth 2285.2 feet. The core is a sandstone, tan color, 22.5 mm in diameter and 23.5 mm long. Both ends are fracture surfaces and there is an additional axial fracture at one end. This is apparently the first sidewall core from the newly drilled section of the well and there is a distinct difference in color.

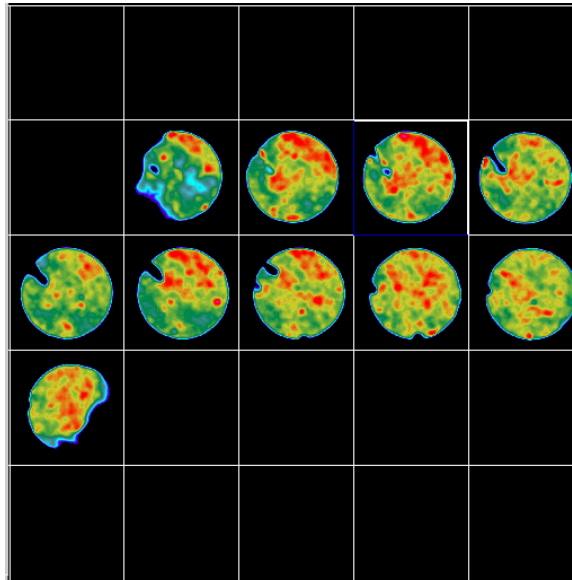
**Figure 12: X-Ray CT Images of Core #6**

The X-ray CT images (**Fig. 12**) of Core #6 are at 2-mm spacing along the core, starting at the well's sand face from left to right. There is significantly more high-density (red) material present than in many of the shallower cores. The fracture is clearly visible in the fourth through seventh images.

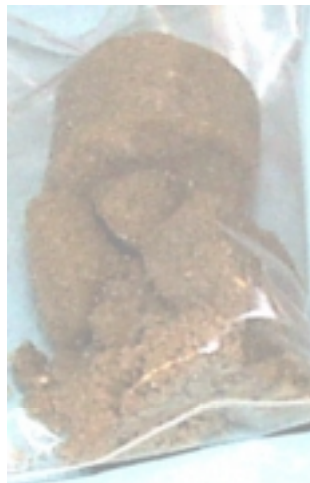
**Figure 13: Photograph of Core #7**

Core #7 (**Fig. 13**) was taken at a depth 2286.5 feet. The core is a sandstone, tan color. The core is largely fragmented with only one small piece of full diameter. No X-ray CT images were taken.

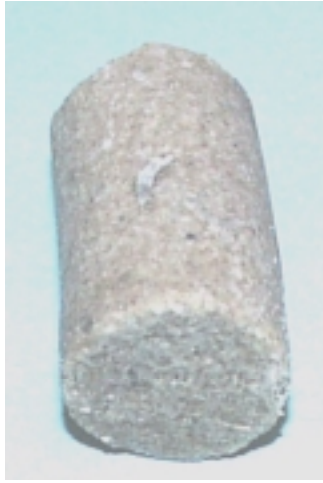
**Figure 14: Photograph of Core #8**

Core #8 (**Fig. 14**) was taken at a depth of 2293 feet. The core is a sandstone, tan in color, 23.3 mm in diameter and 41 mm long. One end is terminated by a smooth curved surface indicating the sand face of the well. The other end is a broken surface where the core was broken off. The sample appears uniform, although mineralized veins are evident on one side.

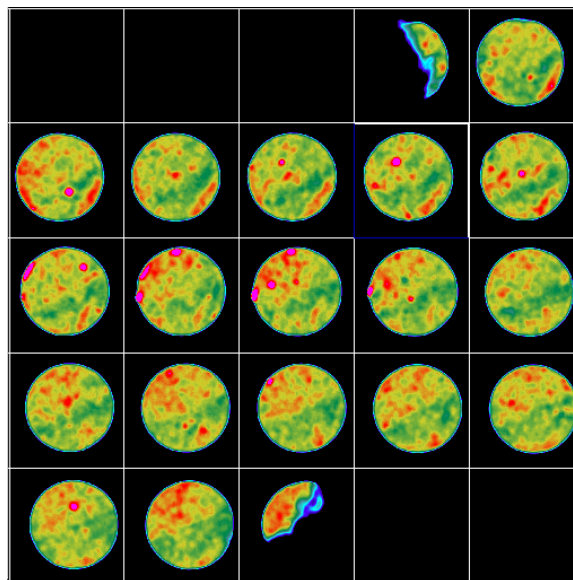
**Figure 15: X-Ray CT Images of Core #8**

The X-ray ct images are 2mm thick starting at the well's sand face from left to right. There is significantly more high-density (red) material present than in many of the shallower cores. There is no evidence of fractures or dissolution features.

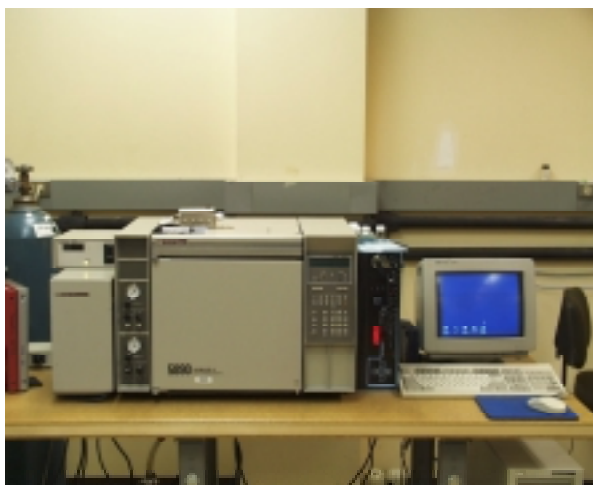
**Figure 16: HP 5971 Mass Spectrometric Detector**

For analysis by Py-GC/MS, approximately 50 mg of sample was loaded into a quartz pyrolysis boat then inserted into a Chemical Data Systems Pyroprobe 1000. The probe was then inserted directly in to the injection port (maintained at 280°C) of a Hewlett Packard 5890 gas chromatograph.

Once in the injection port, the pyroprobe was ramped to a temperature of 610°C at 5°C/ms. Volatile and cleaved organic compounds are swept into the gas chromatograph for separation and identification by the HP 5971 mass spectrometric detector (**Fig. 16**). Pyrolyzate abundances for both samples showed remarkably low total organic carbon content (~0.5-.05%). The major compounds observed were long chain alkanes ranging in carbon number from C20 to C45 with the bulk of the pyrolyzate represented by an unresolved complex mixture (UCM) also representative of aliphatic hydrocarbons. A less abundant suite of chlorinated alkanes was observed for both samples.

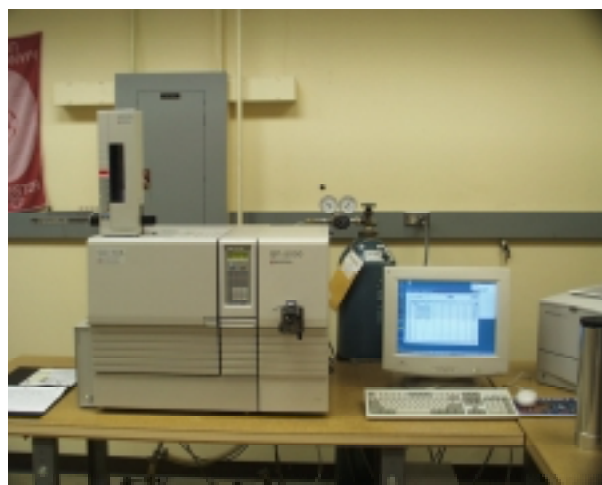
**Figure 17: Shimadzu QP5000**

The extracts were then further processed by passing samples through an aluminum oxide column to isolate GC-amenable compounds. Yields of this process as a fraction of total sample extracted (26.141 g and 25.231 g) were 0.05% and 0.04% for the upper and lower cores, respectively. The sample extracts were then subjected to analysis by GC/MS for separation and compound identification. The instrument used was a Shimadzu QP5000 (**Fig. 17**).

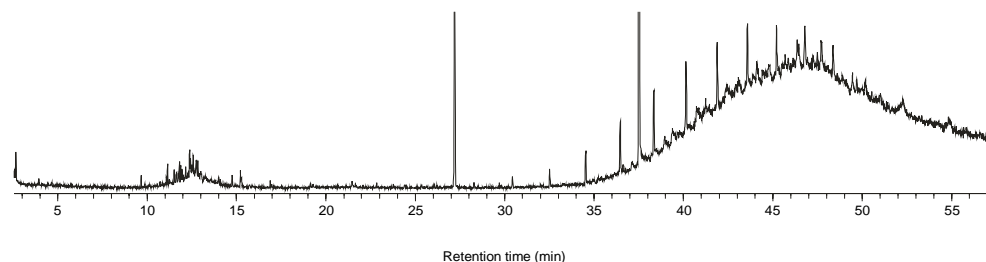
**Figure 18: GC/MS trace for Summit well 1527, core 2285.2'**

The resulting chromatogram from upper core is shown below (**Fig 18**), and indicates a homologous series of straight chain alkanes ranging between 20 and 45 carbons comparable to the results of py-GC/MS analyses. Again, the majority of compounds elute as an UCM comprised of aliphatic hydrocarbons. A notable difference was the presence of orthorhombic sulfur (S8) in the extract of the upper core sample.
