**FILTER COMPONENT ASSESSMENT  
— CERAMIC CANDLES —**

**Final Report**

DOE/NETL Contract No. DE-AC21-94MC31147

M. A. Alvin

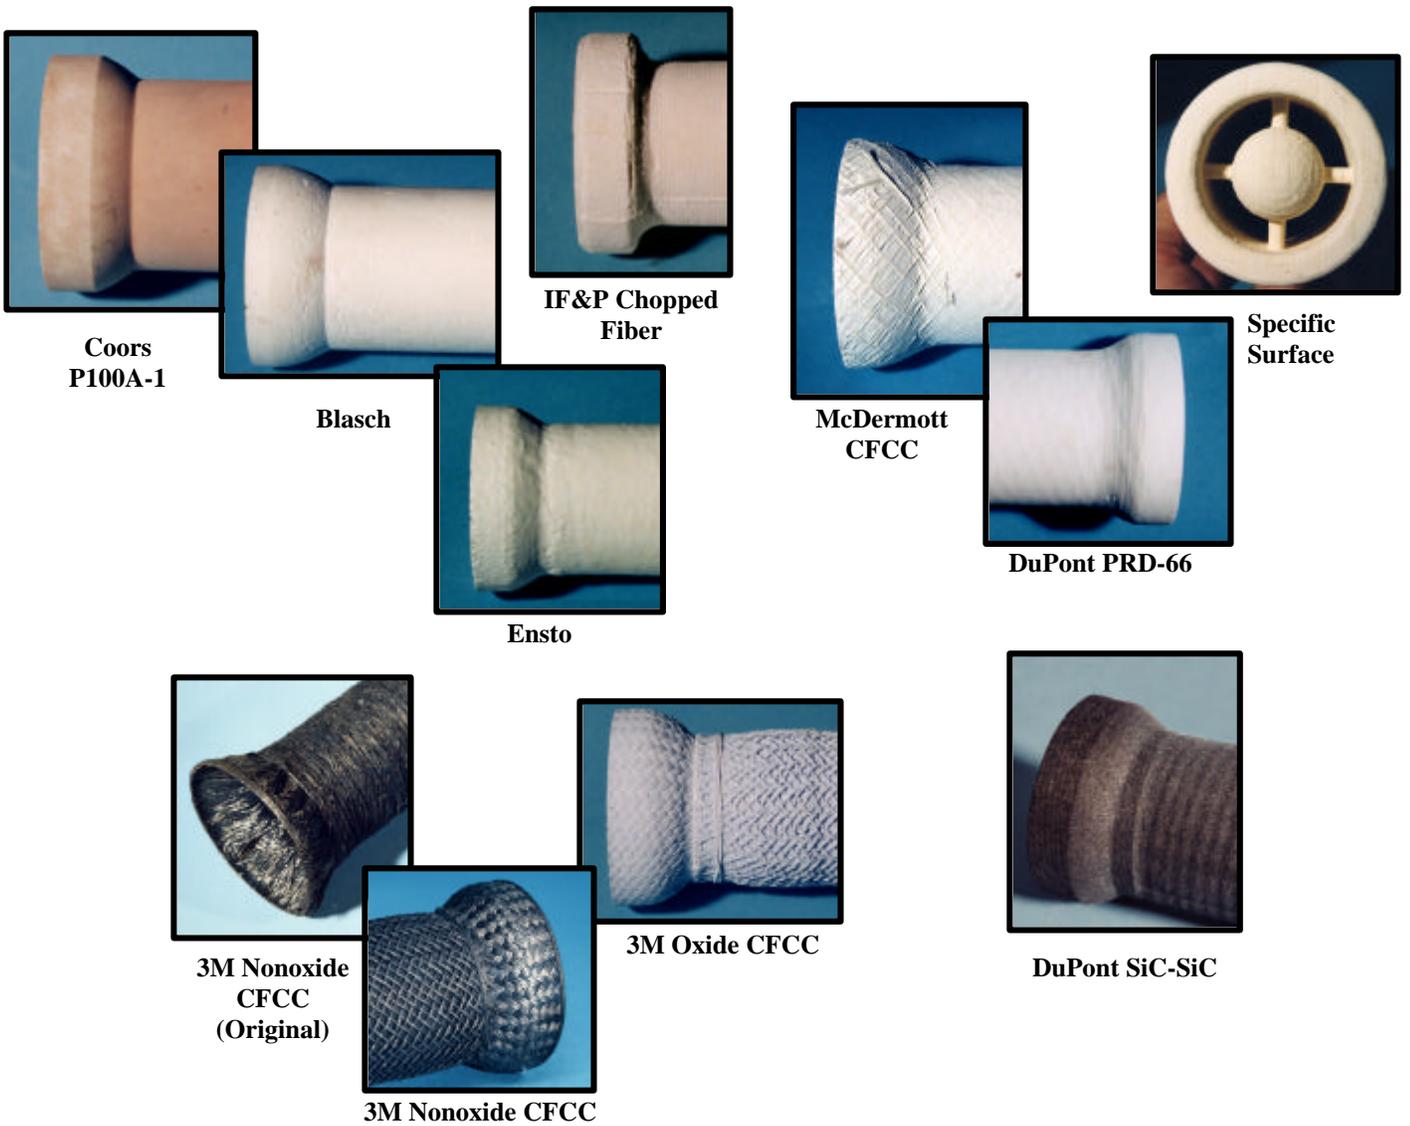
Figure 2 — Variation in the candle flange geometry.

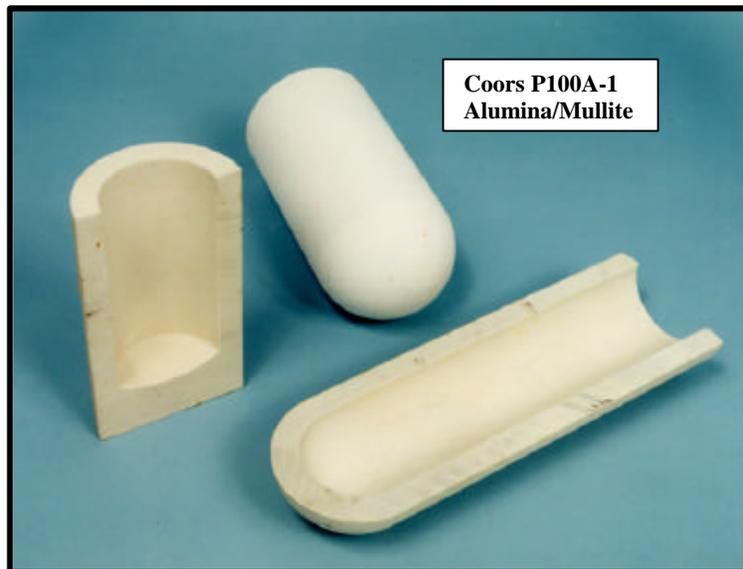
Figure 4 — Variation in the candle filter closed end cap geometry.

With variations in the matrix architecture, differences resulted in the contour of the flange (Figure 2), flange and filter wall thickness (Figure 3), as well as the closed end cap (Figure 4) during manufacturing of the filter elements. Significant differences resulted in the weight of the elements, ranging from ~3632-5448 gm (~8-12 lb) for the 1.5 m monolithic candles, to ~908-2270 gm (~2-5 lb) for the chopped fiber, filament wound, and CFCC matrices. Differences also resulted in the manner by which the individual candle filters were held and sealed within the filter array. Particular focus was directed to the design and positioning of the gasket seals, and the load bearing capabilities and ultimate process temperature strength of the filter flange. During development of the filter technology, efforts also addressed the critical design issues of the monolithic matrix closed end cap in order to eliminate internal stress risers (crack initiators) which ultimately failed many of the initially manufactured, porous, monolithic oxide-based elements (i.e., Coors P-100A-1 alumina/mullite candle filters). Before addressing the critical failure modes of the various ceramic matrices and filter elements in this report, the following sections describe the composition and microstructure of the various porous ceramic filter materials, and illustrate changes that occurred during operation in SWPC's bench-scale and demonstration plant test facilities.

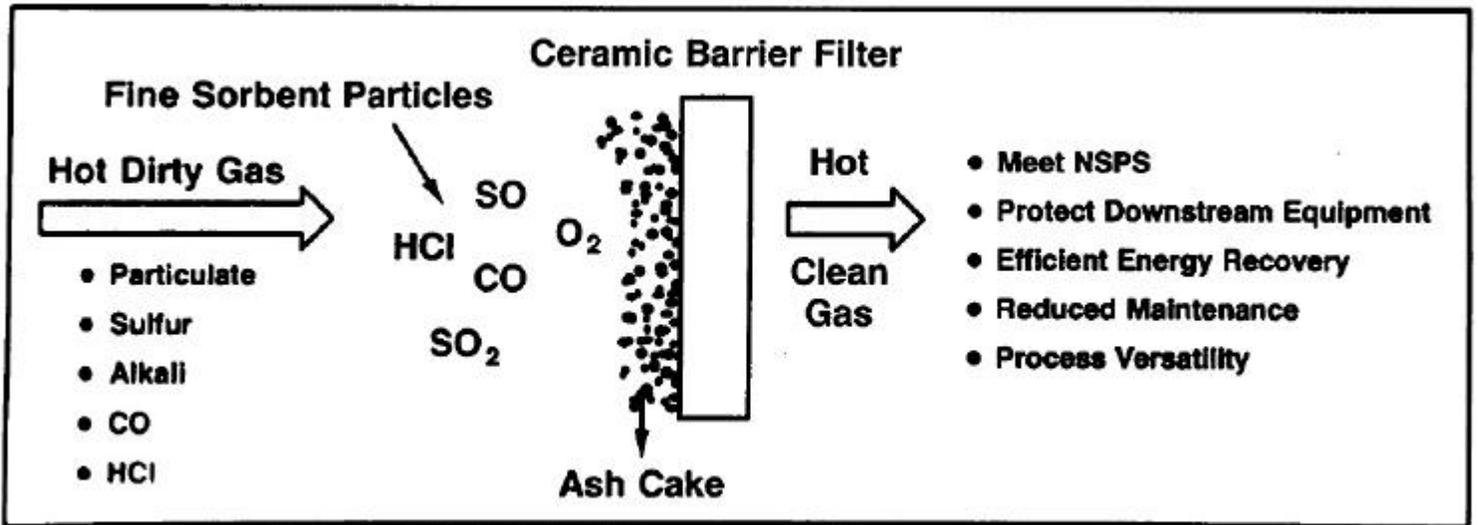
Figure 6 — High temperature particulate filtration.

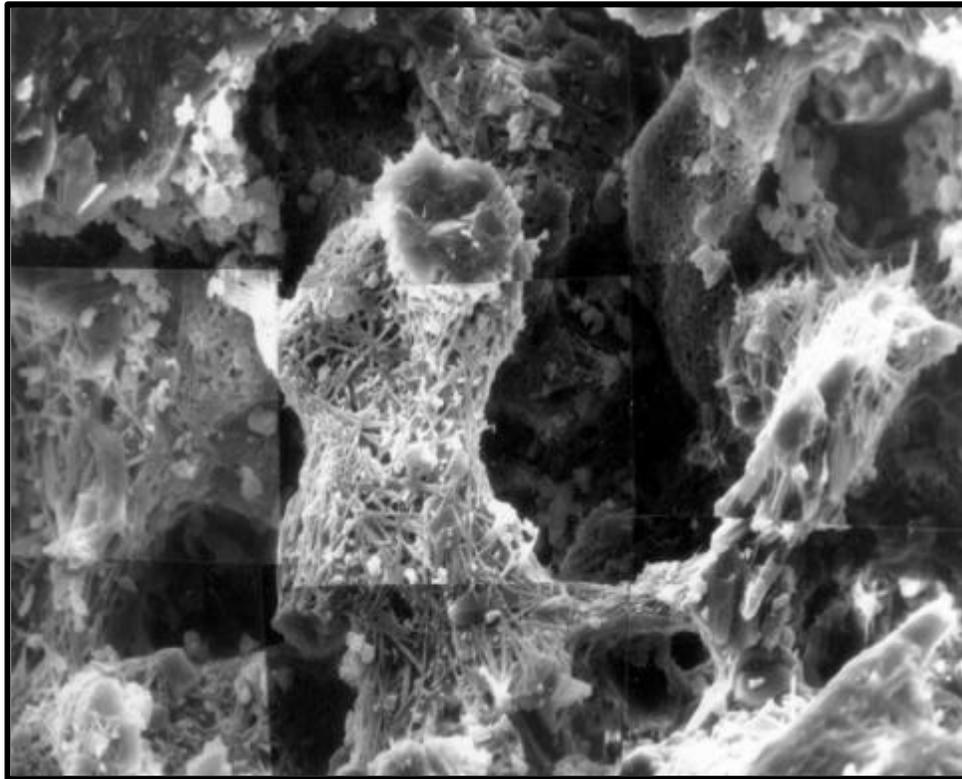
Figure 9 — Crystallization of the Coors P-100A-1 alumina/mullite filter matrix resulted during PFBC/PCFBC operation leading to extensive mullite formation along the surface of pore cavities within the filter element.

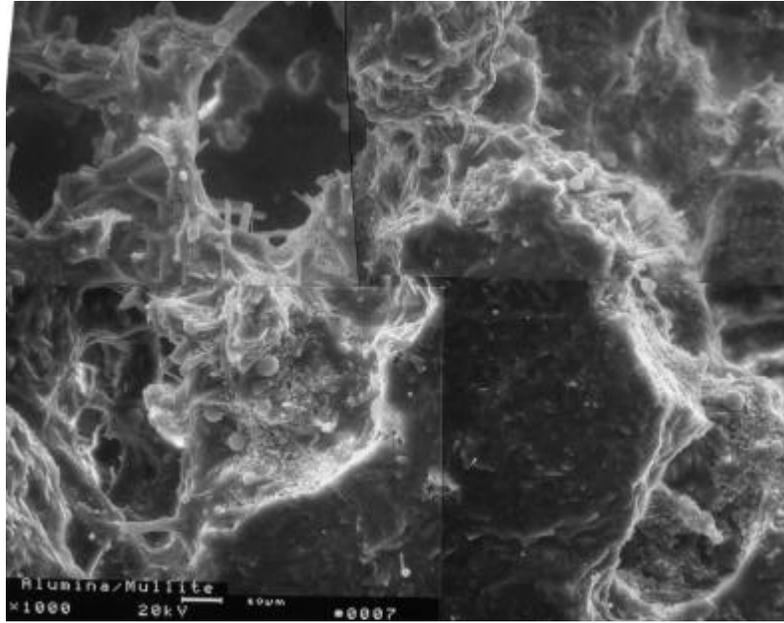
Figure 10 — Anorthite formation along the surface of the pore cavities, and mullitization within the ligaments of the PFBC/PCFBC-exposed Coors P-100A-1 alumina/mullite filter matrix.

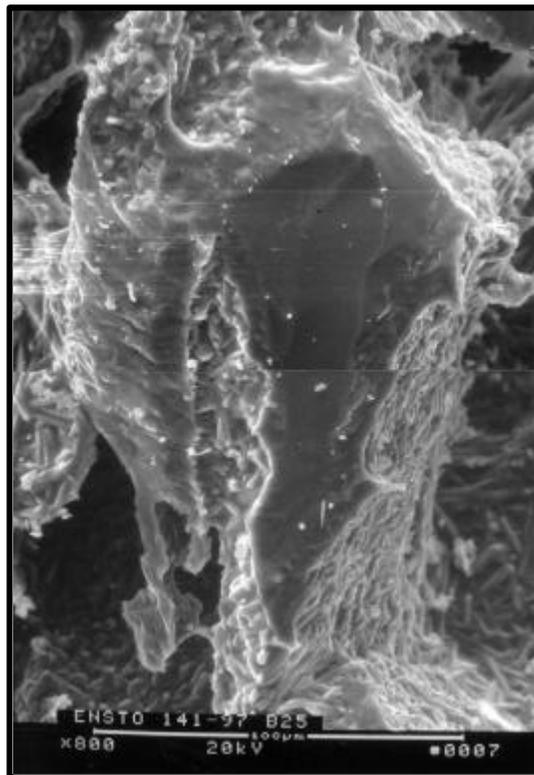
Figure 16 — Mullite ligament formation bonding adjacent alumina grains together within the as-manufactured Ensto filter matrix.

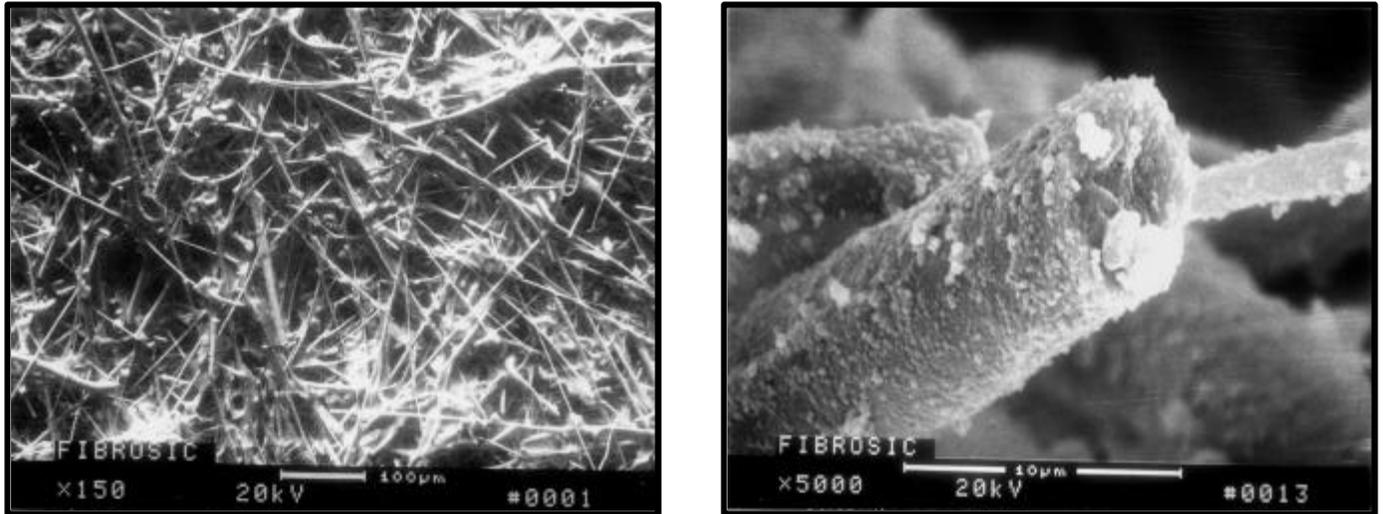
Figure 17 — Vacuum infiltrated chopped fibers contained within the IF&P Fibrosic™ filter matrix.

In contrast to the structurally “harder” monolithic oxides, “softer” chopped fiber oxide-based matrices were manufactured by Industrial Filter & Pump, Inc. (IF&P) and Foseco. As shown in Figure 17, the IF&P Fibrosic™ Hi-Perm filter matrix consisted of a blend of 3 μm diameter aluminosilicate fibers, and a silica and alumina binder. The 1.0 m and 1.5 m Fibrosic™ candle filter surface was vacuum infiltrated or impregnated with alumina to normalize the pore size and to toughen the skin along the outer surface of the filter element.

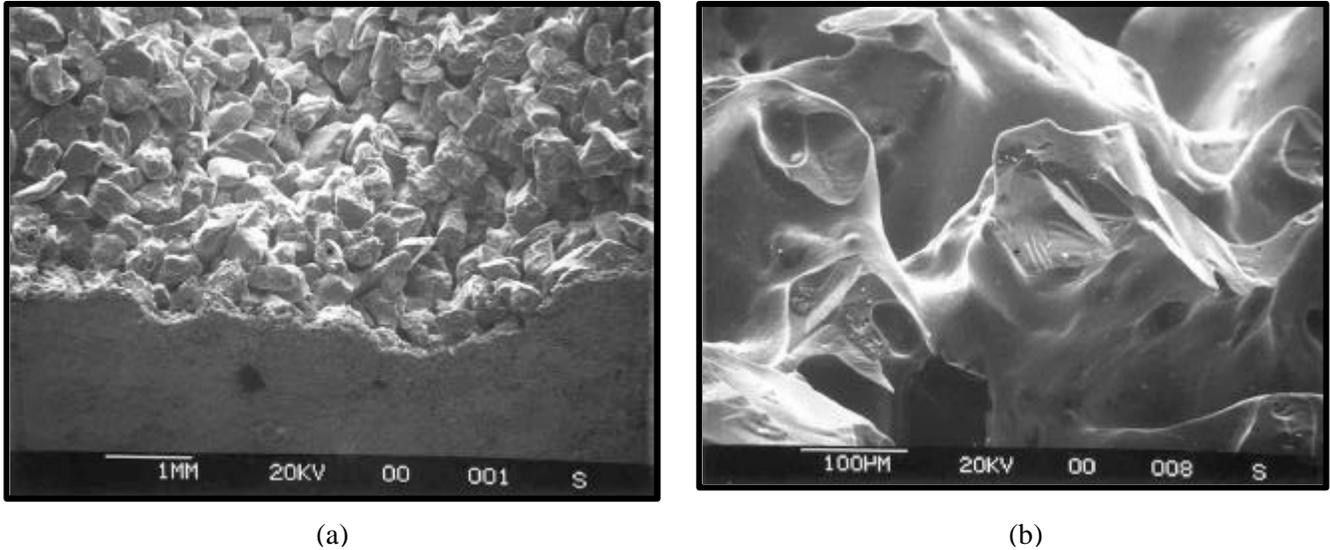
Figure 18 — Morphology of the as-manufactured Schumacher Dia Schumalith clay bonded silicon carbide filter matrix. (a) Fresh fractured cross-sectioned filter surface illustrating membrane coated outer surface and interior coarse silicon carbide grains within the filter element; (b) Higher magnification of the structural support clay bonded silicon carbide grains.

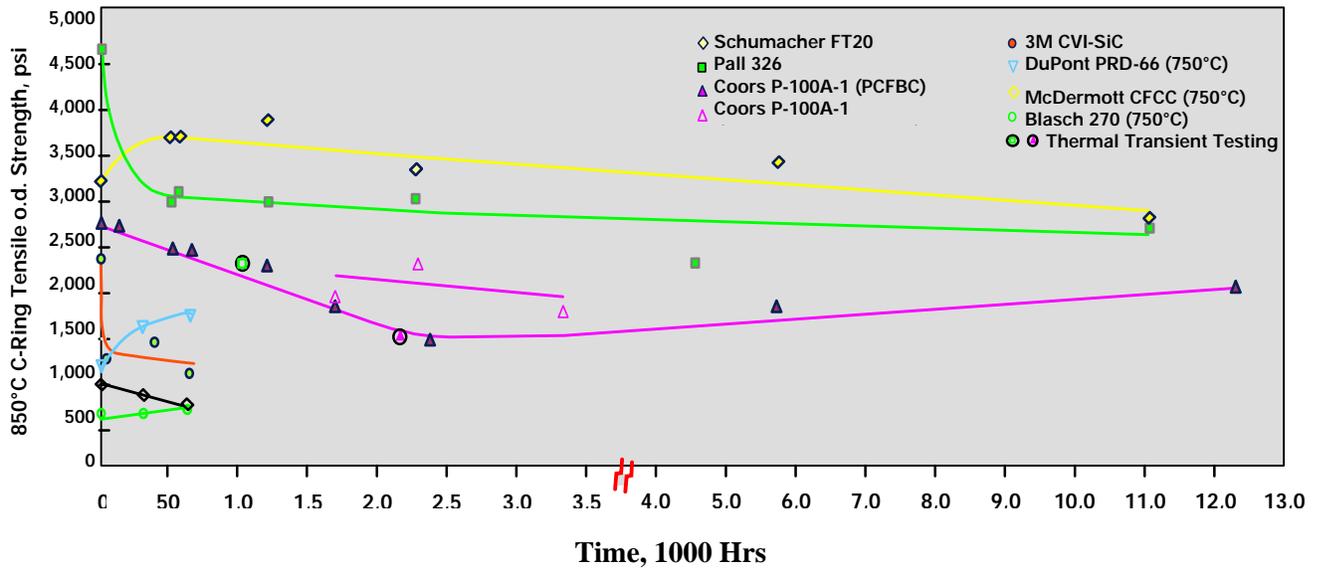
Figure 19 — Residual strength of the PFBC/PCFBC-aged and extended life-tested porous ceramic filter elements.

the thickness of the crystalline silica-enriched layer increased, encapsulating the silicon carbide grains, and extended into the crystallized aluminosilicate ligaments or bond posts. With extended service operation, thermal fatigue at the junction of the crystallized silica-enriched encapsulating layer and the crystallized binder ligaments was considered to occur, reducing the bulk strength of the filter matrix, exposing the underlying silicon carbide grains to further oxidation (Figure 19).

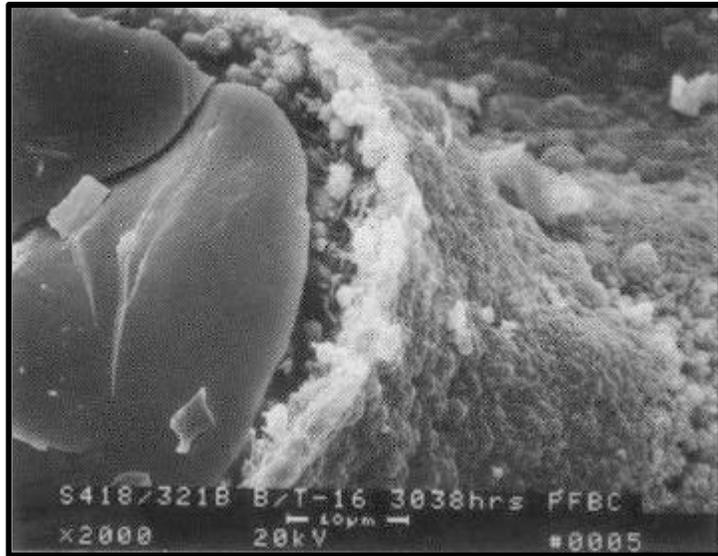
Figure 20 — Coalescence and crystallization of the binder coating that encapsulated the silicon carbide grains within the Schumacher filter matrix after 3038 hours of PFBC operation. The outer surface of the encapsulating layer was enriched with silica while an underlying crystalline aluminosilicate whisker or needle-like formation was evident.

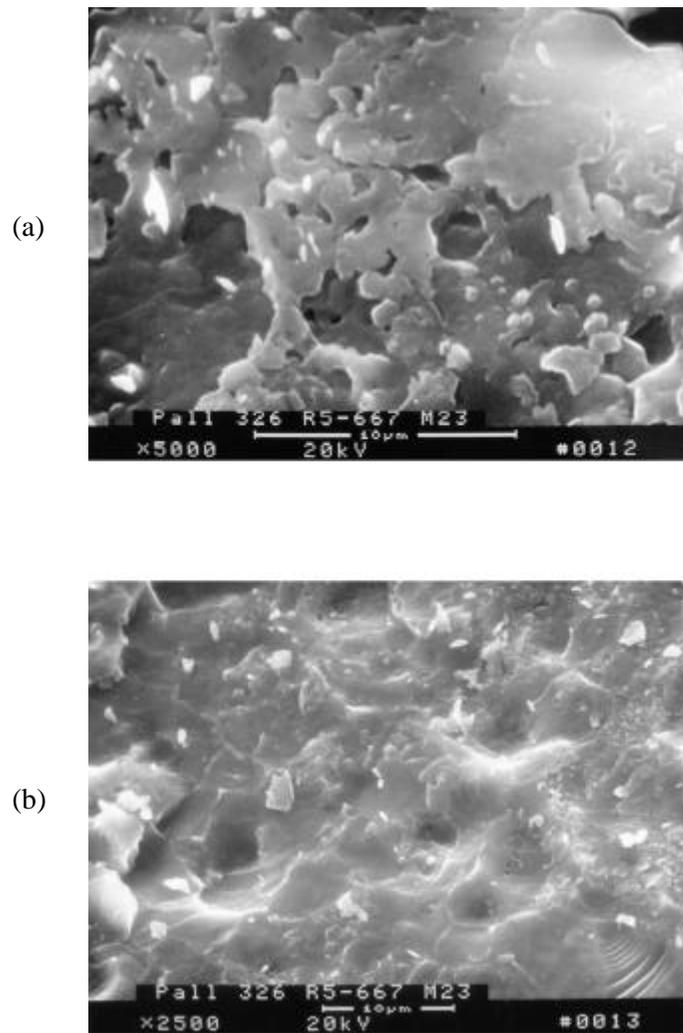
Figure 24 — Morphology of the fresh fractured Pall filter matrix after PFBC/PCFBC operation. (a) Residual silica remaining along the surface of the silicon carbide grains; (b) Pitted surface of the underlying silicon carbide grain after removal of the encapsulating silica-enriched surface layer.

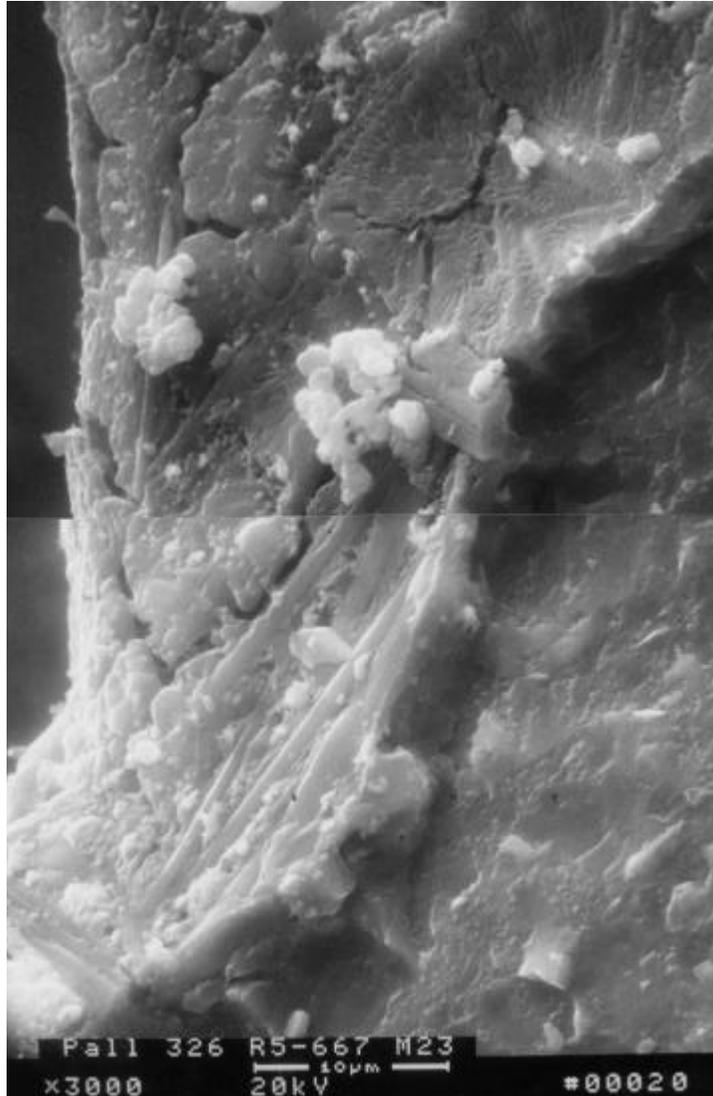
Figure 25 — Formation of a silica-enriched phase along the surface of the silicon carbide grains, as well as at the base of the filter ligaments within the PFBC/PCFBC-exposed Pall and Schumacher filter matrices. Separation or crack formations within the surface silica-enriched phase generally resulted in hexagonal platelets. Once removed, replicate hexagonal features remained along the surface of the underlying silicon carbide grain.

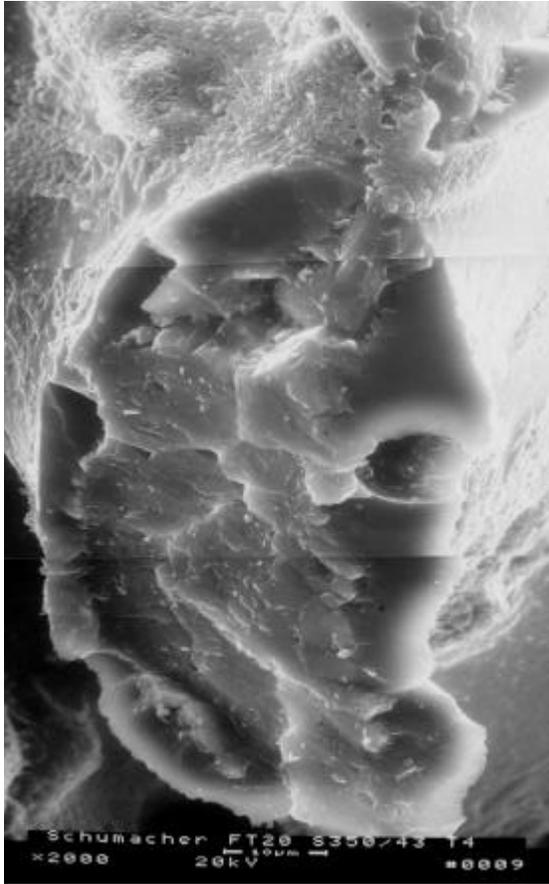
Figure 26 — Crystallization resulting at the base of the fresh fractured ligament in the PFBC-exposed Schumacher filter matrix. Hexagonal silica-enriched platelets formed along the surface of the fresh fractured ligament adjacent to the surface of the underlying silicon carbide grain.

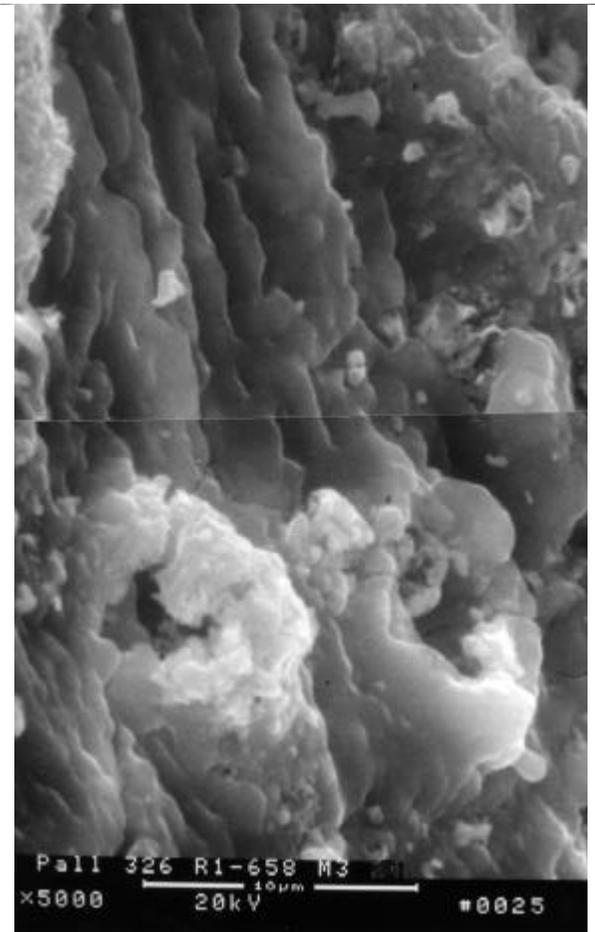
Figure 27 — Outgassing of species along the surface of the PFBC/PCFBC-exposed Pall filter matrix leading to the formation of voids along the silica-enriched crystallized surface.

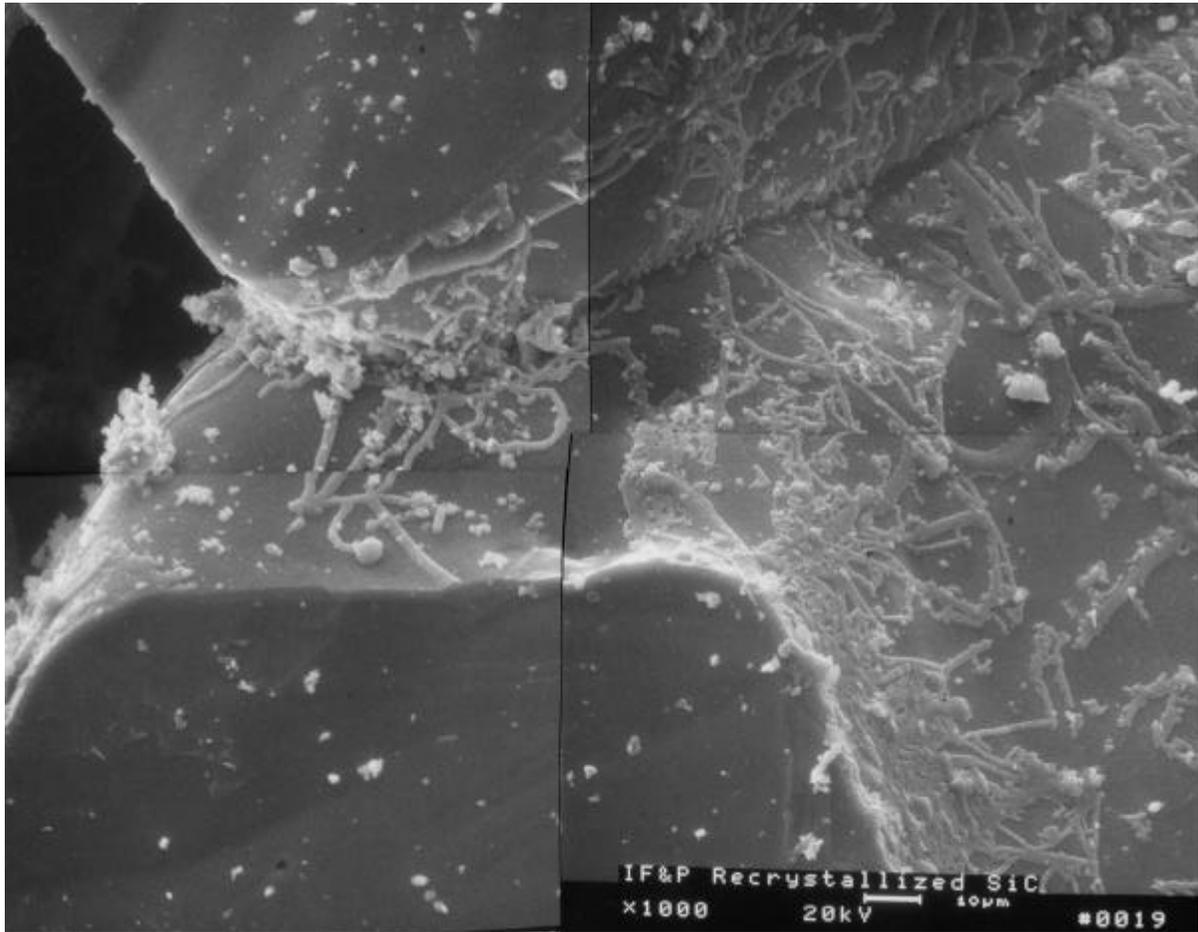
Figure 30 — Dendritic mullite formation along the surface of the simulated PFBC-exposed IF&P recrystallized silicon carbide grains.

In contrast to the clay bonded silicon carbide filter matrix, Industrial Filter& Pump (IF&P) in conjunction with Filtros Ceramic Products manufactured a recrystallized silicon carbide filter matrix (Figure 28), eliminating the use of a binder phase for holding adjacent grains to each other. When exposed to a simulated PFBC environment during bench-scale testing at SWPC in Pittsburgh, PA, silica once again formed along the outer surface of the recrystallized silicon carbide grains (Figure 29). In localized areas, dendritic mullite features were infrequently observed to have formed along the surface of the simulated PFBC-exposed recrystallized silicon carbide grains (Figure 30).

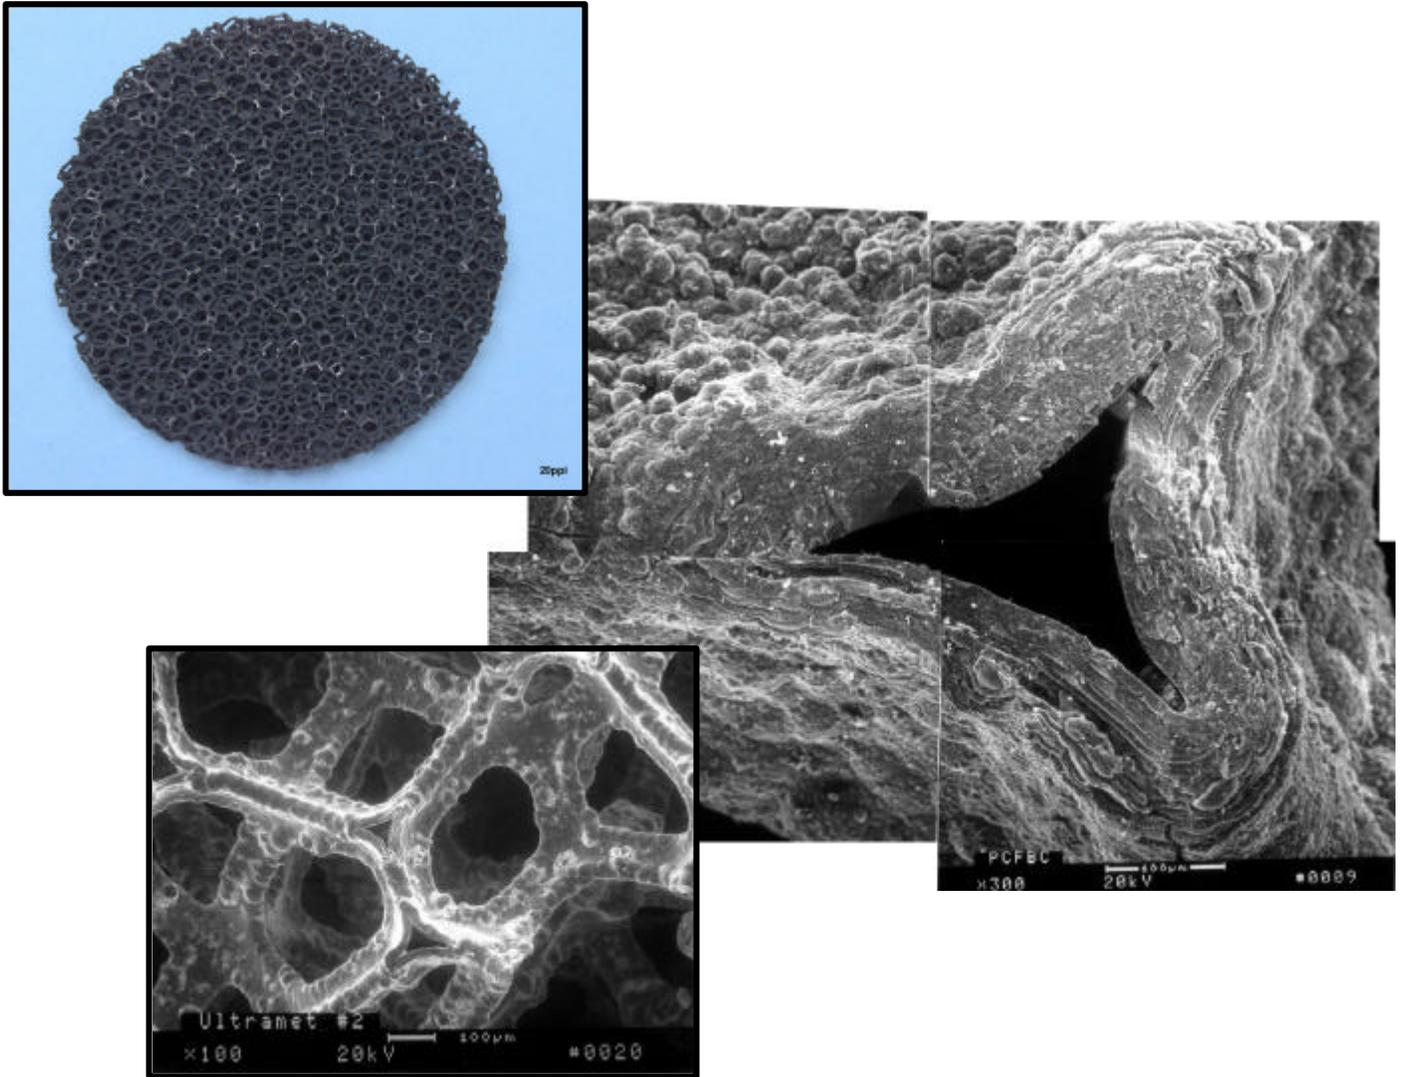
Figure 31 — As-manufactured Ultramet CVI-SiC reticulated foam.

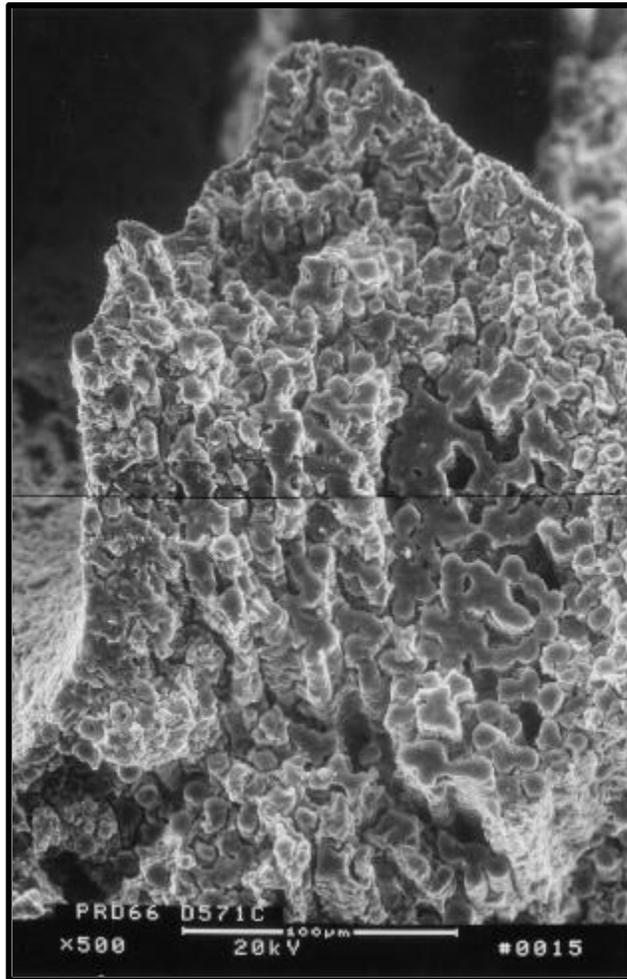
Figure 34 — Cross-sectioned filament within the DuPont PRD-66 filter matrix.

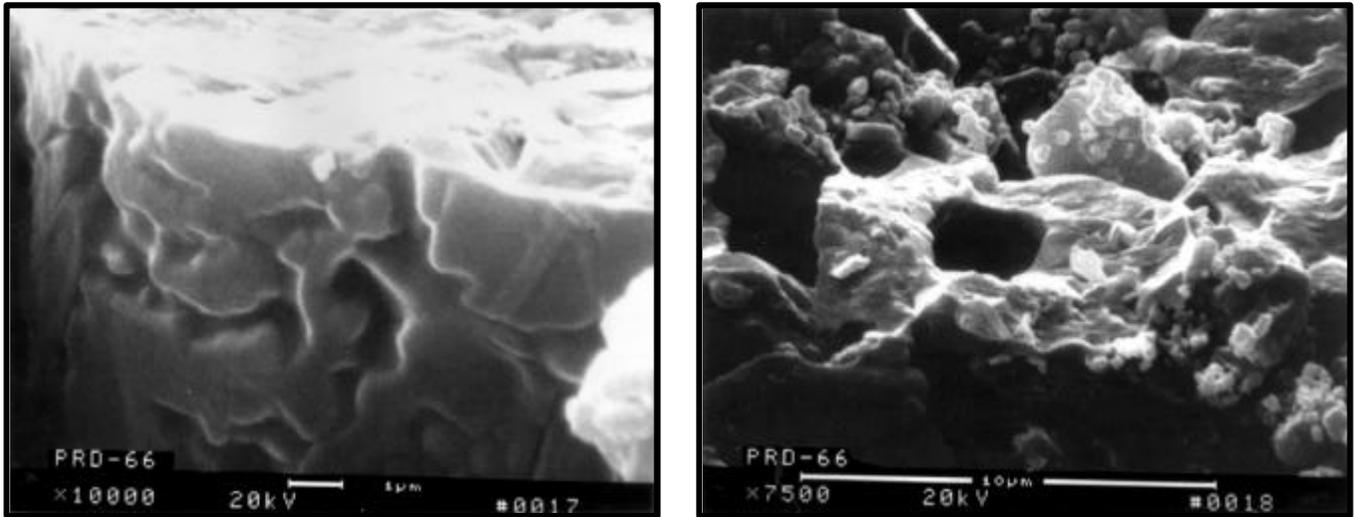
Figure 35 — Crystalline features along the outer surface of the fiber replicas of the DuPont filter matrix. Void formations along the center of the fiber replicas were observed.

The intersecting wound filaments in the structural support filter wall were sinter bonded to each other via slurry matrix grains, thus providing strength to the filter matrix. As along the outer surface membrane, slurry generally filled the crevices between intersecting filaments, and infiltrated into the filament bundles, bonding adjacent fiber replicas to each other. When the as-manufactured DuPont PRD-66 filter wall was cross-sectioned, discrete and coalesced fiber replicas were seen to be present within the filament support matrix (Figure 34). Discrete fiber replicas tended to be surrounded by the infiltrated alumina-enriched slurry matrix. Where the infiltrated slurry matrix was absent, coalescence of the fiber replicas tended to result. Crystalline features were generally observed along the outer surface of the fiber replicas, as well as along their fresh fractured surfaces (Figure 35).

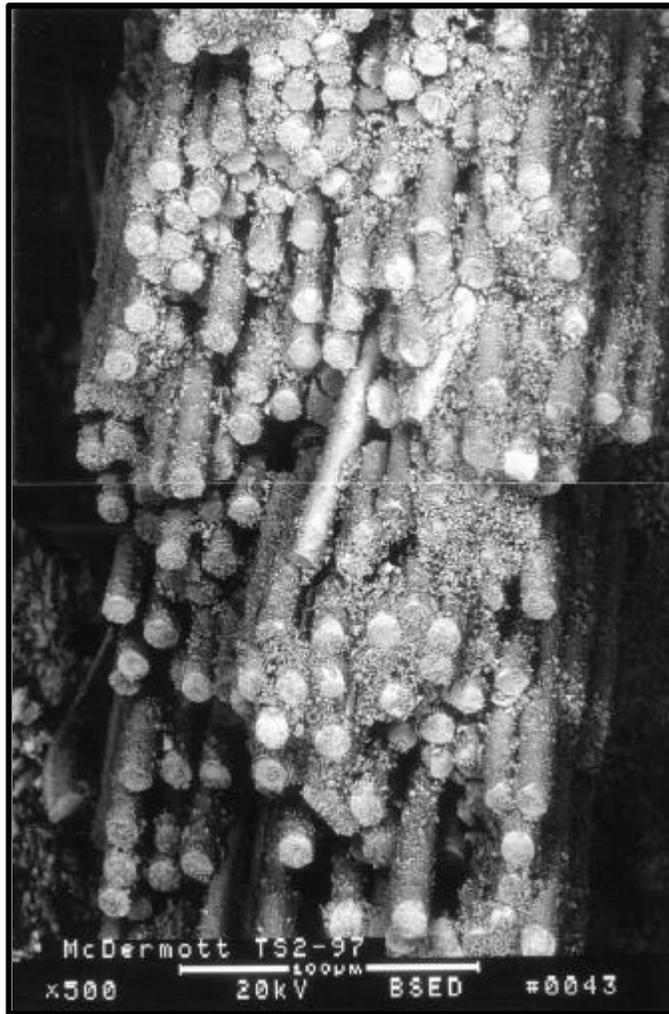
Figure 36 —Nextel™ filament bundles contained within the McDermott CFCC candle filter.

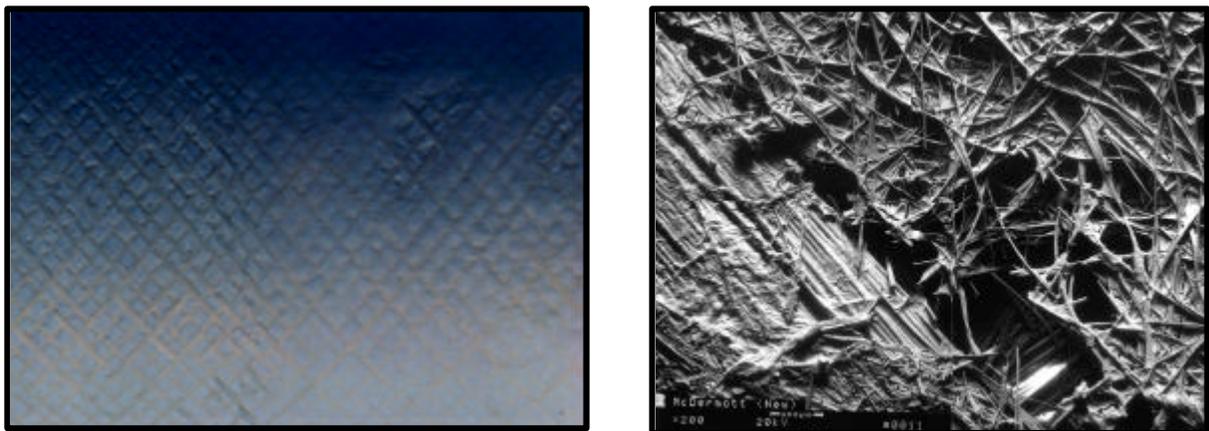
Figure 37 — Filament fiber bundles embedded within the chopped fiber matrix along the o.d. surface of the as-manufactured McDermott CFCC filter element.

When characterized, the diagonally wound filament fiber bundles were generally seen to be embedded within a chopped fiber matrix along the outer surface of the as-manufactured McDermott CFCC candle filter (Figure 37). A mud cracked alumina matrix was also present along the outer surface of the Nextel™ 610 and chopped Saffil fibers. Typically there appeared to be a higher concentration of the bonding matrix along the chopped fibers that were present along the o.d. surface of the McDermott CFCC filter element in comparison to the limited quantity of bonding matrix that was present along the chopped fibers along the i.d. wall of the candle filter. The chopped fibers along the i.d. wall appeared to be randomly held together through packing and/or limited bonding via submicron particles or agglomerates. Along the i.d. wall of the candle filter, chopped fibers were present as a felt-like layer that primarily covered the underlying wound filament fiber bundles.

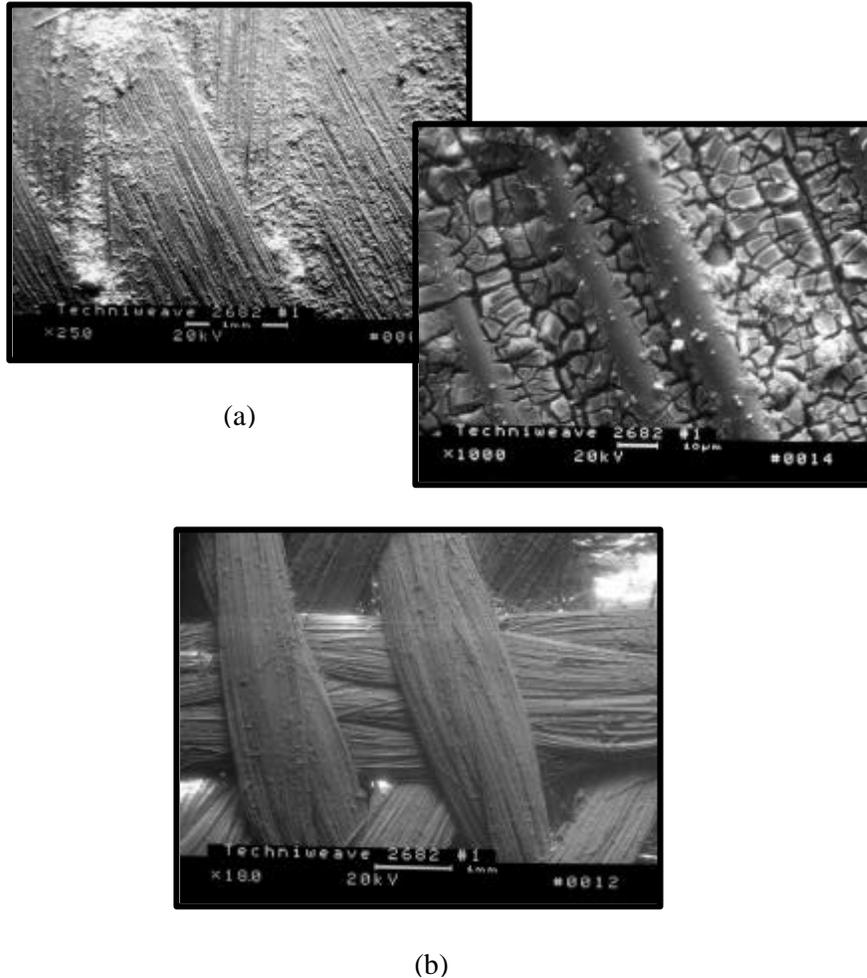
Figure 38 — As-manufactured Techniweave CFCC filter element. (a) Outer surface; (b) Inner or pulse cycled surface of the filter element.

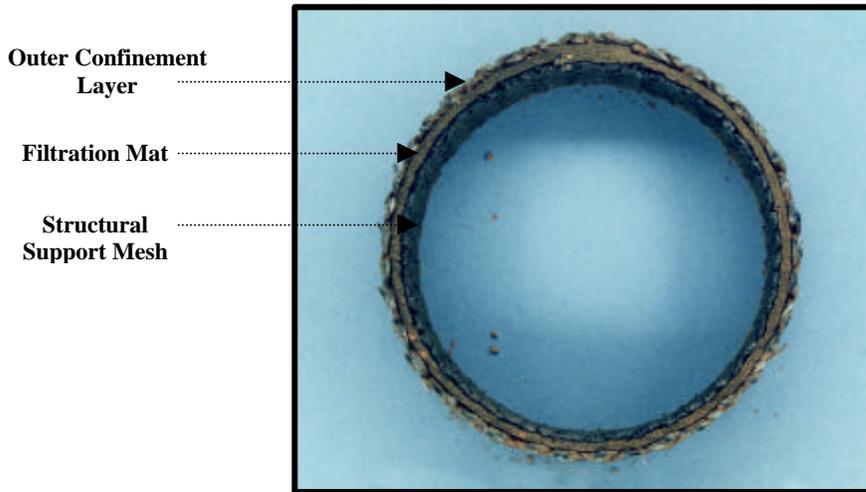
Figure 39 — 3M CVI-SiC filter matrix.

- 3M — Infiltration of an aluminosilicate phase on an aluminosilicate Nextel™ 610 or Nextel™ 720 triaxial braid perform; Chopped alumina-enriched filtration mat layer; Open mesh Nextel™ 610 or Nextel™ 720 outer confinement layer (Figure 39).
- Americom — Nextel™ filament with oxide infiltrate.

The 3M CVI-SiC continuous ceramic fiber composite (CFCC) filter elements consisted of three layers — an open mesh outer confinement layer, a middle filtration layer, and an inner structural support triaxial braided layer (Figure 39). Within the confinement and filtration mat layers, an  $\sim 1\text{-}2\ \mu\text{m}$  thick layer of silicon carbide was chemically infiltrated along the surface of Nextel™ 312 or alumina-based fibers, while an  $\sim 100\ \mu\text{m}$  thick layer of silicon carbide was deposited along the Nextel™ 312 triaxial braid in the support matrix (Figure 40).

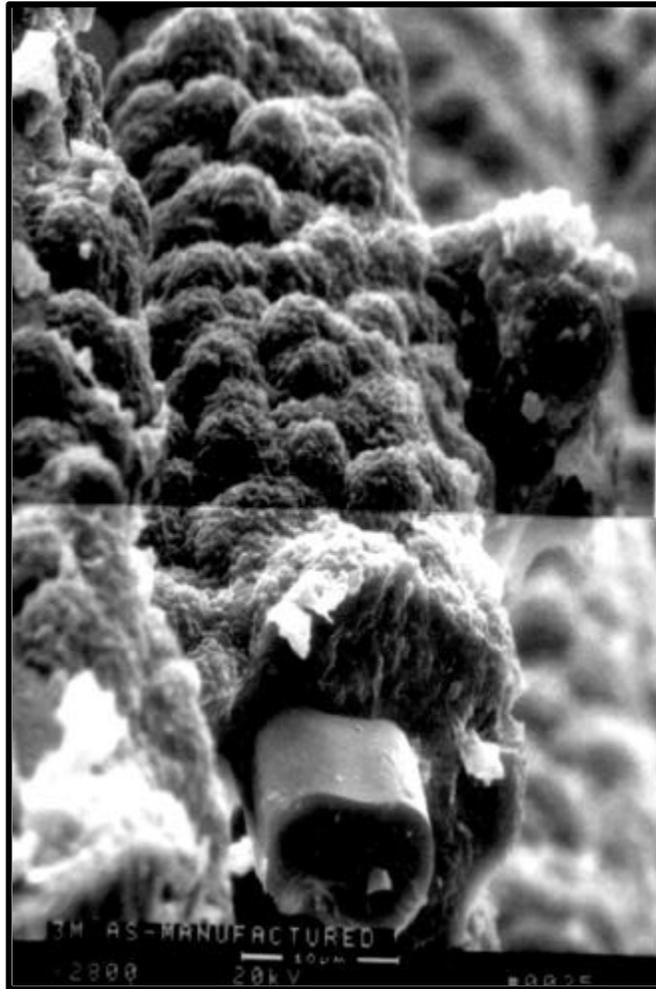
Figure 40 — CVI-SiC layer deposited along the outer surface of the 3M Nextel™ 312 structural support triaxial braid.

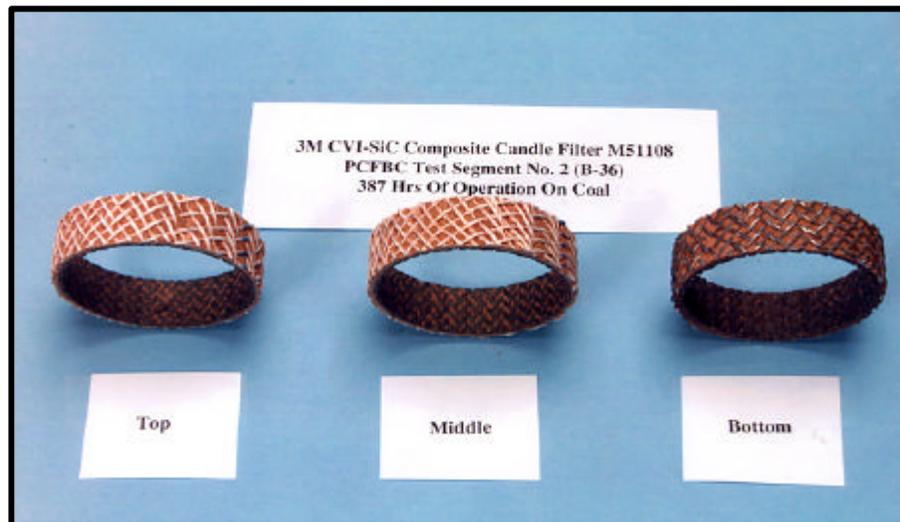
When the 3M CVI-SiC filter element was installed and operated in either the  $825^{\circ}\text{C}$  ( $1520^{\circ}\text{F}$ ) PFBC filter array at the AEP Tidd demonstration plant in Brilliant, OH, or in the  $850^{\circ}\text{C}$  ( $1560^{\circ}\text{F}$ ) PCFBC filter array at the Foster Wheeler Karhula test facility, a color change was readily evident along the outer confinement and filtration mat layers (Figure 41). After 387 hours of PCFBC operation, the outer confinement layer appeared to be white (excluding the presence of ash fines), while the filtration mat layer appeared to be a light to medium gray. The triaxial support braid retained its as-manufactured dark black appearance. Scanning electron microscopy/energy dispersive x-ray analysis (SEM/EDX) characterization of the PCFBC-exposed 3M CVI-SiC composite filter matrix confirmed that removal of the SiC layer which initially encapsulated the Nextel™ 312 fibers in the outer confinement layer had occurred. Characterization of the lapped filtration mat indicated that oxidation of the  $2\ \mu\text{m}$  thick CVI-SiC shell had also occurred. As a result, an  $\sim 1\ \mu\text{m}$  thick oxygen-enriched region formed along the inner surface of the CVI-SiC shell, bonding the shell to the filtration mat fibers. Bonding of the oxygen-enriched CVI-SiC shell to the fibers ultimately reduced the fracture toughness of the composite matrix layer. After 2815 hours of PFBC operation at Tidd, the  $2\ \mu\text{m}$  CVI-SiC layer that infiltrated into the triaxial braid, coating individual fibers, similarly formed an outer  $\sim 1\ \mu\text{m}$  thick  $\text{SiO}_2$ -enriched layer that frequently contained cracks (Figure 41). After 2815 hours of exposure to the PFBC process gas environment, only  $\sim 21\%$  of the initial strength of the triaxial support braid remained. Neither the filtration mat nor the outer confinement layers were expected to significantly contribute to the overall strength of the 3M CVI-SiC composite filter matrix.

Figure 41 — Sections of the 3M CVI-SiC composite candle filter after PFBC or PCFBC operation.

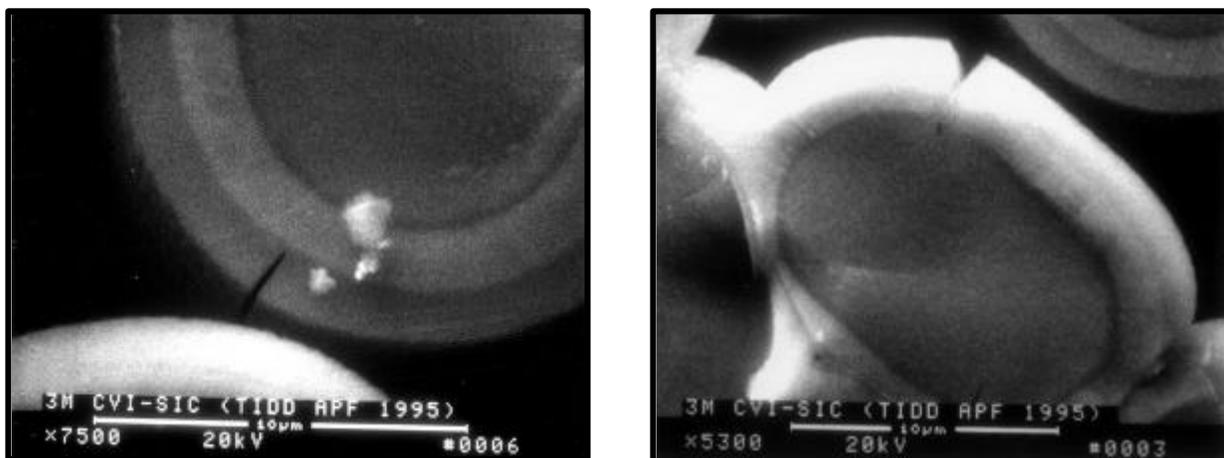
Figure 42 — Crack formations along the silica-enriched infiltrated layers that surrounded the Nextel™ 312 fibers in the triaxial support braid of the 3M composite filter matrix after 2815 hours of exposure above the Siemens Westinghouse APF system tubesheet at AEP. Cracks formations resulted from volume expansion of the silica, thermal mismatch with the underlying SiC layer, and plant startup/shutdown cyclic operation.

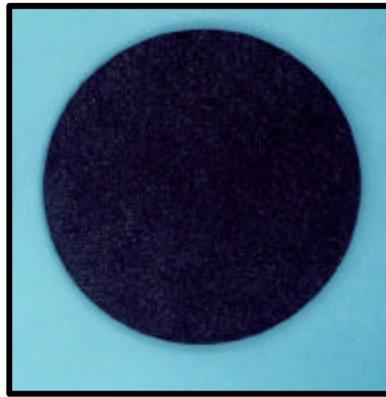
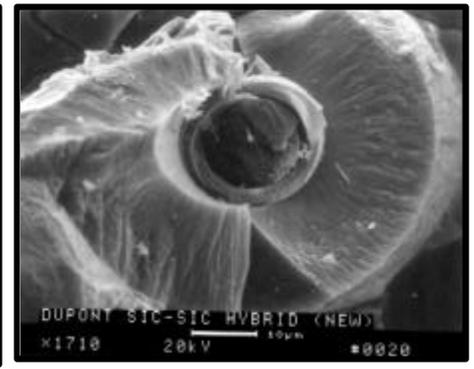
Figure 44 — DuPont SiC-SiC CFCC filter architecture. (a) Felt layer surface; (b) Mesh screen support surface; (c) As-manufactured single-ply layer; (d) As-manufactured mesh screen support layer; (e) Presence of an interface layer encapsulating the Nicalon™ fibers in the as-manufactured single-ply felt layer.

Subsequently DuPont manufactured SiC-SiC composite candle filters using a hybrid architecture (Figure 44). An open mesh Nicalon™ screen served as the candle filter support structure. A Nicalon™ single-ply felt was layered over the mesh, and the unit was subsequently subjected to silicon carbide CVI. A silicon carbide grit was applied to the outer surface of the CVI-SiC felt in order to form an effective particulate barrier filter membrane. Since Nicalon™ is primarily a silicon carbide fiber which contained oxygen, and silicon carbide was deposited along the fiber rigidizing the perform, the material was designated as a SiC-SiC composite filter matrix.

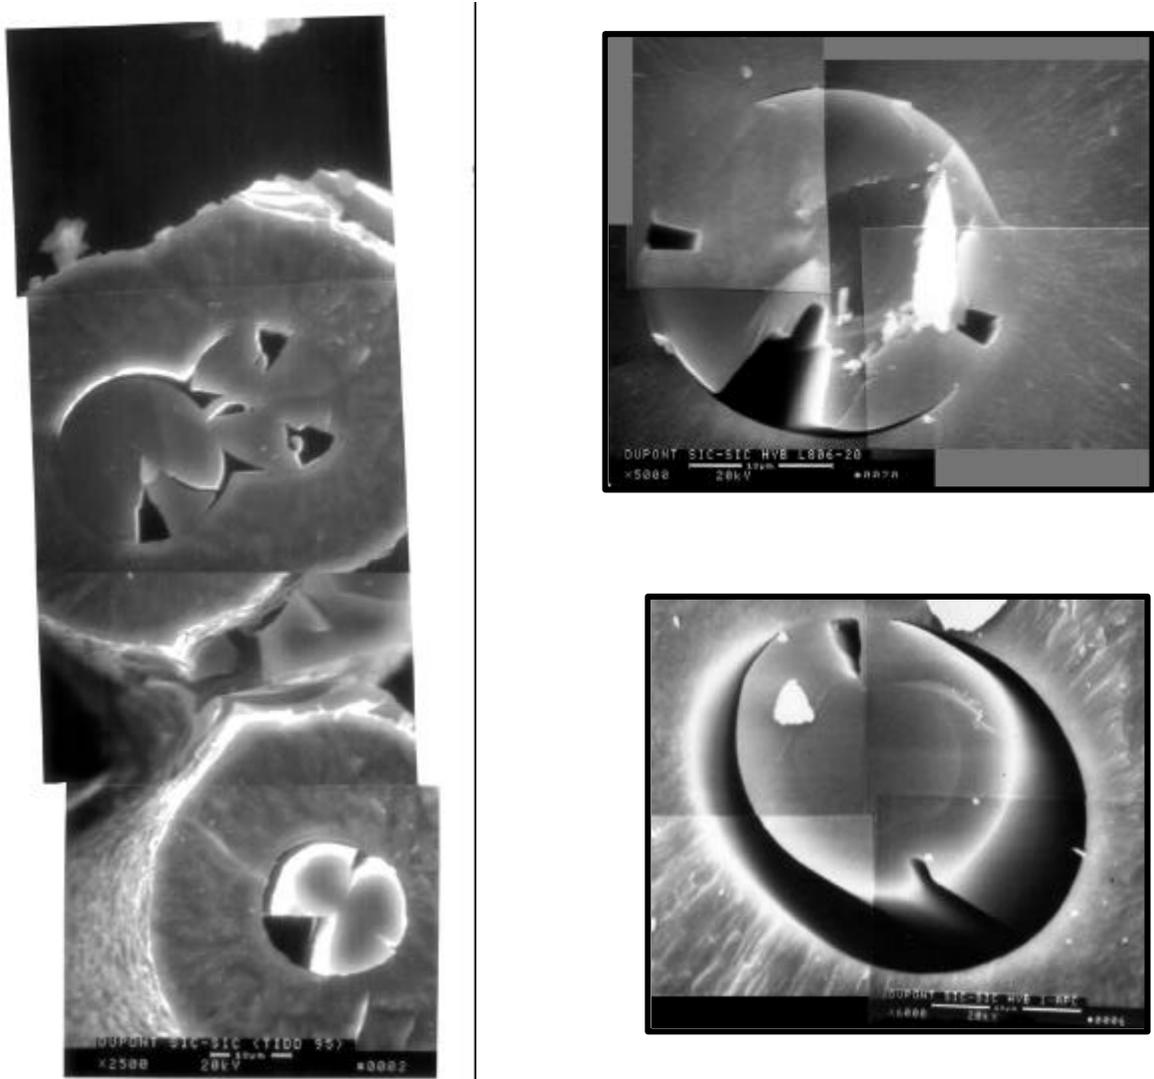
Figure 45 — Morphology of the Dupont SiC-SiC CFCC hybrid filter matrix after accelerated pulse cycle testing in SWPC's PFBC simulator test facility.
