**FILTER COMPONENT ASSESSMENT  
— CERAMIC CANDLES —**

**Final Report**

DOE/NETL Contract No. DE-AC21-94MC31147

M. A. Alvin

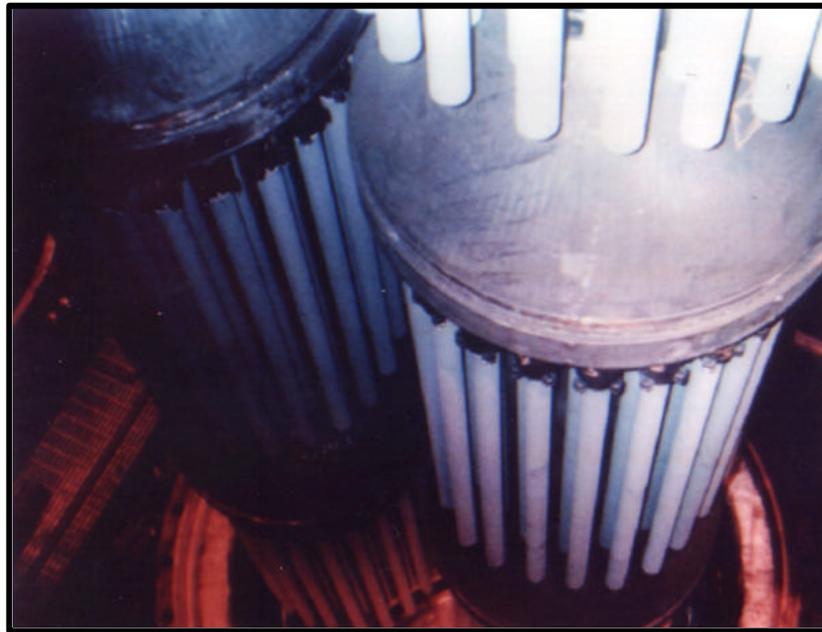
Figure 46 — SWPC APF system at the AEP PFBC Tidd demonstration plant in Brilliant, OH.

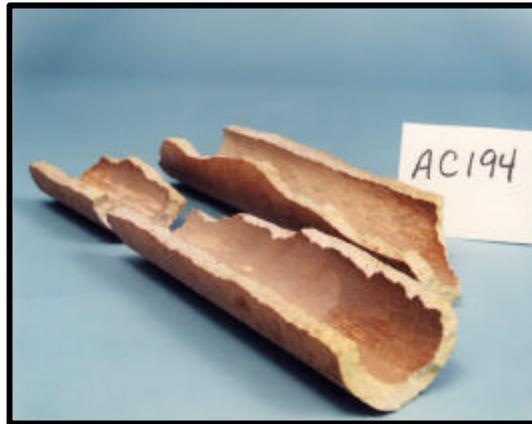
Figure 47 — Thermal fatigue of the Coors P-100A-1 alumina/mullite filter matrix.

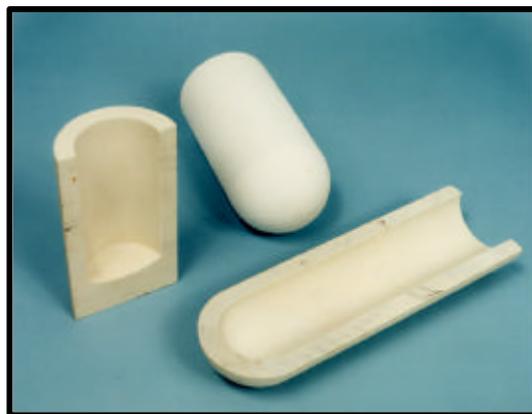
Figure 48 — Coors P-100A-1 alumina/mullite closed end cap. Radiusing of the filter wall in the end cap region eliminated stress risers within the matrix, mitigating failure of the filter body.

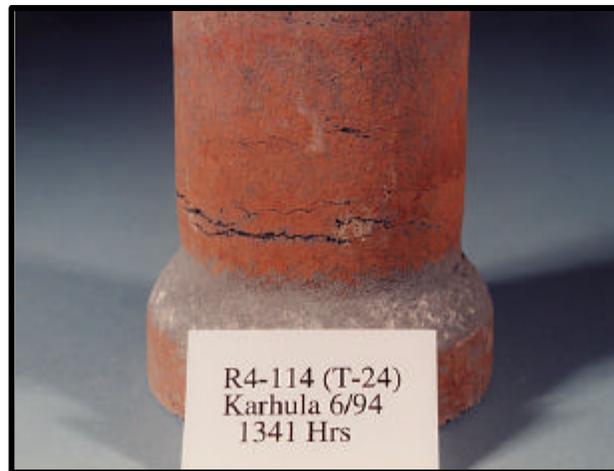
Figure 49 — Crack formations at the base of the Pall Vitropore filter flange as a result of high temperature creep during operation at AEP.

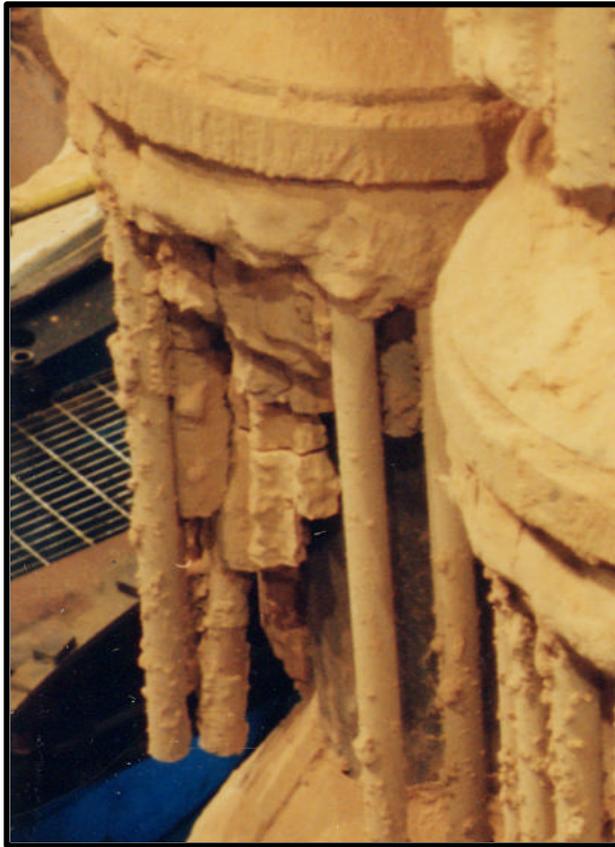
Figure 50 — Failure of the porous ceramic filter elements as the result of ash bridging within the filter array.

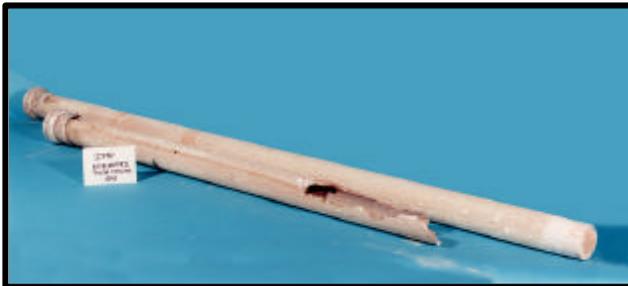
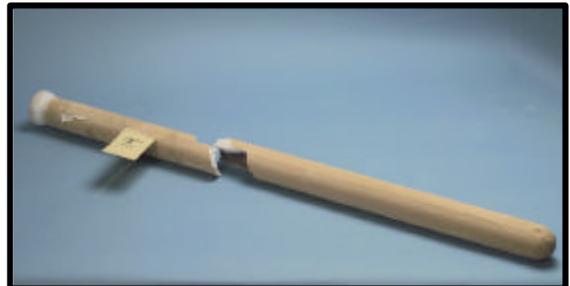
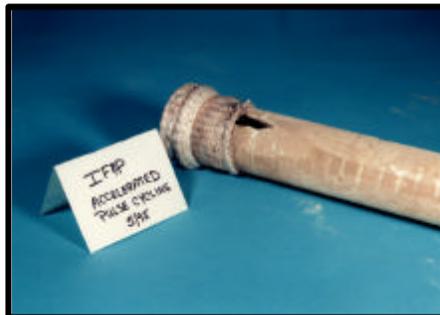
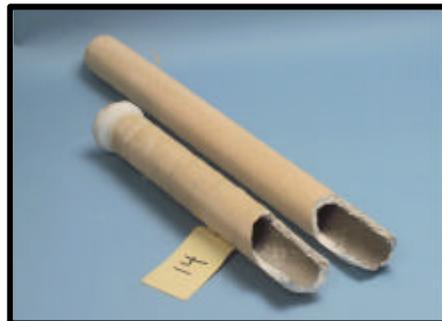
Figure 51 — Failure of the vacuum infiltrated chopped fibrous candle filters.

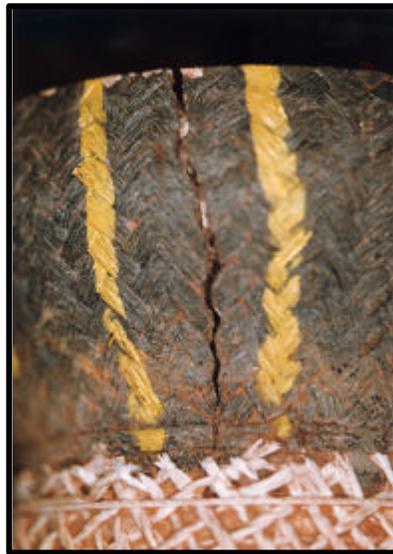
Figure 52 — Failure of the thinner walled 3M CFCC filter element flange.

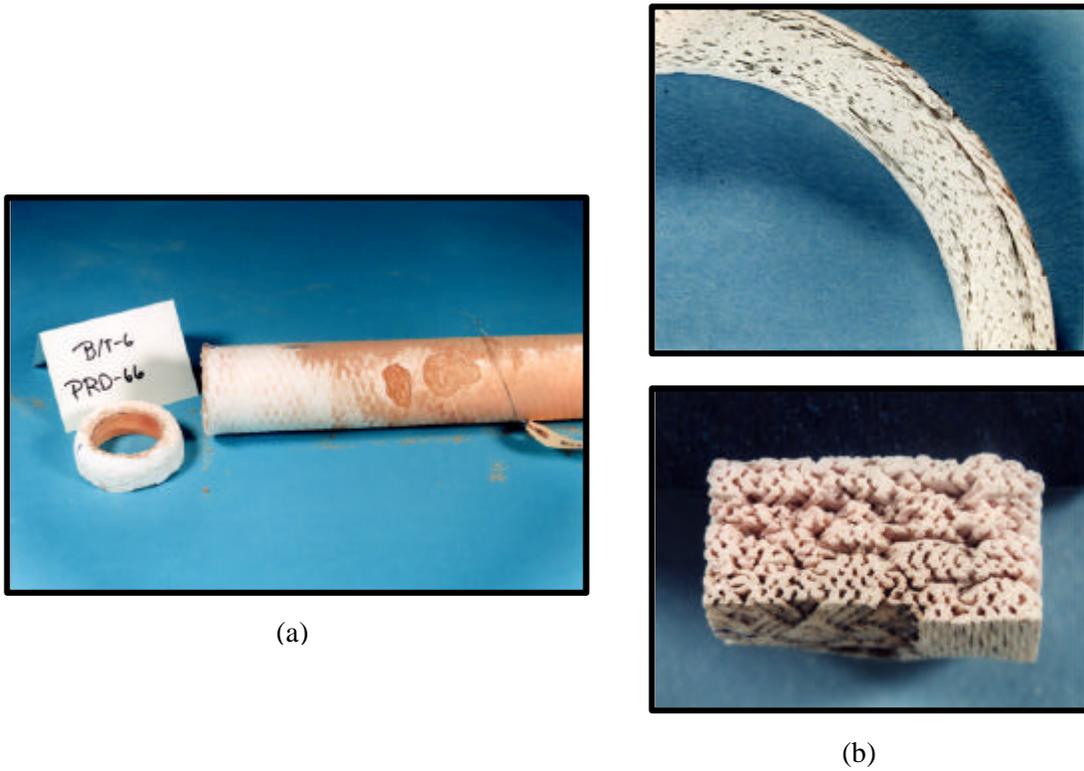
Figure 53 — Failure of the DuPont PRD-66 filter element. (a) Flange failure and divot formation; (b) Gap formations within the cross-sectioned filter wall.

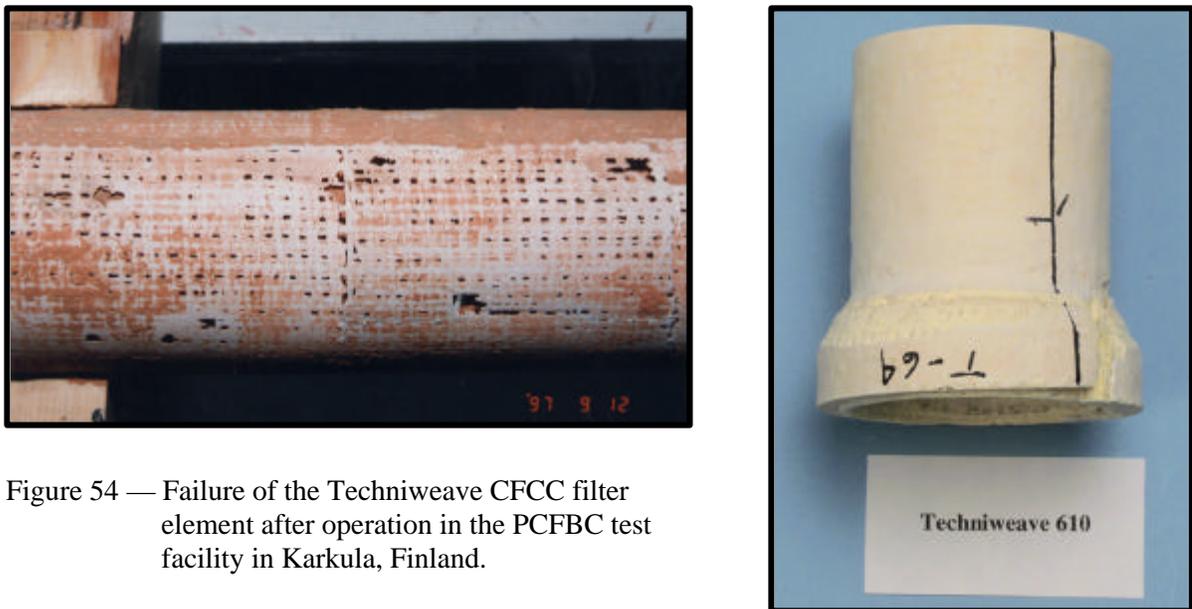
Figure 54 — Failure of the Techniweave CFCC filter element after operation in the PCFBC test facility in Karkula, Finland.

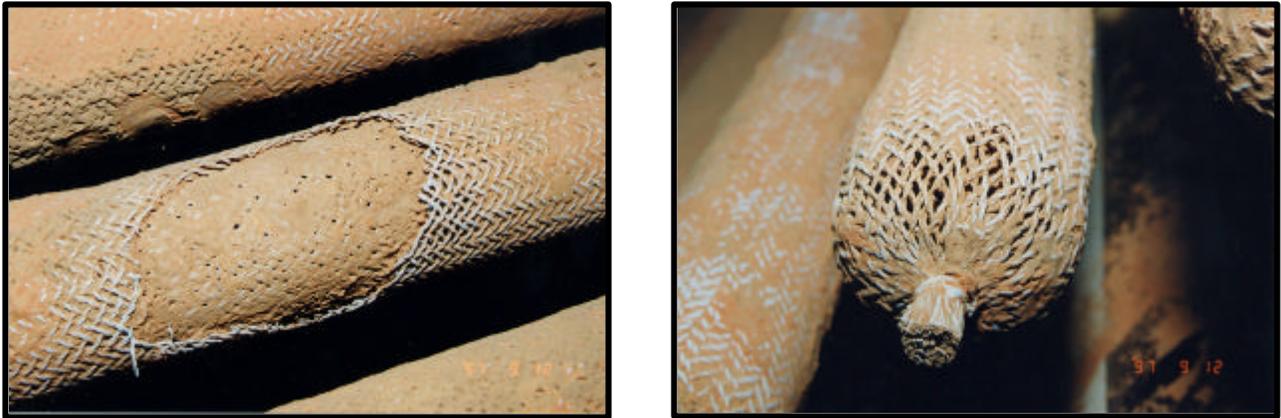
Figure 55 — Failure of the 3M oxide-based CFCC filter elements.

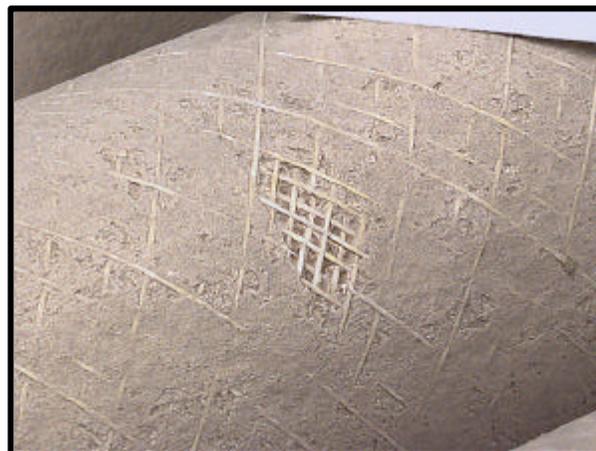
Figure 56 — Removal of fibers along the outer surface of the McDermott CFCC filter element.

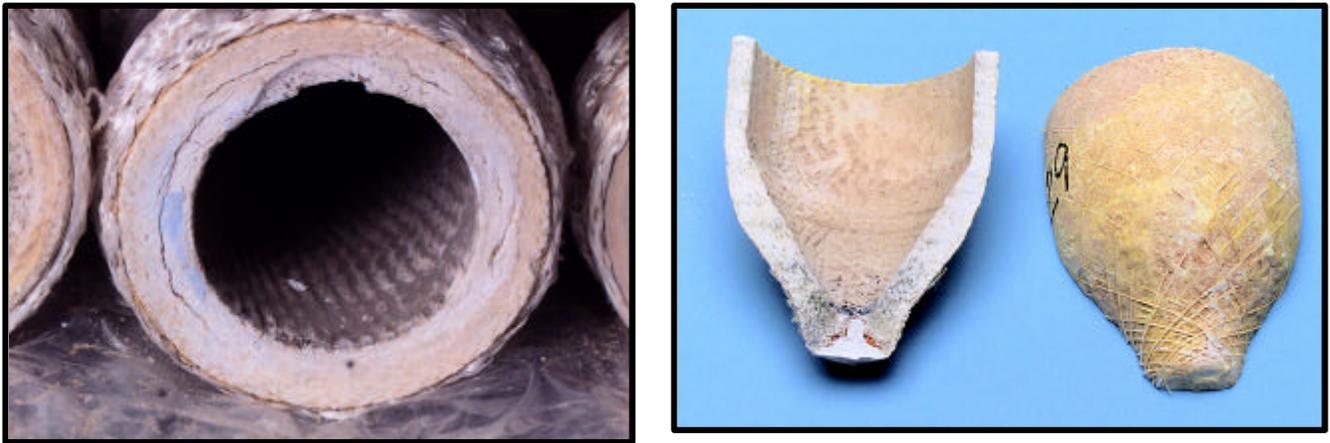
Figure 57 — Critical inserts within the McDermott CFCC filter element.

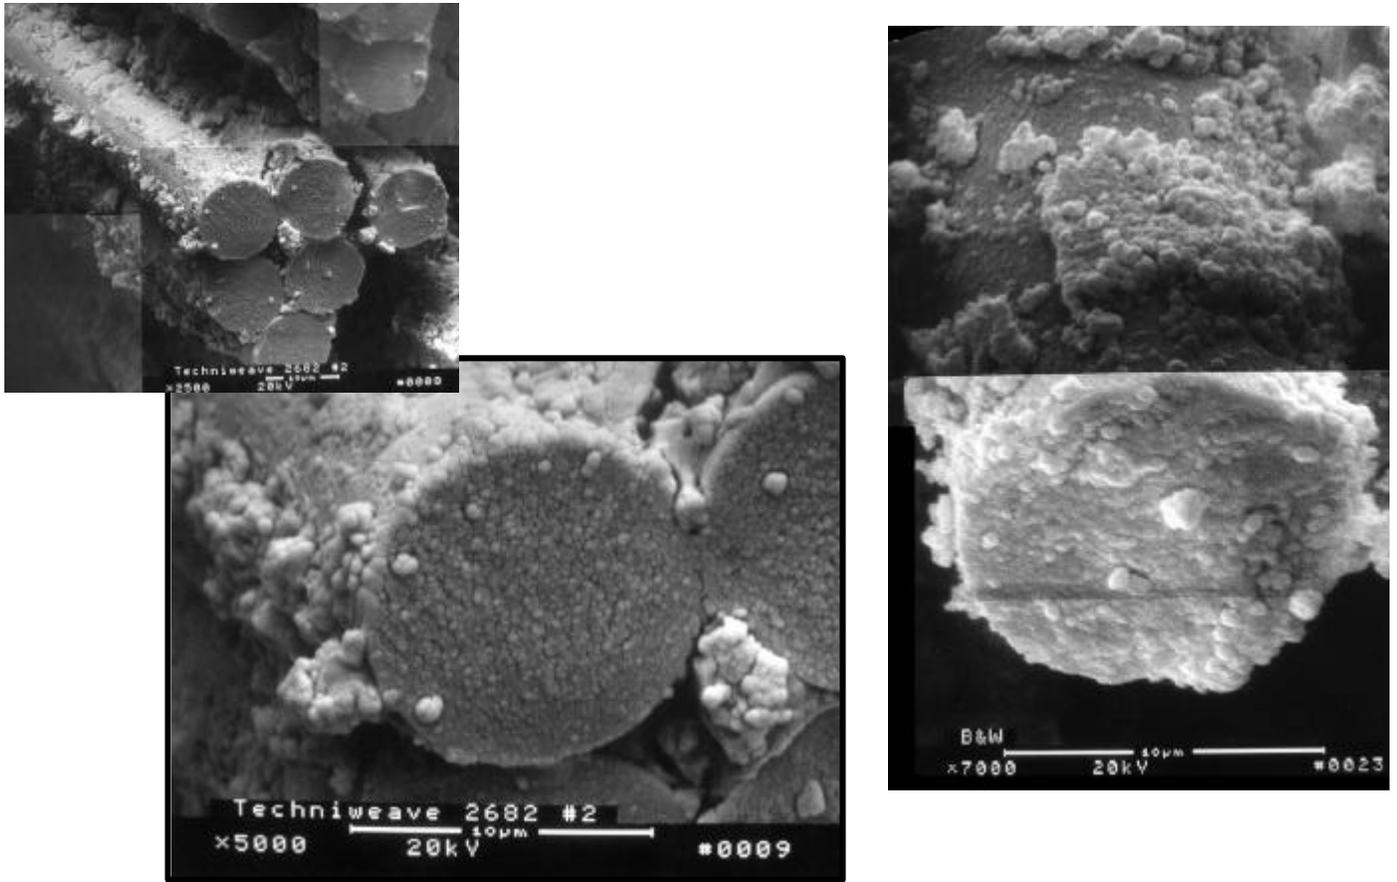
Figure 58 — Crystallization of the Nextel™ fibers within the oxide-based CFCC filter matrices.

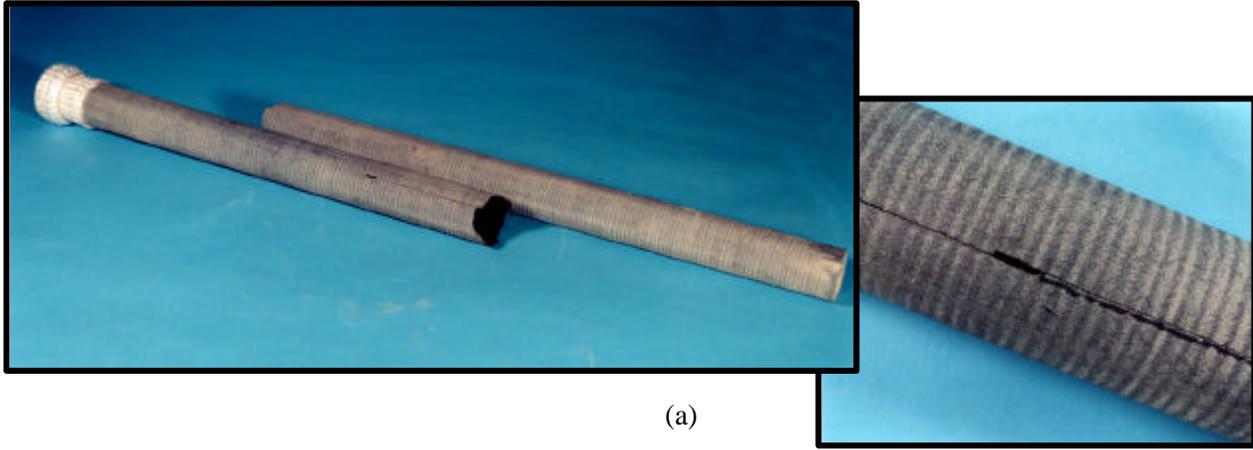
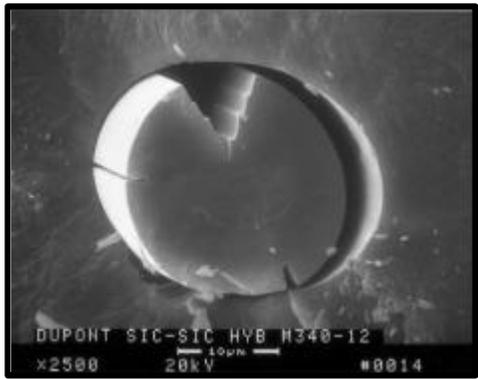
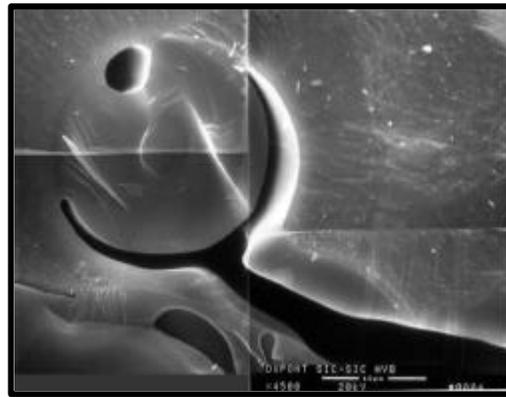
Figure 60 — Failure of the DuPont SiC-SiC CFCC filter matrix. (a) Longitudinal seam failure; (b) Removal of the interface layer and oxidation of the Nicalon™ fiber; (c) Oxidation of the internal surface of the CVI-SiC encapsulating layer and bonding with the oxidized Nicalon™ fiber.

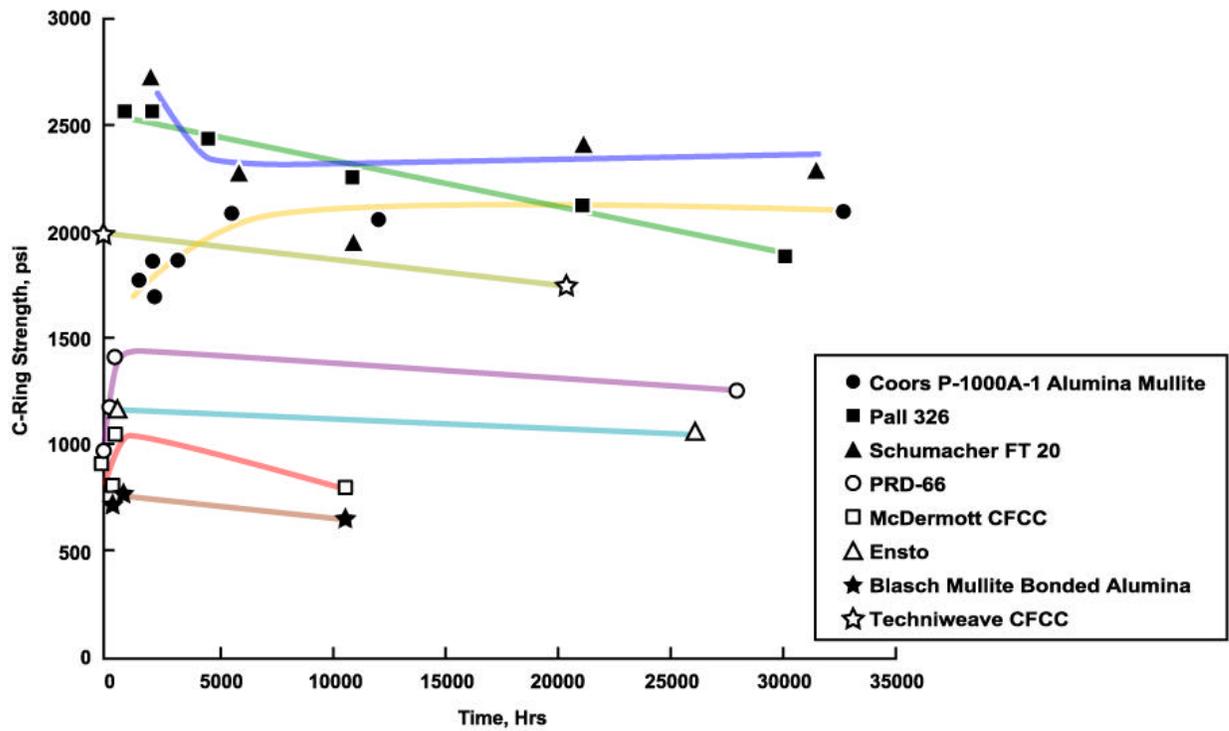
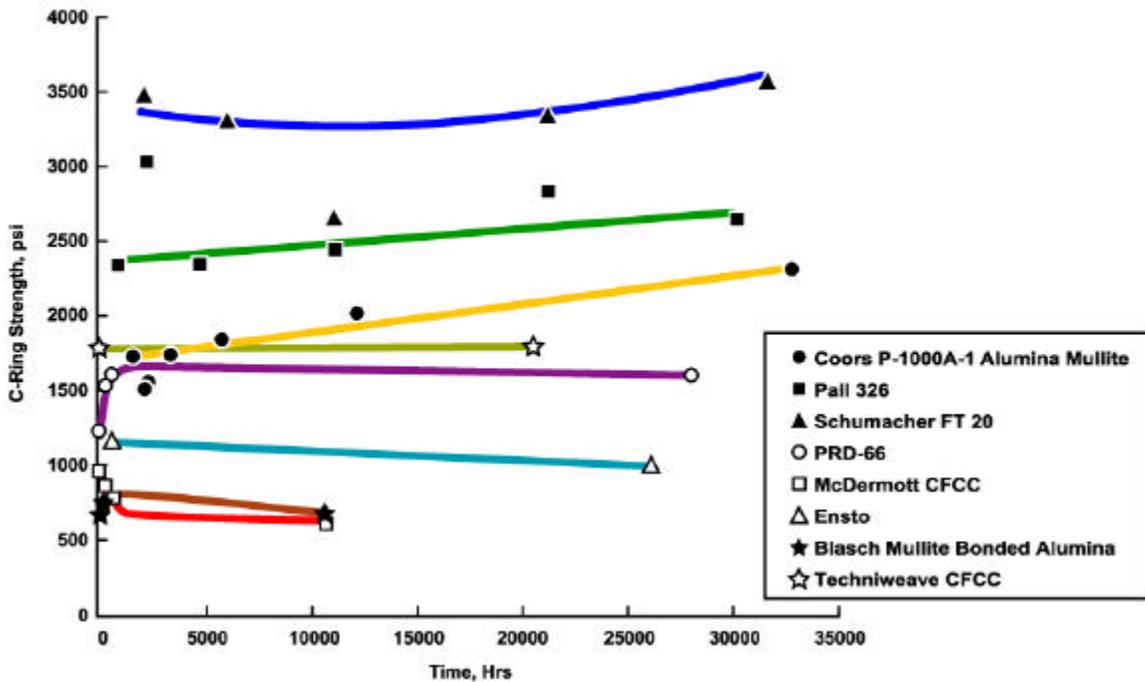
Figure 61 — Residual room and process temperature compressive strength of the various ceramic candle filter materials as a function of field and extended simulated PFBC accelerated life testing.

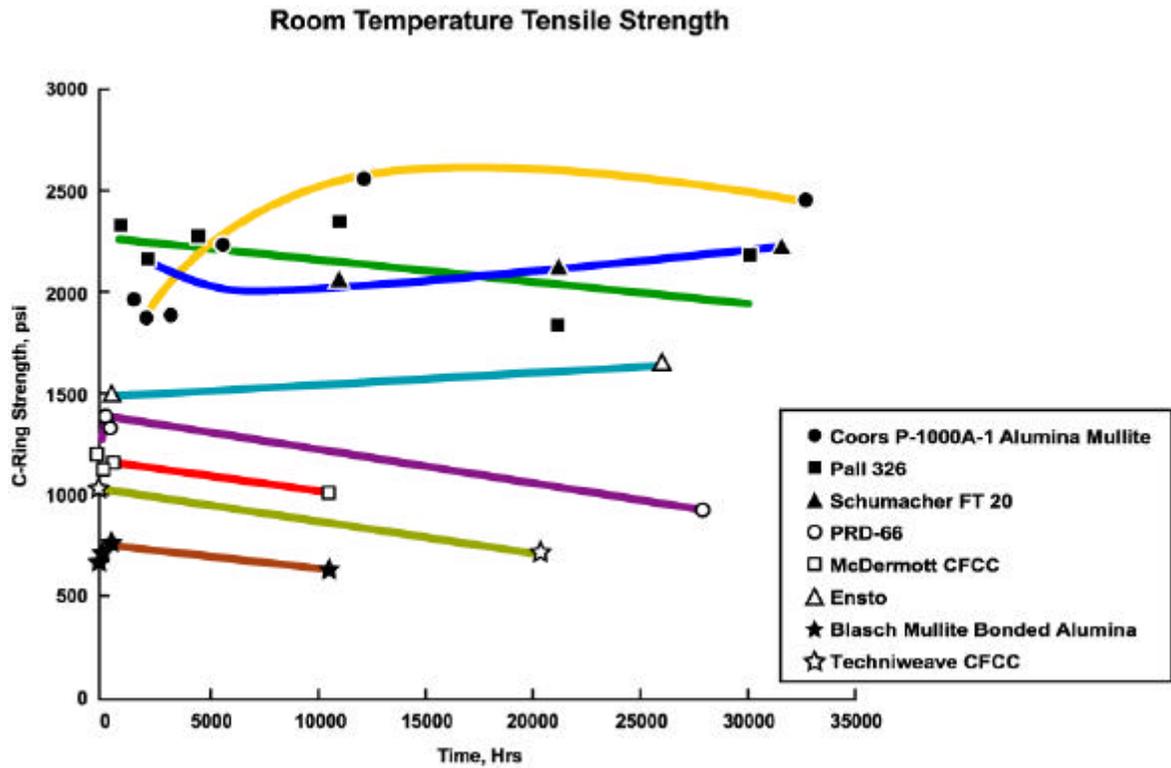
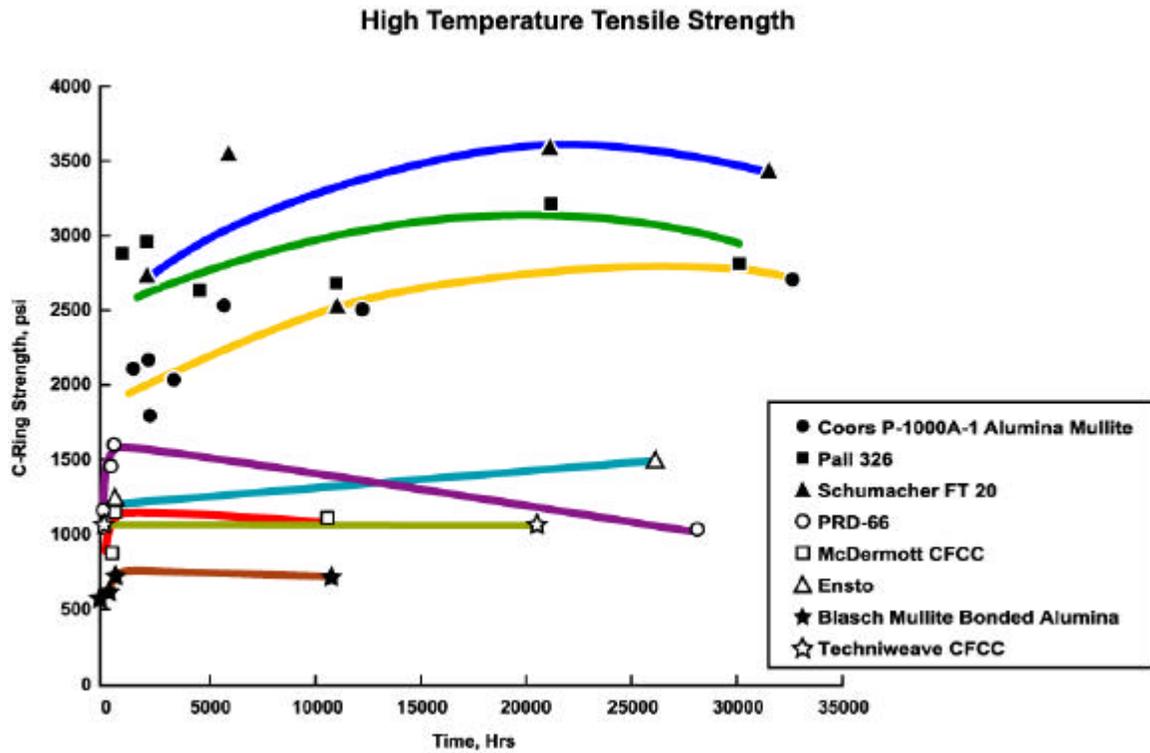
Figure 62 — Residual room and process temperature tensile strength of the various ceramic candle filter materials as a function of field and extended simulated PFBC accelerated life testing.

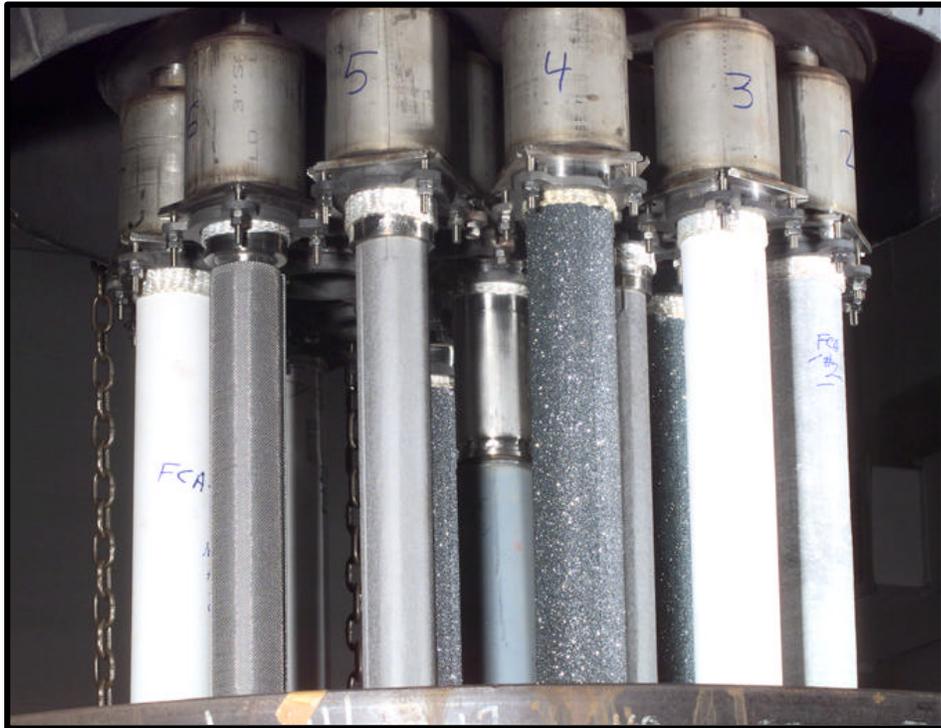
Figure 63 — Ceramic and metal candle filter array.

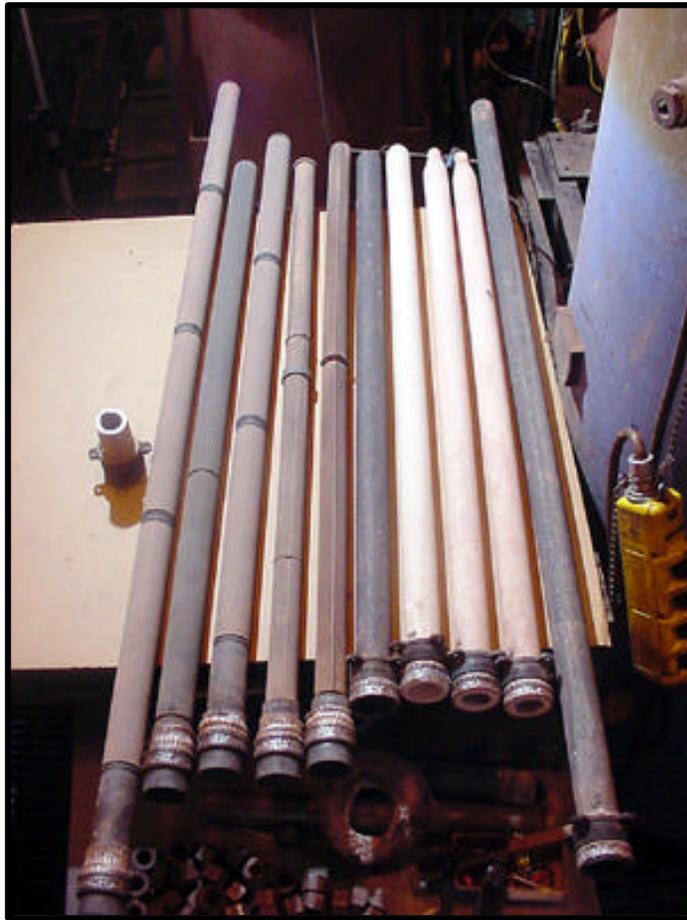
Figure 65 — Filter elements at the conclusion of steady state, accelerated pulse cycling and thermal transient testing. From left to right: 2.0 m Pall FeAl; 1.5 m U.S. Filter/Fluid Dynamics 316L; 1.5 m Pall FeAl; 1.5 m Bekaert/Mott Fecralloy; 1.5 m Microfiltrex Fecralloy metal media filter elements; 1.5 m Filtros recrystallized SiC; 1.5 m Techniweave CFCC; two 1.5 m DuPont PRD-66; and 2.0 m Filtros recrystallized SiC ceramic filter elements.

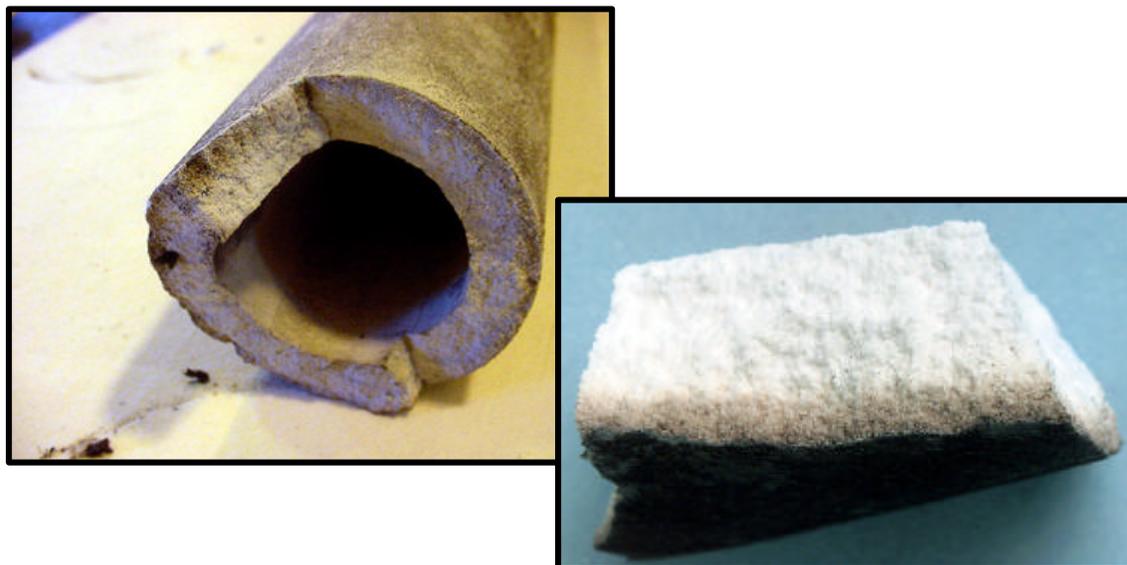
Figure 66 — Failure of the Blasch mullite bonded alumina candle filter after 282 hours of operation in the 840°C (1550°F), simulated PFBC process gas environment containing gas phase sulfur and alkali (Test Segment No. 1).

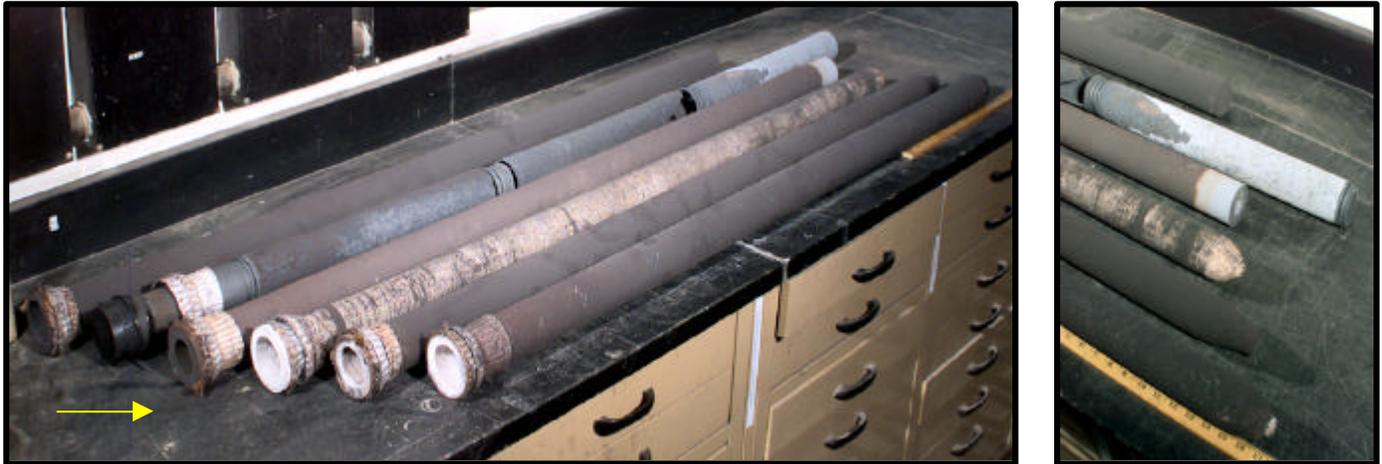
Figure 67 — Candle filters at the conclusion of Test Segment No. 2 — 486 hours of exposure at 840°C (1550°F) in the simulated PFBC process gas environment containing gas phase sulfur and alkali. Elements from left to right include: Filtros recrystallized SiC; Pall iron aluminide; Schumacher clay bonded SiC FT20; Techniweave CFCC; DuPont PRD-66; and McDermott CFCC.

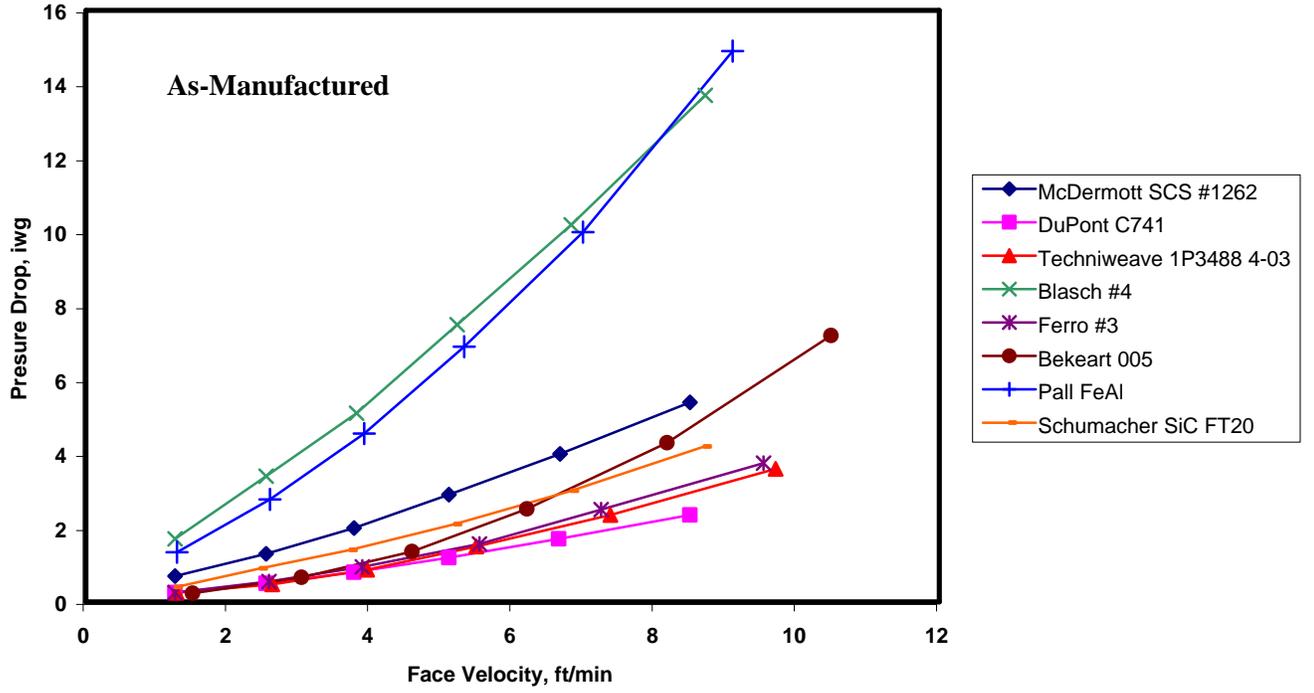
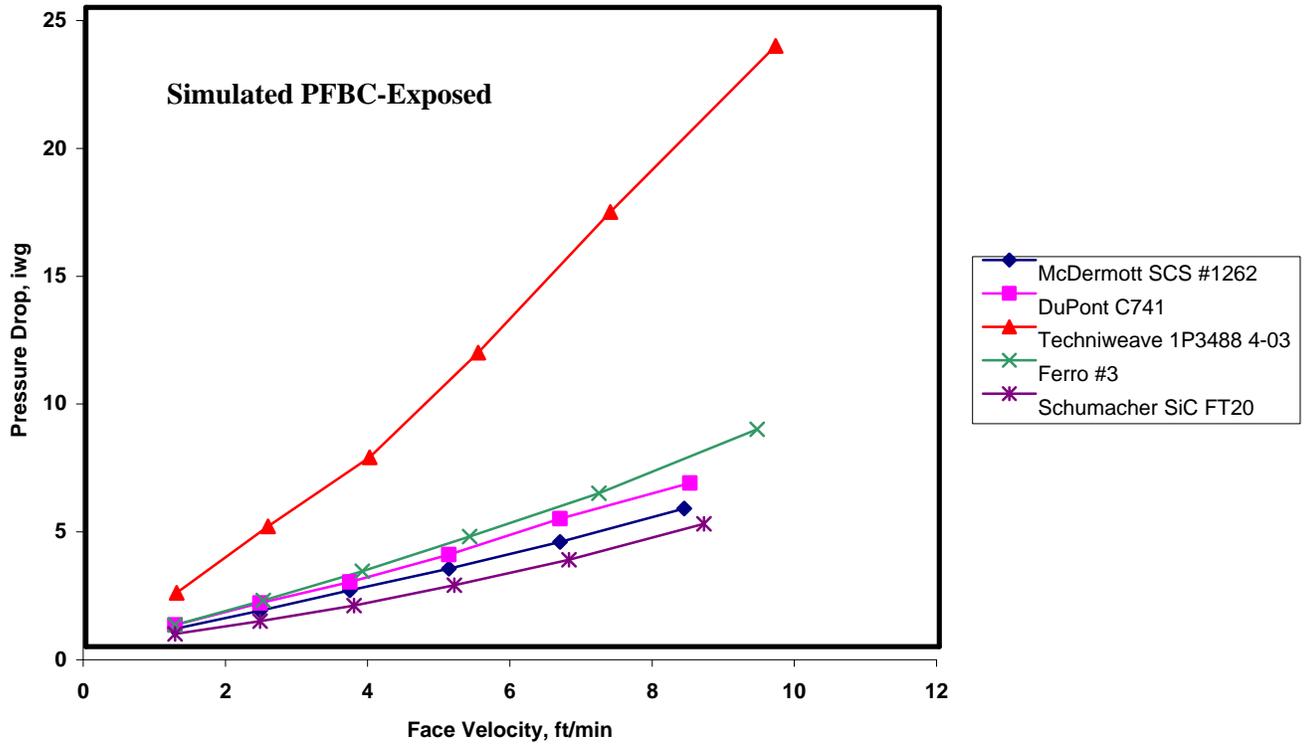
Figure 68 — Room temperature gas flow resistance through the porous filter elements.

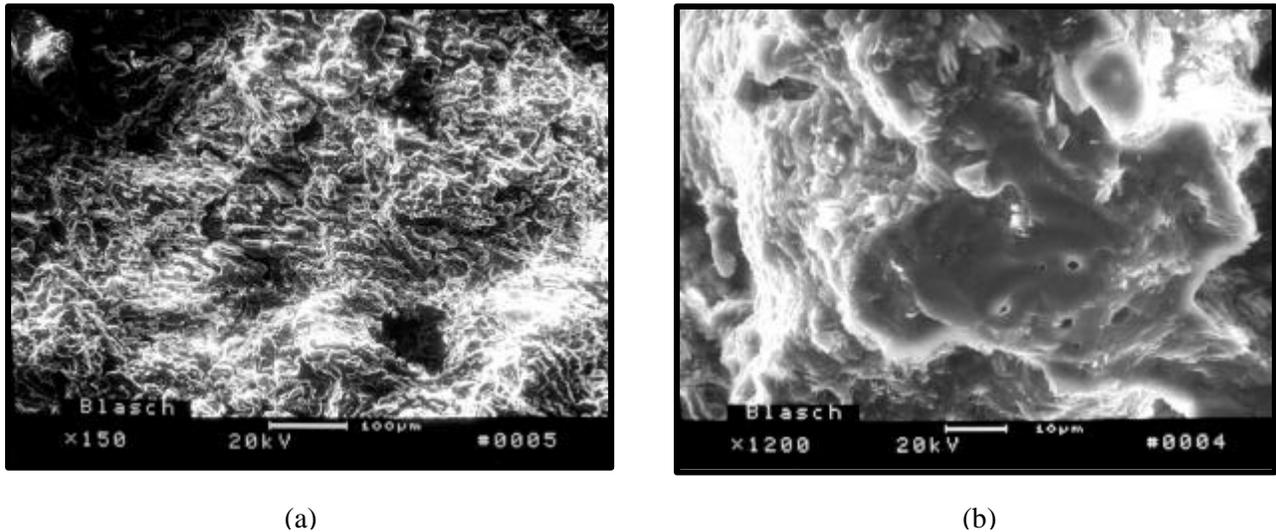
Figure 71 — Morphology of the Blasch filter matrix after 282 hours of exposure to the gas phase alkali and sulfur-laden, 840°C (1550°F), simulated PFBC process gas environment. (a) Striated platelet matrix formations within the mid-section of the filter wall; (b) Non-crystalline morphology within the interior of the fresh fractured ligament.

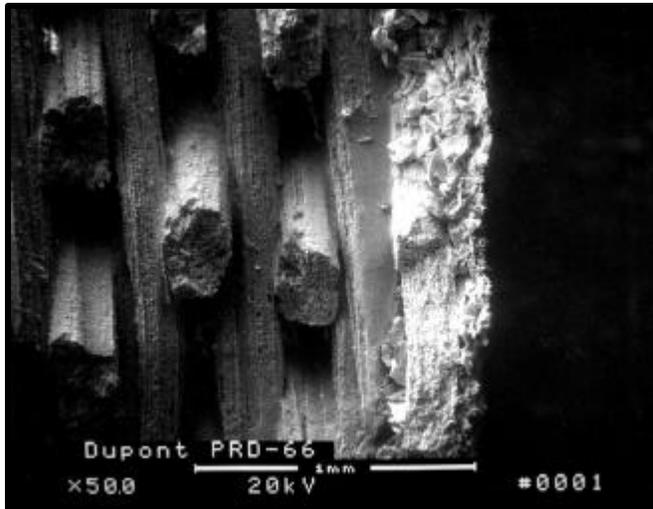
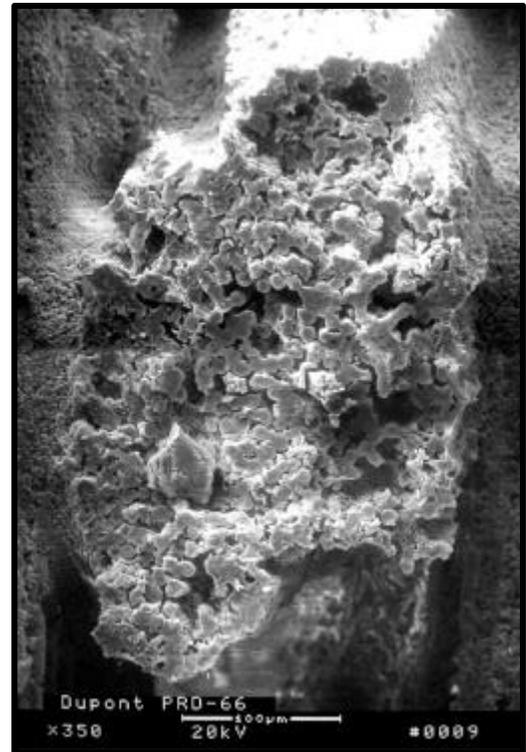
Figure 72 — Microstructure of the DuPont PRD-66 filter matrix after 486 hours of exposure to the gas phase alkali and sulfur-laden, 840°C (1550°F), simulated PFBC process gas environment. In comparison to an as-manufactured DuPont PRD-66 filter matrix, negligible microstructural changes were detected.

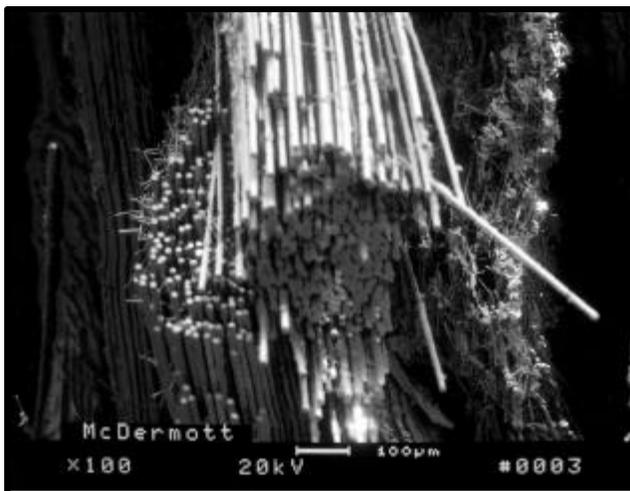
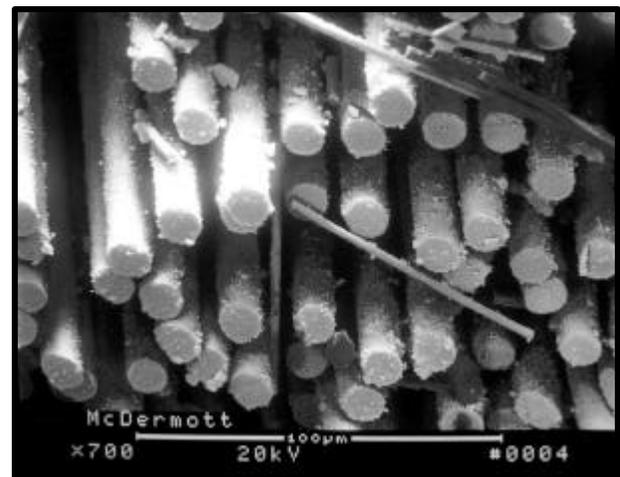
Figure 73 — Microstructure of the McDermott CFCC filter matrix after 486 hours of operation in the gas phase alkali and sulfur-laden, 840°C (1550°F), simulated PFBC process gas environment.

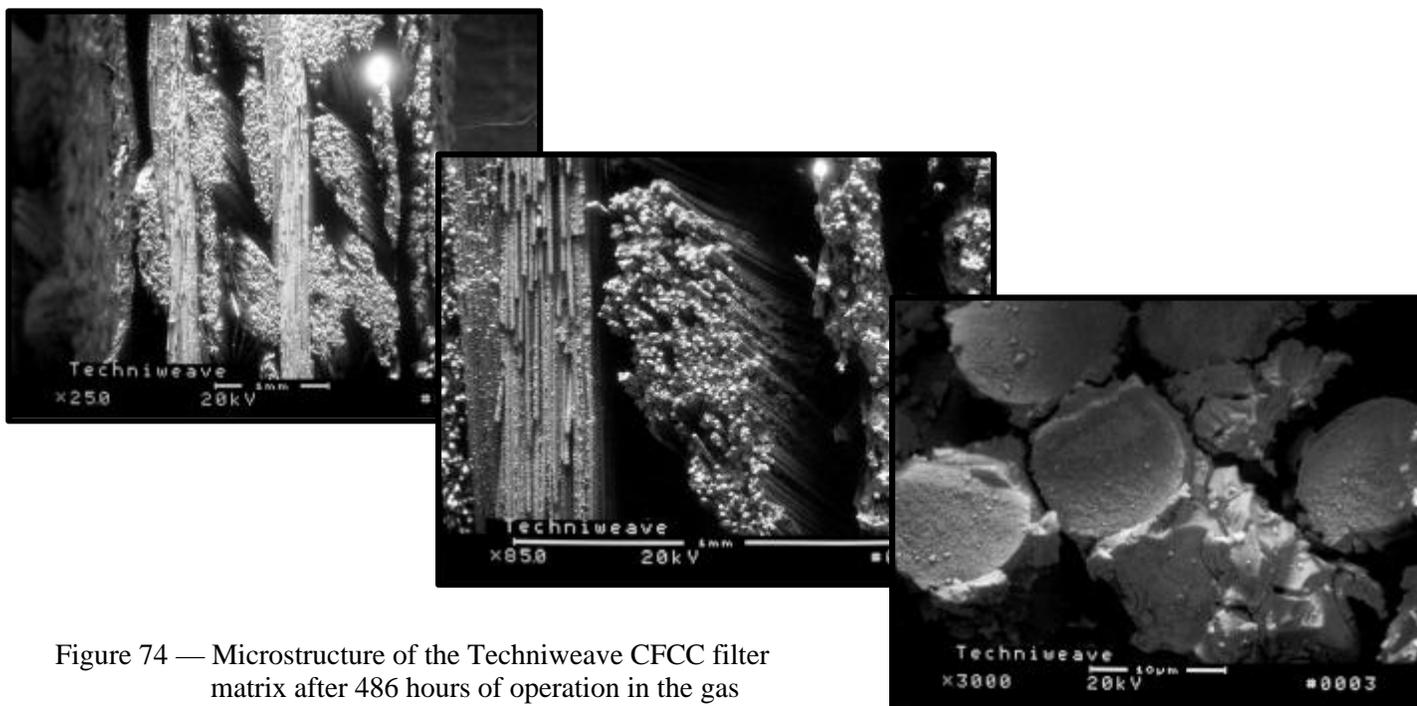
Figure 74 — Microstructure of the Techniweave CFCC filter matrix after 486 hours of operation in the gas phase alkali and sulfur-laden, 840°C (1550°F), simulated PFBC process gas environment.

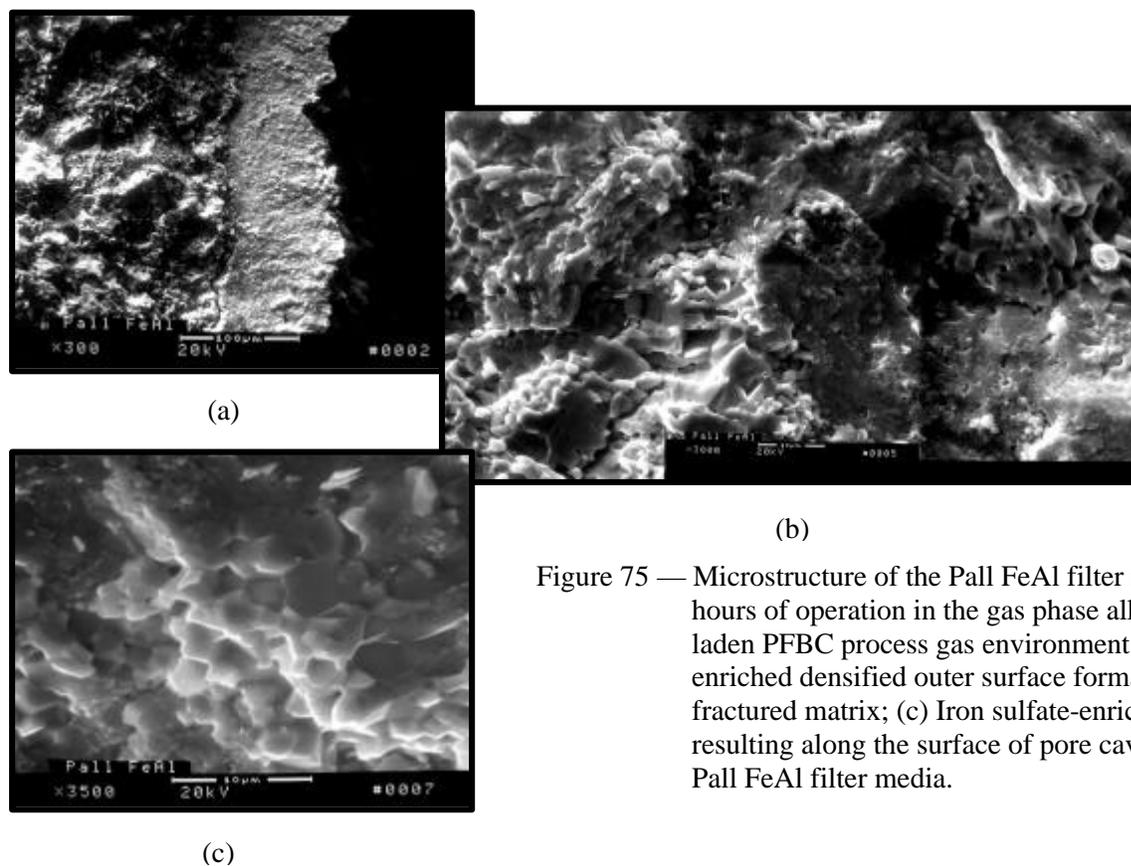
Figure 75 — Microstructure of the Pall FeAl filter matrix after 204 hours of operation in the gas phase alkali and sulfur-laden PFBC process gas environment. (a) Iron oxide-enriched densified outer surface formation; (b) Fresh fractured matrix; (c) Iron sulfate-enriched features resulting along the surface of pore cavities within the Pall FeAl filter media.

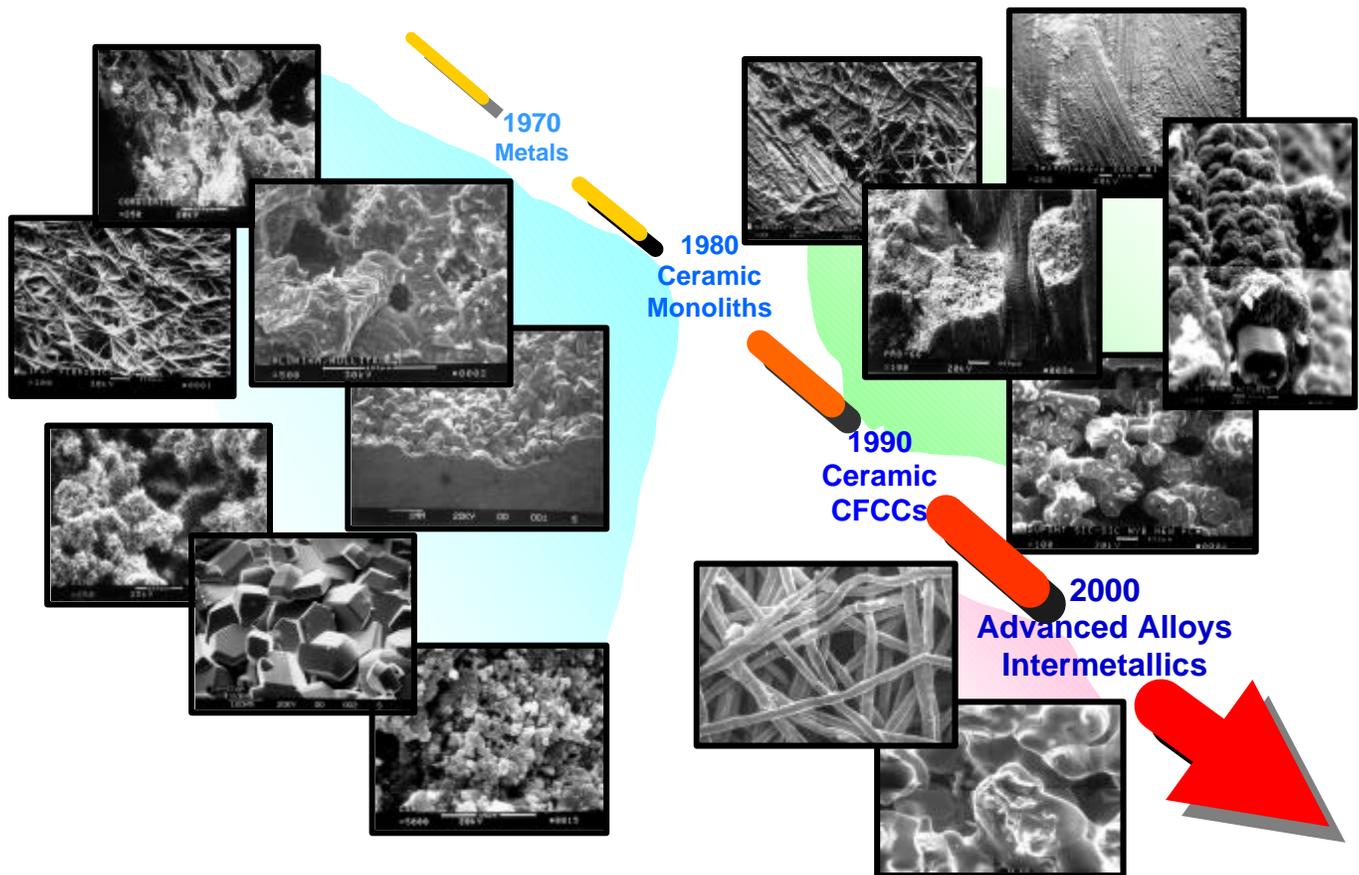
Figure 76 — Porous hot gas filter material technology development.
