**FILTER COMPONENT ASSESSMENT  
— CERAMIC CANDLES —**

**Final Report**

DOE/NETL Contract No. DE-AC21-94MC31147

M. A. Alvin

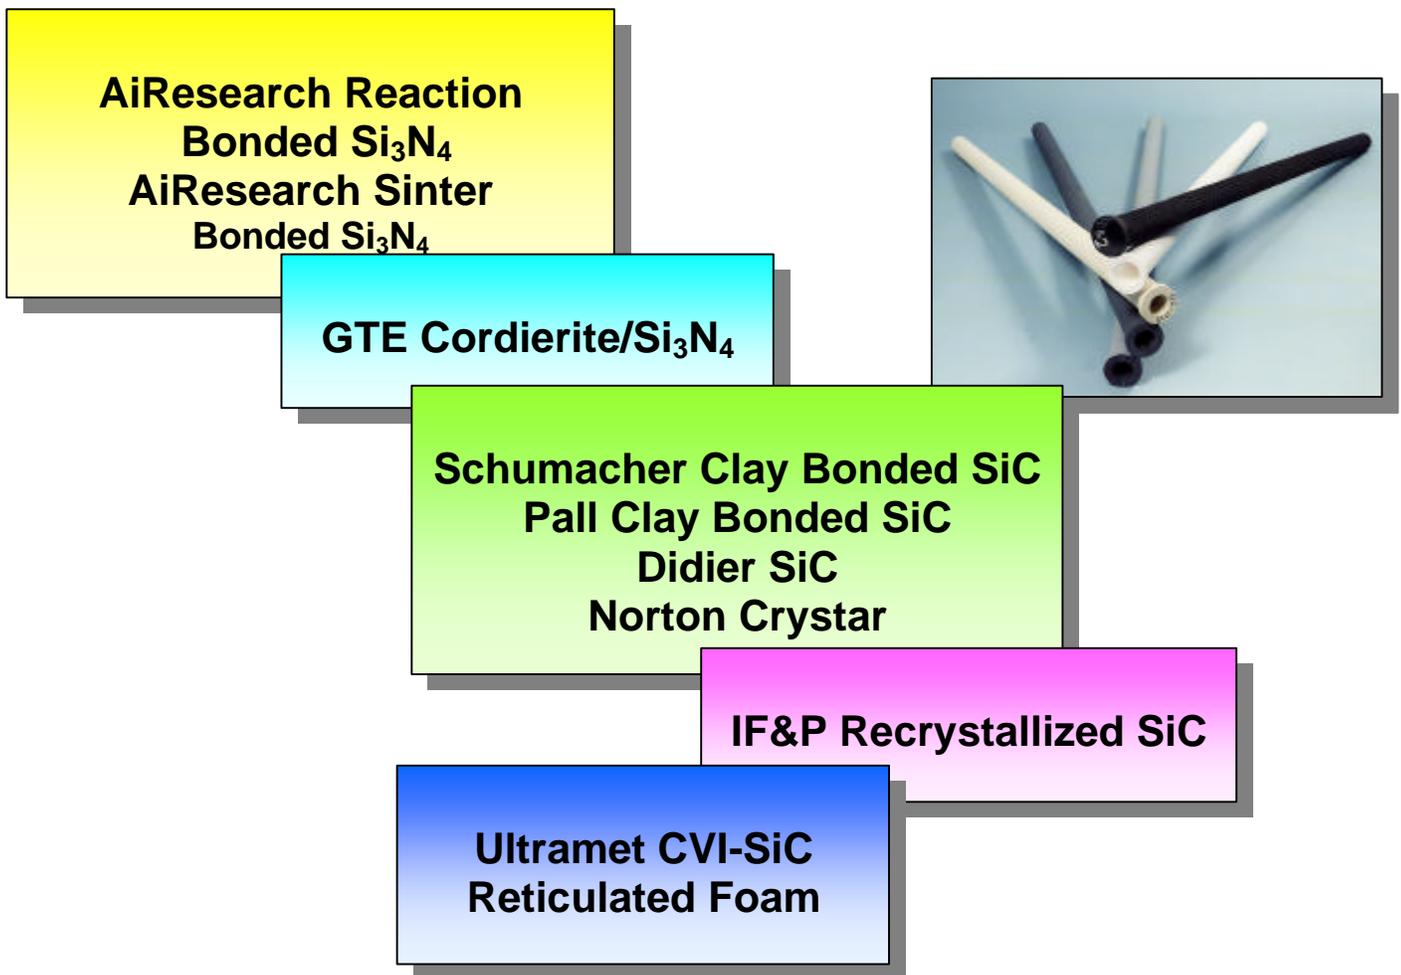
Figure 77 — Porous monolithic nonoxide-based ceramics used for hot gas filter technology development.

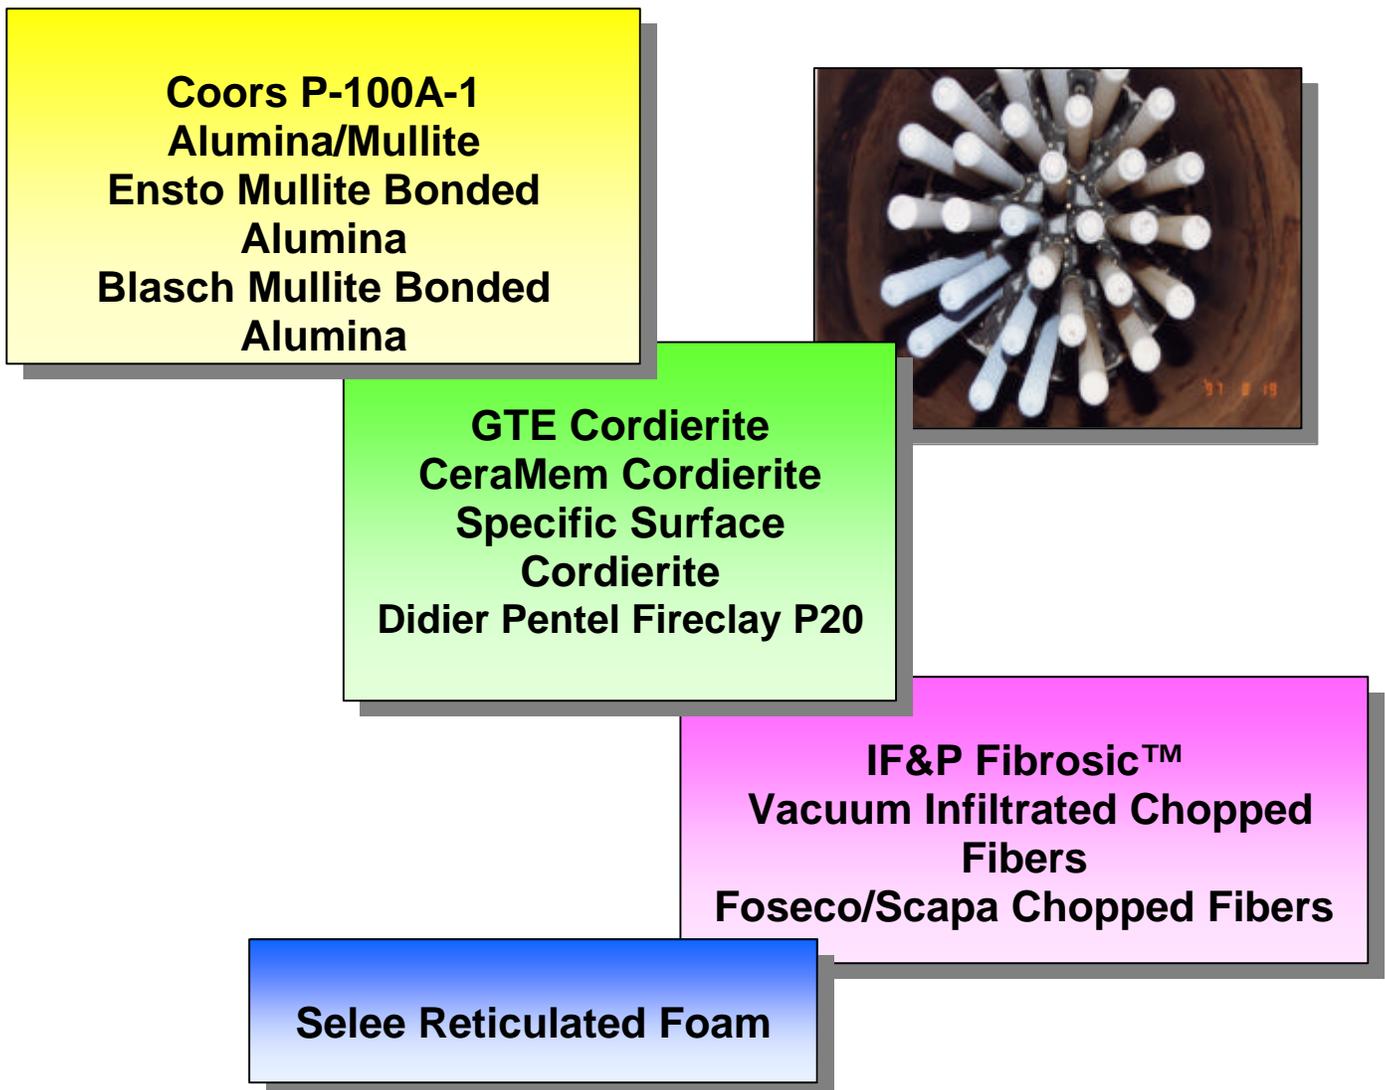
Figure 78 — Porous monolithic oxide-based ceramics used for hot gas filter technology development.

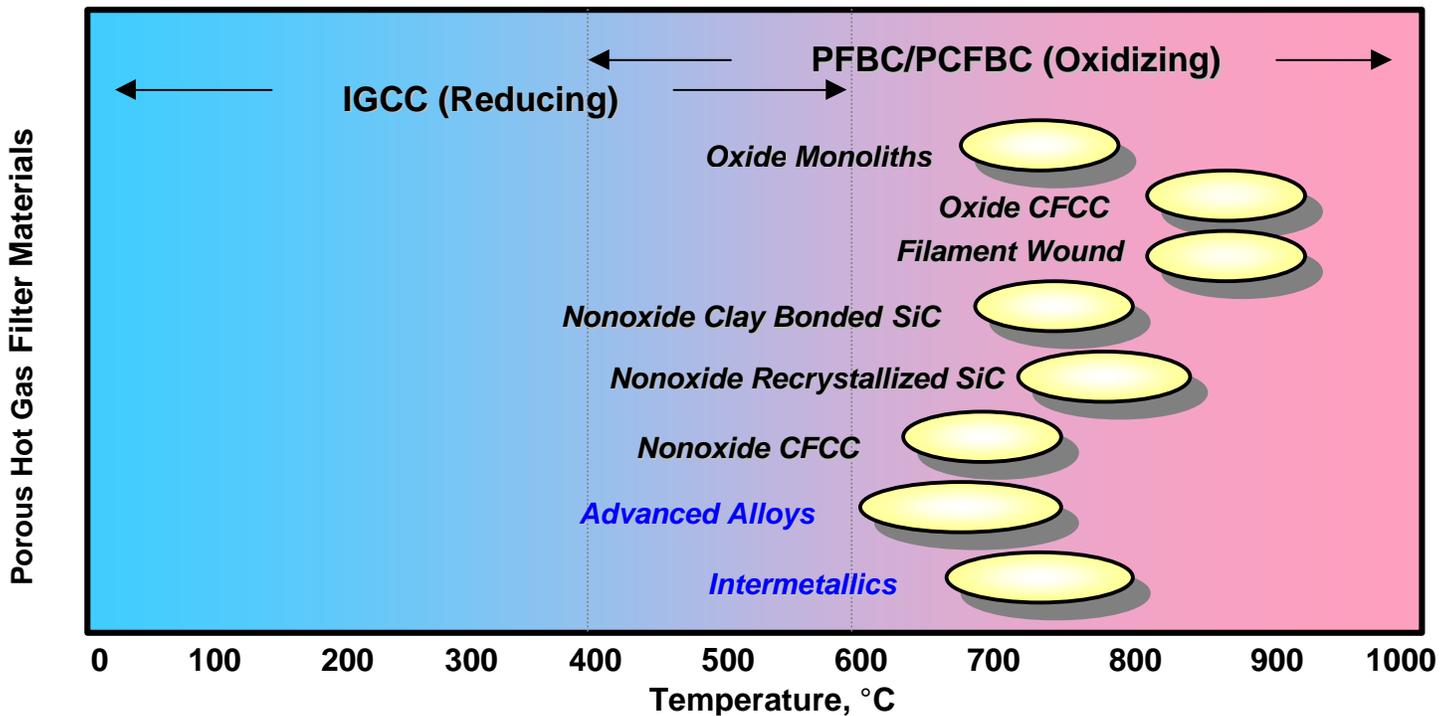
Figure 81 — Recommended maximum operating temperatures for hot gas filter material stability.
