A Cost Effective Multi-Spectral Scanner for Natural Gas Detection

Semi-Annual Progress Report No. 2

Principal Authors: Yudaya Sivathanu, Jongmook Lim and Vinoo Narayanan

Issue Date: October 25, 2004

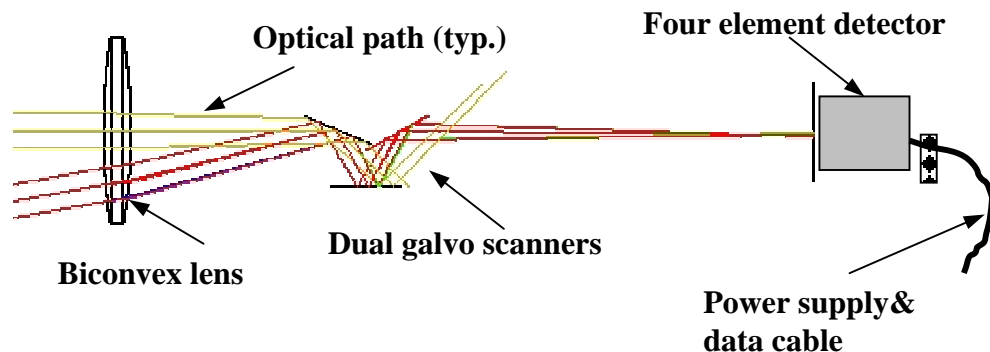
Figure 1. Schematic diagram of the optical design for the multi-spectral scanner.

The light from the ambient is collected using a Bi-convex lens (CaF_2) with a focal length of 150 mm, and a diameter of 38.5 mm. The field of view of the system was designed to be approximately 4 feet by 4 feet. This light is relayed through two galvo scanners that trace the image formed by the lens onto a four element detector. A four element detector was chosen instead of the three element detector proposed since these are cheaper and commercially available. The spot sizes that will be seen on each of the detectors is shown in Fig. 2.

The third task is the design and fabrication of the laboratory scale scanner. The optical design for the multi-spectral scanner using the Zeemax code was completed. A schematic diagram of the optical design for the scanner is shown in Fig. 1.

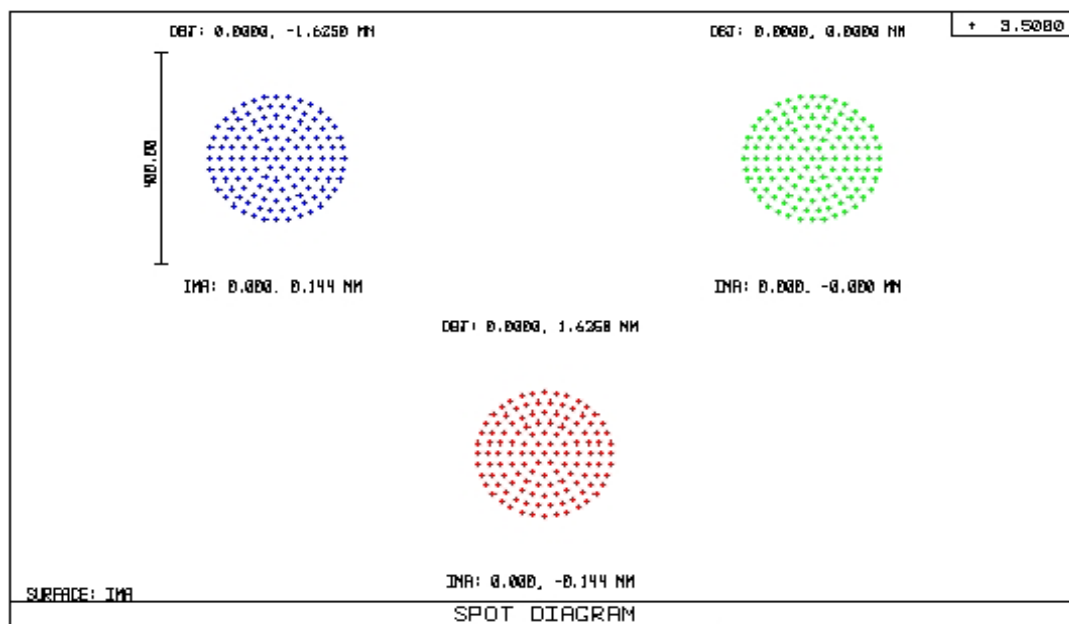
Figure 2. Optical performance of the scanner/lens combination for the multi-spectral scanner.

The RMS spot diameter is approximately 90 microns and the geometric radius is approximately 117 microns at the detector surface. Each of the four elements of the detector has

a size of approximately 500 microns. Therefore, the spatial resolution of the system is sufficient. Four filters with central wavelengths of 3.4, 3.8, 3.9, and 4.3 microns were purchased and delivered to the detector manufacturer. The filters were mounted onto the detector surface, and delivered to En'Urga Inc.

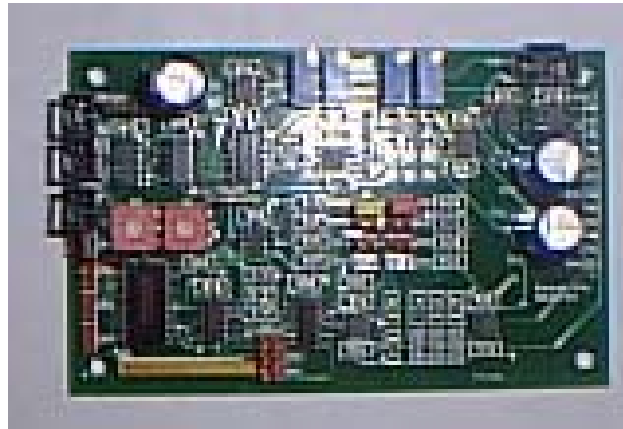
The last board is the scanner driver. Five PCB's each were fabricated by an outside vendor and shipped to En'Urga Inc. A picture of the PCB populated with the necessary electronic components for driving the scanner is shown in Fig. 4.

Figure 4. Photograph of the custom PCB for driving the scanners.

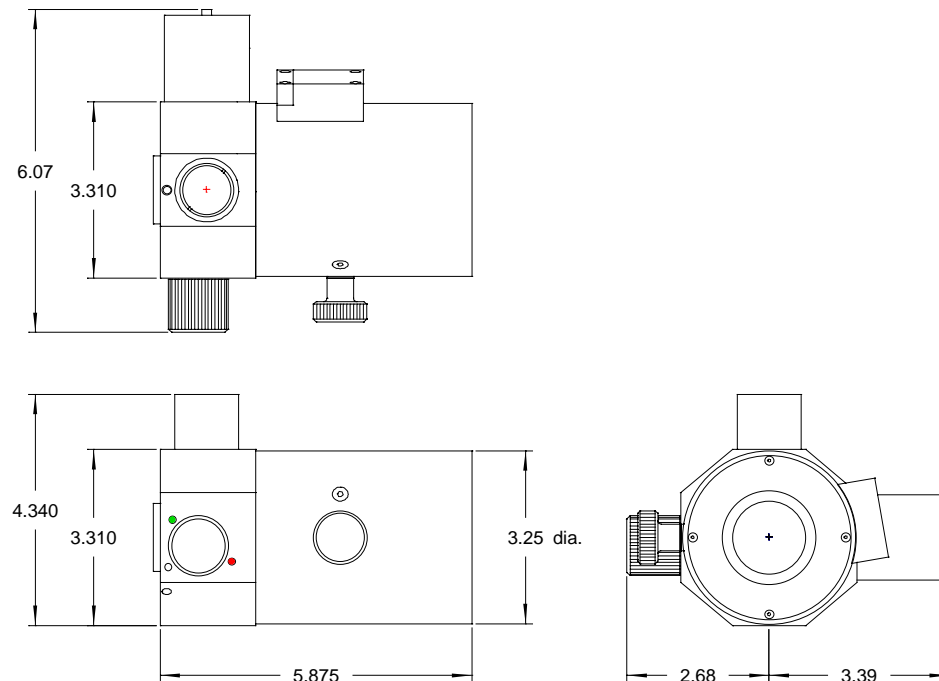
Figure 5. Engineering drawings of the housing assembly for the scanner optics.

The lenses and scanners are housed in a cylindrical aluminum tube, 3.25 inches in diameter and 4 inches in length. This is the only section that is theoretically required as the front end optics. However, for ease of use during the prototype stage, a laser pointer and a view port has been added. These two additional features increase the length of the front end optics to 5.875 inches. A photograph of the fabricated scanner is shown in Fig. 6.

The mechanical engineering design of the scanner housing was completed in tandem with the electronic design. The scanner was designed to be modular. The front module houses the lenses and scanners along with a sighting tube and a laser pointer. The read end module consists of the detector, chopper, and PCB. The engineering drawing of the scanner is shown in Fig. 5.

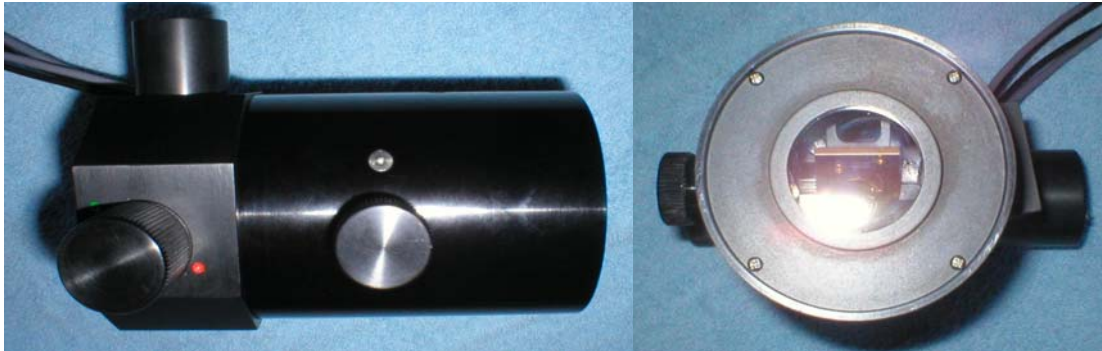
Figure 6. Side view and front view of the scanner assembly.

The side view of the scanner is shown on the left hand side of the figure and a front view of the scanner is shown on the right hand side of the figure. On the left hand side of the side view, a knob for viewing the image visually is provided. The sensor housing mounts directly on the back end of the scanner assembly.

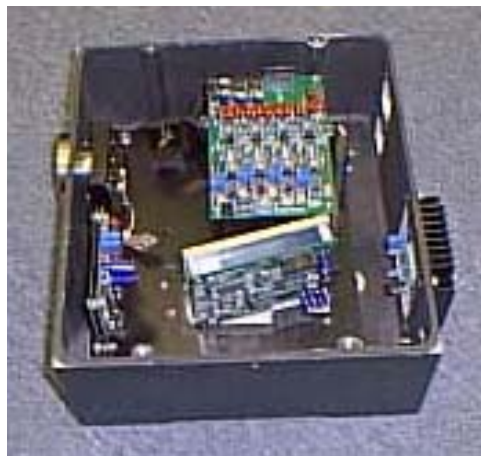
Figure 7. Photograph of housing with sensor and PCBs.

The housing contains the sensor, sensor PCB, and the scanner PCB. In addition, couple of optical elements to image the entrance slit of the housing to the four element sensor is provided within the housing. The entire system is mounted on an optical bench that is floating

inside the housing on rubber pads. The sensor is to be evaluated in the field using a truck. Unlike a stand-alone application, this can cause serious vibration problems. Therefore this modified design was adopted rather than the one specified in the proposal.

The second module that houses the sensor, chopper, and PCB was completed in an available electronics box. A photograph of the housing for the sensor and the custom PCBs is shown in Fig. 7.

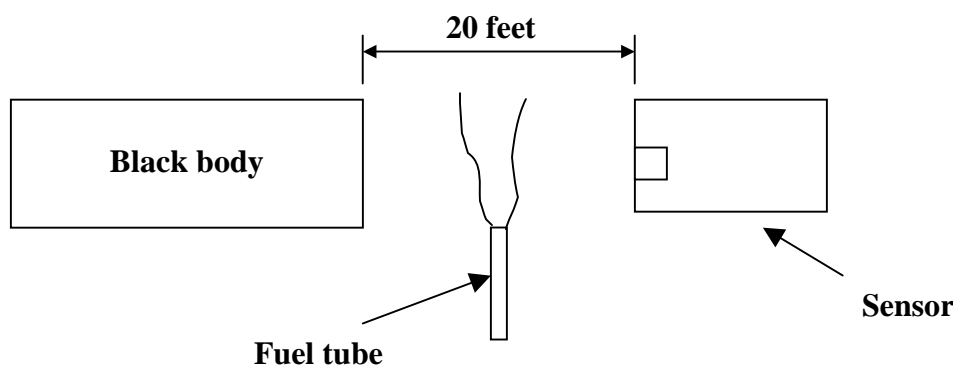
Figure 8. Experimental arrangement used to evaluate the multi-spectral scanner.

A blackbody was placed behind the sensor to mimic the external radiation. A fuel tube was placed in between the sensor and the blackbody. Small amounts of natural gas were passed through the tube. The sensor was easily able to pick up natural gas at flow rates as low as 5 SCFH as scanning speeds of 0.1 Hz. For most stationary and hand mounted operations, these speeds are sufficiently fast. However, the second set of tests planned was at the DoE RMOTC facility. These tests require that a pipeline of 9 miles be scanned in one and a half hour. The above speed of the scanner is too slow. However, it is anticipated that at higher speeds, the scanner will still be able to pick out larger leaks. It was decided to modify the scanner after the RMOTC tests and during the second year if the field evaluations are not satisfactory.

The last task planned for the first year of the project was to evaluate the scanner. First the scanner was evaluated at En'Urga Inc. using a small natural gas leak. A schematic of the experiment arrangement is shown in Fig. 8.

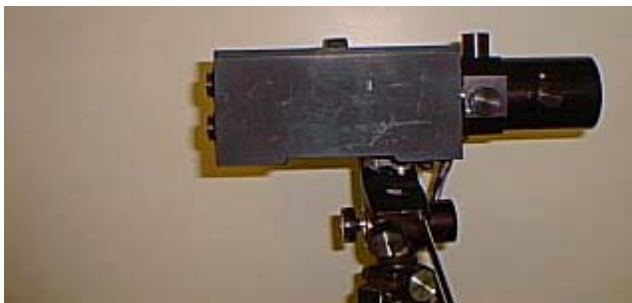
Figure 9. Photograph of the multi-spectral scanner mounted on a tripod.

front end of the system houses the two dimensional scanner. The four element detector, the drive circuit and power supply PCBs are housed in a cast aluminum enclosure. The system is designed to look at a 50 feet wide path across the pipeline.

A photograph of the multi-spectral scanner, mounted on a tripod is shown in Fig. 9. The
