**INCREASING YIELDS AND BROADENING MARKETS: PROCESS
INNOVATIONS IN THE MANUFACTURING OF ENERGY-SAVING
WINDOW GLAZINGS**

FINAL REPORT

Principal Authors: Dr Mark Burdis and Dr Neil Sbar

SAGE Electrochromics, Inc,

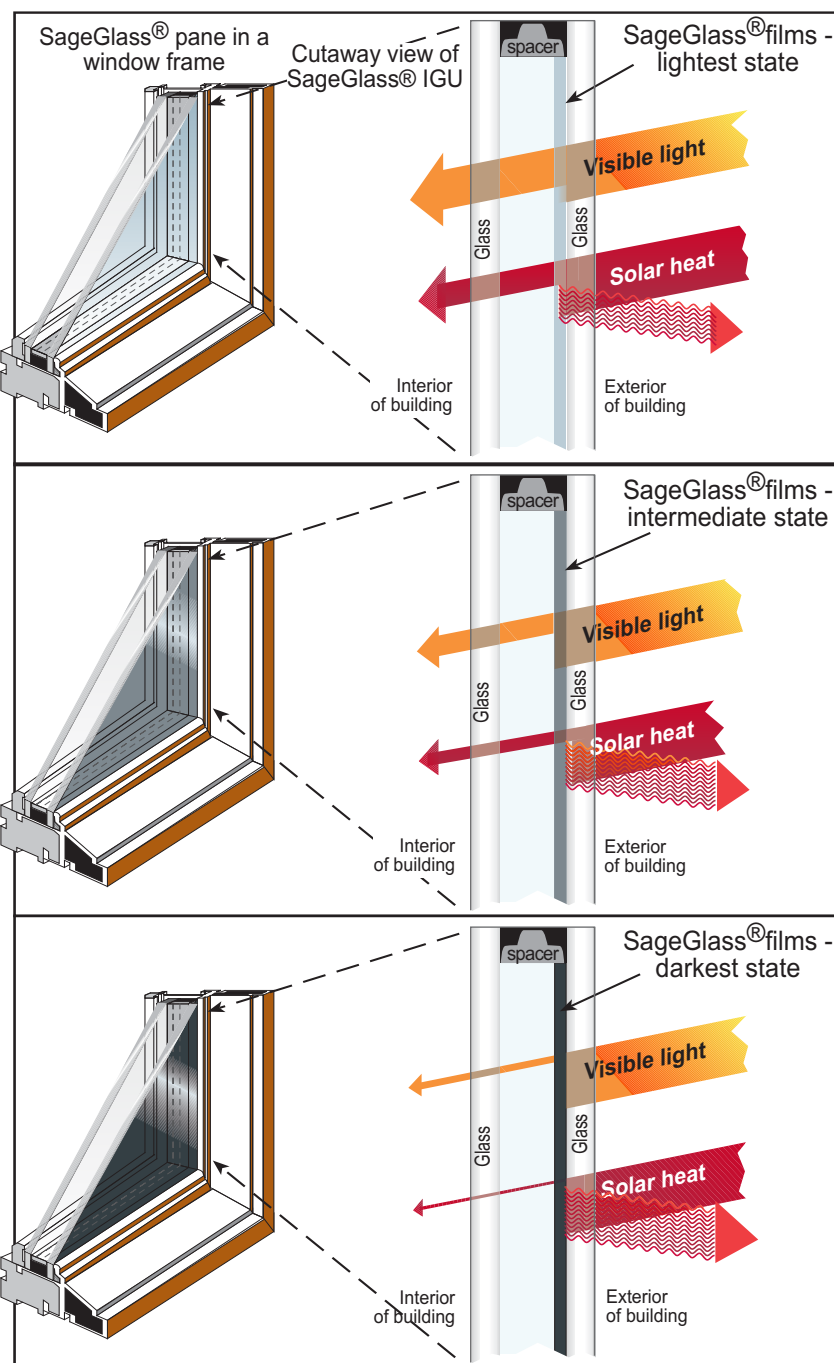
Figure 1.1 – Schematic of the principle of operation of a SageGlass® EC window.

Electrochromic (EC) windows represent the next generation of advanced glazing technology that will (1) reduce the energy consumed in buildings, (2) improve the overall comfort of the occupants and (3) improve the thermal performance of the building envelope. “Switchable” EC windows provide, on demand, dynamic control of visible light, solar heat gain, and glare without blocking the view. As exterior light levels change, the window’s performance can be electronically adjusted to suit conditions. A schematic illustrating how SageGlass[®] electrochromic windows work is shown in Figure 1.1.

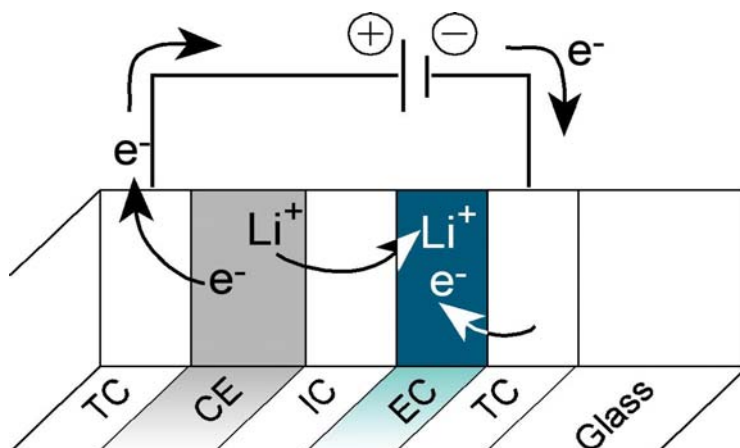
Figure 1.2 – The SageGlass® electrochromic device.

are transparent conductors, which are used to apply a voltage to the active layers sandwiched between. The active layers consist of an electrochromic (EC) layer, an ion conductor (IC) layer, and a counter electrode layer (CE). Charge, in the form of electrons

and ions, is shuttled between the CE and the EC layers, producing the bleached and colored states respectively: The electrons are passed around the outer circuit, while the ions are transported through the IC. Insertion of charge into the EC layer will cause that layer to color to a depth that depends upon the amount of charge transferred. The effect is completely reversible, and is accomplished simply by reversing the polarity of the voltage. This is shown schematically in Figure 1.2.

The SAGE EC device is a series of thin films that are deposited onto a glass substrate one on top of the other to form a stack⁴. This is shown in Figure 1.1. The outermost layers

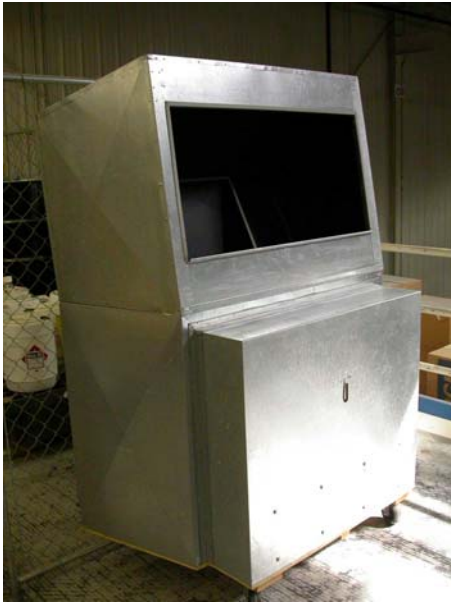
Figure 2.1 – Photograph of glass inspection system.

The process was started by evaluating several different types of lighting for inspection of the glass. These included: front surface diffuse lighting, back lighting, off-angle lighting and edge lighting. All of these methods are routinely used by the glass industry to highlight debris that may be on the surface of the glass. Incidentally, they are also used as an after deposition tool to see defects in sputtered films. However, it was found that these techniques were not effective for many defects, primarily track marks, which may have been on the surface of the substrate.

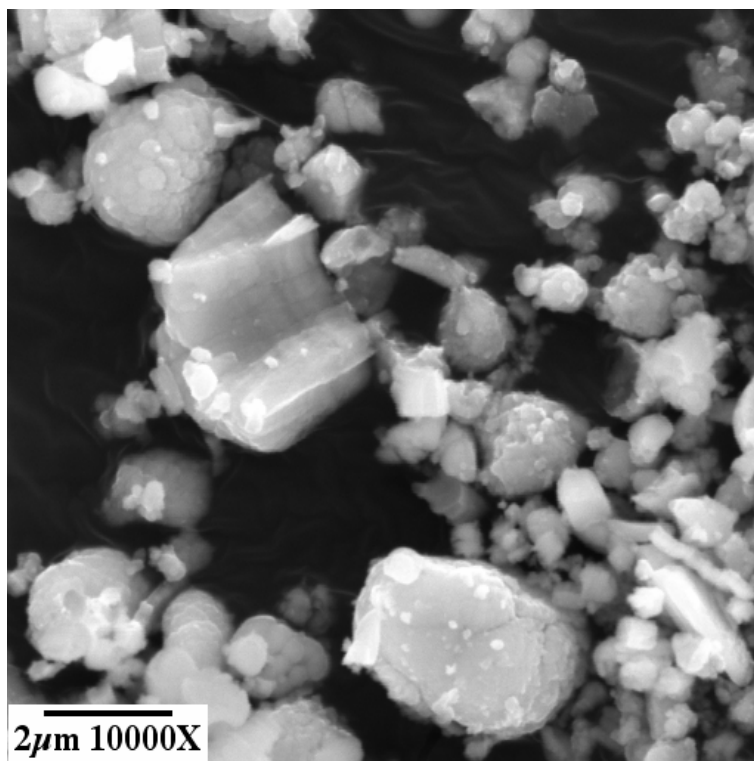
Figure 2.2 – Scanning electron micrograph of coater dust. The smallest resolved particle is less than 40nm in diameter.

microscopy – energy dispersive x-ray analysis (SEM – EDS). We used kapton tape to trap the particles, and swabs were taken from representative areas when the coater was vented for routine maintenance. Finally in the approach intended to look specifically at particles generated during the sputtering process, substrates were immersed in a solvent bath, which was subsequently filtered to capture dislodged coater dust.

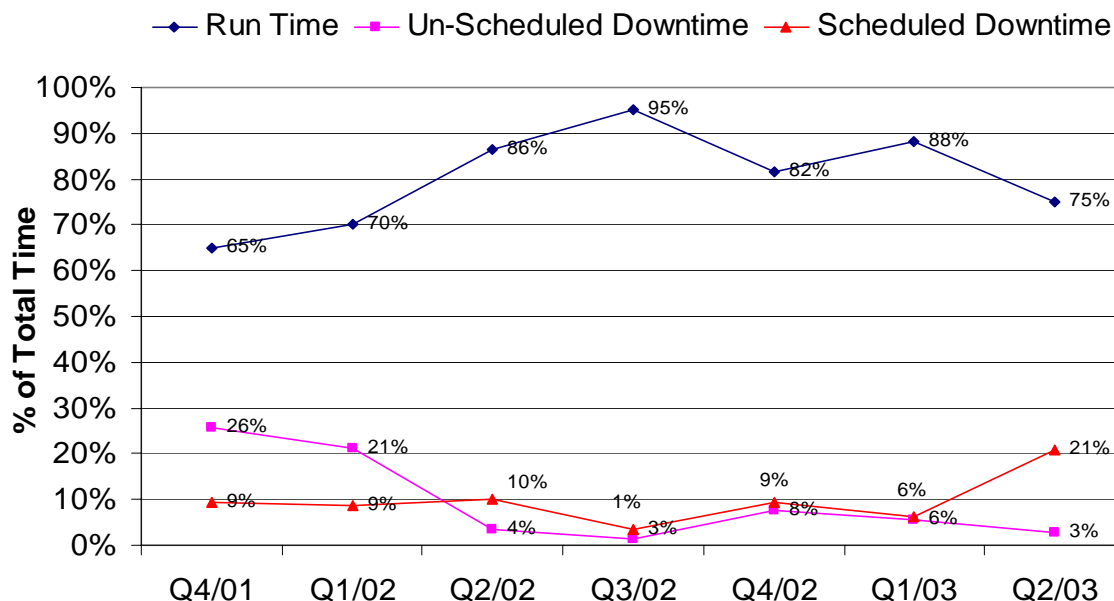
Figure 2.3 – Plot of the percentage run time, scheduled and un-scheduled downtime for the pilot line coater. Unscheduled downtime has been reduced from around 25% at the start of the project to approximately 3% at the time of writing.

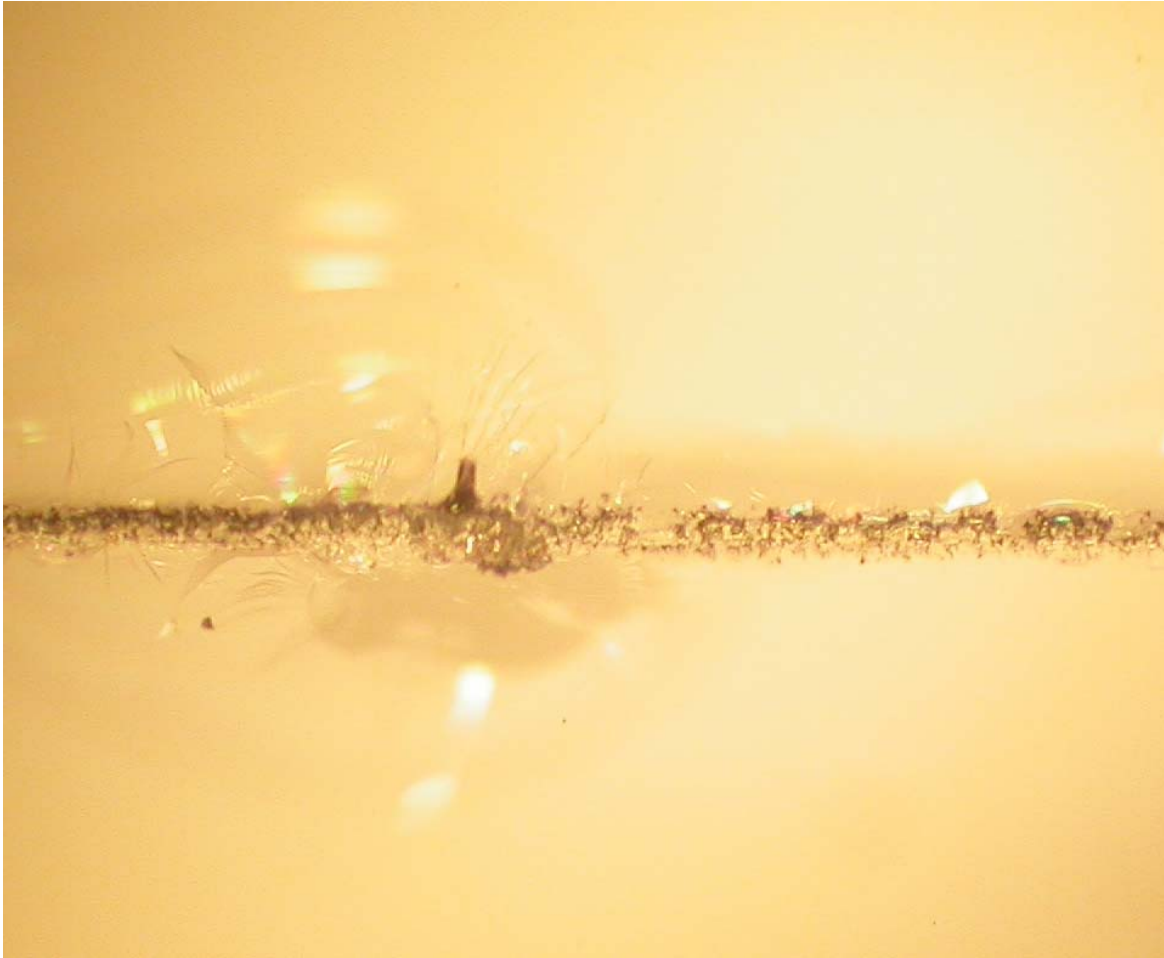
Figure 2.4 – Close-up view of a score mark in glass prior to breaking, showing significant glass damage and some loose particulate contamination. Many particles are visible near to the score, and some flakes where the glass has been removed are visible, particularly over to the left of the image.

The glass is then broken into two pieces simply by snapping using the score as a guide

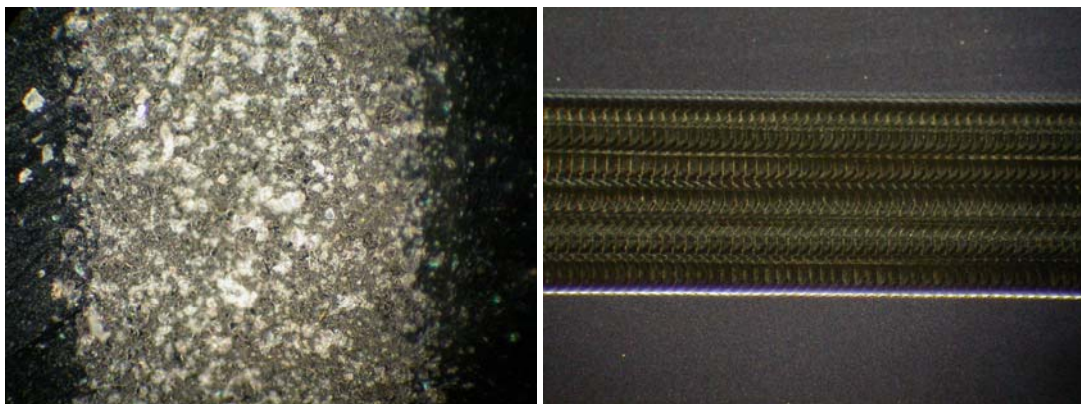
Figure 2.5 – Examples of dark field images of sandblasted, running vertically (on the left – 100x magnification) and laser isolated, running horizontally (right – 200x magnification) lines.

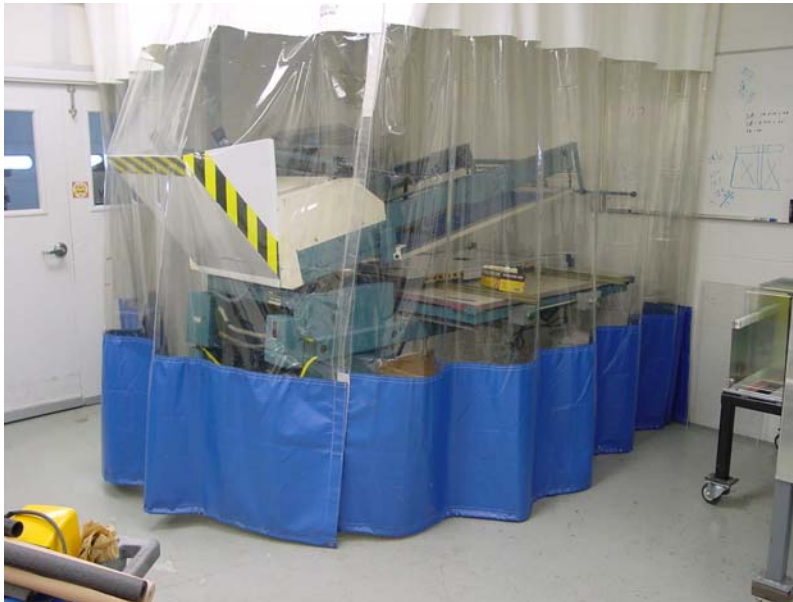
Figure 2.6 – Picture of screen printer showing the plastic shroud, and the proximity to the door discussed in the text.

The bus bars for the EC device substrates are applied using a modified screen-printing process. The equipment for performing this operation is shown in Figure 2.6. The plate holding the screen can be seen at an angle of about 25° and this is in the position to enable the glass to be loaded. The screen has already been charged with the conductive material. The glass substrates are placed (one at a time) onto the table beneath the screen,

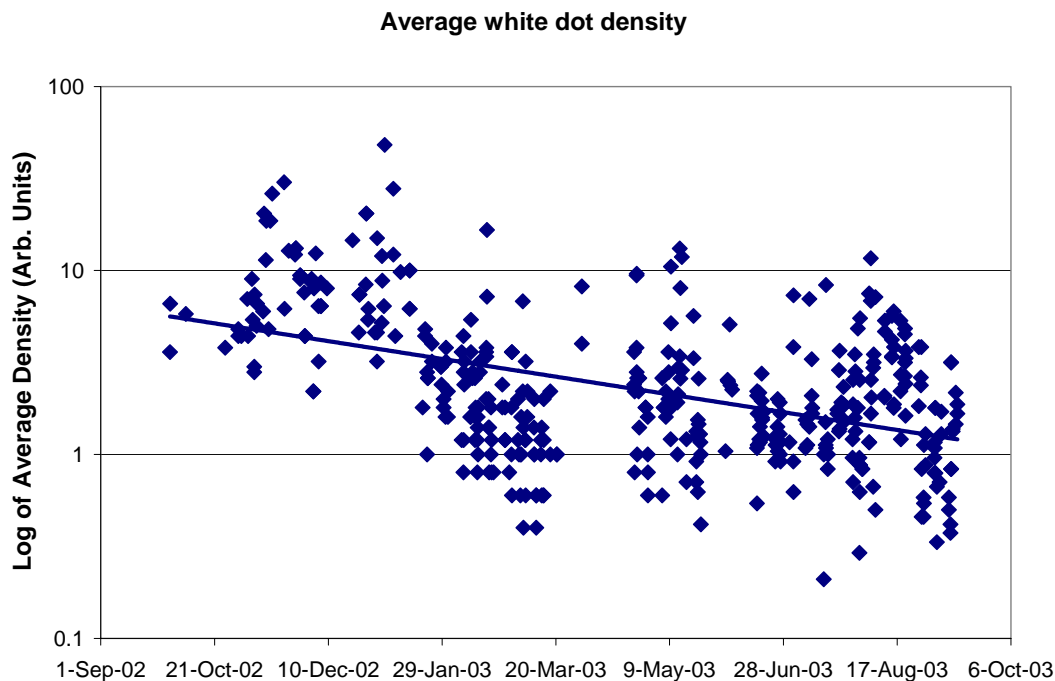
Figure 2.7 – Plot of average white dot density over the last year, showing a significant reduction primarily caused by the contamination reduction measures that have been implemented.

This is supported by the data shown in Figure 2.7 where the average density of white dots measured on a finished EC device is plotted as a function of time. The trend is clearly downwards, indicating the success in contamination reduction.

Inspection of Figure 2.7 shows that it is clear that the efforts being made as a result of overall quality improvements are having an impact on the general level of white dots seen in the devices. There are really no significant points where the improvement can be

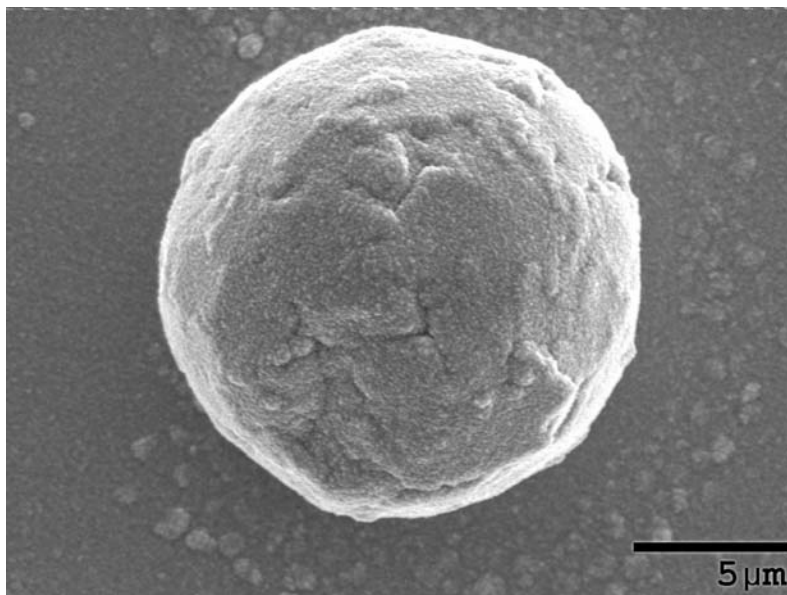
Figure 2.8 – Tin speck on glass surface formed during the glass deposition process. The spheroid is approximately an order of magnitude larger than the electrochromic film thickness and therefore interrupts the thin film stack, creating a localized short.

Generally, these defects are detectable by careful visual inspection of the glass prior to processing, provided they are sufficiently large. We now have an inspection procedure that is fairly effective at rejecting all glass with such defects.

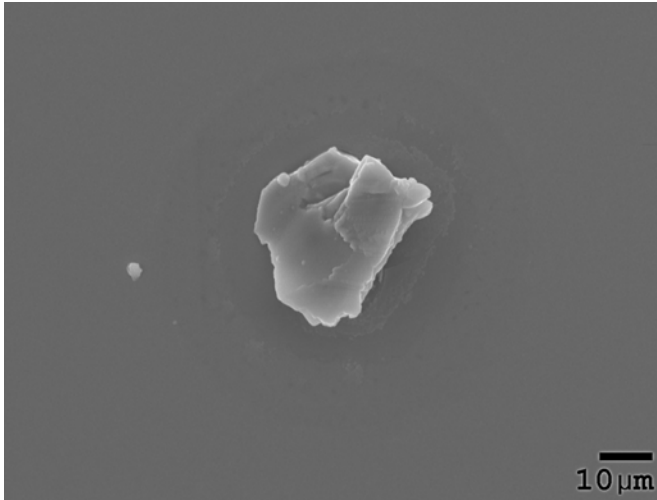
Figure 2.9 – Example of an SEM photomicrograph of a glass fragment found at the center of a short.

At first sight, it is difficult to understand why a glass particle would lead to an electrical short, as it is an insulator itself. It is speculated that the films growing near to the glass particle are somehow shadowed so that they are significantly thinner near to the defect. We suspect this because of many observations of fringing effects around the defects, indicating changes in the film thickness at that point.

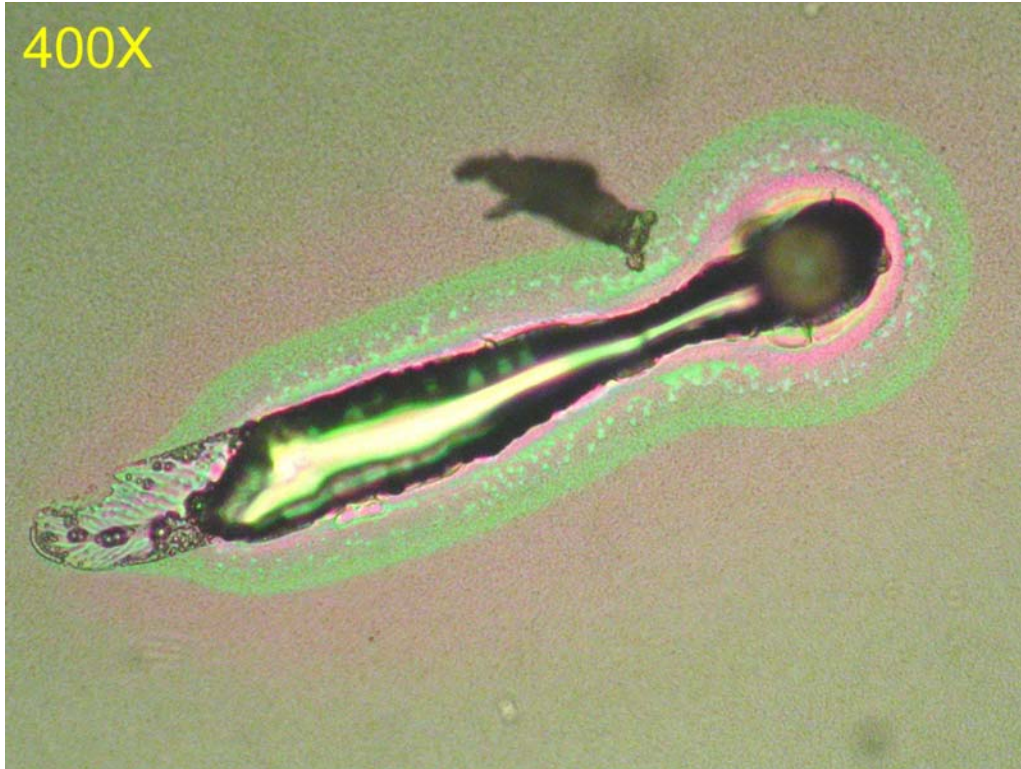
Figure 2.10 – Picture taken through a microscope of a line short, showing a typical shape for this type of short.

The occurrence of these shorts tends to be clustered in time: the Pilot Line can operate for a significant period without the occurrence of any line shorts, and then suddenly they will appear in high concentrations. This is thought to be related to the formation mechanism. For example, a number of metallic line shorts were observed for a period between late 2002 and early 2003. The metallic contaminant is used as a standard bonding material for sputter targets, and is used on several of the planar targets. By carefully analyzing the positions of the shorts with respect to the location within the coater, we were able to deduce that the shorts were probably originating from one of the targets.

Upon venting the coater, it was discovered that this was indeed the case, and that the manufacturer had assembled the target incorrectly. (Usually, if a target is made up of a series of tiles, the gaps between the tiles are ‘sealed’ to prevent the bonding material from migrating up the gaps between the tiles and contaminating the sputtered film. In this case, the sealing material had been omitted, and metal had found its way up onto the surface of the target). Once the metal is at or close to the surface of the target, it can easily become molten (as it has a very low melting point), and this molten material can then be ejected and end up on the substrate and cause a short.

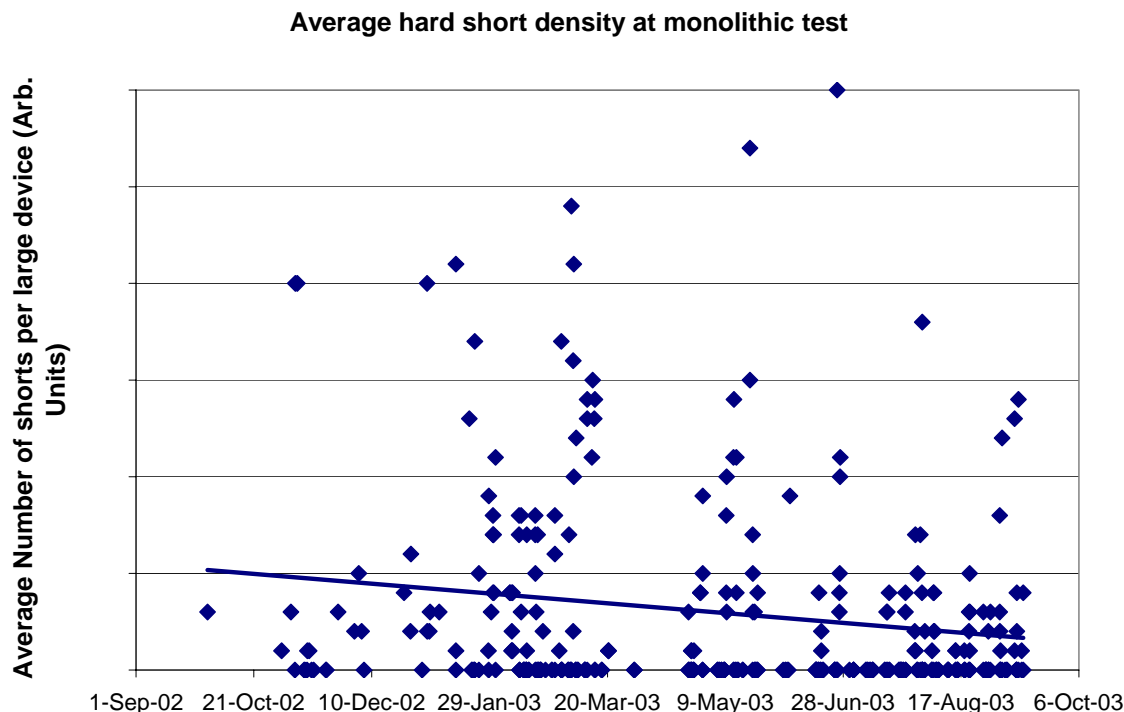
Figure 2.11 – The number of hard shorts measured at initial test for each large device produced in the last year. The line is a best-fit trend line, showing the overall decrease with time.

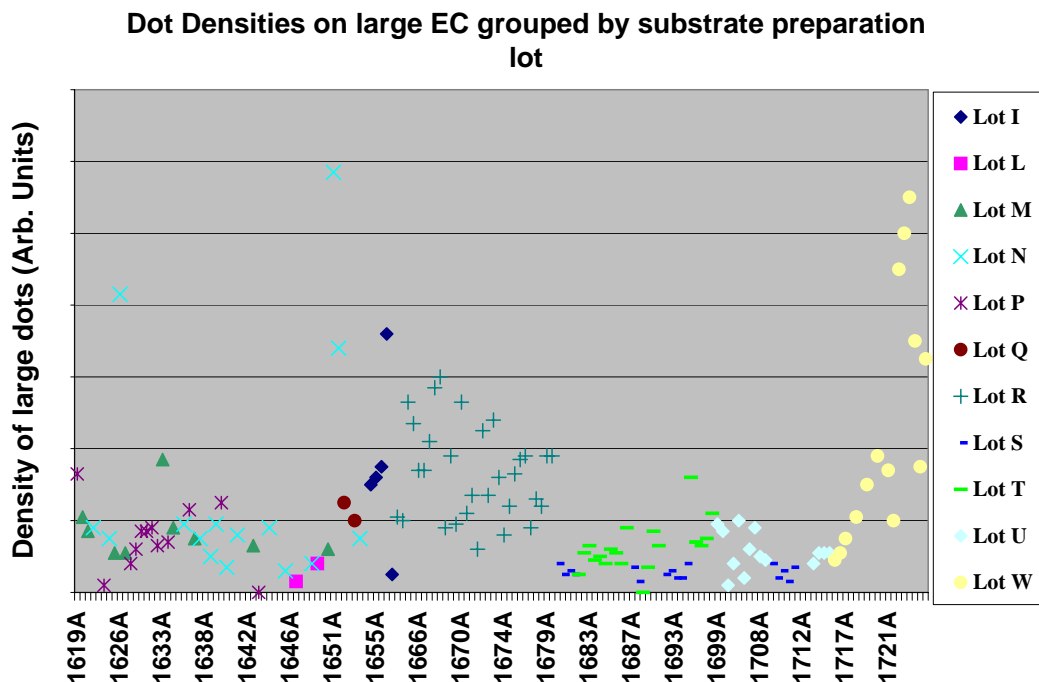
Figure 2.12 – The average white dot density divided into substrate preparation lots, showing the correlation of dot density with preparation lot. It is thought that the variation may be a result of uncontrolled variation seen in the tempering furnace.

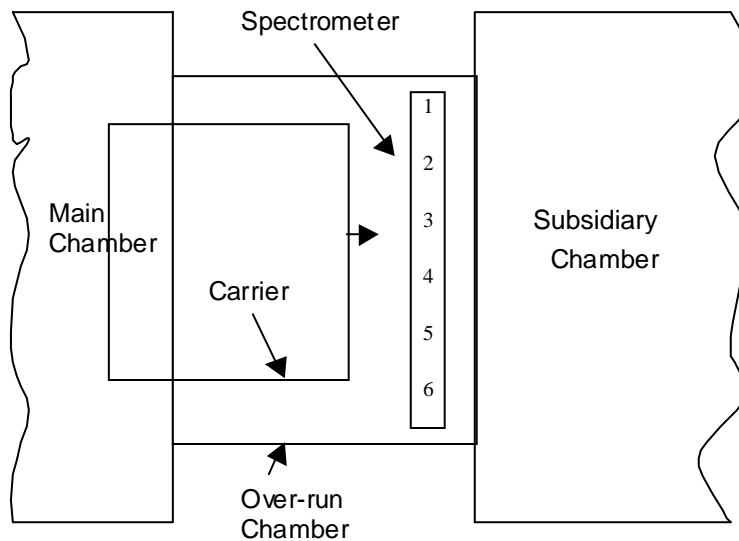
Figure 2.13 – Schematic diagram of the layout of the spectrometer system. The individual channels are labeled 1-6, and the carrier is shown schematically moving under the spectrometer.

The spectrometer system allows six spectra to be acquired simultaneously. A schematic layout of the system is shown in Figure 2.13. This is done by using six separate spectrometers (separate dispersive elements, with one light source), and multiplexing the output signals, which are read directly into a PC using a high performance A/D card. The spectrometer allows spectral measurements to be taken between 200 and 1100 nm, with a resolution of 0.3 nm. Spectra can be acquired in as little as 3 ms or integration can take place over times up to 60 seconds, depending on the amount of light available. Fiber optic cables were specified and purchased allowing optical signals to be taken into and out of the vacuum system, and specially designed vacuum flanges were fabricated to permit this. Collimating lenses are used for light collection in all of the applications to boost the signal to usable levels.

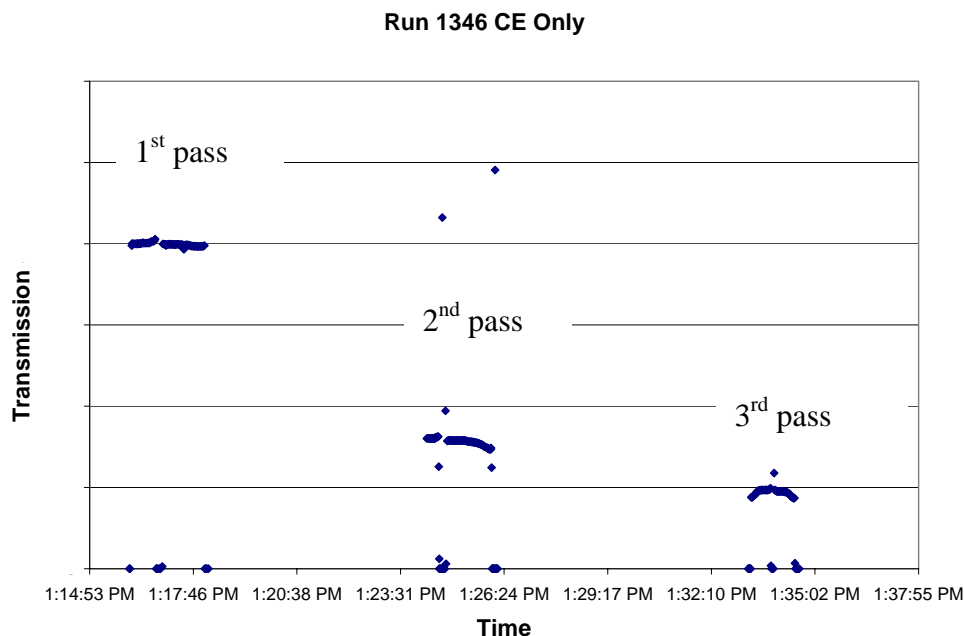
Figure 2.14 – Example of the measurement of the *in-situ* transmission of the CE layer during deposition.

The absorption of the CE film is an important indication of the state of oxidation of this layer – larger absorption indicates a more oxidized film. It is important to maintain consistency of the oxidation state of this film to assure uniform performance of the final product. We have carried out several experiments to determine the effects of gaseous additives to the plasma on the oxidation state of the CE. The results are described in some detail in Appendix 11.

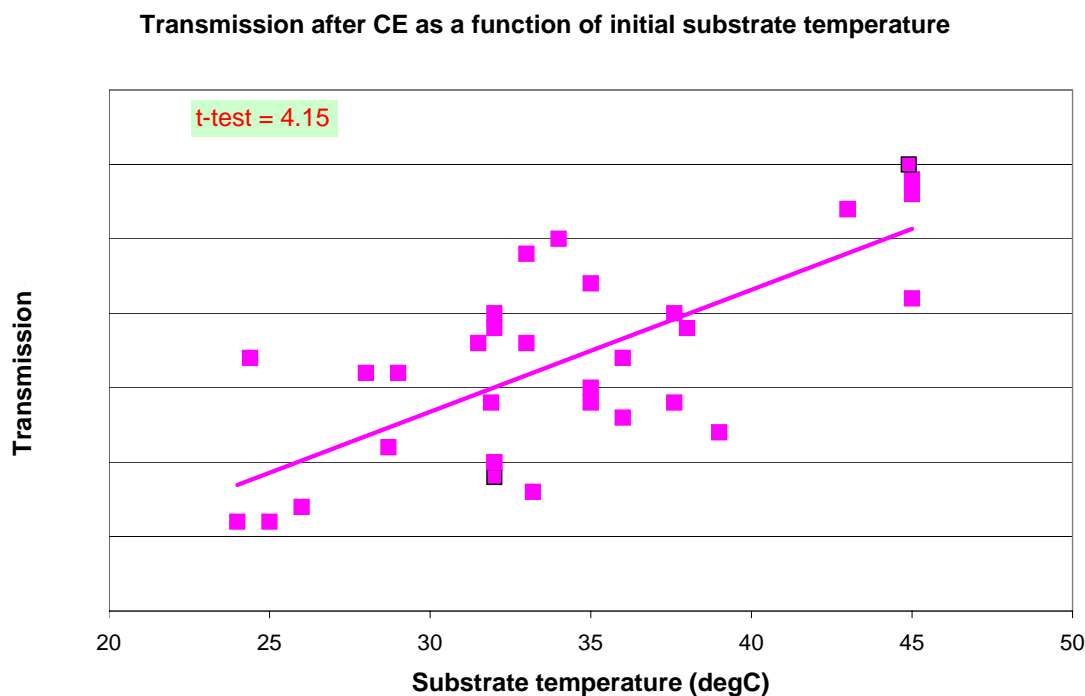
Figure 2.15 – Relative dependence of the final transmission of the CE upon the initial substrate temperature.

The reason for the variation in temperature is twofold: first, the temperature of the load-lock will depend on whether the heater has been used recently and is therefore still hot. Second, immediately prior to CE deposition, the glass is removed from the oven having had the previous film heated. Obviously, there is room for variation in the substrate temperature from both of these sources.

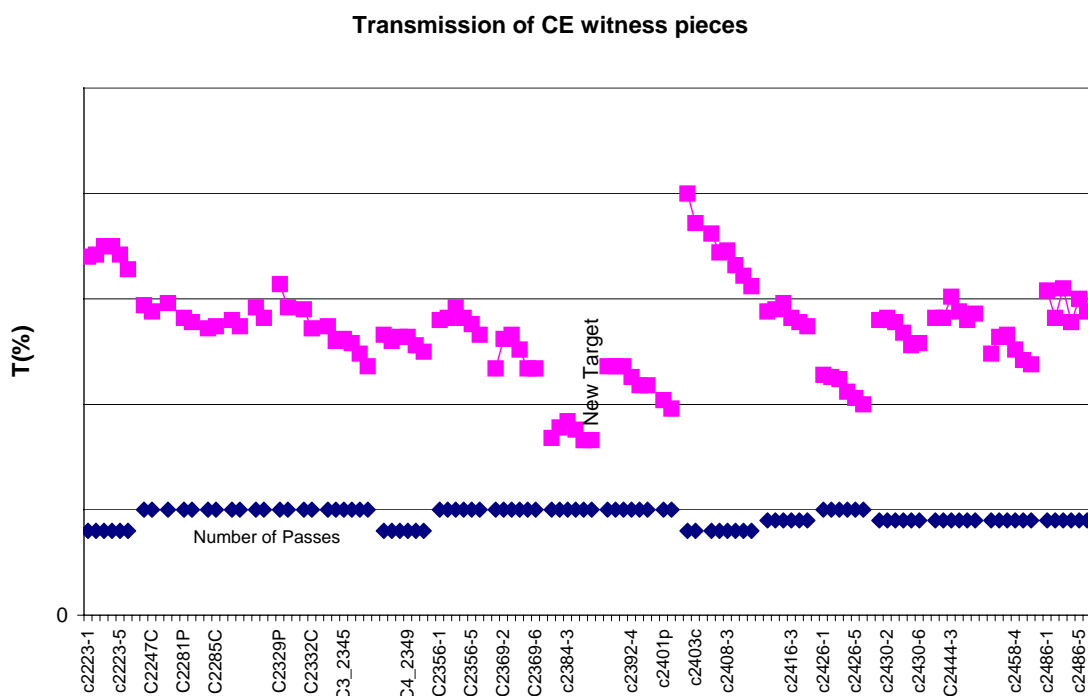
Figure 2.16 – The relative transmission of CE witness pieces labeled by run number for a period of approximately five months.

In the current process, the layers are deposited without venting the system. This means that although it is possible to collect *in-situ* transmission data characteristic of the whole stack, it is not possible to determine the detailed optical indices of the individual layers. Although this is not necessarily a problem for process control, it is an issue for process development, where it is important to understand the effects of differences in individual layer properties on the finished device performance.

A significant variation in transmission is obtained immediately after installation of a new CE target, and this is attributed either to a 'burning-in' of the target surface, or some sort of outgassing of the porous target material itself. These targets have a density of around

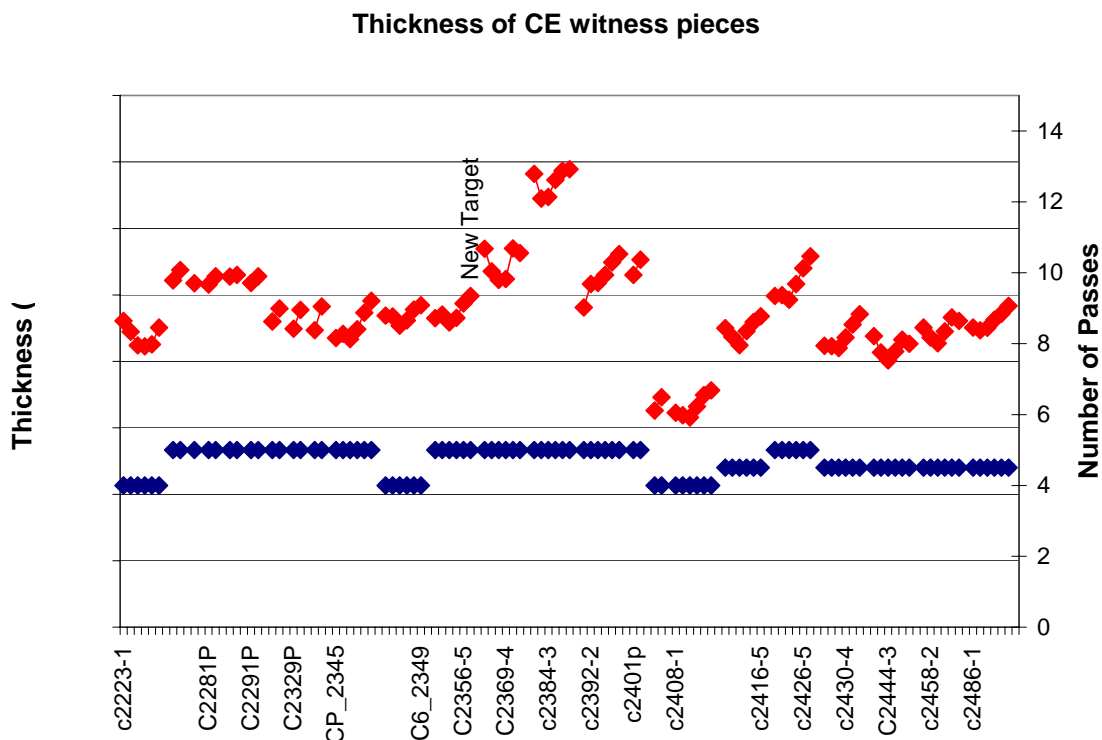
Figure 2.17 – The relative thickness of the samples measured by the method outlined in the text, for samples whose transmission is given in Figure 2.16.

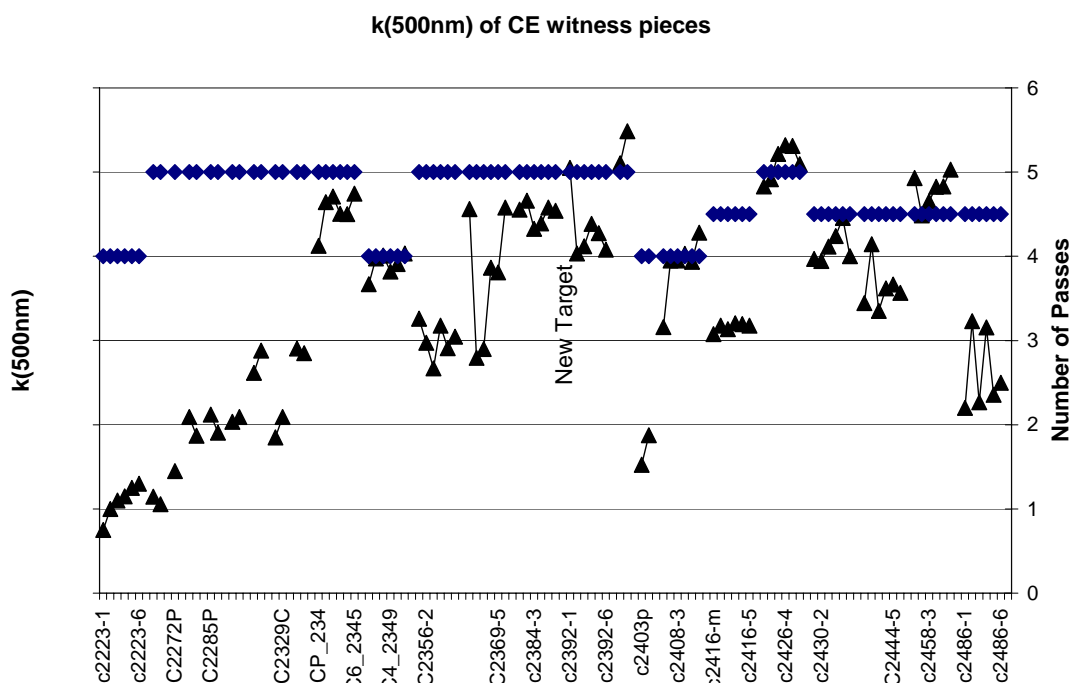
Figure 2.18 – The value of $k(500\text{nm})$ of the samples measured by the method outlined in the text, for those samples whose transmission is given in Figure 2.16.

In addition, a variation of each of the parameters *within* a given run is seen, indicating a variation related to the target and cathode assembly. The thickness variation, shown by sequential measurements that decrease and then increase across the target, has been partially correlated to the variation of the magnetic field strength of the cathode itself. Steps were taken to improve the uniformity of the magnetic field, which resulted in an increase in the uniformity of the coating within each run as anticipated. However, the transmission on such things as substrate temperature (Section 2.3.1.2.2) and background

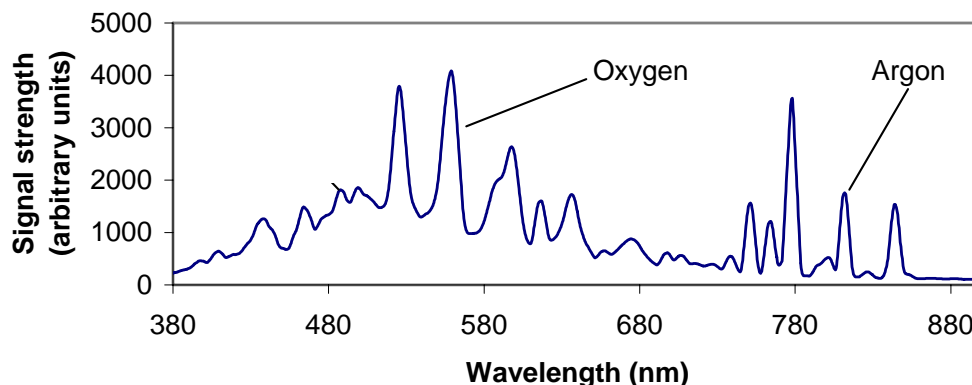
Figure 2.19 – Boosted plasma emission signal from EC plasma, showing improved resolution over the unboosted signal.

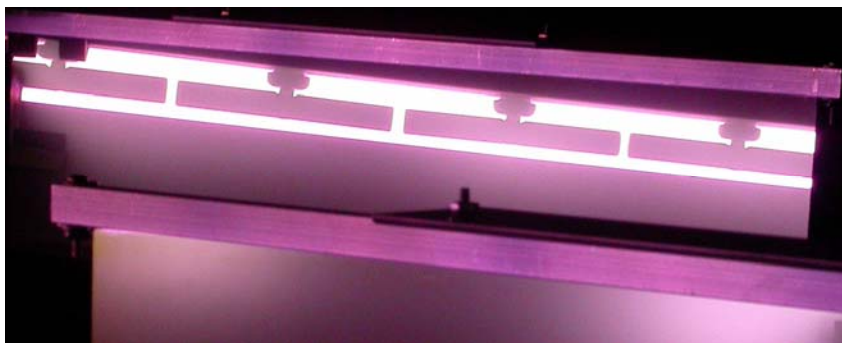
As both the uniformity of deposition and rate, are important, steps have been taken to extend the PEM technique to address this. Folding mirrors have been installed to allow an observer looking in from the side of the coater to view *the profile of plasma emission* along the length of the sputter deposition zone. This means the mirrors are at 45° to the viewer. Figure 2.20 shows the folding mirrors from the side of the coater, as installed. The upper mirror provides a view of one side of a sputter deposition zone, showing bright plasma emission, where the center of the deposition zone is at the right. Digital cameras aimed at each mirror, and equipped with line filters for atomic emission selectivity, will record the plasma emission profile across the deposition zone, so that a plasma emission

profile can be monitored in real time. This will permit real time feedback control, so that deposition uniformity can be controlled adaptively.

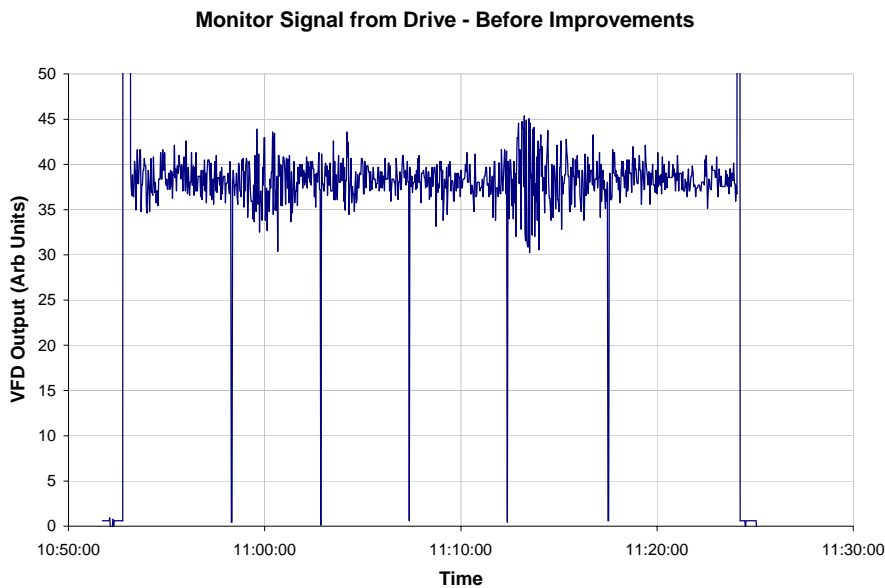
Figure 2.22 – Control signal responsible for drive-speed prior to the changes discussed in the text.

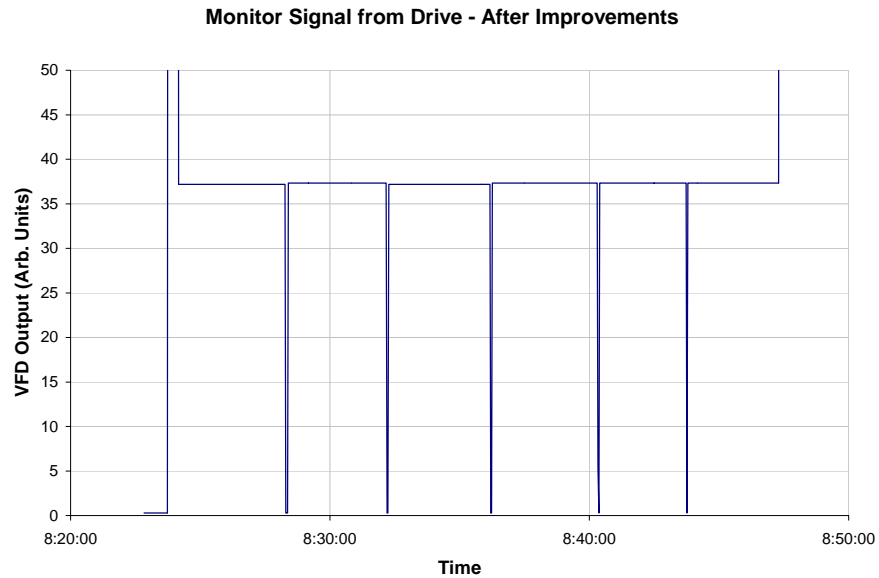
Figure 2.23 – Control signal for drive-speed after improvements.

more pronounced, and was leading to linespeed changes that were visible to the operators. The decision was made to replace the signal derived from the PLC with a signal generated by a completely separate source. This signal is shown in Figure 2.23.

It is clear that the signal after improvement is significantly cleaner and less noisy than before. It is therefore anticipated that there may be an improvement in the consistency and therefore quality of the films deposited as a result. This appears to be borne out by inspection of resulting film thickness for one of our critical layers. Some data are shown in Figure 2.24, where we show the measured thickness for one of the films, before and after the change just described. There is a clear reduction in variation – from around 6% prior to the change, to around 1%. This is a good example of the improvements in quality which we are striving for, and this one could only have been accomplished by monitoring the drive control signal using our integrated process monitoring system.

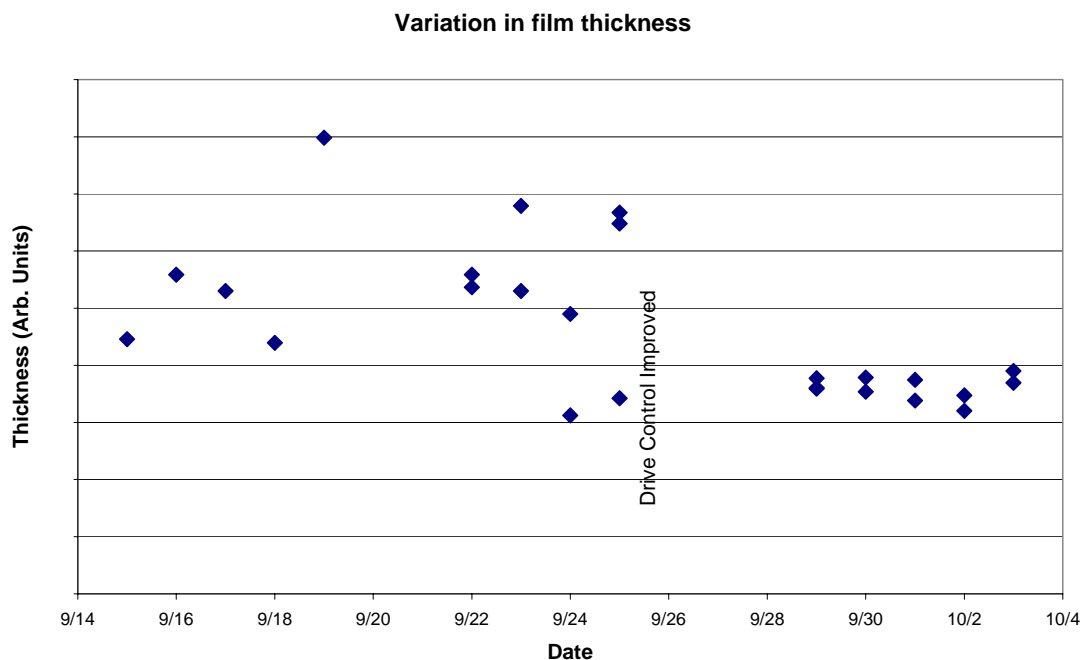
Figure 2.24 – Measurement of the thickness of one of the key layers in the EC device, both before and after the changes were made to the drive control signal.

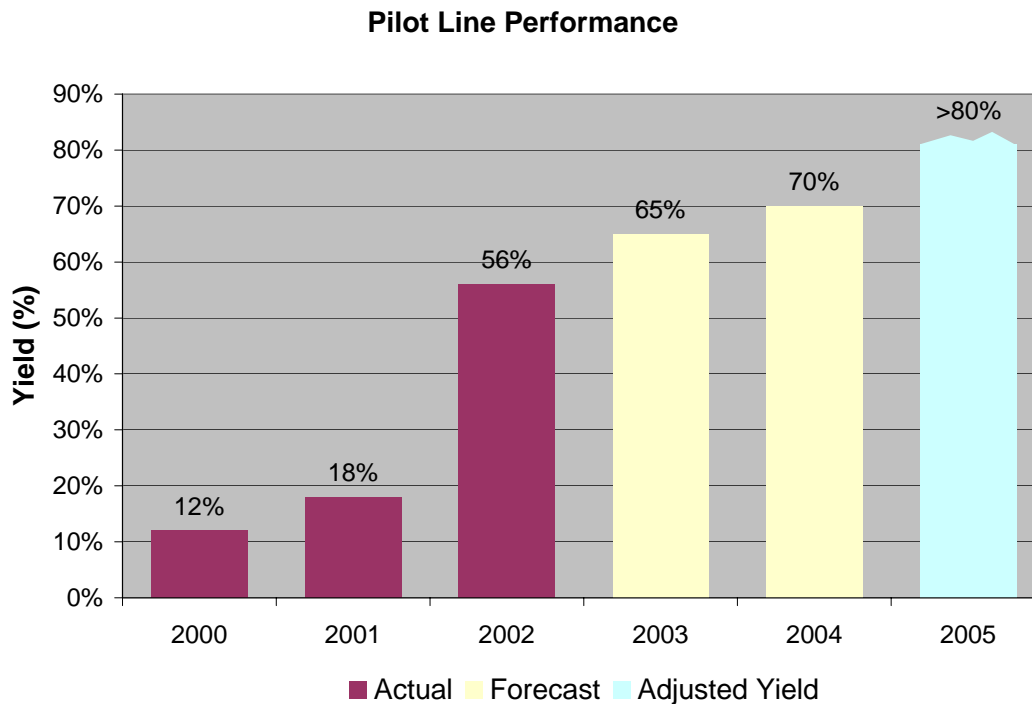
Figure 3. 1 – Overall yield for the Pilot Line both actual and predicted. The yield figure for 2005 has been adjusted to accommodate the known equipment and logistical issues of the present Pilot Line.

The yield is calculated using an internal specification, which has been developed as a precursor to the final specification which will be used to determine whether a product can be shipped to a customer. The current specification is fairly close to the final version, and so provides a good measurement of the actual progress. Devices made in ‘experimental’ runs have been excluded, as these are carried out for process development.
