Inspection of Fusion Joints in Plastic Pipe

Reporting Period:
October 1, 2004 through March 31, 2005

DOE Award No.: DE-FC26-03NT41882

Submitted By:
Edison Welding Institute
1250 Arthur E. Adams Drive
Columbus, OH 43221

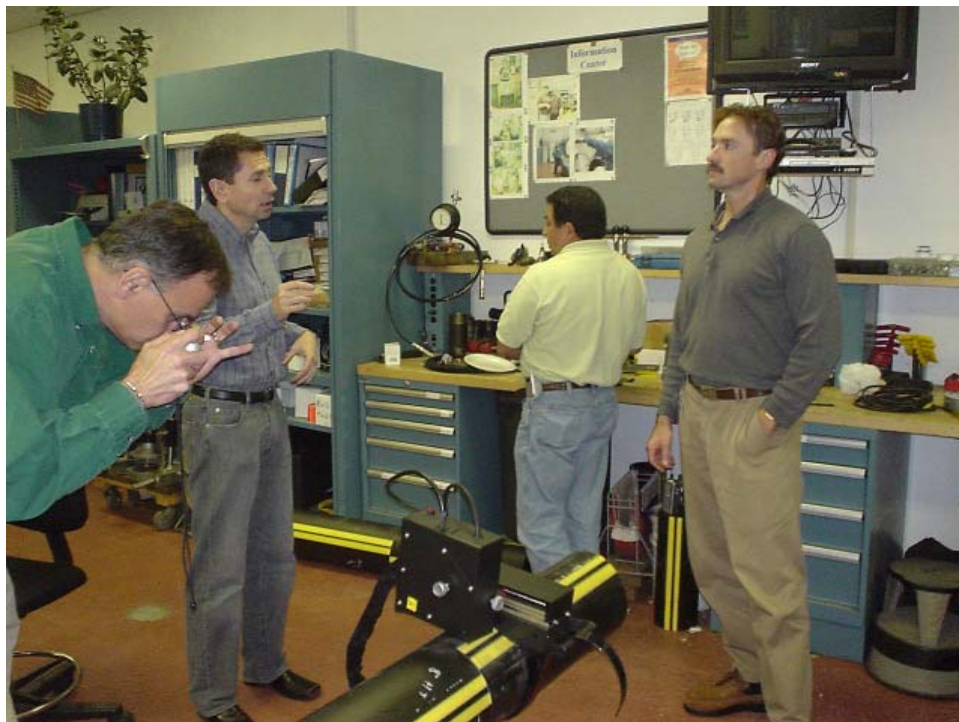
Figure 13 Inspection System on Pipe at Demonstration

Please see Figure 13 through Figure 15 for pictures taken during the Field Prototype Demonstration. Since the demonstration, EWI has improved upon the inspection tool by implementing the suggestions of the Field Test facility personnel as well as project partner NYSEARCH.

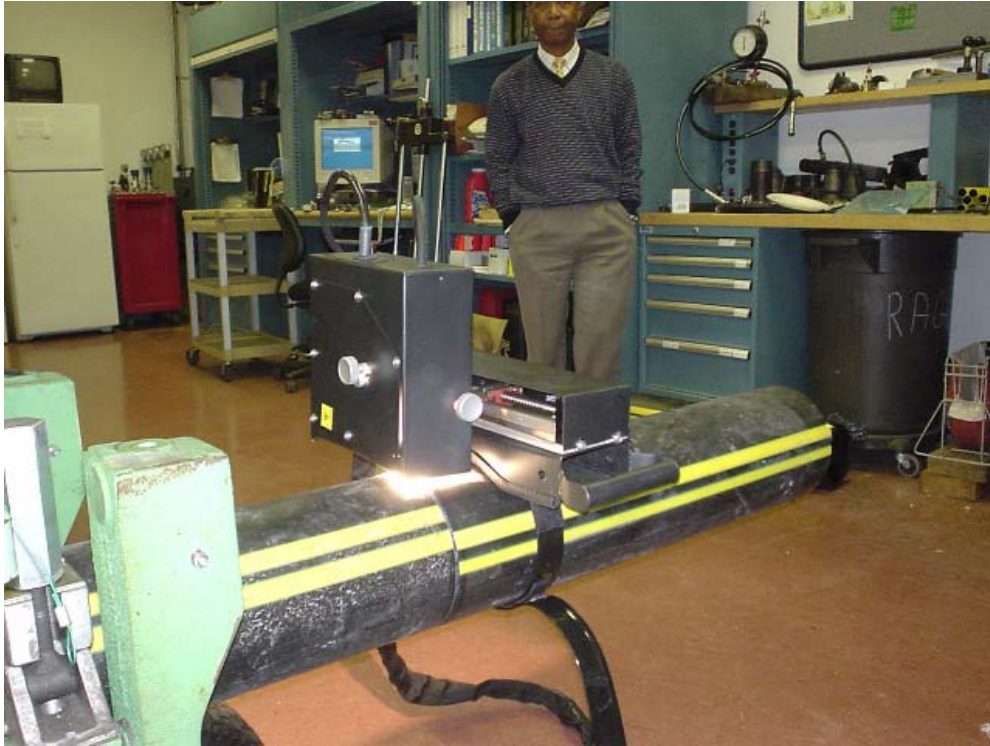
Figure 14 Inspection System on Pipe during Heating Phase of Inspection Process

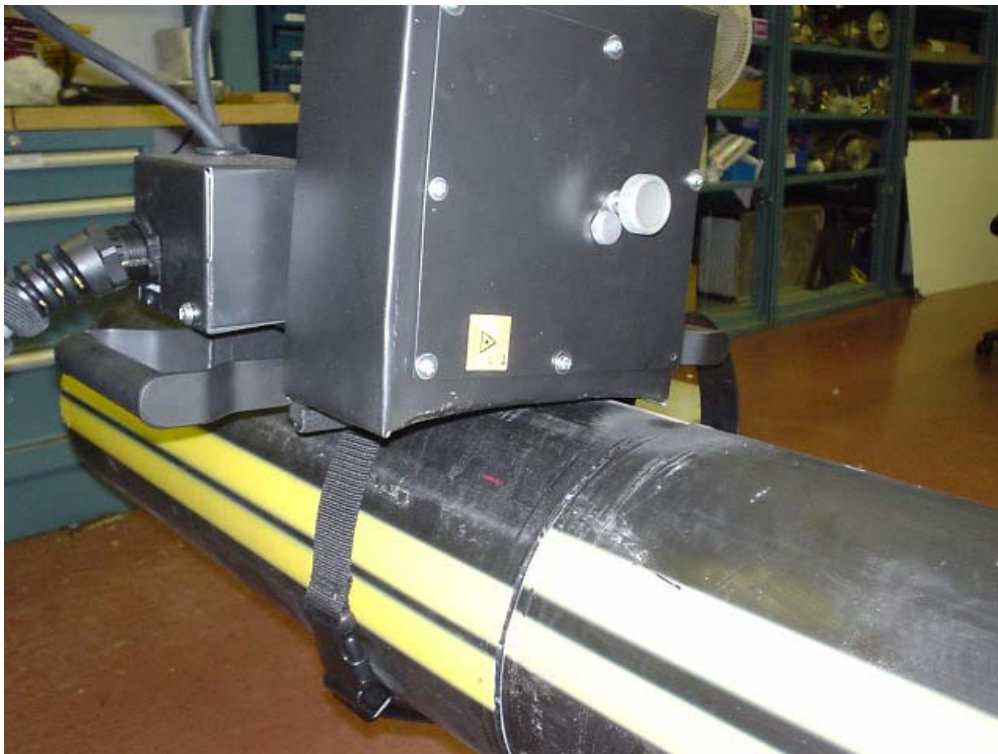
Figure 15 Inspection System on Pipe during Laser-based Inspection Phase
