A Cost Effective Multi-Spectral Scanner for Natural Gas Detection

Semi-Annual Progress Report No. 4

Principal Authors: Yudaya Sivathanu, Jongmook Lim, Vinoo Narayanan, and Seonghyeon Park

Contract Number: DE-FC26-03NT41857

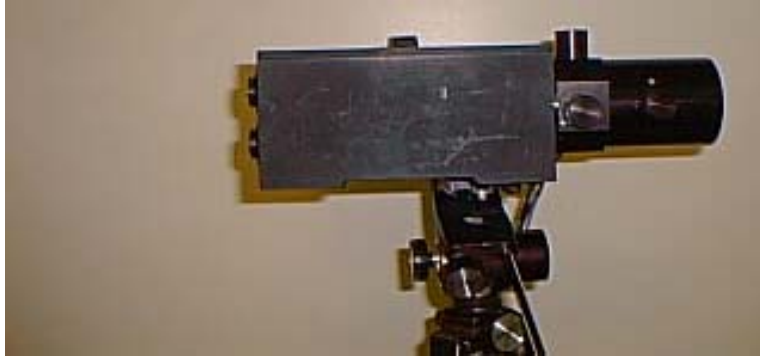
Figure 1. Photograph of the laboratory scale scanner mounted on a tripod.

The scanner essentially consists of a four element, thermoelectrically cooled, lead selenide array with a 2-dimension scanner and associated optical elements to image a scene at four wavelengths. The power for the scanner and the four element sensor was supplied from an external power supply box, and the data was read out using a laboratory computer and a high speed data acquisition board.

The third task is the design and fabrication of the laboratory scale scanner. The optical design for the multi-spectral scanner was completed using a ray-tracing algorithm (Zeemax). The electronic design of the circuit boards for the scanner was completed using a PCB design and layout software (Protel). The mechanical design was completed using a solid modeling package (ProEngineering). The circuit boards and the scanner housing were fabricated using outside vendors. A photograph of the final laboratory scale scanner is shown in Fig. 1.

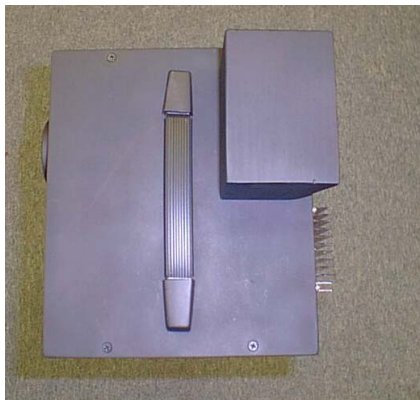
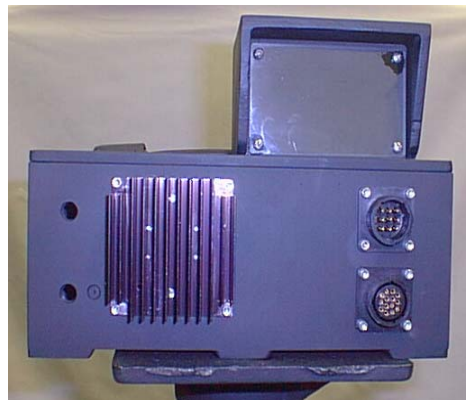
Figure 2. Photographs of the prototype scanner.

The prototype scanner is approximately 10"x9X"x5". It can be either mounted on a tripod or carried using a handle (shown on the left side photograph). The entire scanner weighs about 14 lbs. The scanner has a back-facing mount for the LCD display (shown on the right side photography). In addition, two connectors, one for the power, and another for the data downloads are also on the back surface of the prototype scanner. Provisions for purging the interior of the prototype scanner has also been provided.

The last subtask was to complete the mechanical design and fabrication of the prototype scanner. The entire device had to be packaged into a stand-alone system that can be operated directly from a battery. The mechanical design of the housing was completed on ProEngineer solid modeling package. Two photographs of the resulting prototype scanner is shown in Fig. 2.

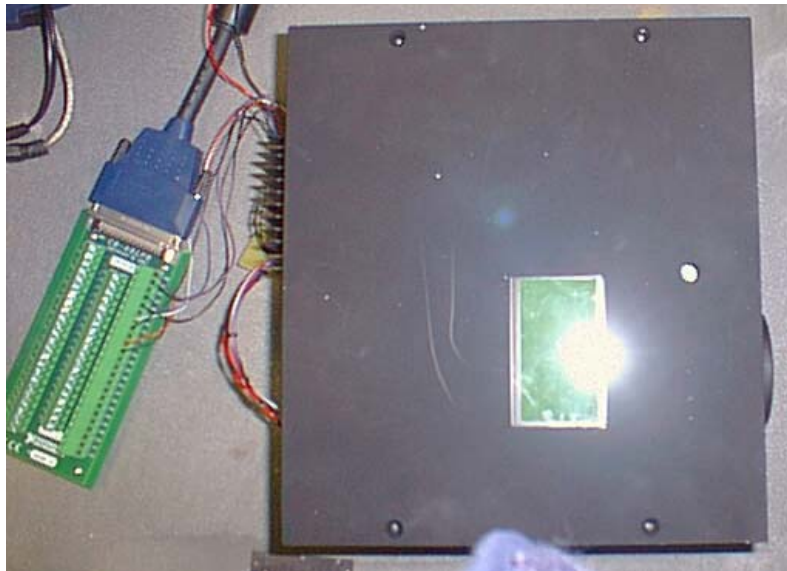
Figure 3. Photograph of the modified prototype scanner.

In addition to the LCD display, there is also a breakout terminal that enables the output from the channels to be sample and stored in a computer. The breakout terminal is also shown in Fig. 3. This completed Task 5 of the project.

During the initial tests, the backward facing LCD screen had some problems with maintaining the integrity of the housing. The purge air used to check the integrity of the housing showed extensive leaks through the backward facing mount. This is not acceptable since in service, the entire unit can get easily coated with dust, and the leakage would result in dust entering the housing. Therefore, it was decided to mount the LCD screen directly on the scanner housing, using a rubber gasket. This modification was accomplished and the resulting prototype scanner is shown in Fig. 3.

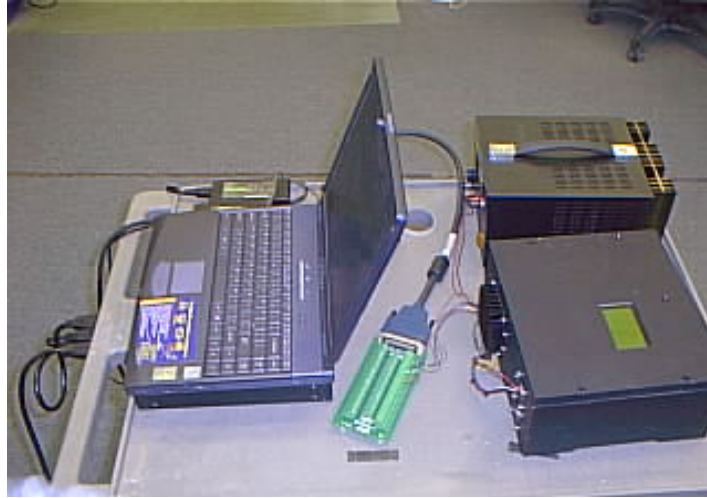
The last task of the project was the evaluation of the prototype scanner. The scanner was turned on and data collected using the breakout box. The experimental arrangement used to collect the data is shown in Fig. 4.

Figure 4. Photograph of the arrangement used to evaluate the prototype scanner.

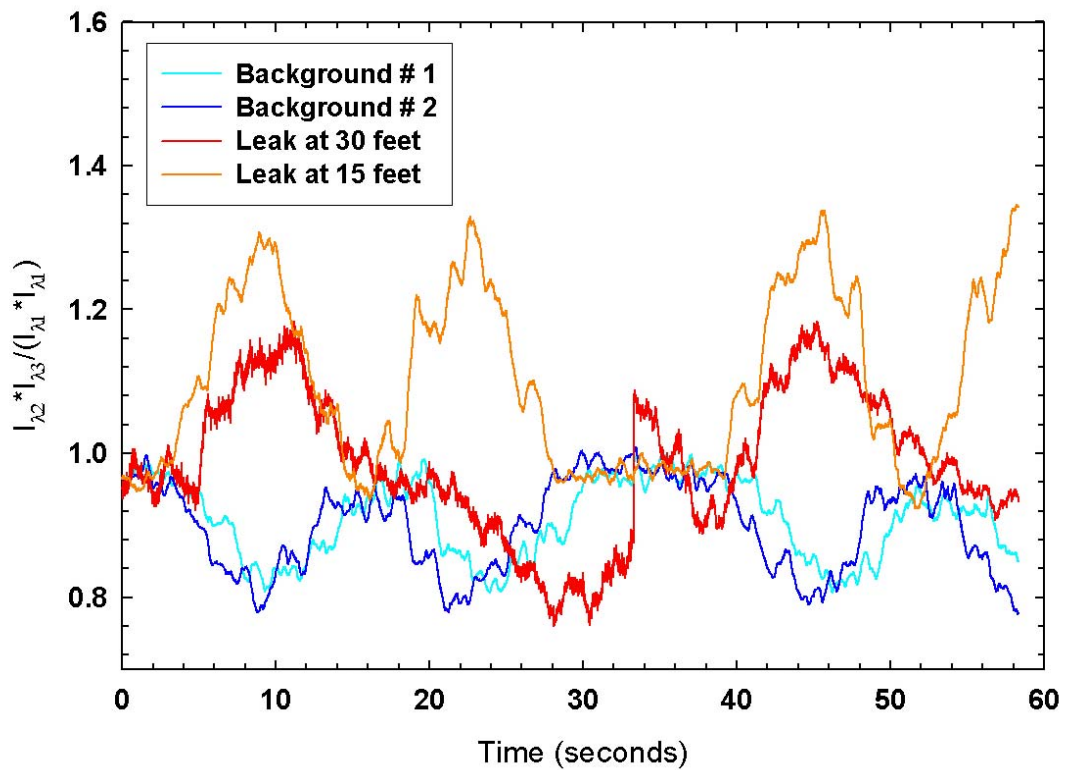
The data was directly displayed on the LCD panel. In addition, the data was collected on a laptop computer for analysis. The prototype scanner was evaluated, with and without a 25 SCFH flow of methane in its path. Sample results obtained from four separate scans are shown in Fig. 5. Two of the scans, shown by the blue and cyan lines, were obtained without any gas

Figure 5. Sample results obtained from the prototype scanner.

flow in the path of the prototype scanner. The intensity ratios are plotted as a function of time for approximately one minute. The intensity ratio moves up and down, due to the changes in the emissivity of the surroundings. For two of the scans, methane at 25 SCFH was flowed through a quarter inch tube at distances of 15 feet and 30 feet from the prototype scanner. The intensity at the first wavelength, $I_{\lambda 1}$ is at 3.4 microns, and the intensity at the second and third wavelengths, $I_{\lambda 2}$ is $I_{\lambda 3}$ is at 3.8 and 4.0 microns.

When there is methane in the path, some of the background radiation is absorbed only at the first wavelength. Therefore, the ratio of intensities will increase. This is clearly seen in the results. The width of the plume is much bigger than the 6 mm tube used for the leaks. In some cases, when methane disperses too much, it is difficult to make out the plume very distinctly from the background.

When the prototype scanner is placed within 15 feet of the leak, the ratio of the intensities obtained is as high as 1.4. This is approximately 40% than the peak observed without any methane. When the prototype scanner is placed within 30 feet of the leak, the ratio of intensities is as high as approximately 1.18. This is approximately 18% higher than the maximum observed without any methane. Therefore, it is clear that the prototype scanner can clearly see a natural gas leak from 30 feet. Similar information is also obtained from the LCD display. This completed the last task of the project.
