SANDIA REPORT

SAND2005-2638

Final Report on Development of Pulse Arrested Spark Discharge (PASD) for Aging Aircraft Wiring Application

Applied Electromagnetic Technologies
Department 1643

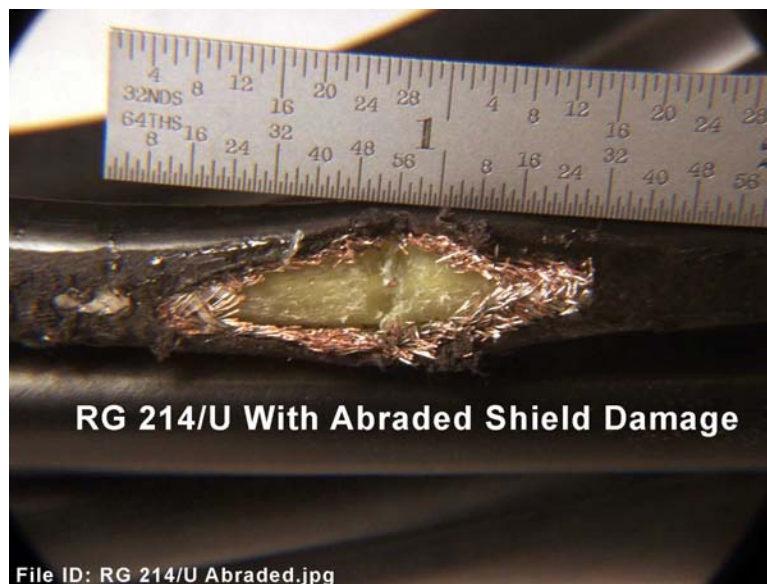
Figure 3: Abrasion on coaxial cable

Figure 3 and Figure 4 illustrate wiring damage investigated under the Navy program and the resulting waveforms.

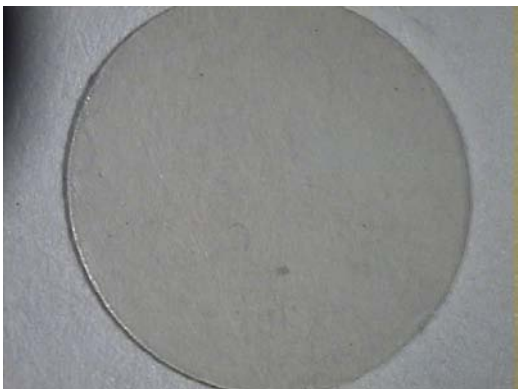
Figure 12: Microscopic photograph of a mylar sample before a low energy pulse.

Figure 12 and Figure 13 contain photographs of a mylar sample before and after a low energy discharge. Notice the contamination (specs) apparent in Figure 13 following the low energy discharge. Since this contamination is located in areas not in the discharge path, they were likely in the fixture prior to the test. The important item to note is the lack of evidence in the photograph of insulator damage as a result of the discharge.

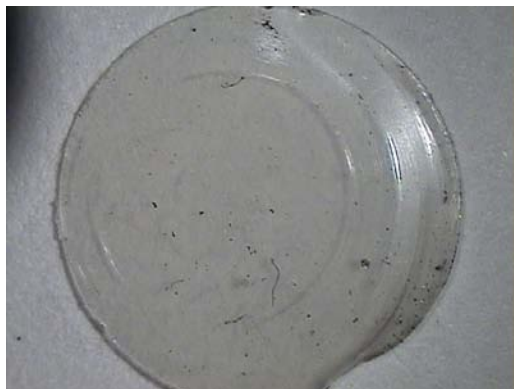
Figure 13: Microscopic photograph of a mylar sample after a low energy pulse.

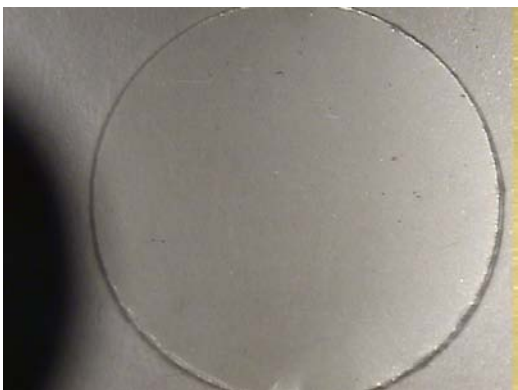
Figure 14: Microscopic photograph of mylar sample before PASD pulse.

Figure 14 and Figure 15 contain photographs of a mylar sample before and after a PASD pulse. Notice the contamination (specs) apparent in Figure 15 following the PASD pulse. This contamination is significantly less than the contamination apparent in Figure 13. It is unclear whether the PASD pulse removed some of the contamination or if there was less contamination in the fixture during the test. Again the important item to note is the lack of evidence in the photograph of insulator damage as a result of the discharge.

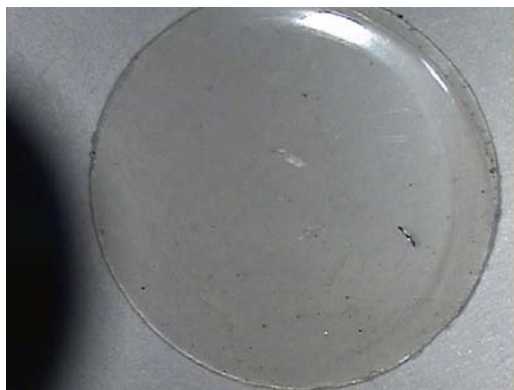
Figure 15: Microscopic photograph of mylar sample after PASD pulse.

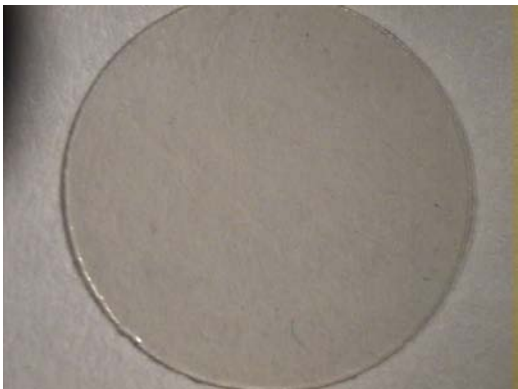
Figure 16: Microscopic photograph of mylar sample before high energy pulse.

Figure 16 and Figure 17 contain photographs of a mylar sample before and after a high energy discharge. Notice the material deposition apparent in Figure 17. This material deposition is suspected to be metal removed from the BNC connector pin evident in Figure 18. The deposition characteristics are not consistent with those of arc tracking due to insulation carbonization.

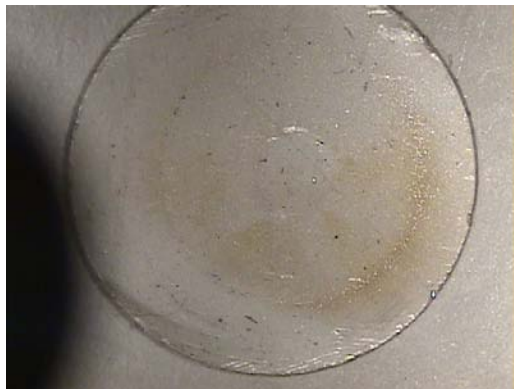
Figure 17: Microscopic photograph of mylar sample after high energy pulse.

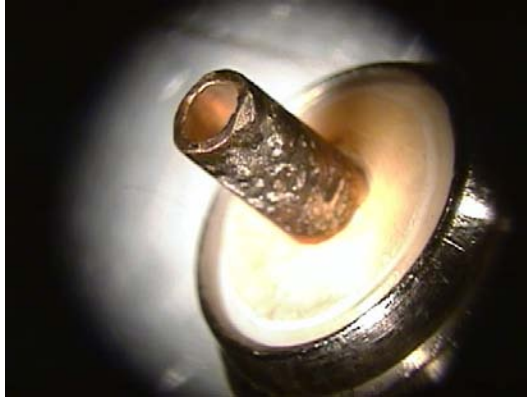
Figure 18: High voltage electrode following insulation material testing.

Based on the data obtained from this testing, it is believed that the PASD pulse does not damage the insulator under test². There was no evidence of breakdown strength changes following PASD pulse application other than the expected statistical variation, no evidence of an effect upon the low energy breakdown voltage after a PASD pulse or the higher energy pulses, and microscopic inspection did not indicate any material deposition characteristic of high energy destructive tracking.

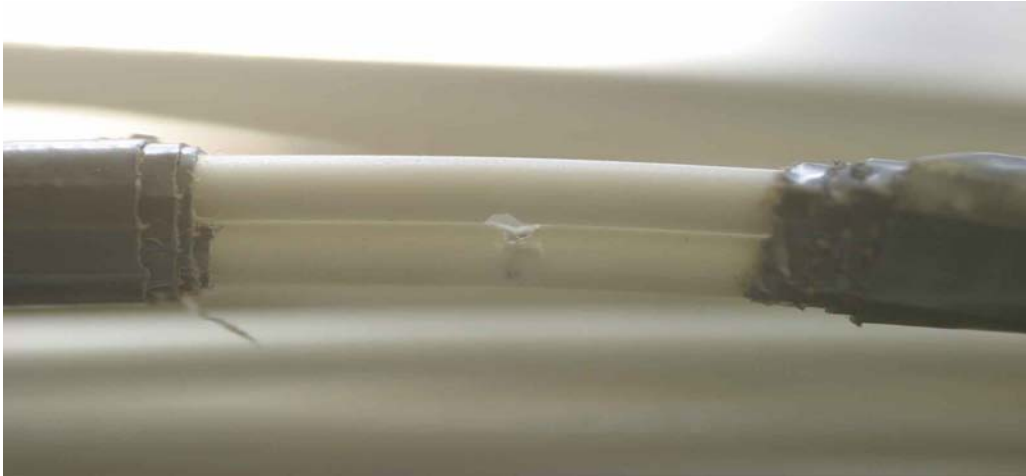
Figure 24: Wire to wire defect

The next aircraft wiring test documented in this report was a wire to wire type insulation defect as seen in Figure 24. This was a ten foot discrete wire configuration with the depicted defect located at 5 feet 8 inches. In Figure 25 the PASD diagnostic waveform depicts the cable with a temporal length of 31ns and a divergence of the baseline and breakdown waveforms at 23.6ns.

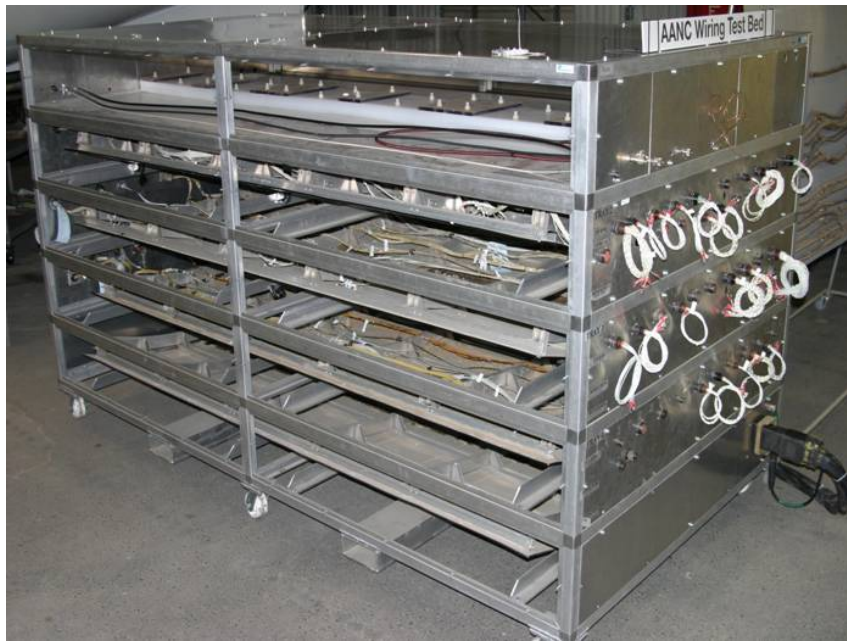
Figure 28: AANC Wiring Test Bed

PASD was applied to a standard that other aircraft wiring system diagnostic manufacturers had been tested on, the AANC (Airworthiness Assurance Non-destructive testing Center) Wiring Test Bed³ (see Figure 28). This test bed contains over 80 harnesses, most of which were extracted from retired commercial aircraft, with various assortments of wiring defects fabricated into them. PASD is a wiring diagnostic designed to detect insulation type defects, therefore these defect types were the focus of the PASD system testing on the wiring test bed.
