MULTI-POLLUTANT EMISSIONS CONTROL: PILOT PLANT STUDY OF TECHNOLOGIES FOR REDUCING Hg, SO₃, NO_x AND CO₂ EMISSIONS

**Final Technical Report
For The Period September 5, 2001, through May 30, 2005**

**Report Issued: June 1, 2006
DOE Cooperative Agreement DE-FC26-01NT41181**

**CONSOL Energy Inc.
Research & Development
4000 Brownsville Road
South Park, PA 15129**

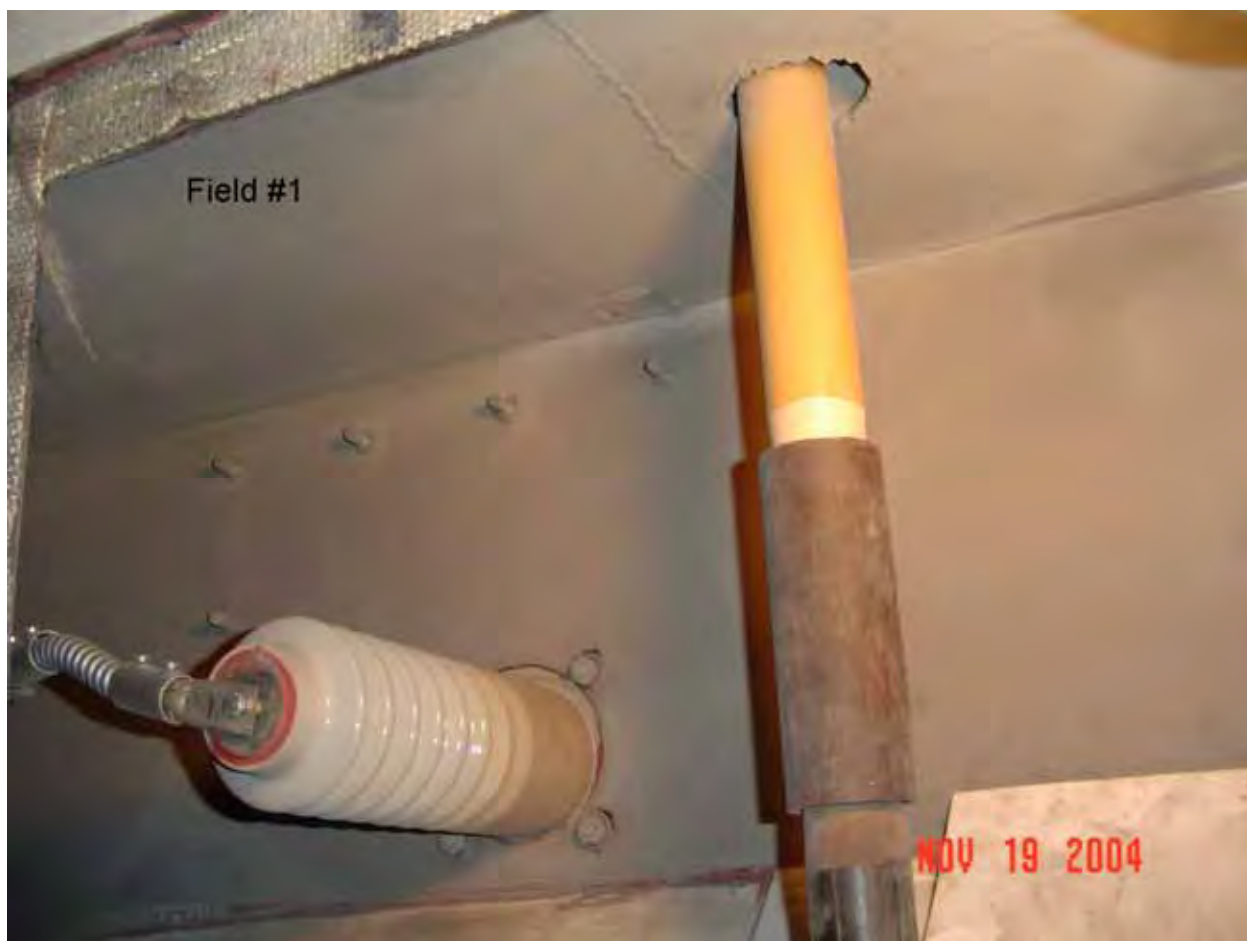
A number of high-voltage insulation failures occurred. The high voltage insulation failures were most often due to contamination from fly ash, and acid or moisture condensation. The fly ash and moisture contamination was reduced by the installation of a hot-air purge into the high-voltage compartment. The acid condensation failures were eliminated during $\text{Mg}(\text{OH})_2$ injection. Figure 49 shows the almost-new condition of the rapper rod insulator after operation with $\text{Mg}(\text{OH})_2$ injection during Task 6 through 7 (142 hours), which shows the effectiveness of SO_3 reduction by $\text{Mg}(\text{OH})_2$ injection. Figure 50 shows a failed rapper rod insulator where the lower portion was blackened by acid condensation during operation without $\text{Mg}(\text{OH})_2$ injection during Task 3. The acid gas was able to enter the high-voltage compartment through the unsealed edges and openings in the $\frac{1}{4}$ " thick Teflon barrier between the flue gas and high-voltage compartments. Full-scale ESPs are better protected than the pilot ESP, and are more resistant to acid condensation.

Figure 49. High-Voltage Compartment with Rapper Rod Insulator in Foreground, Wall Bushing and Teflon Barrier in Background

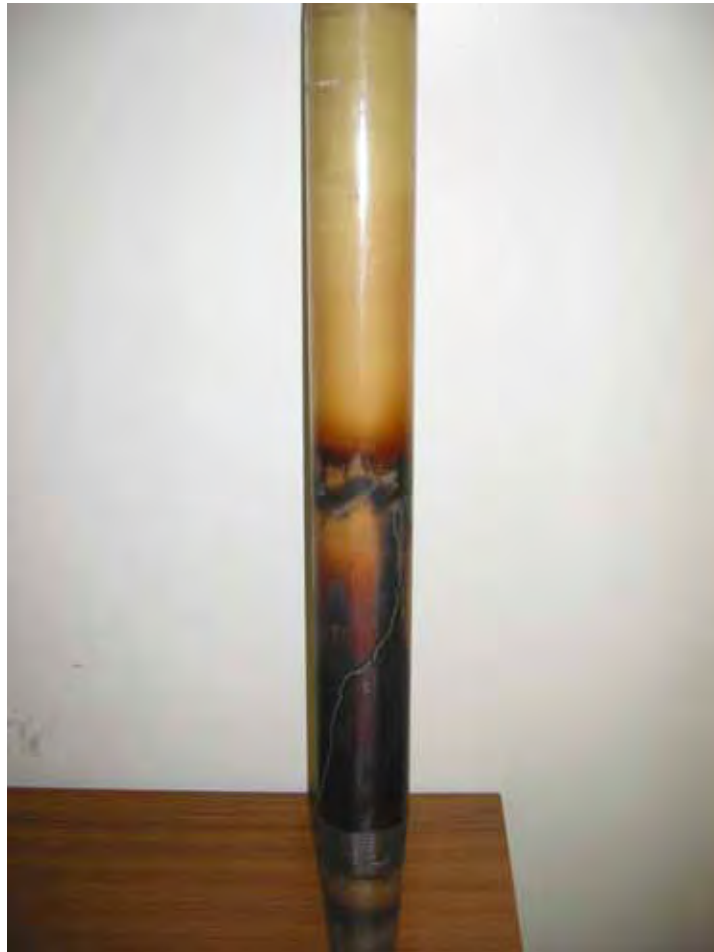
Long-term operation (Task 7) at low temperature (210 °F) with humidification was not able to be conducted due to an electric short (arcing) through a fly ash deposit on the surface of a Teflon barrier. After approximately four hours of operation with water spray cooling the high voltage power supply was shut down when arcing was detected. The Teflon barrier collects fly ash (see Figure 17), which becomes more conductive as moisture is added to the flue gas entering the ESP during humidification. With air heater-only cooling, the Teflon barrier showed no signs of arcing even with a fly ash deposit on the surface of the barrier.

Figure 50. Failed High-Voltage Rapper Rod Insulator, Lower Portion Blackened by Acid Condensation

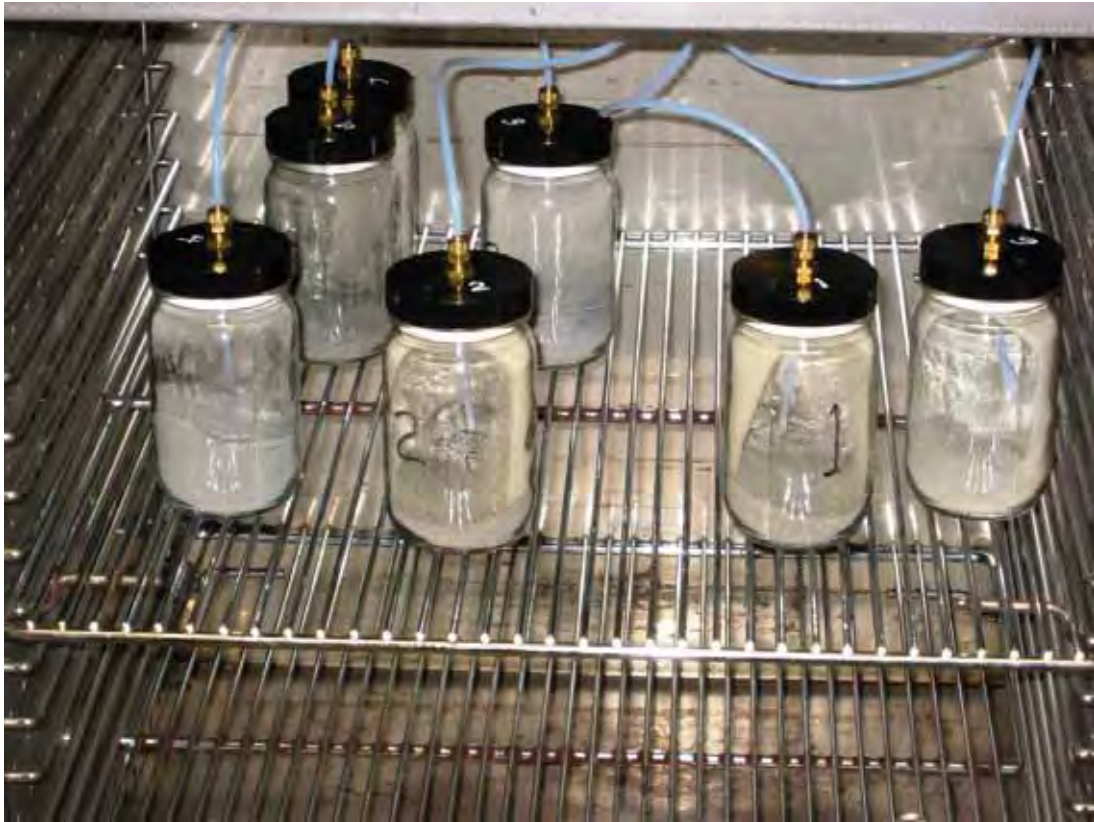
Figure 52. Mercury Volatility Fly Ash Samples in 140 °F Oven
