UDR-TR-2006-00158

ELEVATED TEMPERATURE SENSORS FOR ON-LINE CRITICAL EQUIPMENT HEALTH MONITORING

Final Report

TECHNICAL PROGRESS REPORT, UNIVERSITY COAL RESEARCH PROGRAM

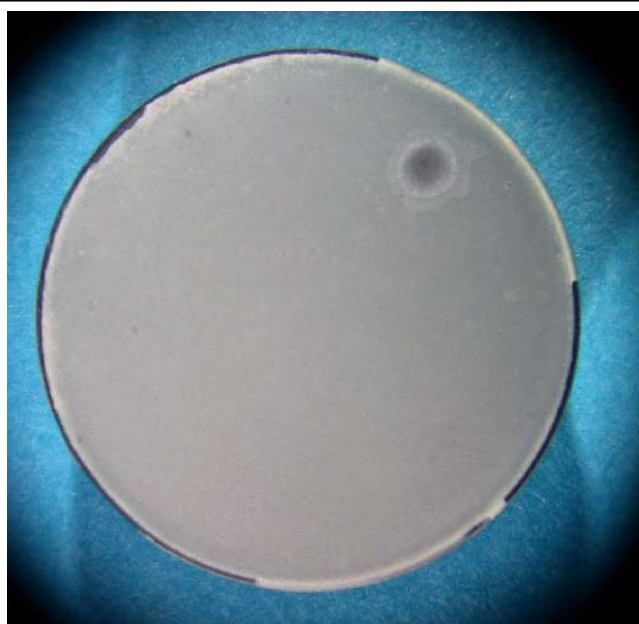
Figure 1. Polished AlN film on WC

During deposition, AlN crystals nucleate on the surface, and the crystals with the desired orientation for piezoelectric use grow in the thickness direction. Occasionally the crystal structure will be disrupted, leaving a pinhole gap or similar defect in the film; previous work with the deposition process has reduced the occurrence of such defects. More commonly, similar defects begin to form after the film has begun to grow, resulting in low areas in the films. The occurrence of defects in this manner limits the overall film thickness, as more defects occur as the film grows. The surface is initially polished by hand on 400 grit SiC paper after deposition to eliminate high spots for the initial ultrasonic evaluation. Further polishing on 400 and 600 grit paper is required to maximize the ultrasonic signal, with additional lapping sometimes used. Figure 1 shows a polished AlN film deposited on tungsten carbide.

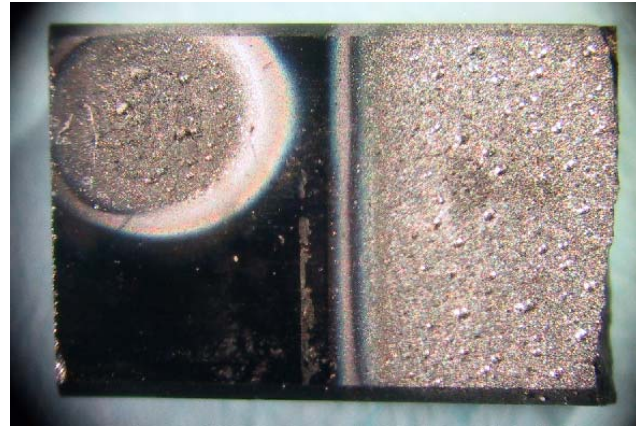
Figure 2. AlN film on SiC deposited by PLD.

($\lambda=1064\text{ nm}$) of a Q-switched Nd:Yag laser with a heated substrate placed within a few mm of the irradiated area. The ablation is performed in a background pressure of ammonia in a vacuum chamber, forming AlN on the heated substrate. Placing the substrate at such a close distance to the target allows most of the ejected material to strike the target. The laser can deliver up to 400 mJ/pulse of its fundamental radiation. An infrared pyrometer was used to determine the substrate temperature during deposition. The films deposited by PLD have not been further polished. Figure 2 shows an AlN film deposited on silicon carbide using the PLD method.

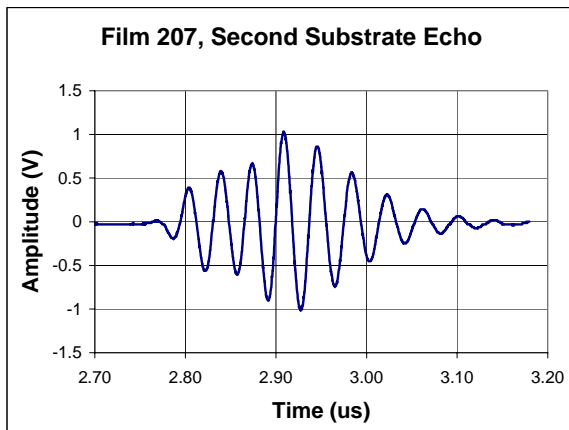
Figure 3. Narrowband ultrasonic signal with significant ringing produced by AlN film on WC substrate.

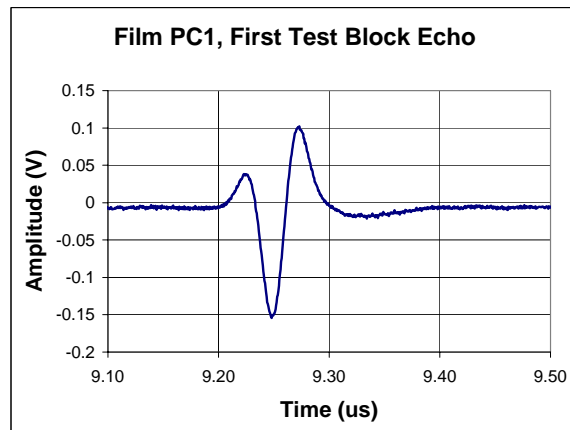
Figure 4. Wideband ultrasonic signal produced by AlN film on SiC substrate

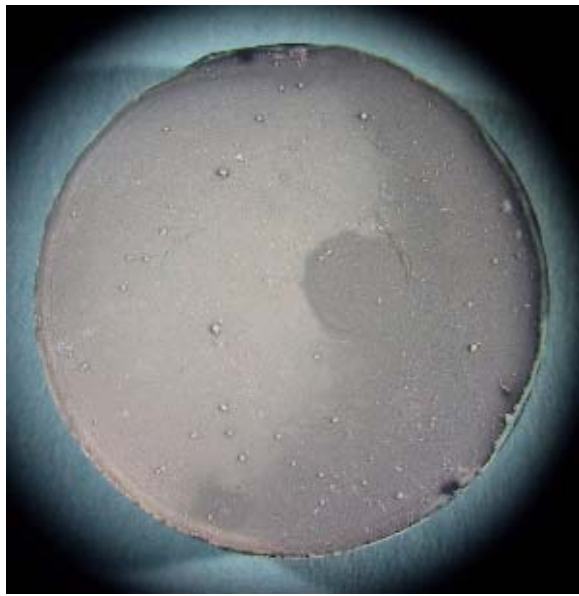
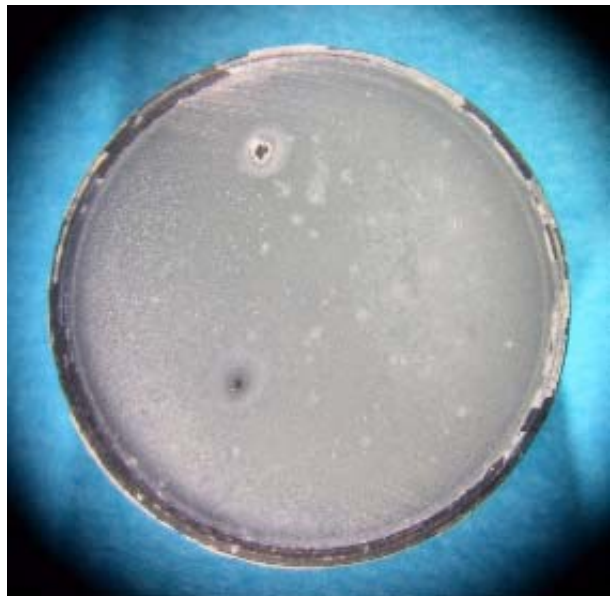
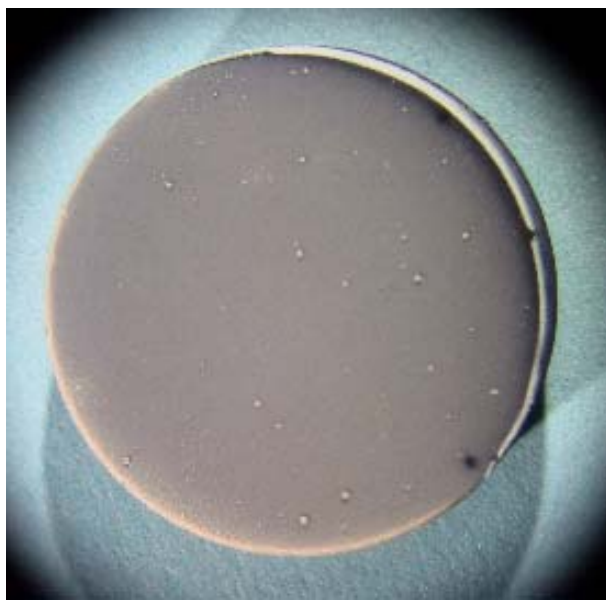
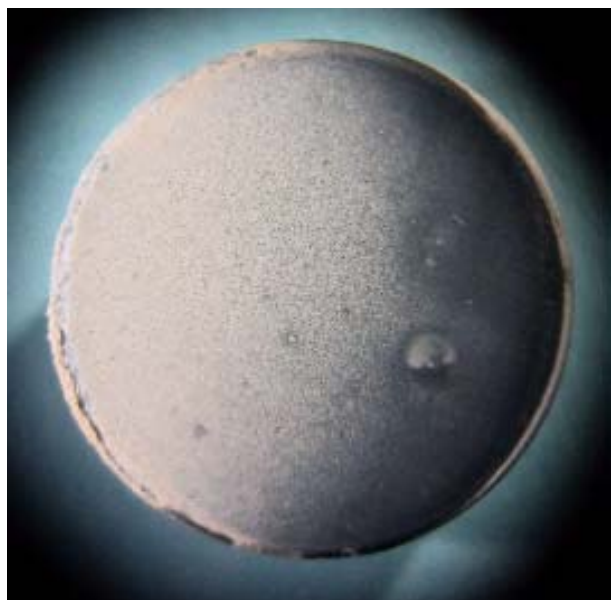
Figure 5. As-deposited AlN film on SiC.

Figure 6. Rough-polished AlN film on *Hexoloy SG*.

Figure 7. As-deposited AlN film on *Pure SiC-LR*.

Figure 8. As-deposited AlN film on *Performance SiC*.

The AlN films on SiC showed mixed results. Most films exhibited good initial adhesion, as shown in Figures 5-8. Some of these were rather weakly bonded, however, and underwent significant damage or delamination upon polishing. Figure 18 shows a typical example with edge damage and a delamination (white area) extending from under a pore. Figure 19 shows more severe damage incurred on a different SiC material. The Hexoloy SG and Pure SiC-LR materials both showed acceptable adhesion and were further evaluated for ultrasonic properties and thermal cycling resistance.

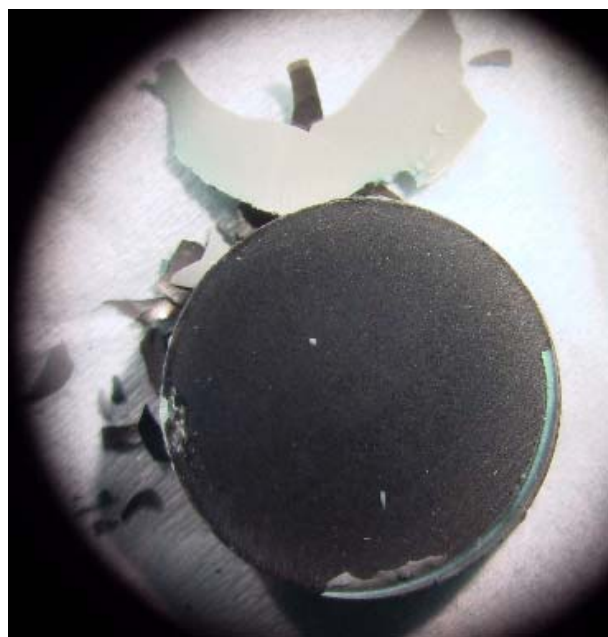
Figure 9. AlN film spalled from cobalt-coated SiC

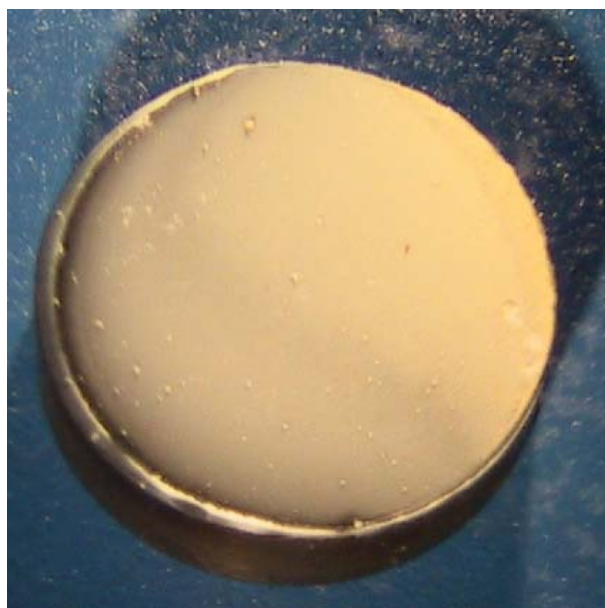
Figure 10. As-deposited AlN film on conductive bulk AlN substrate.

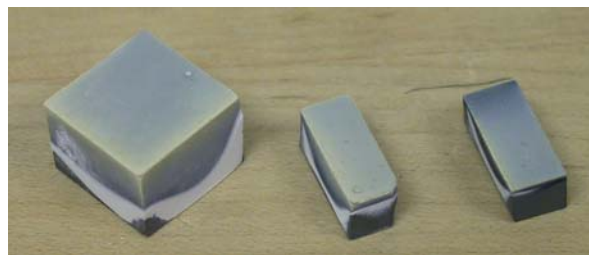
Figure 11. Initial AlN Deposition on siliconized (square) and porous SiC (rectangular).

Two different forms of the material were investigated- porous SiC as described above, and siliconized porous SiC which had been infiltrated with molten elemental silicon. An initial deposition on both SiC materials was promising. The films were well adhered and piezoelectric. The SiC was conductive enough to provide a back surface electrode. The non-infiltrated porous substrates scattered and attenuated the ultrasonic energy to the point that a coherent back surface echo could not be detected. Initial films are shown in Figure 11, and an ultrasonic signal from a film reflected from the back of a test block is shown in Figure 12. Applying a thermal cycle to

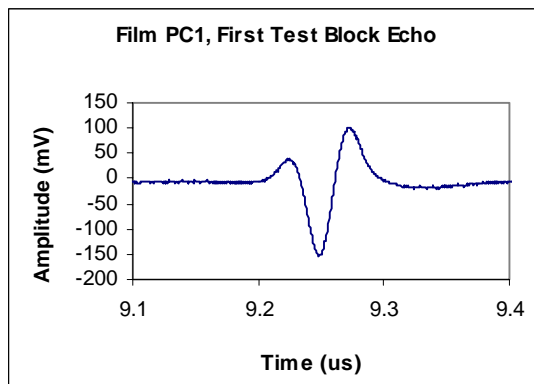
Figure 12. Wideband ultrasonic signal produced by AlN film on porous SiC substrate

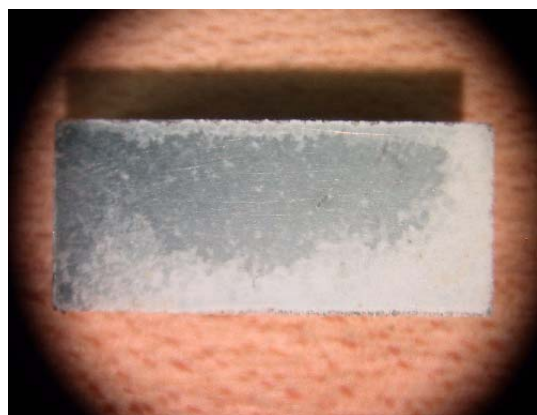
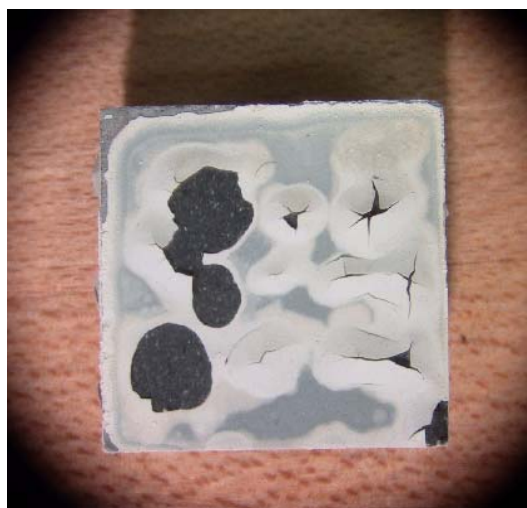
Figure 13. AlN film on porous SiC after 700°C thermal cycle and polishing.

Figure 14. AlN film on siliconized SiC after 700°C thermal cycle.

several films quickly indicated that the AlN bonding to the siliconized SiC was poor, while the porous material continued to show promise. Thermally cycled films are shown in Figures 13 and 14.

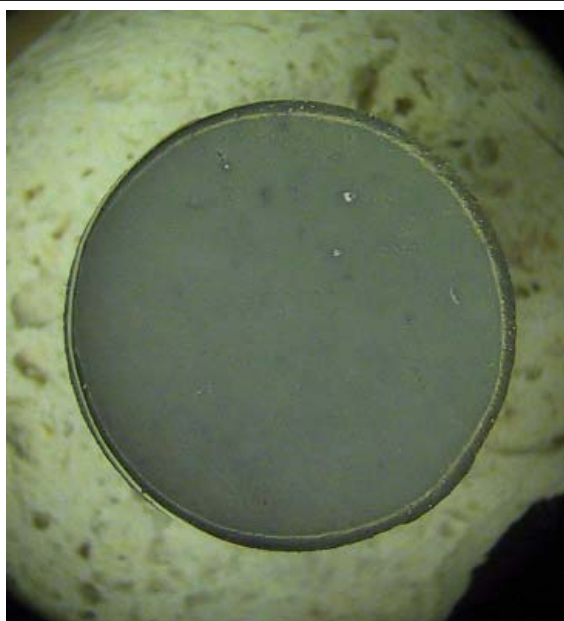
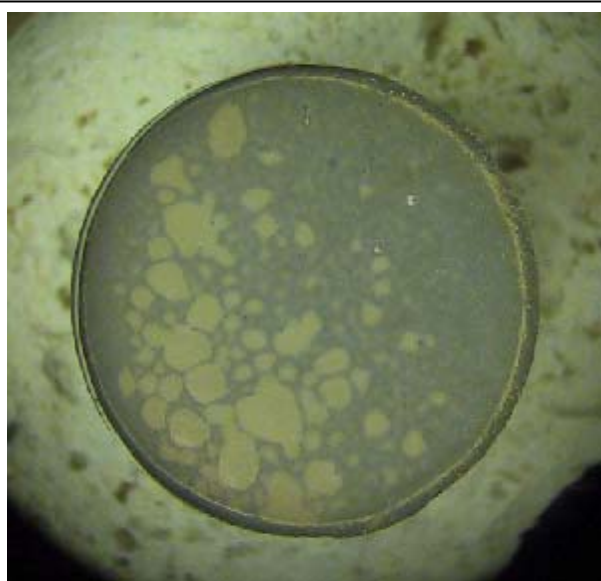
Figure 15. As- deposited AlN film on porous SiC cylinder.

Figure 16. AlN film on porous SiC cylinder after 200°C thermal cycle.

However, as with the other forms of SiC, adhesion was not maintained consistently upon thermal cycling. Varying the surface condition through additional polishing did not solve the adhesion issue. Figures 15 and 16 show an as-deposited film and a film after cycling to only 200°C that exhibited a typical, patchy failure mode.

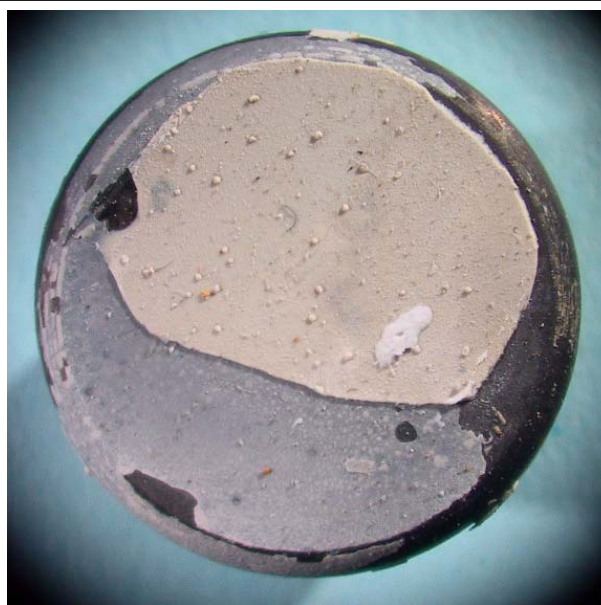
Figure 17. AlN film on Ti delaminated by heating.

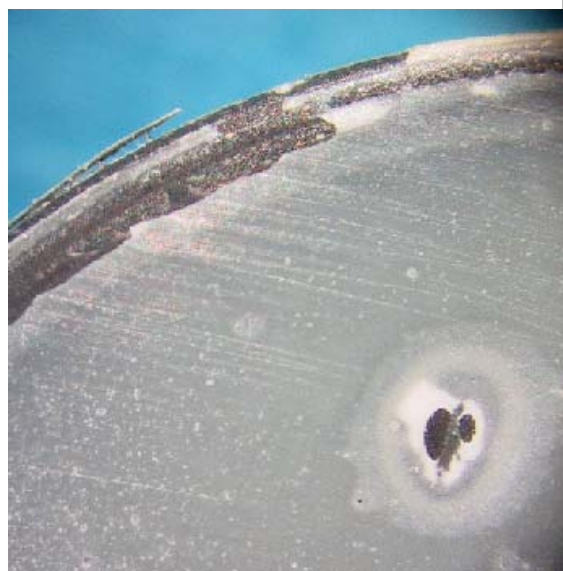
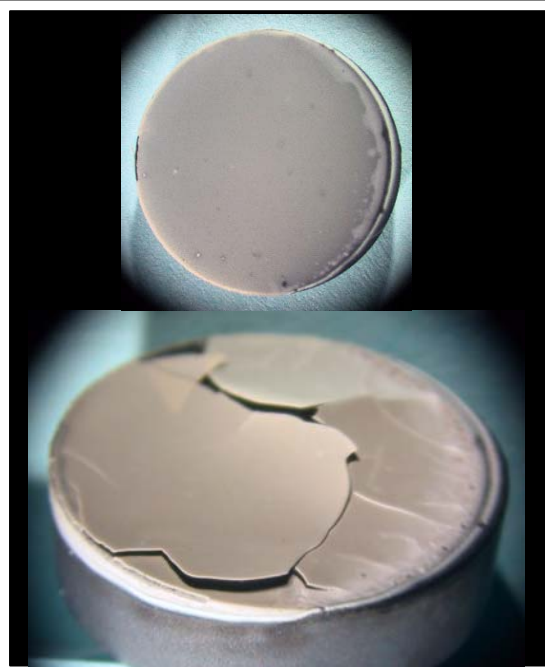
Figure 18. Minor localized polishing damage on Hexoloy SG substrate.

Figure 19. Polish-damaged AlN film on Performance SiC substrate.

Figure 20. Delaminated AlN film on Hexoloy SG substrate after heating.

Figure 21. Massively delaminated AlN film on Pure SiC-LR substrate before and after heating.

Both materials showed poor adhesion upon thermal exposure. Delaminations usually began at an edge or existing defect, and spread quickly under the film, which split and buckled. Figure 20 shows the same film as Figure 18, after polishing and heating to only 400°C. The pore in Figure 18 is at the top of Figure 20, just left of center. The darker areas are still well adhered, but more than half of the film has delaminated and cracks are visible in the center of these regions. An

AlN film on Pure SiC-LR, which had only minor edge delamination prior to heating, experienced even more severe damage. Figure 21 shows this film before and after heating.

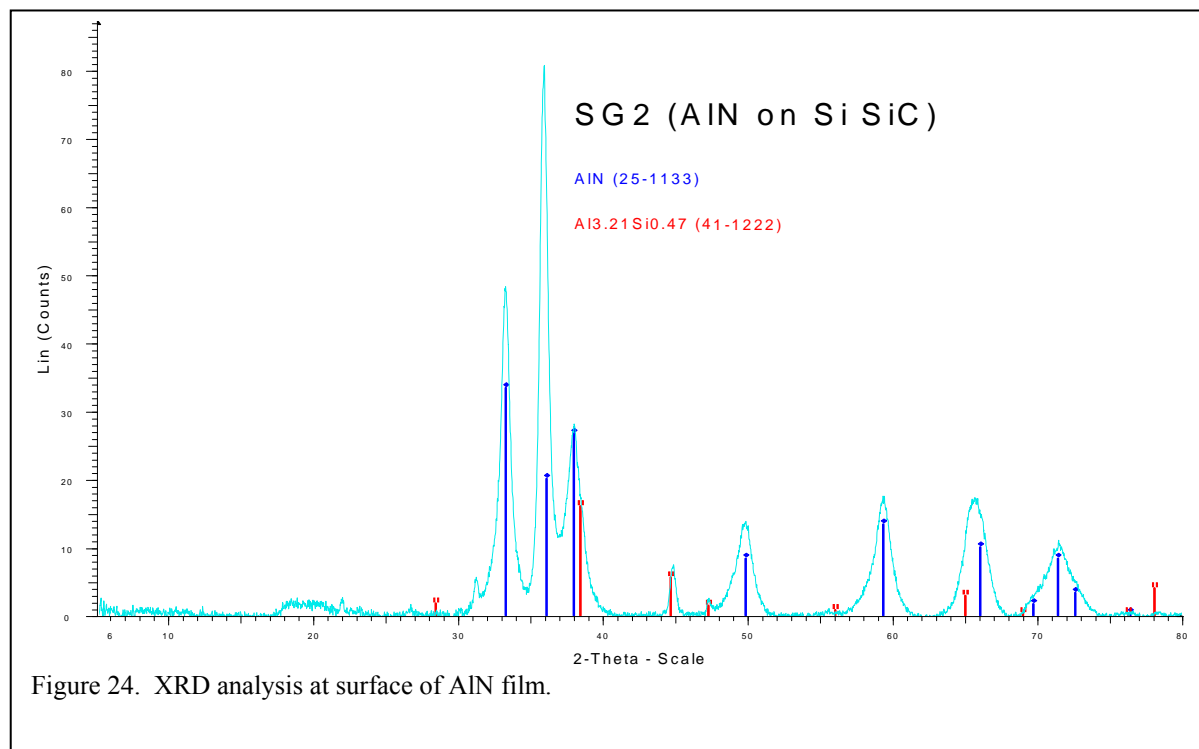
Figure 24. XRD analysis at surface of AlN film.

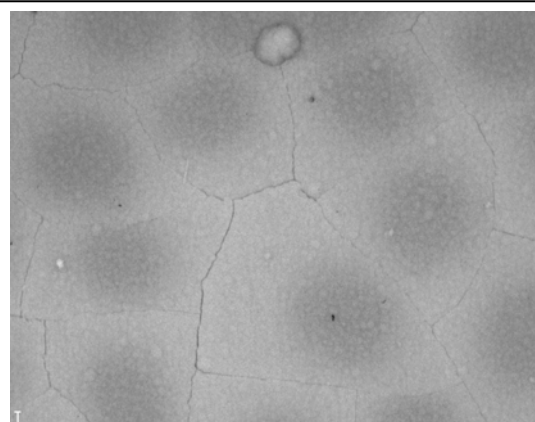
Figure 25. SEM photomicrograph of cracked AlN film on siliconized SiC after thermal cycle.

The SEM allowed the discovery that even films that appeared to survive initial thermal cycles did not do so without substantial microscopic damage. Figure 25 shows the surface of an AlN

film on siliconized SiC before and after a thermal cycle to 1050°C in an inert (argon) atmosphere. The presence of this sort of damage indicates that oxidation from the atmosphere is not a requirement for the damage to occur. The cracking pattern may indicate the boundaries between individual crystal grains, suggesting that thermal strains arise, stressing the film-substrate bond.

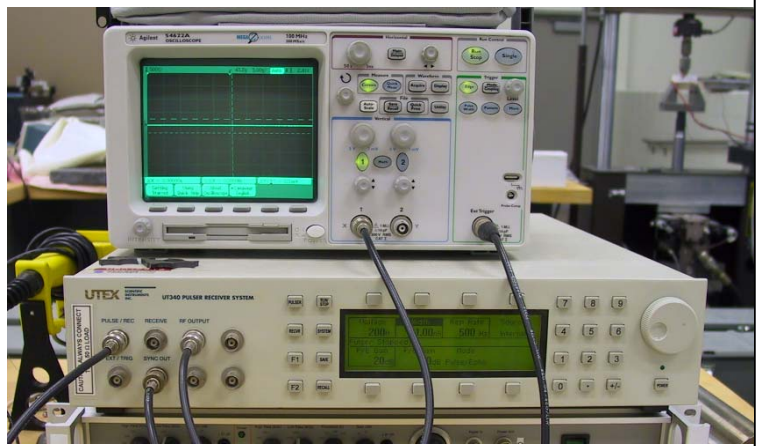
Figure 22. Utex 340 Pulser-Receiver and Agilent Oscilloscope.

Finally, testing for ultrasonic properties was performed, generally before a heating test. A Utex 340 ultrasonic square wave pulser/receiver instrument was used with an Agilent 54622A digital oscilloscope for these tests. Figure 22 shows the Utex 340 incorporates programmable low pass and high pass filtering, and can supply pulses of 5-80 ns with an amplitude of 100 to 500 V. Test voltages near 300 V were used for most films unless electrical shorting near damaged areas forced the use of lower voltages. For most testing, the film was placed on water-based ultrasonic couplant on a flat metal electrode. A two pronged probe from the pulser/receiver was then touched to this stack, with the ground on the metal electrode and the signal lead on the film's substrate. Pulse width, gain, and receiver filters were adjusted to maximize the signal on a film-to-film basis.

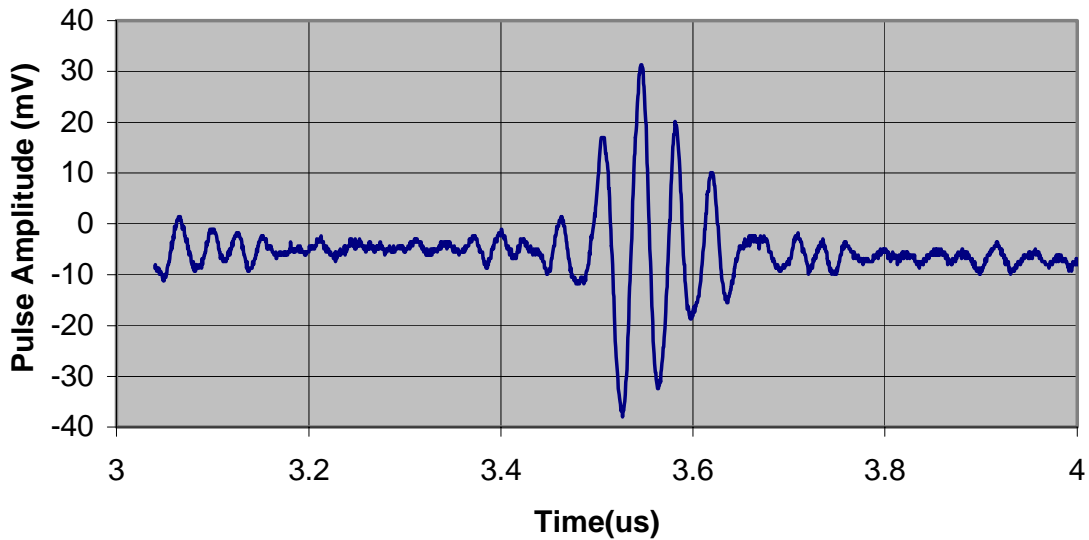
Figure 23. Typical ultrasonic pulse produced and received by AlN film.

The frequency content of the first clear echo from the back of the substrate was used to determine the natural frequency of the films. The echo from the far surface of a 25.4 mm thick, 17-4PH stainless steel cylinder with parallel faces, used as the metal ground electrode, was also used to provide a film-to-film strength comparison without effects from the substrate geometry. Pulse width and gain settings were adjusted as needed. Averaging of multiple pulses was used to increase the signal to noise ratio. A typical ultrasonic waveform is shown in Figure 23.

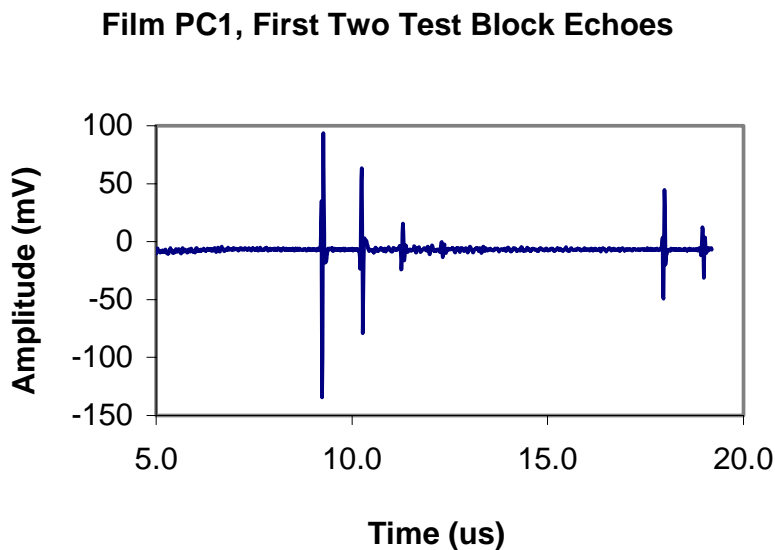
Figure 24. Ultrasonic signal produced by AlN film on porous SiC substrate, showing rapid attenuation of ringing in substrate after reception of each pulse

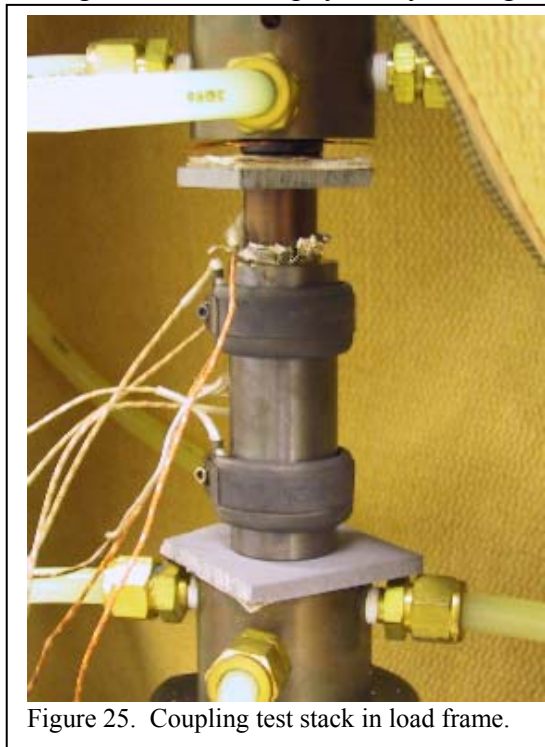
Figure 25. Coupling test stack in load frame.

In order to test metal foil coupling, the same apparatus and procedure were followed, except that a larger compressive load was required; a servohydraulic load frame with water-cooled compression platens applied this load as shown in Figure 25. Ceramic and mica sheets placed between the platens and the test stack described above prevented the rapid conduction of heat into the cooled platens. A spherical washer at the top platen accounted for any misalignment in the test stack. While the load frame used in the experiments was capable of applying 500 kN, the lowest range was selected and the largest force used in this testing was 12 kN. After the load was set, the servohydraulic controller maintained the load, accounting automatically for displacements caused by thermal expansion when the test stack was heated. Aluminum, silver, and gold foils were tested for coupling.

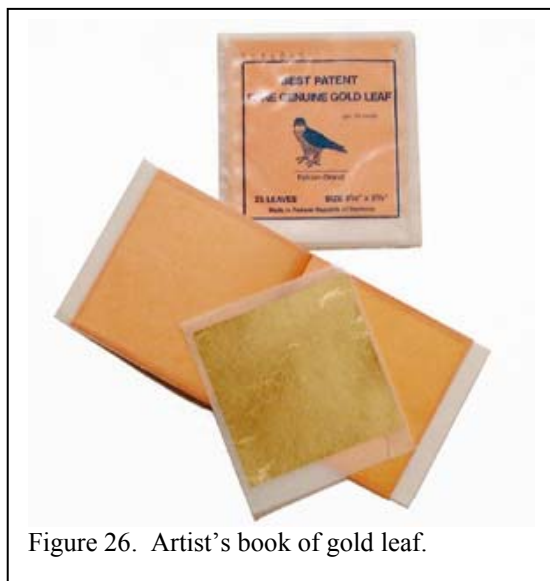
Figure 26. Artist's book of gold leaf.

Gold foil was initially used for coupling, but investigation continued in search of a more economical material. Gold leaf, used by artists and architects to apply a very thin coating of true gold to objects, was obtained. The 24k leaf is extremely thin ($0.1\mu\text{m}$) and is thus much less expensive than foil ($\sim 25\mu\text{m}$). A book of gold leaf such as the one in Figure 26 costs less than \$100 and contains $\sim 1800\text{ cm}^2$ of gold leaf. Several layers of gold leaf between objects provided good ultrasonic coupling, similar to foil. Handling the leaf is more difficult, however, as it is very delicate. For this reason, plain loose gold leaf was found to be superior to “patent” gold leaf, which is sold adhered to tissue paper for support during handling but is difficult to remove from the paper when not adhered to something else. No adhesives could be used in this work due to the high temperatures involved, and easily evaporated liquids such as water and methanol did not work as alternatives.

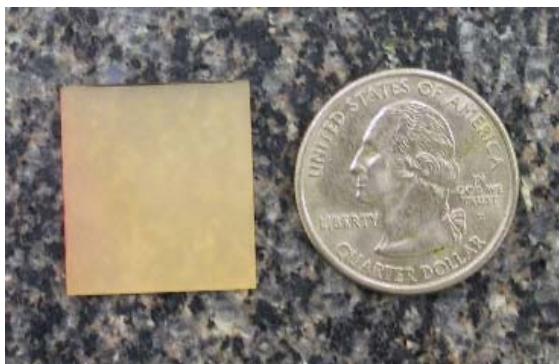
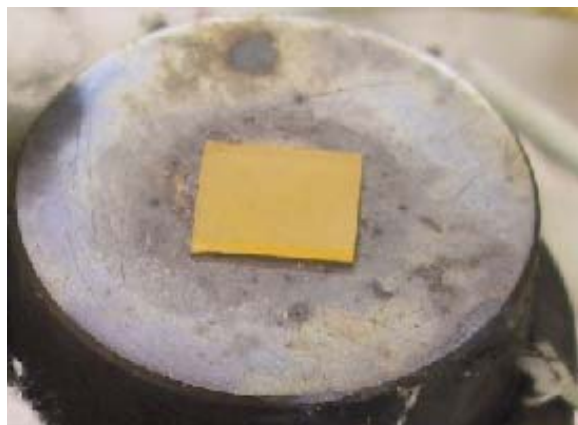
Figure 27. LGS crystal, as received.

Figure 28. LGS crystal after 700°C thermal cycle.

Samples of LGS were procured from two sources, Axtal (Germany), and Mitsubishi Electronic Materials (Japan). Figure 27 shows a Mitsubishi crystal, which is the translucent orange color typical of the LGS. The same crystal in Figure 28, has been cycled to 700°C with no apparent oxidation or other effects, and no degradation in signal strength. To evaluate the piezoelectric behavior with temperature, a test was devised where the crystal was placed on a heated platen, a flat electrode was placed on top, and a voltage pulse was applied across the crystal as it would be

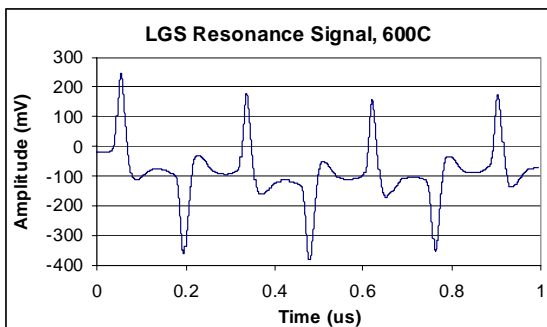
Figure 29. Free vibration piezoelectric resonance in LGS crystal.

applied in an ultrasonic transducer. This induced a free resonant vibration through the thickness of the crystal because it is not ultrasonically coupled to a backing material or test material on either face. These vibrations, shown in Figure 29, indicate that the resonant frequency of the 1.0 mm thick crystal is about 3 MHz. It is therefore acoustically very similar to AlN. The graph in Figure 30 further shows the behavior of this vibration with temperature- the LGS becomes more responsive up to at least 600°C. This peak value was not consistent between different samples of the material, and may be the result of electrode oxidation or other effects not tied to the crystal itself, or may be a softening of the crystal with temperature. Similar behavior was exhibited by the Axtal material, 0.85mm thick.

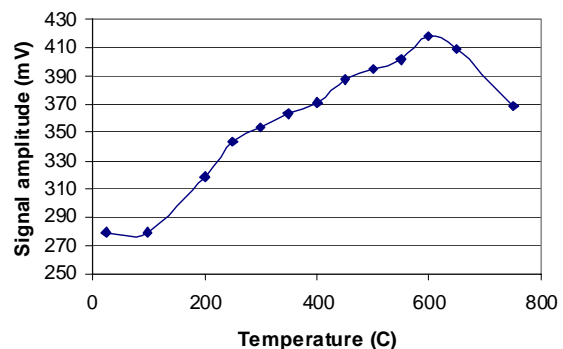
Figure 30. Resonance amplitude in LGS crystal as a function of temperature.

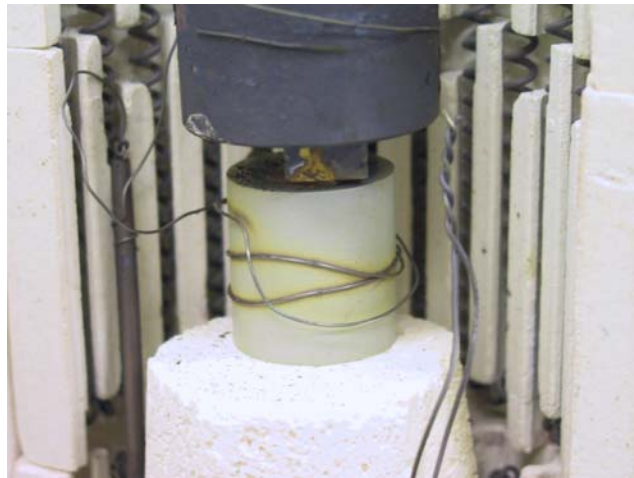
Figure 31. Simulated transducer in furnace after test.

electrode on the other side. The twisted wire on the right side of Figure 31 was the thermocouple used to monitor the test temperature. Figure 32 shows the assembly before placing it in the furnace; Figure 33 shows the individual components after the test. Note that the gold leaf has bonded to both surfaces it contacted; the gold leaf and conductors are intact. The LGS crystal and SiAlON backing material showed no degradation.

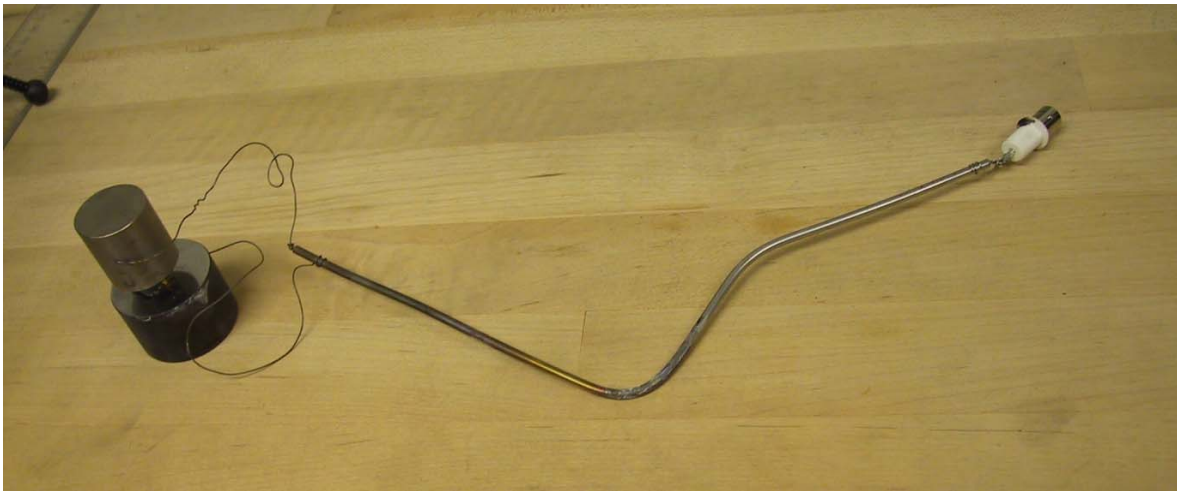
Figure 32. Transducer assembly before test.

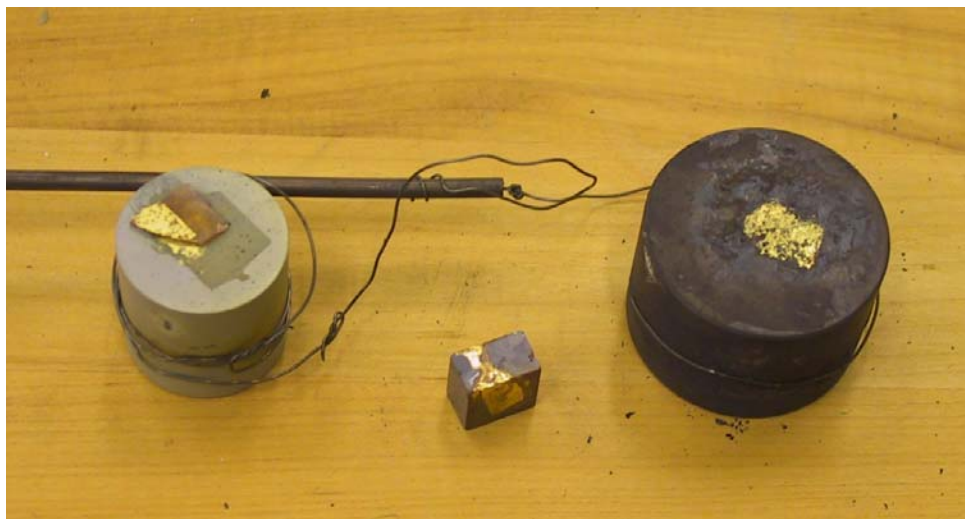
Figure 33. Transducer components after test.

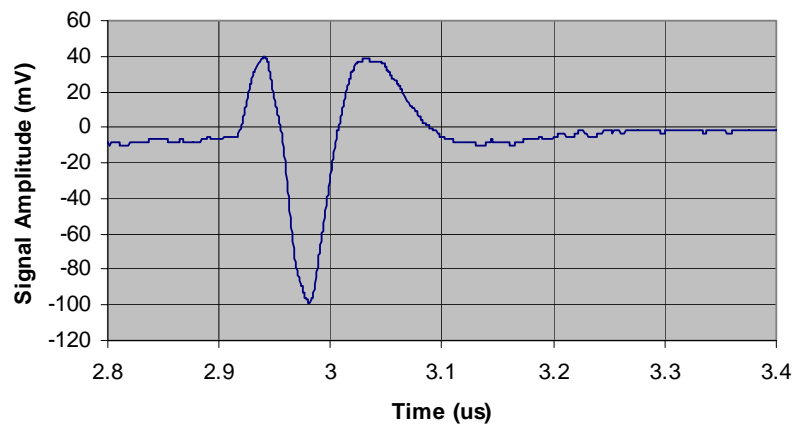
Figure 34. First back-surface echo of ultrasonic pulse from ~13 MHz AlN film on WC.

New films on tungsten carbide show signal strength and properties similar to previously produced films. Films thick enough to have center frequencies below 30 MHz and substantial energy below 10 MHz are routinely produced. Films on titanium have similar ultrasonic properties with respect to center frequency and signal strength. Because the titanium is a closer acoustic impedance match to the AlN than the tungsten carbide substrates, the ultrasonic pulse shape is improved on the titanium, having a more broadband signal with less resonant ringing. Ultrasonic data from AlN films on titanium and tungsten carbide is shown in Figures 34-37.

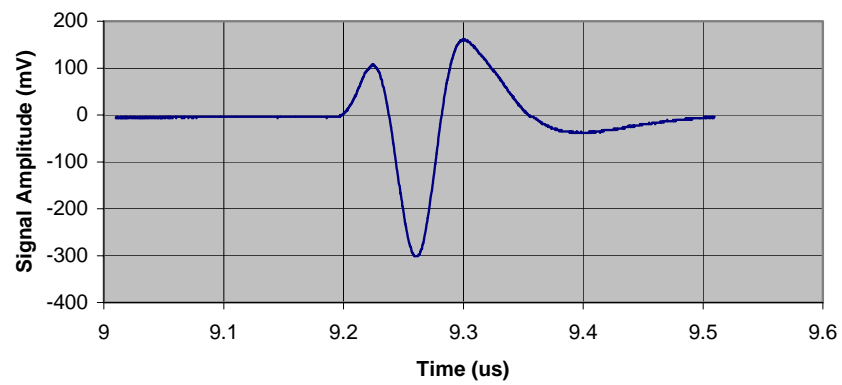
Figure 35. First echo in steel test block of ultrasonic pulse from ~13 MHz AlN film on WC.

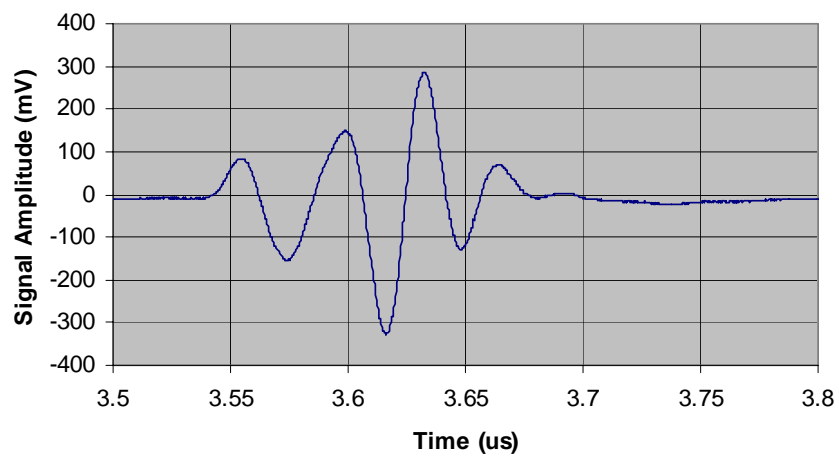
Figure 36. First back-surface echo of ultrasonic pulse from ~30 MHz AlN film on titanium.

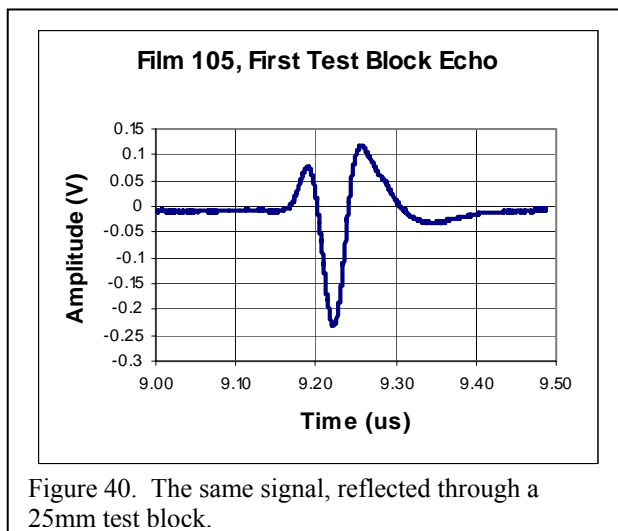
Figure 40. The same signal, reflected through a 25mm test block.

shown in Figure 39. Figure 40 shows a reflection of a pulse from the same film off an external, 25mm thick block of 17-4 PH stainless steel. This block has polished, parallel faces, so the amplitude of the echo in it may be used to compare the strength of films to one another. The signal in Figure 39 is ~350mV p-p, 15 MHz center frequency, and was recorded with only 20dB of gain with a 200V excitation pulse. These waveforms are representative of the signals produced by the stronger AlN films on SiC. The reason for the change in center frequency is

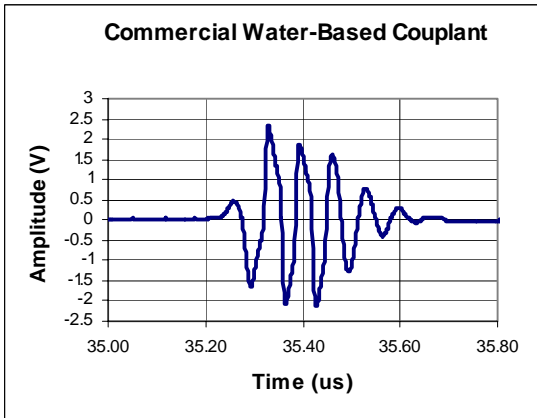
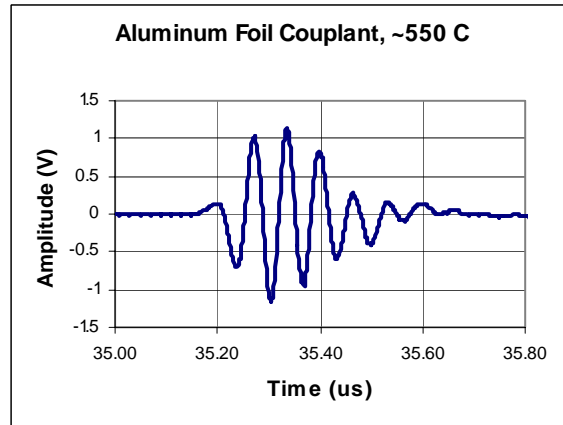
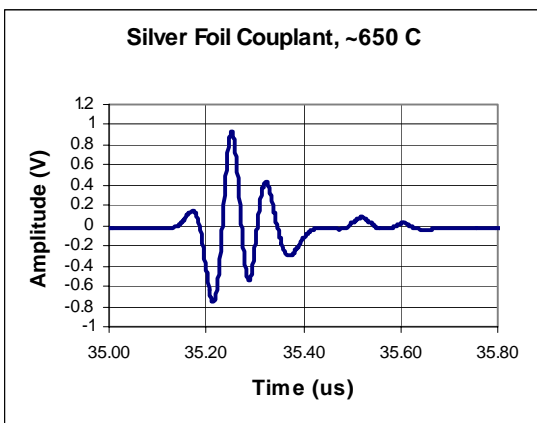
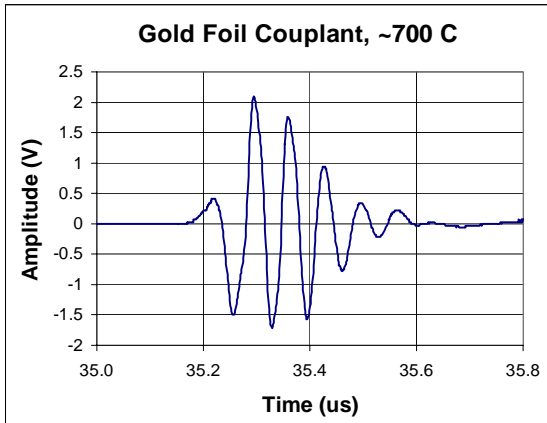
Figure 41. First reflection in 100 mm test block, water-based couplant, room temperature.

Figure 42. First reflection in 100 mm test block, aluminum couplant.

Figure 43. First reflection in 100 mm test block, silver couplant.

Figure 44. First reflection in 100 mm test block, gold foil couplant.

Figures 41-44 compare the first echo in the test block using a commercial water-based couplant at room temperature to the echoes received using the various foil couplants at elevated temperatures. Note that good coupling is achieved, even at temperatures approaching the melting point of the aluminum foil. Aluminum and silver foils showed some degradation with time, likely the result of oxidation. The strongest signals were achieved using the gold foil. In general, some degree of coupling occurred as soon as a compressive load was applied to the test fixture. Upon heating, the softening of the foils improved the coupling, and a high degree of coupling was maintained even after cooling and the removal of almost all the compressive load. A single AlN film on a tungsten carbide substrate was used for all the foil couplant tests in order to insure that the signal being coupled was of consistent strength.

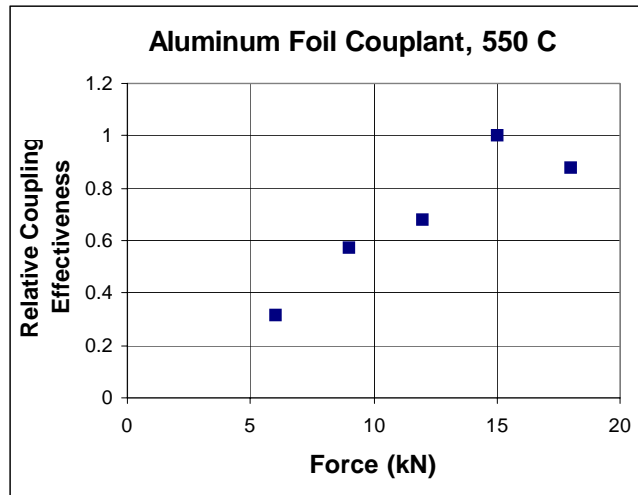
Figure 45. Coupling effectiveness as a function of compressive load.

The aluminum foil couplant was used to evaluate the effects of compressive load on coupling effectiveness for foil couplants. Figure 45 shows an increase in coupling effectiveness with load up to about 15 kN, corresponding to a pressure of about 10 MPa. Note that this value cannot be compared to the yield strength of the aluminum because creep effects dominate at these temperatures and the thin aluminum layer is in a triaxial state of stress, corresponding more closely to a hydrostatic pressure than uniaxial compression. This shows that for foil coupling, there is an ideal load that should be reached, beyond which additional loading is unnecessary. As mentioned earlier, this load need not be maintained after initial loading and heating.

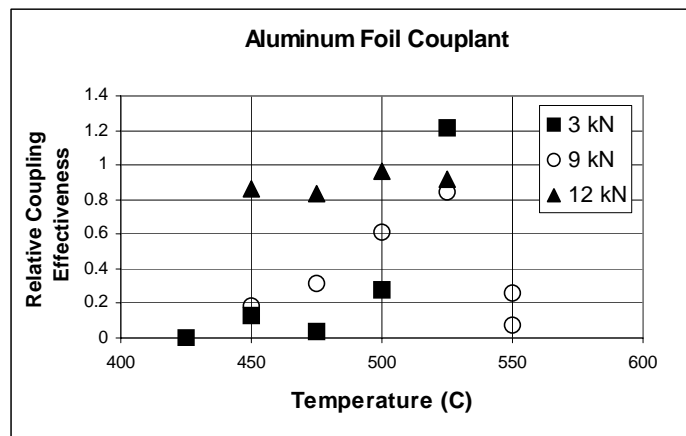
Figure 46. Coupling effectiveness as a function of compressive load and test temperature.

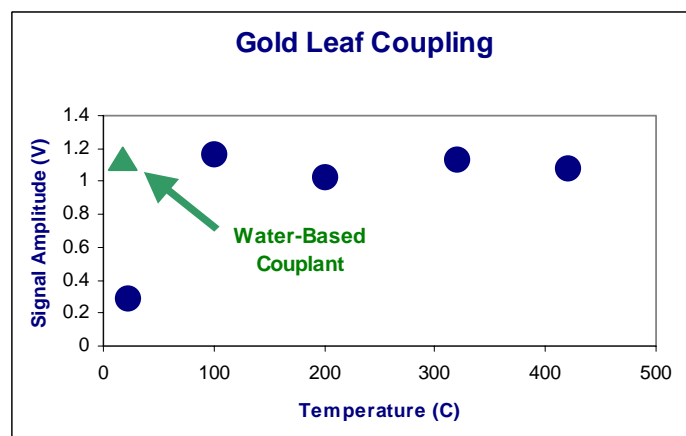
Figure 47. Gold leaf coupling compared to water-based couplant.

Gold leaf was found to perform as well or better than the gold foil, comparing favorably with the coupling achieved by a commercial water-based couplant used at room temperature. Figure 47 shows that the initial coupling with the gold leaf is weak, but as the temperature increases, the thin gold leaf quickly conforms to any irregularities at the interface and good coupling is obtained. Coupling is maintained even after cooling the test fixture to room temperature.

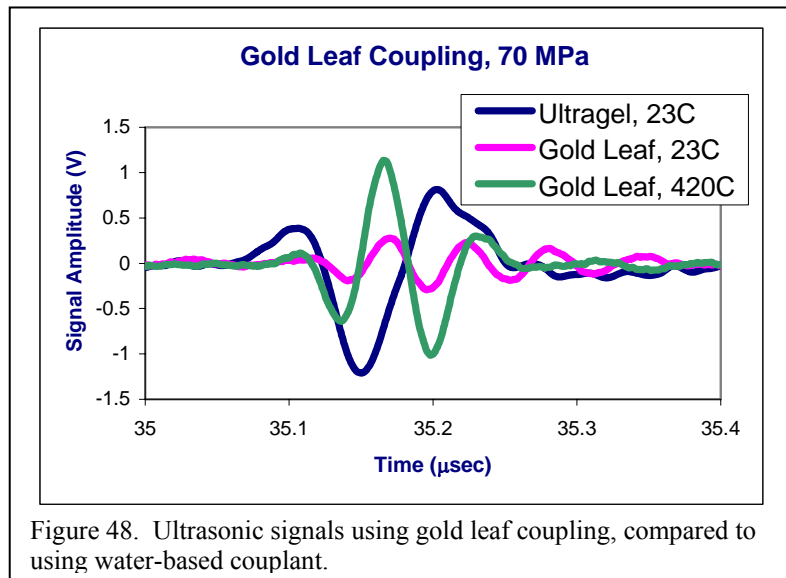
Figure 48. Ultrasonic signals using gold leaf coupling, compared to using water-based couplant.

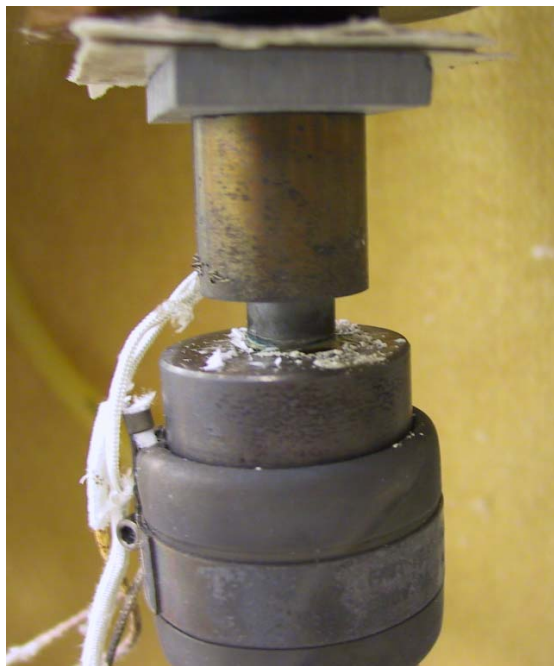
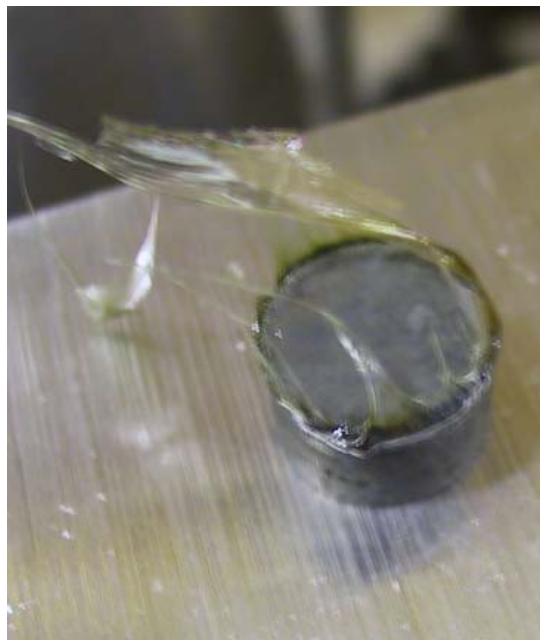
Figure 49. Glass couplant test setup prior to heating.

Figure 50. Glass couplant after test.

Testing was also performed using molten glass couplant. Figure 49 shows the glass powder (white) in the test fixture prior to heating; Figure 50 shows it on the AlN film after the test was completed. The AlN film was separated from the test block while the glass was still soft. The ultrasonic coupling within the appropriate temperature range was adequate, as shown in Figure 51, although this data was acquired at 10 dB greater gain and still has a lower amplitude than the earlier plots. The molten glass was found to be effective in only a narrow temperature range for

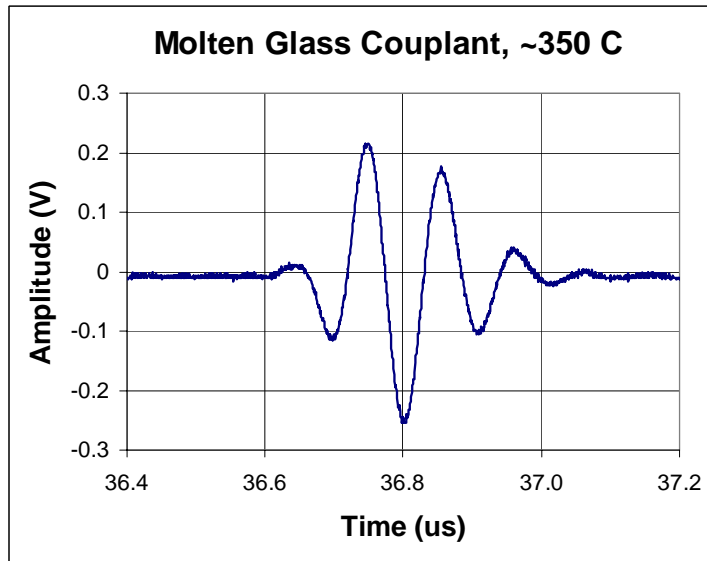
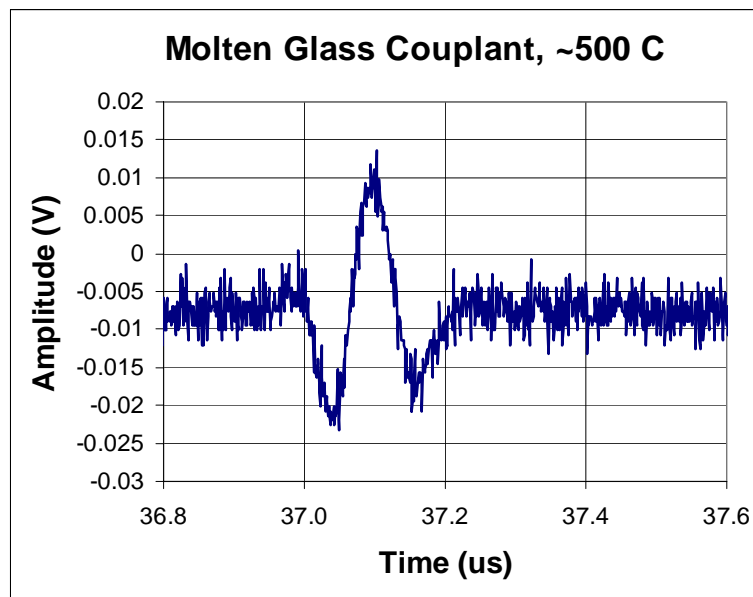
Figure 51. Glass-coupled ultrasonic signal.

Figure 52. Glass-coupled ultrasonic signal.

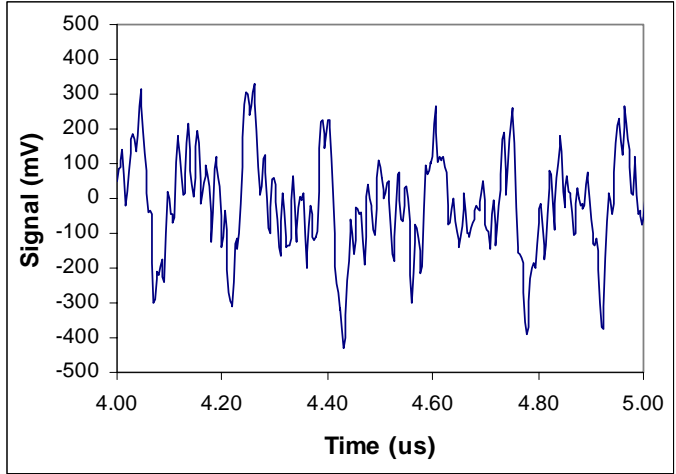
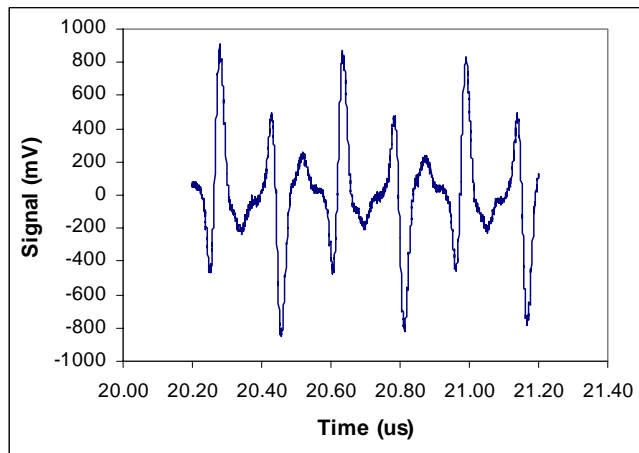
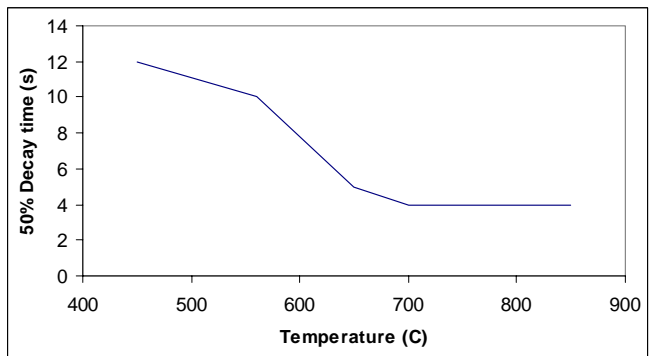
Figure 53. LGS crystal vibration at 150°C

Figure 54. LGS crystal vibration at 450°C

Figure 55. Increased damping with temperature

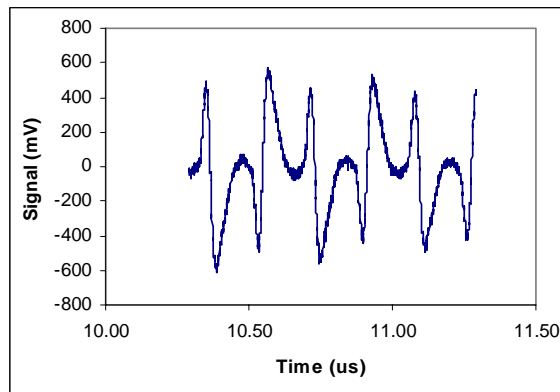
Figure 56. LGS crystal vibration at 850°C
