LAWRENCE
LIVERMORE
NATIONAL
LABORATORY

UCRL-TR-227786

Butt Joint Tool Status: ITER-US LLNL-NMARTOVETSKY-01312007

Re: Butt joint tool status: ITER-US-LLNL-NMARTOVETSKY-01312007

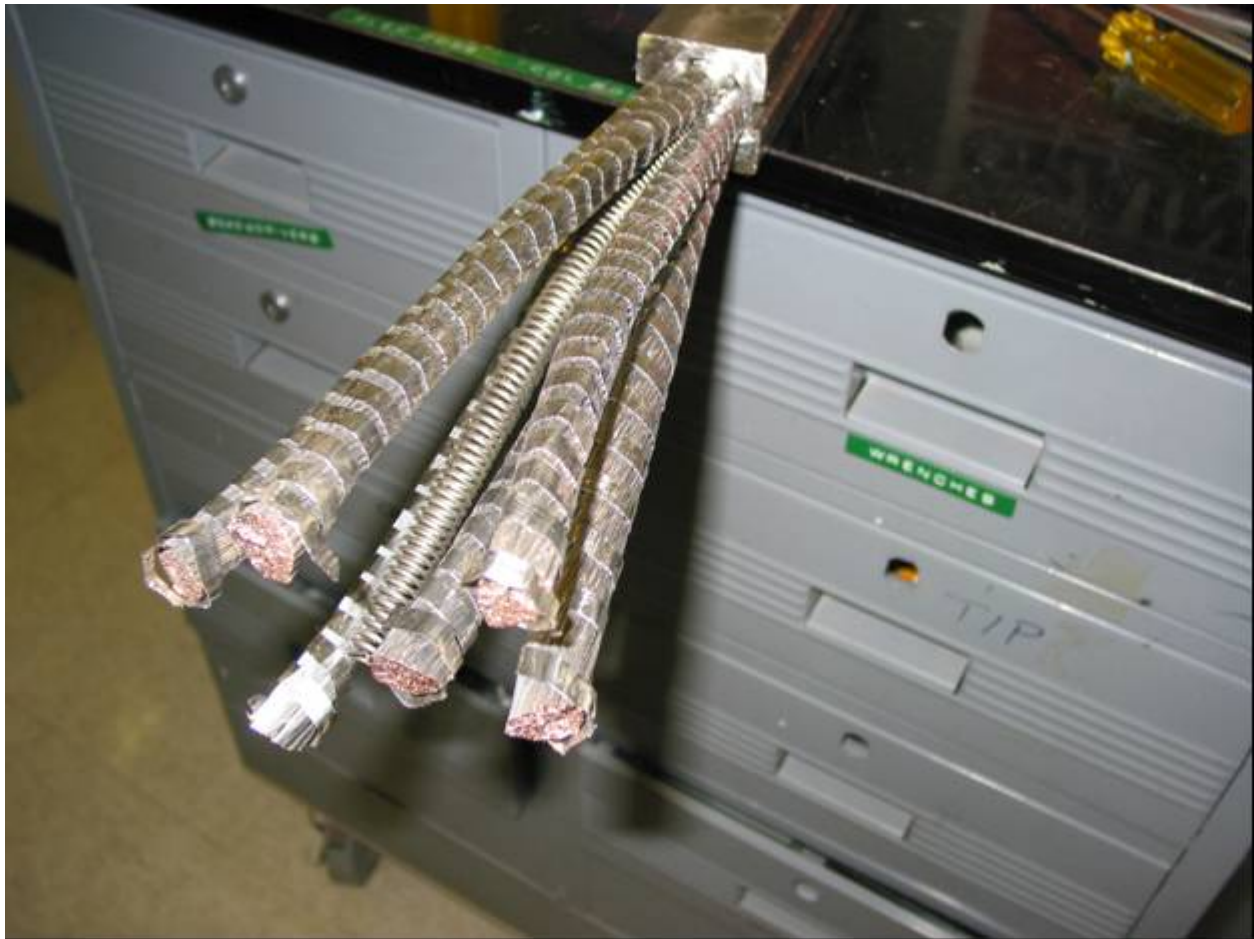
Fig. 4. The CS2 CICC after the jacket is stripped off and the outer wrapped is removed.

We followed the procedure given in the specs [5]. We stripped off the conduit from the portion of the cable we needed to work with, see fig. 4.

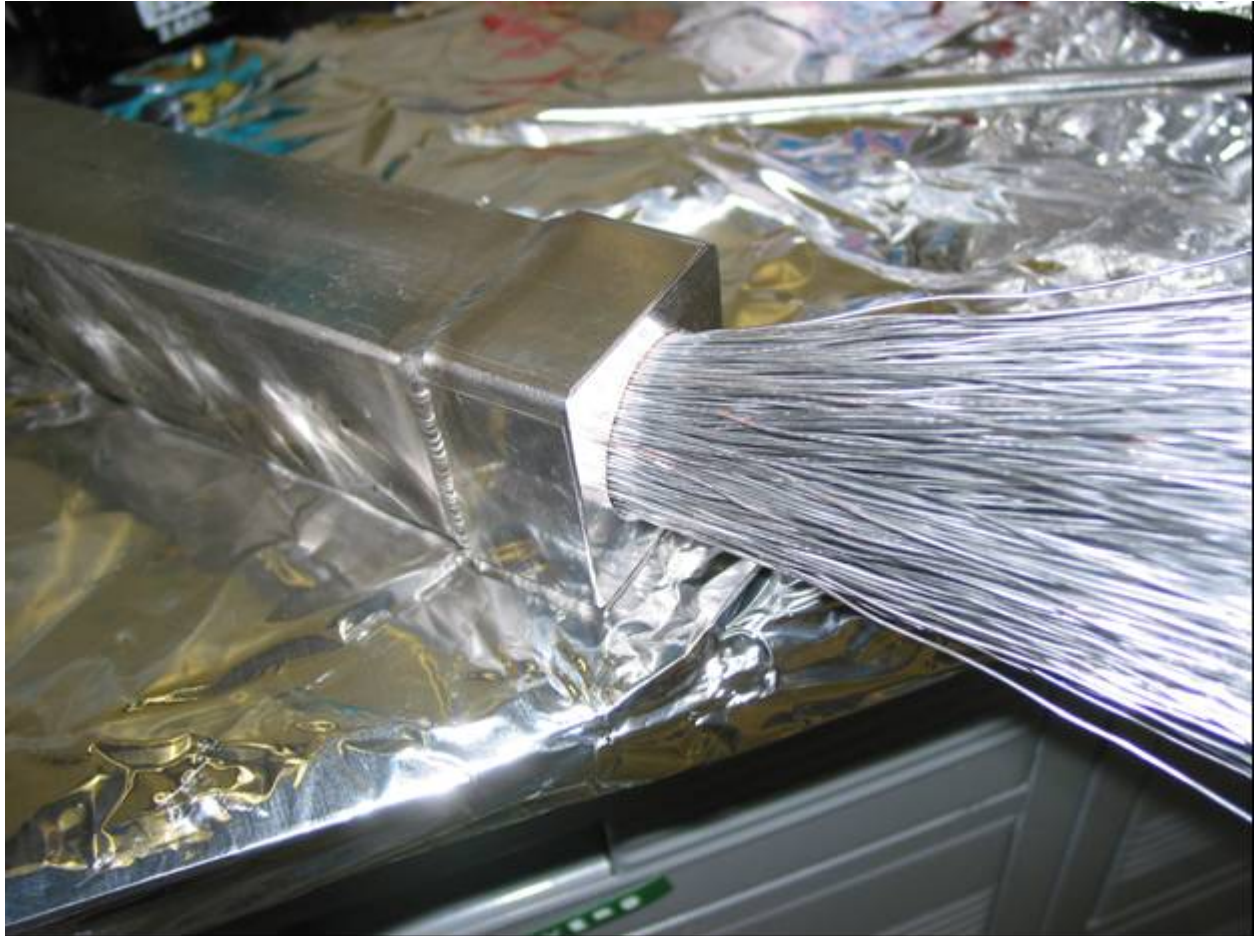
Fig. 6. Transition piece welded to the CS2 conductor.

The transition piece welded to the jacket is shown in Fig. 6.

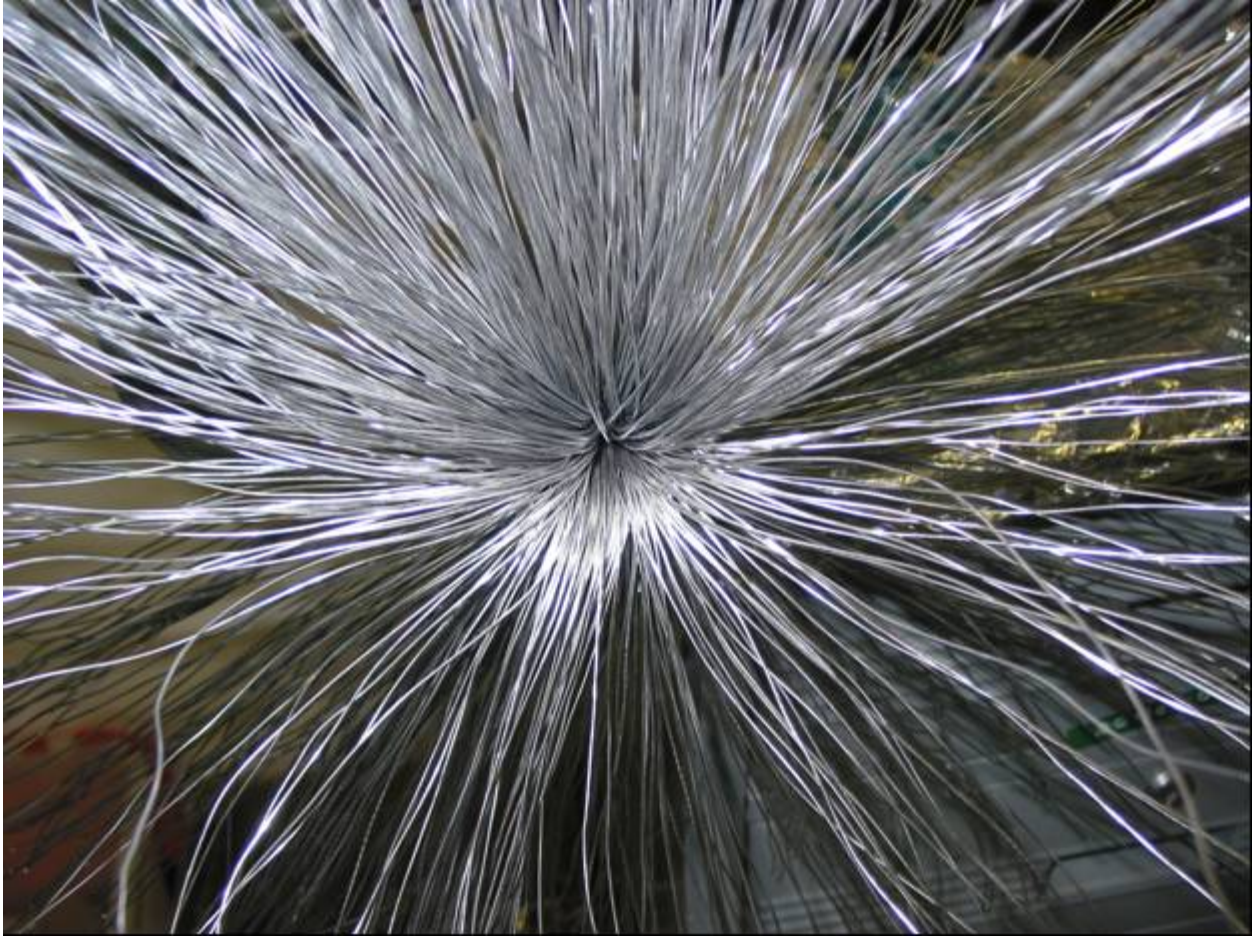
Fig. 7. Cable with the spread strands.

The next operation we did was inserting the internal flow distributor. For the conductor where we uncabled all the strands it took a while to find the location of the central hole to insert the flow distributor. Fig. 7 shows how the cable with fanned strands looks like.

Fig. 7 and 8 once again illustrate that undoing the cabling is not advisable.

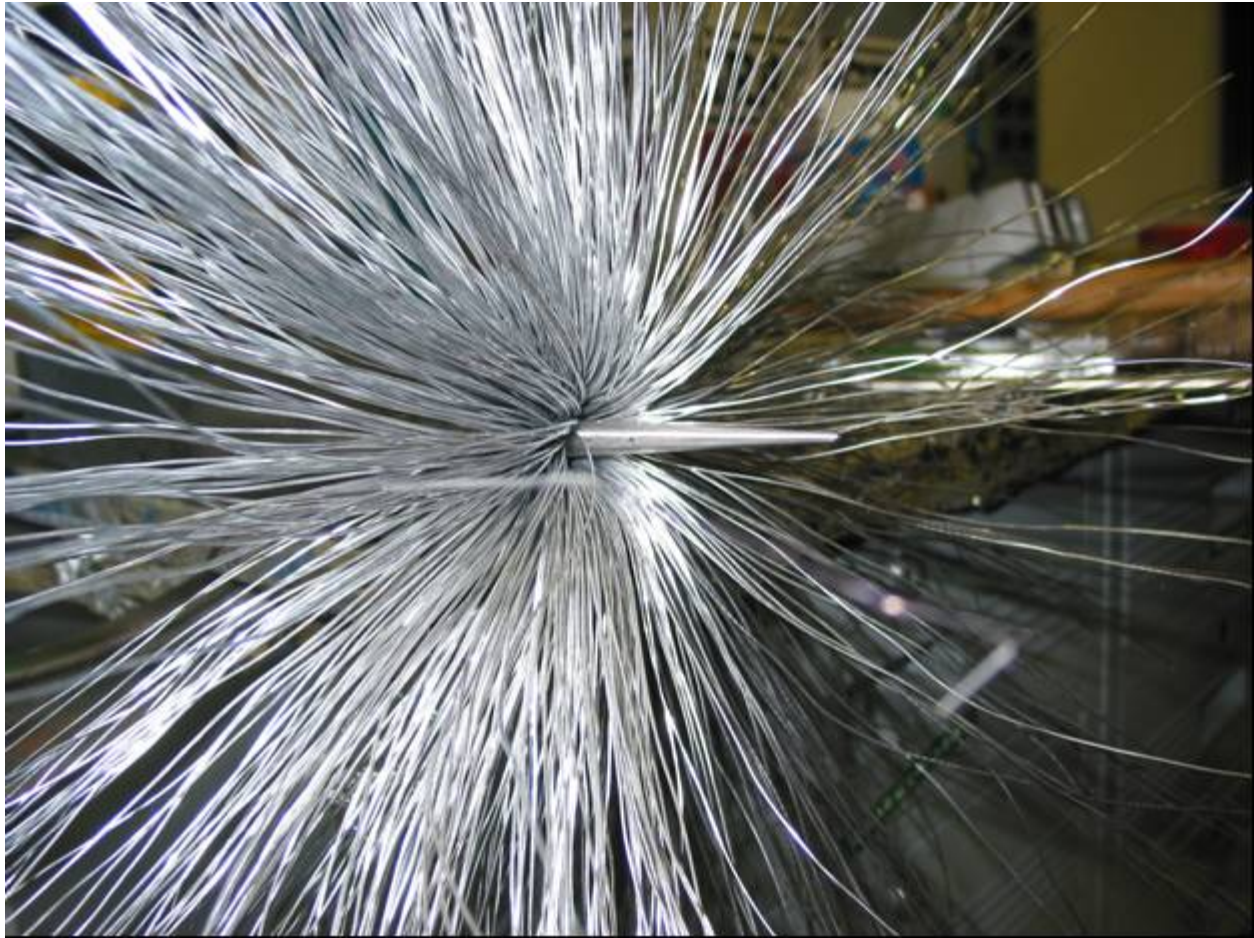
Fig. 8. Inner flow distributor inserted in the cable central channel.

Fig. 8 shows the flow distributor inserted.

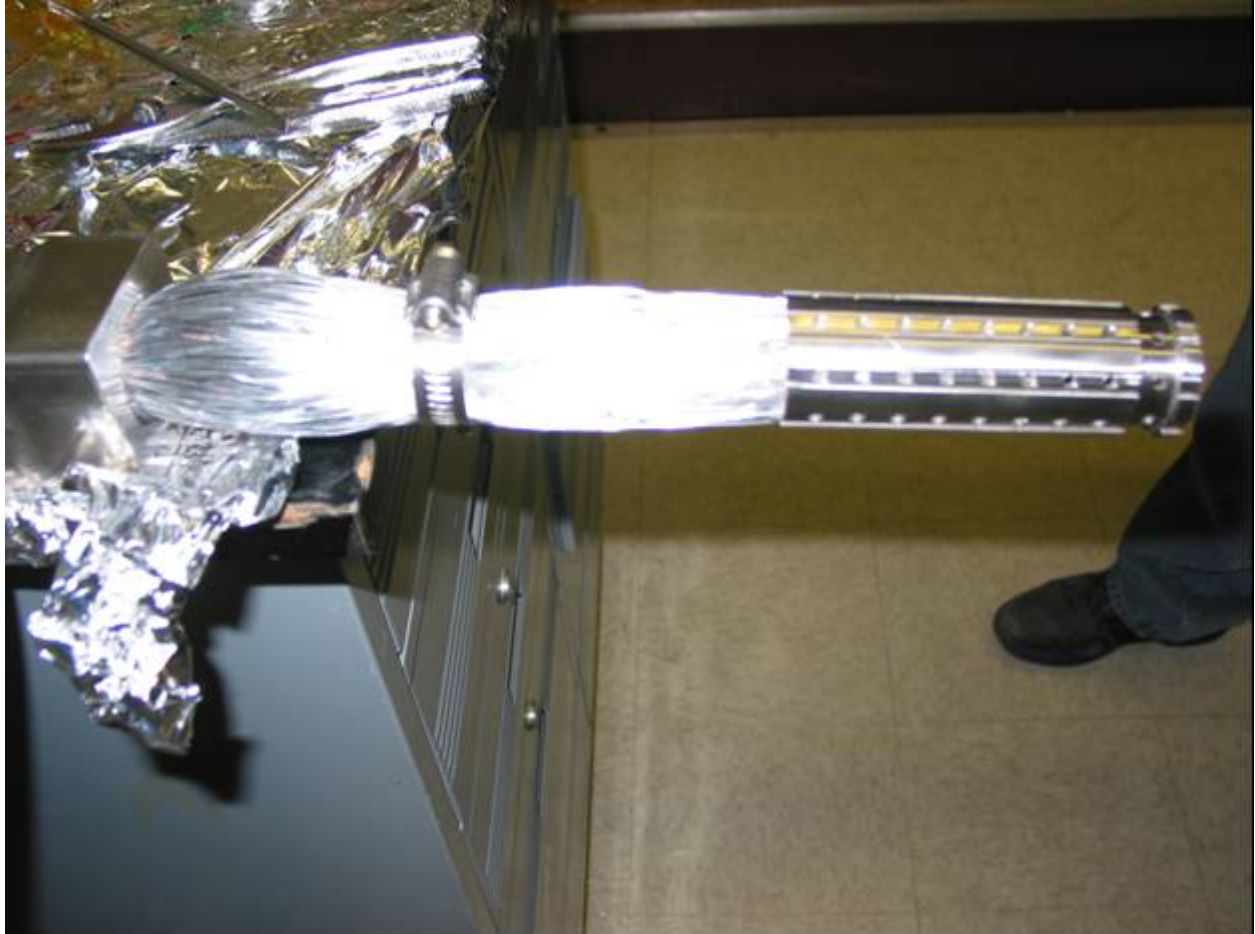
Fig. 9. The flow distributor is stuck on the cable and would not go.

This step did not go well at all. The flow distributor is made of 304 steel. The inner hole is conical and the outer diameter is constant, in other words the OD surface is cylindrical, with grooves and holes. The hope was that the slight tapping on the distributor will overcome friction.

That hope did not come true. The distributor did not want to go, see Fig. 9.

I decided to simplify the procedure by splitting the distributor in two halves and then put it on and compress it with the band clamps. It did not work – significant number of strands got caught and it was not humanely possible to squeeze it all without some strands caught in the crack. I ended up cutting more strands from the cable underneath the flow distributor. I left all the strands underneath the copper sleeve to preserve the compaction of the sleeve.

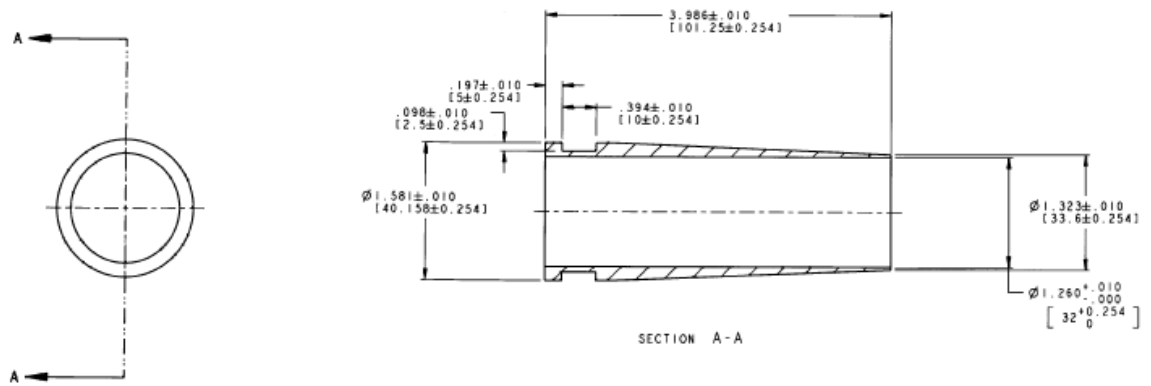
Fig. 9a. Modified flow distributor (has no holes and grooves to try for feasibility).

This is OK for the sample, but for the real conductor something needs to be changed. For the future trials I decided to modify the flow distributor. From now on I will use the flow distributors with the

inner diameter cylindrical and outer diameter conical and after I put it on I will compact it with my crimping tool. Due to my relocation this step will have to be demonstrated later.

The idea of a new flow distributor, without holes and grooves for simplicity is shown in Fig. 9a.

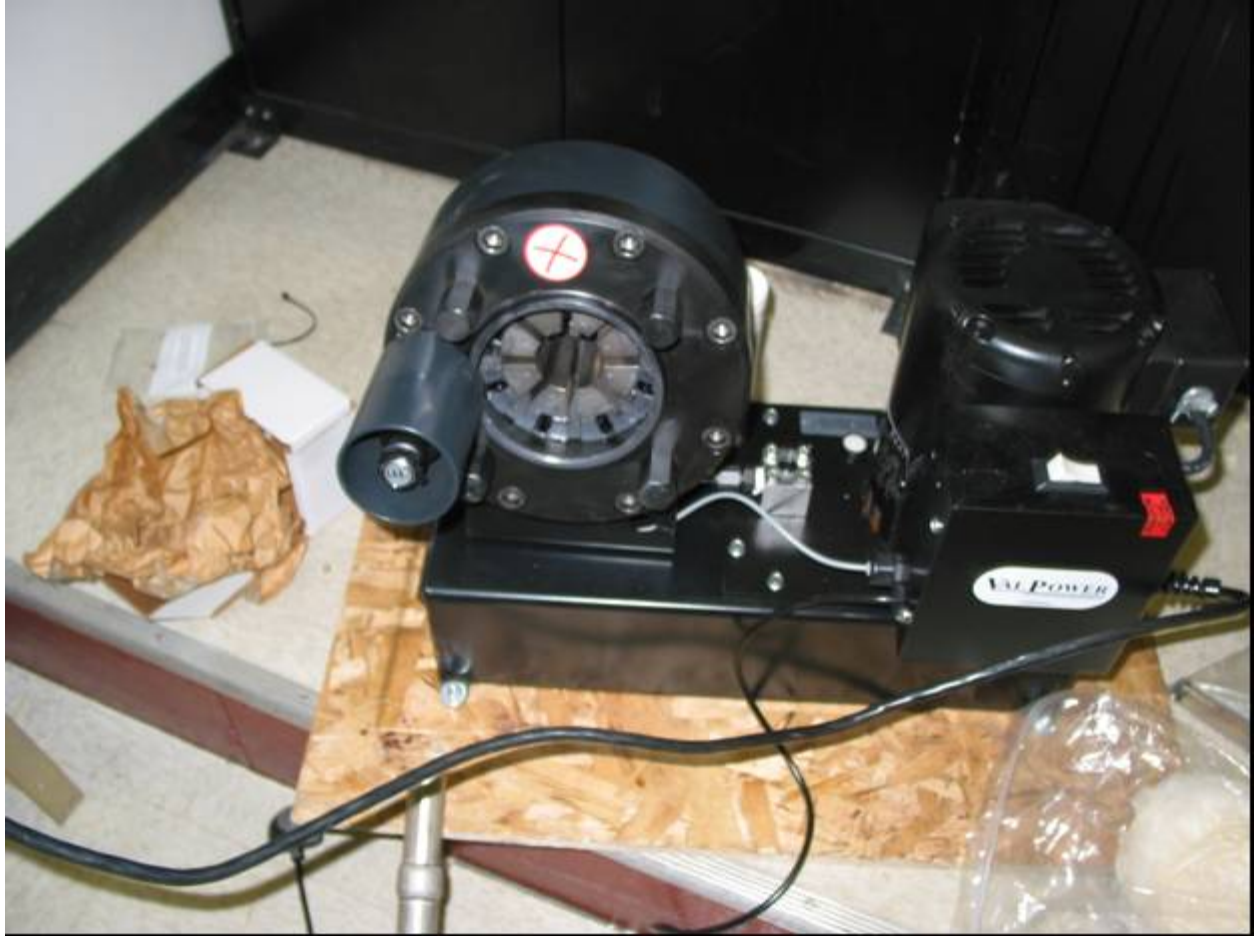
Fig. 10. Hydraulic crimper used for compacting the cable in the copper sleeve.

Compaction of the copper sleeve with the cable went smoothly. We used the crimper we bought for this purpose a year ago, shown in Fig. 10. The crimper is capable of applying of 140 t of force to compact the sleeve.

The final compaction of 31-31.1 mm was achieved by applying all 140 t of force of the die, which at the final squeeze was not fully closed, which illustrates that the compaction could not be increased with this tool. The cross section looks acceptable to me and at a glance corresponds to 5-8% required void.

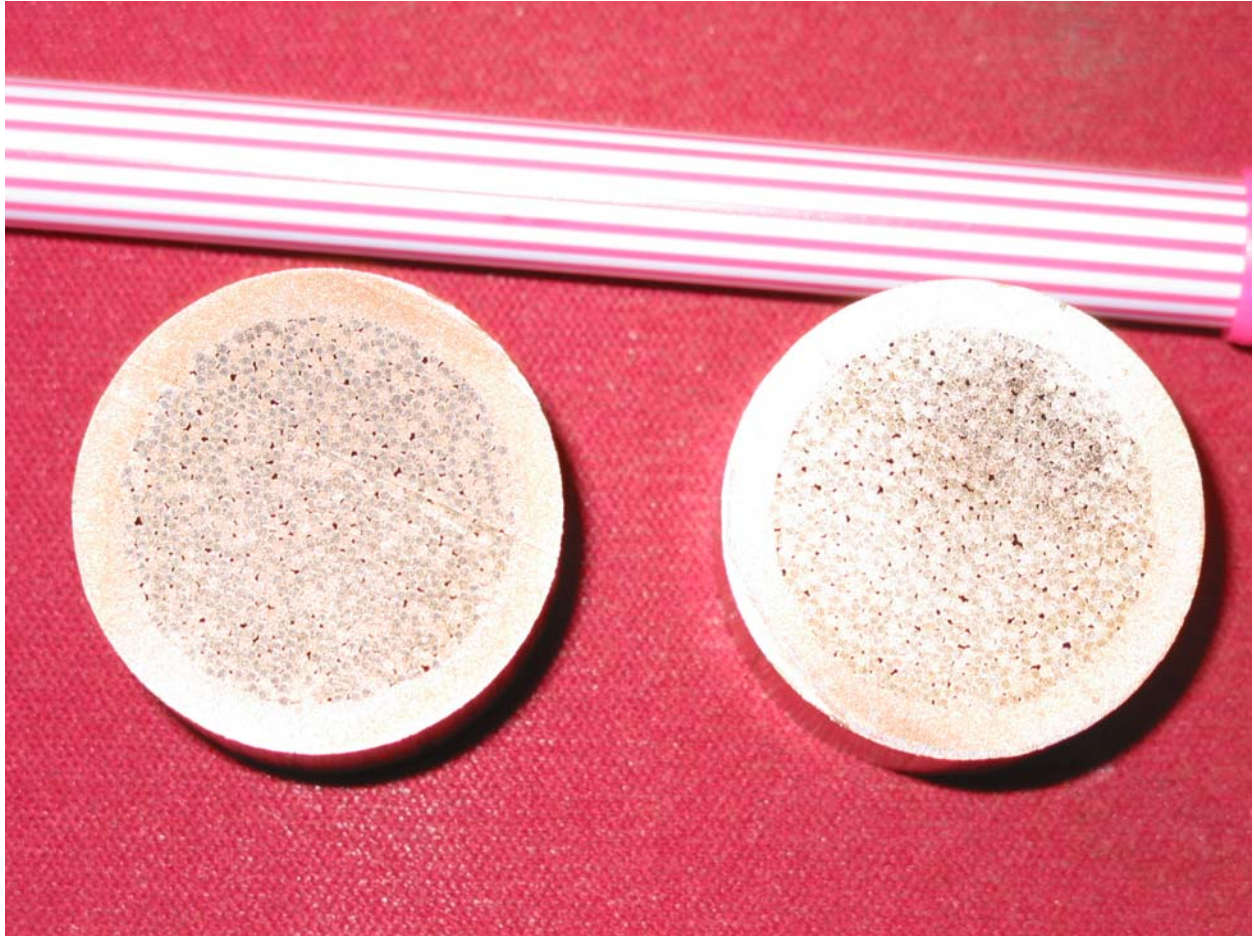
Fig. 11. Compacted and sliced cables in the copper sleeve.

I doubt that the void will get smaller with higher compaction force. Before it closes I'd imagine we'd see a great deal of deformation in the strands, which we would not like fearing breakage of the diffusion barrier and filaments deformation. The cross section of the compacted cable in the sleeve is shown in Fig. 11, which is intentionally a little overexposed to emphasize the voids.

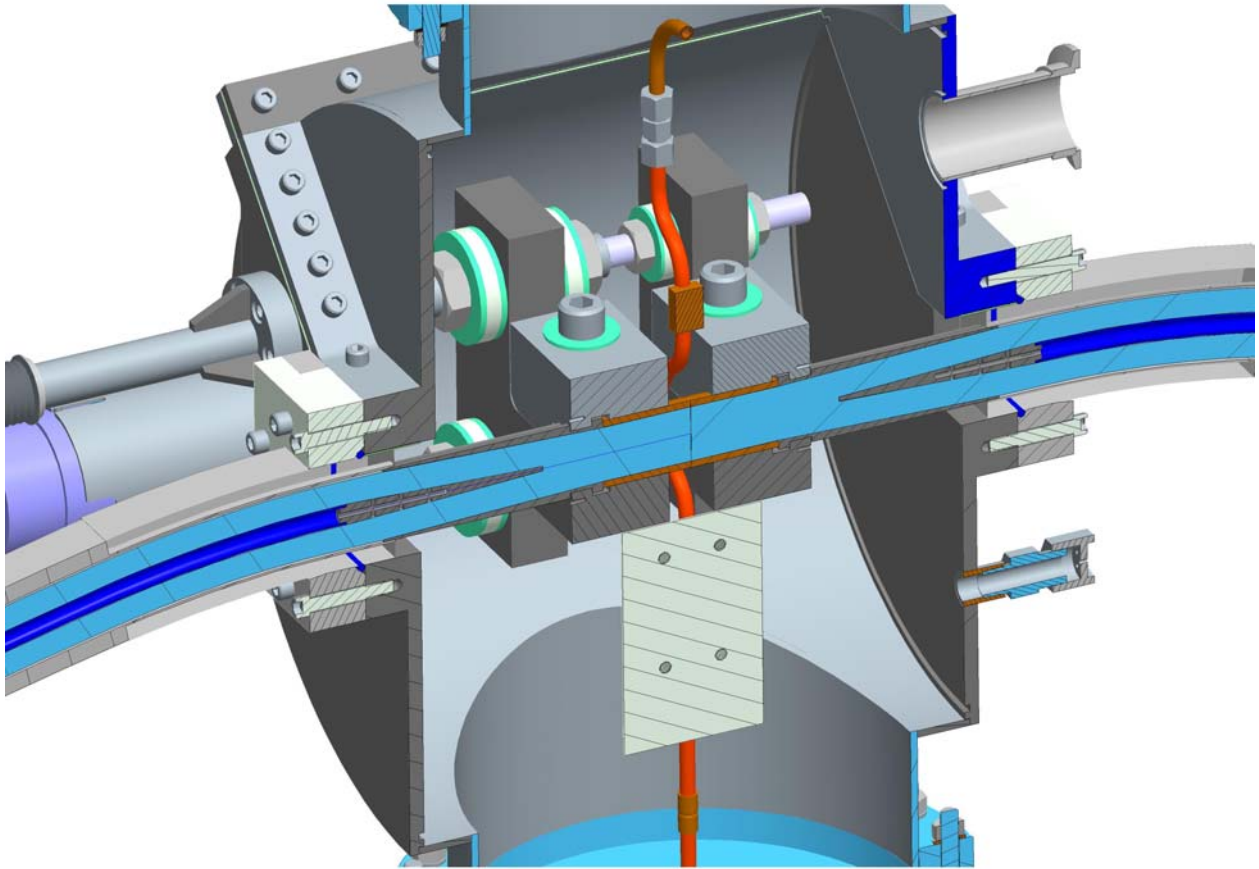
Fig. 12. Cross section of the vacuum chamber.

Principle schematic of the butt joint tool is shown in Fig. 12, which gives a CAD cross section of the tool with the conductors prepared for butt joining.

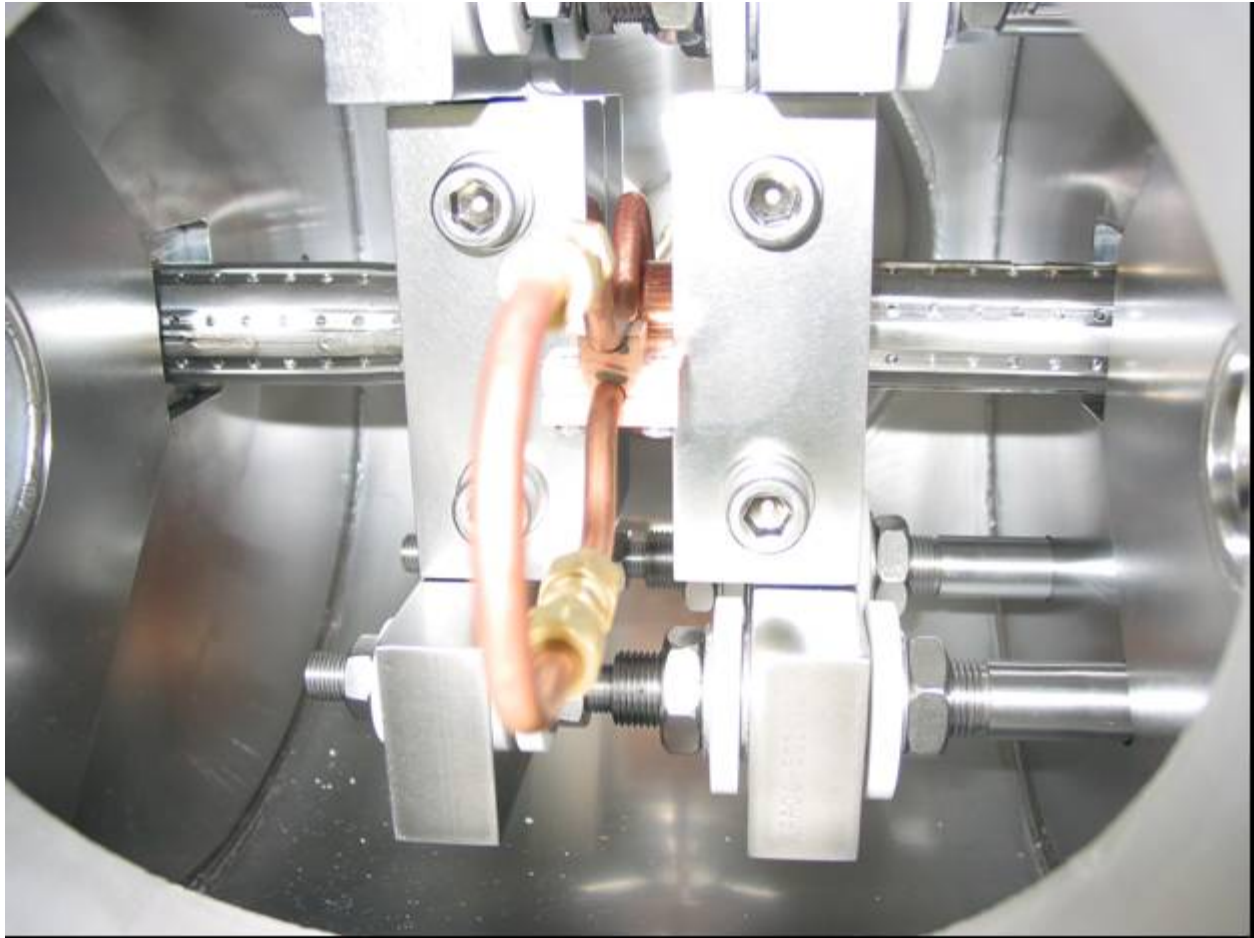
Fig. 13. Inside the butt joint tool.

Fig. 13 is a photograph of the inside of the vacuum chamber tool with the samples.

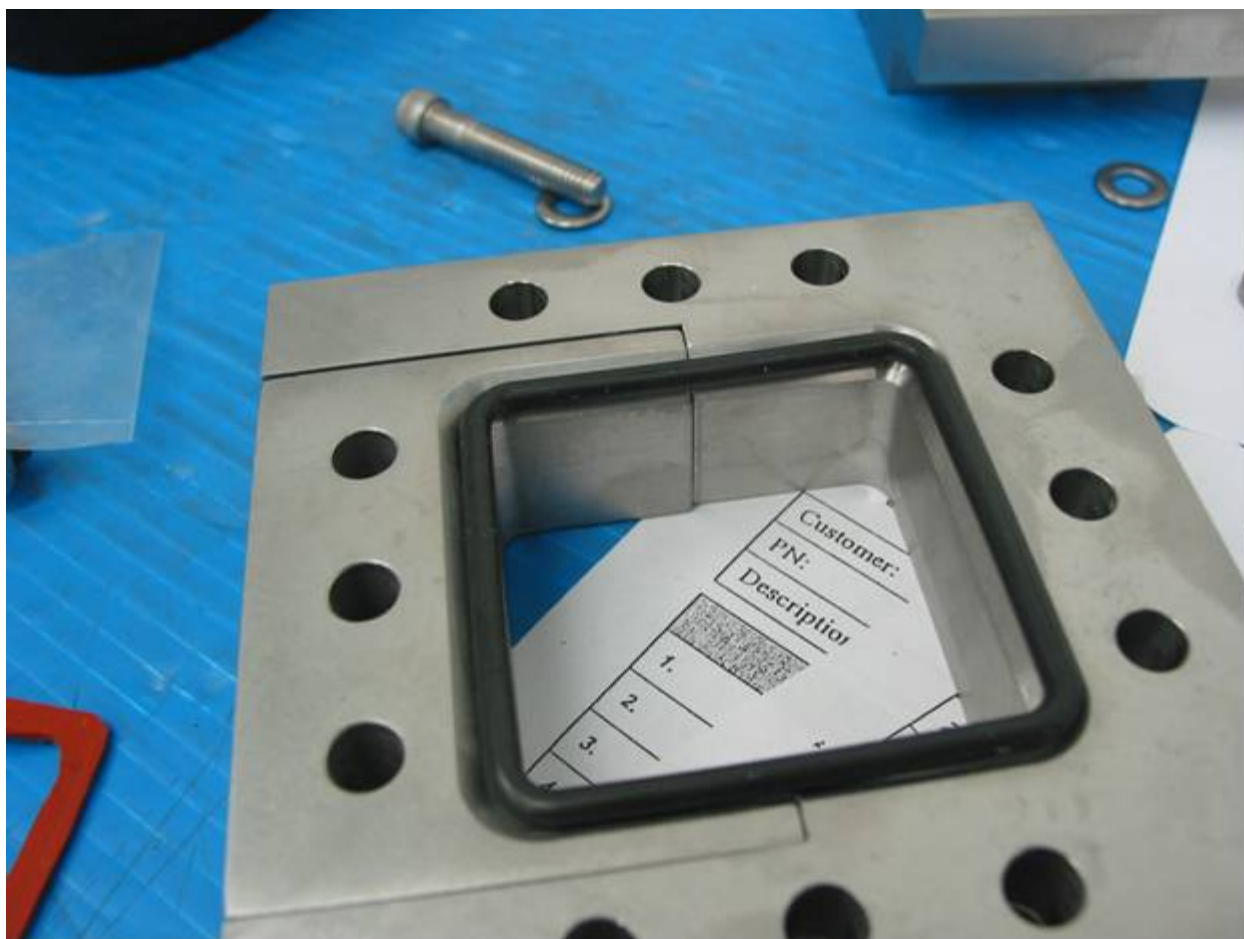
Fig. 14. The O-ring cross section is too small to seal around conductor.

First, the O-ring around the conductors leaked badly. A close look revealed that the O-ring cross section is too small, see Fig. 14.

To eliminate this problem we used a duct seal putty to seal the conductor. However it did not fix the problem. The pressure did not go under 500 mtorr, which was not even sufficient to turn on the mass spectrometer leak detector.

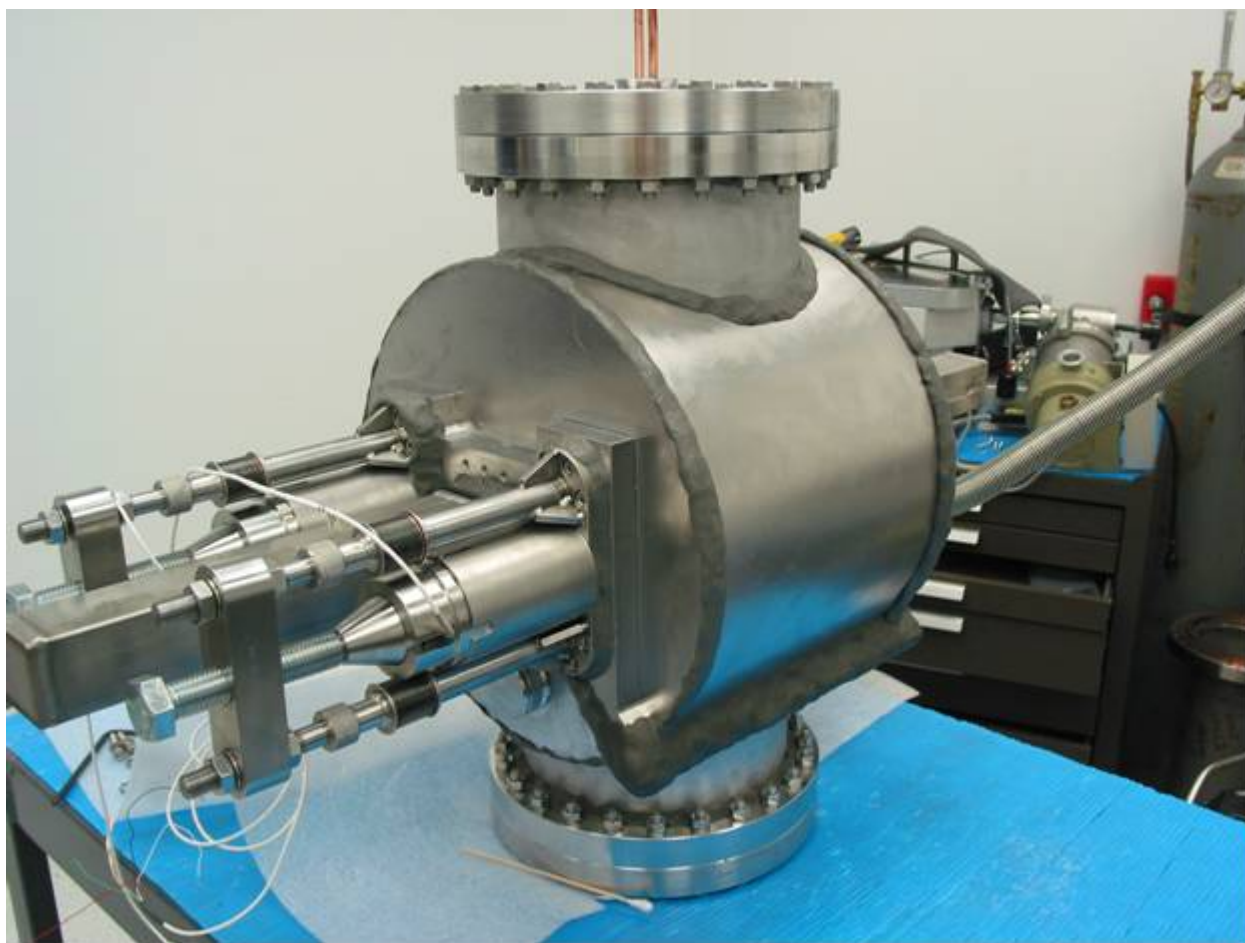
Fig. 15. The vessel with sealed seams.

We decided to use the duct putty to seal all the welds, cracks with O-rings, see Fig. 15. The vacuum was the same.

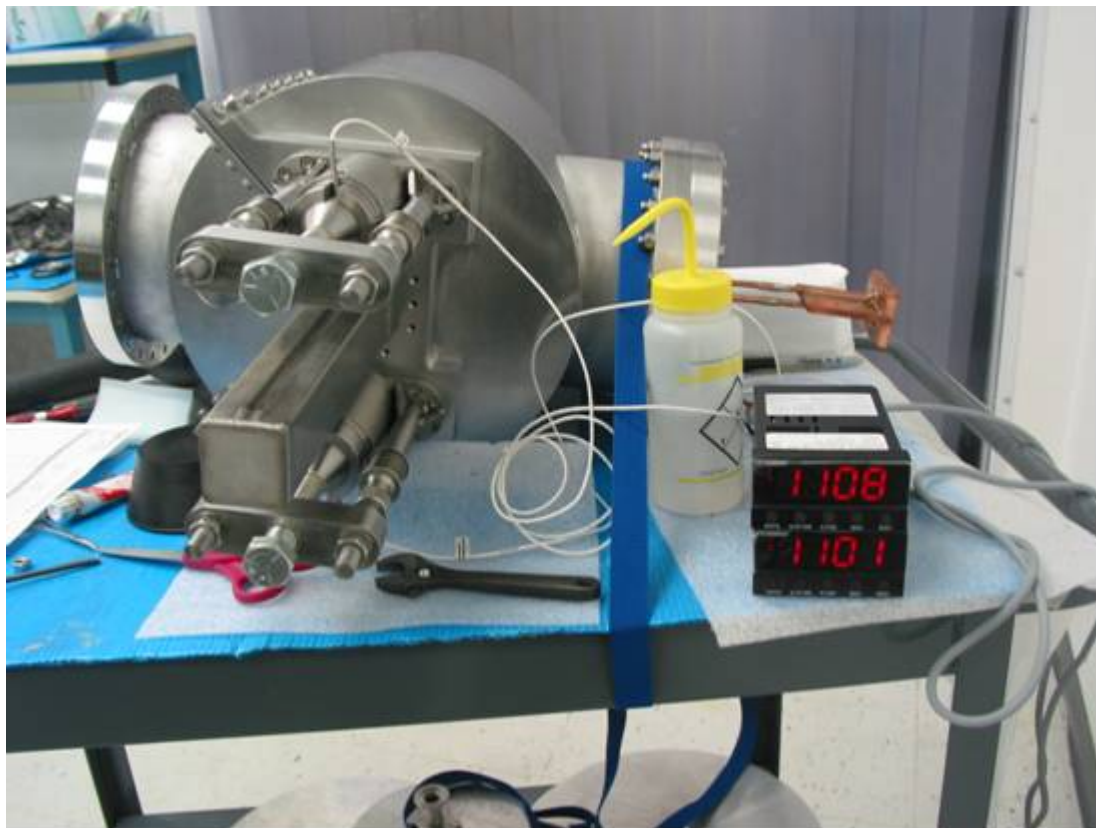
Fig. 16. Loading test, force on the interfaces is 2.2 tones, about 22 kN.

The load test was conducted to demonstrate that we can apply required force. At required 25 MPa and 31 mm OD, the required force is 17.4 kN or 1.77 metric tons of force.

We decided to go up to 2.2 tons, since we were applying force at RT, instead of 750 C which will be necessary during butt joining.

We put a copper foil 100 microns thick and a sheet of a pressure sensitive film in between the butts of the samples to monitor quality of the contact.

We successfully applied 2.2 force (see Fig. 16) which shows readings of the load cell indicators.

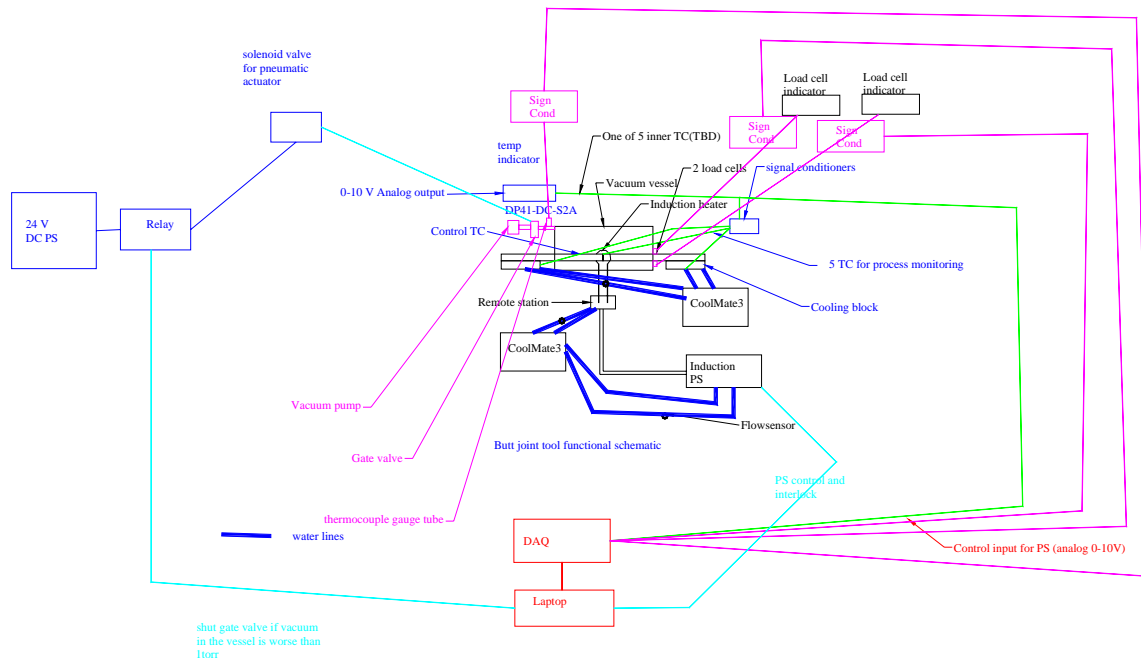
Fig. 17. Functional diagram.

A functional schematic of the butt joint tool is shown in fig. 17.
