Tonopah Test Range

Environmental Restoration Corrective Action Sites

Location of Use Restrictions and Post-Closure Inspection Sites

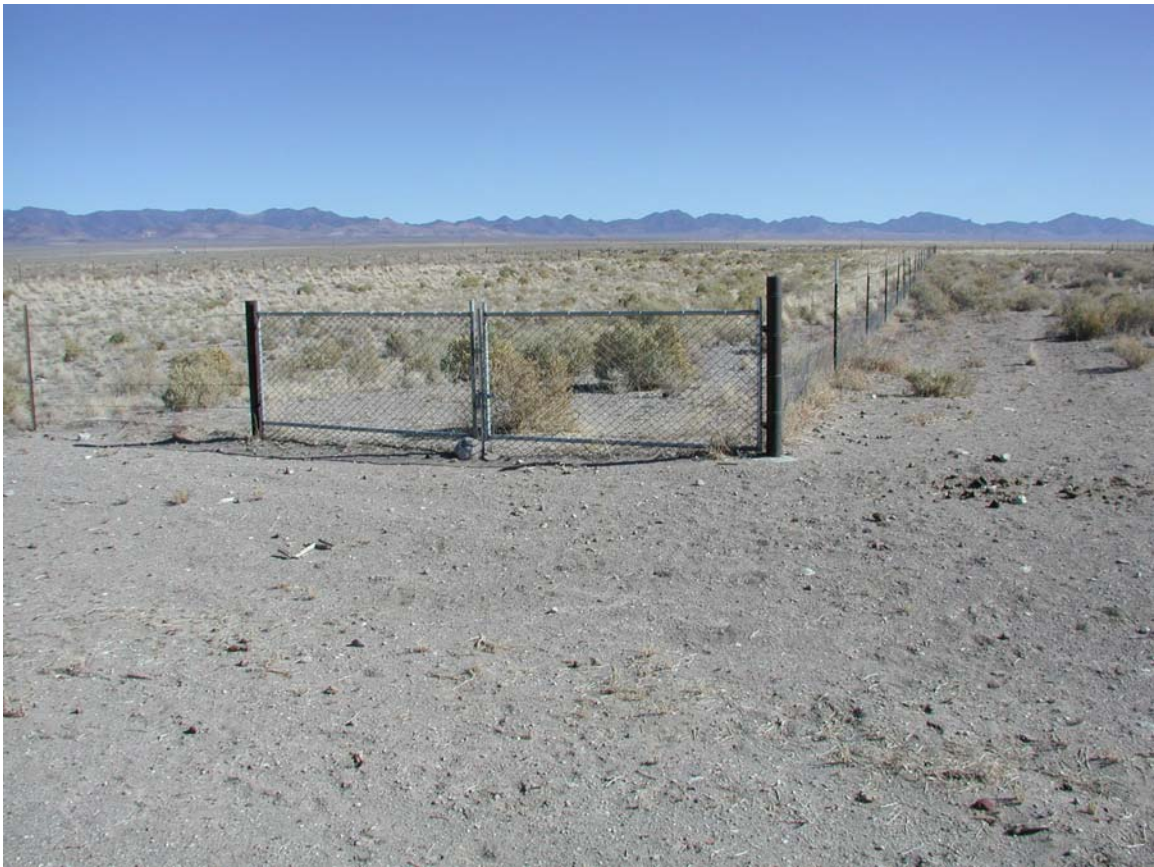
CAU 400 CAS TA-19-001-05PT (Five Points Landfill)

CAS TA-19-001-05PT (Five Points Landfill) is located approximately 1.2 miles north of Five Points Intersection along Perimeter Road. Ordnance debris was removed from this site and the area was graded, contoured, and revegetated. The area is currently fenced until vegetation can be documented as being substantially established. Fencing will be removed after vegetation is documented as being established and approval has been received from the Nevada Department of Environmental Protection. The site was clean closed and the only post-closure requirement is for reestablishment of vegetation at the site.

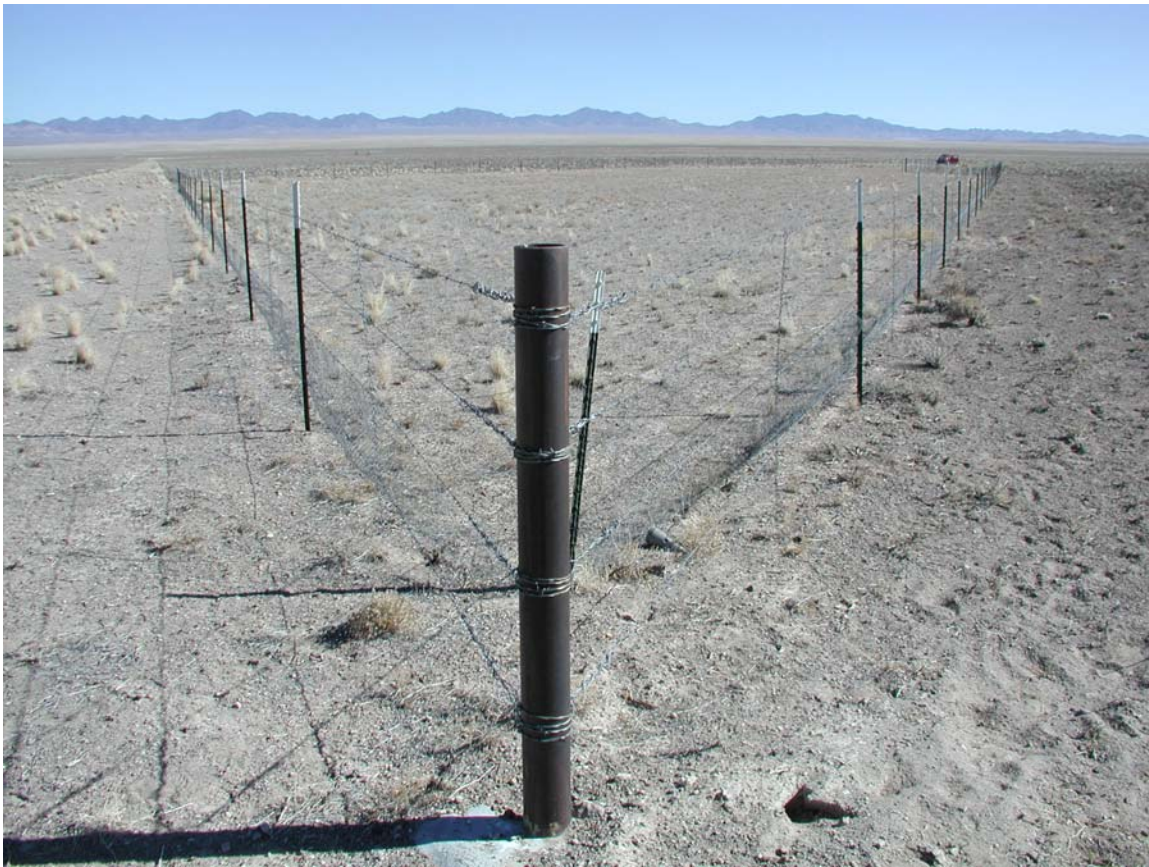
CAU 400 CAS TA-55-001-TAB2 (Bomblet Pit)

CAS TA-55-001-TAB2 (Bomblet Pit) is located approximately one mile northwest of Bunker 2 Road. The Bomblet Pit and five associated excavations were used for the disposal of debris from an antipersonnel and antivehicular bomblet (or cluster bomb unit) test at TTR. Ordnance debris was removed from the excavations and the areas were backfilled, graded, and revegetated. The area is currently fenced until vegetation can be documented as being substantially established. Fencing will be removed after vegetation is documented as being established and approval has been received from the Nevada Department of Environmental Protection. The site was clean closed and the only post-closure requirement is for reestablishment of vegetation at the site.

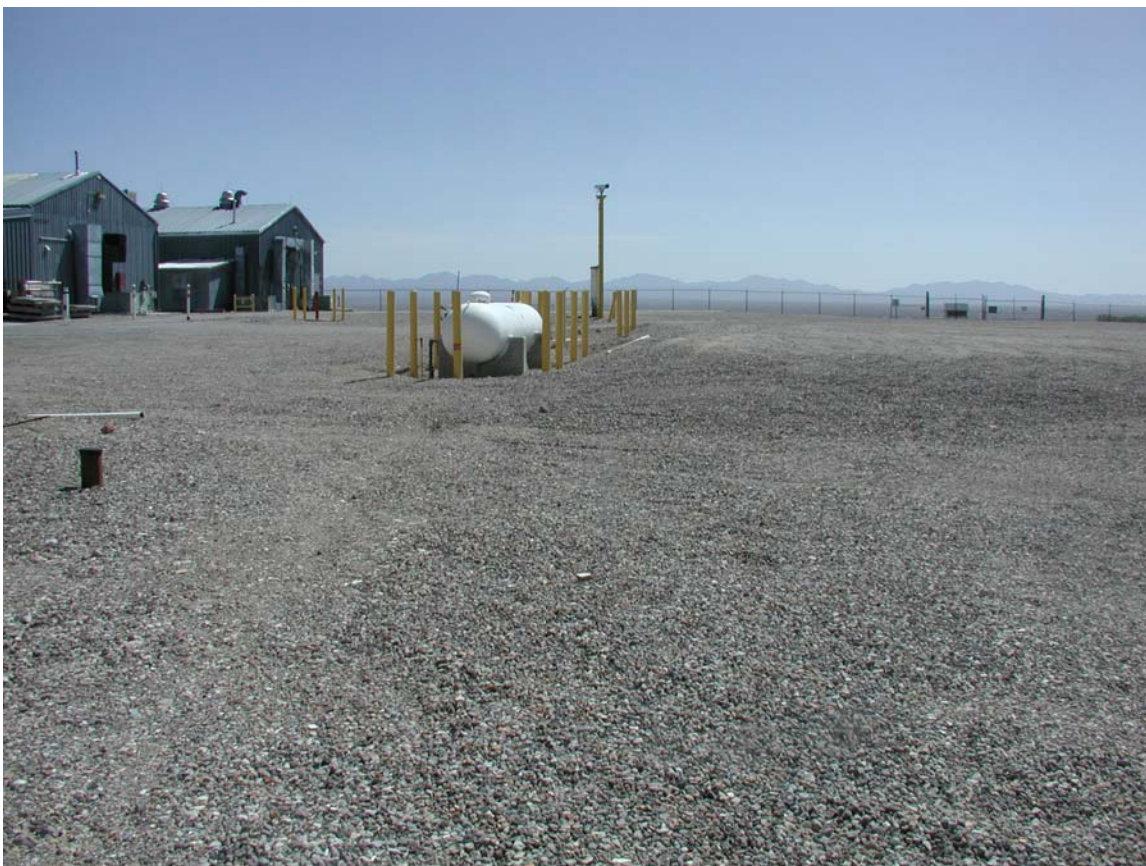
Vicinity of former CAU 403 Area 3 Second Gas Station

Hydrocarbon-impacted soil above the action level of 100 milligrams per kilogram (mg/kg) was closed in place at this site.

CAS 03-02-004-0360 (Second Gas Station) is located within the TTR Area 3 compound. An underground storage tank was removed from this site and hydrocarbon-impacted soil was closed in place because the contaminated soil extended under adjacent building foundations.

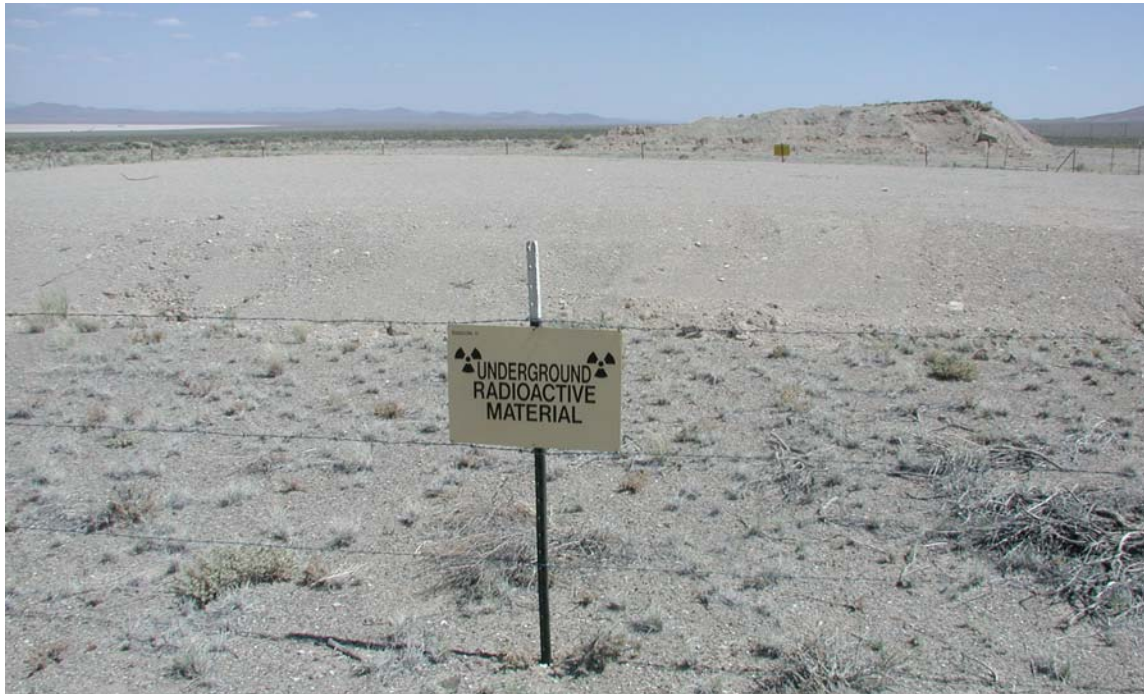
CAU 407: Roller Coaster RadSafe Area

During the removal of radioactive-impacted soil from this CAS, several pieces of concrete were removed which were determined to be transuranic waste. The waste was removed and disposed offsite. The remaining contamination was closed in place.

An engineered cover was constructed over the area containing radioactive-impacted debris and soil and the area was fenced and posted as an “Underground Radioactive Material” area. The CAS has a land-use restriction and is inspected annually to ensure the engineered cover, postings, and fencing have not been compromised.

CAS TA-23-001-TARC (Roller Coaster RadSafe Area) is located at the intersection of Main Road South and Brownes Lake Road.

The CAS TA-23-001-TARC (Roller Coaster RadSafe Area) was used during Operation Roller Coaster in 1963 to decontaminate vehicles, equipment, and personnel from the Clean Slate tests.

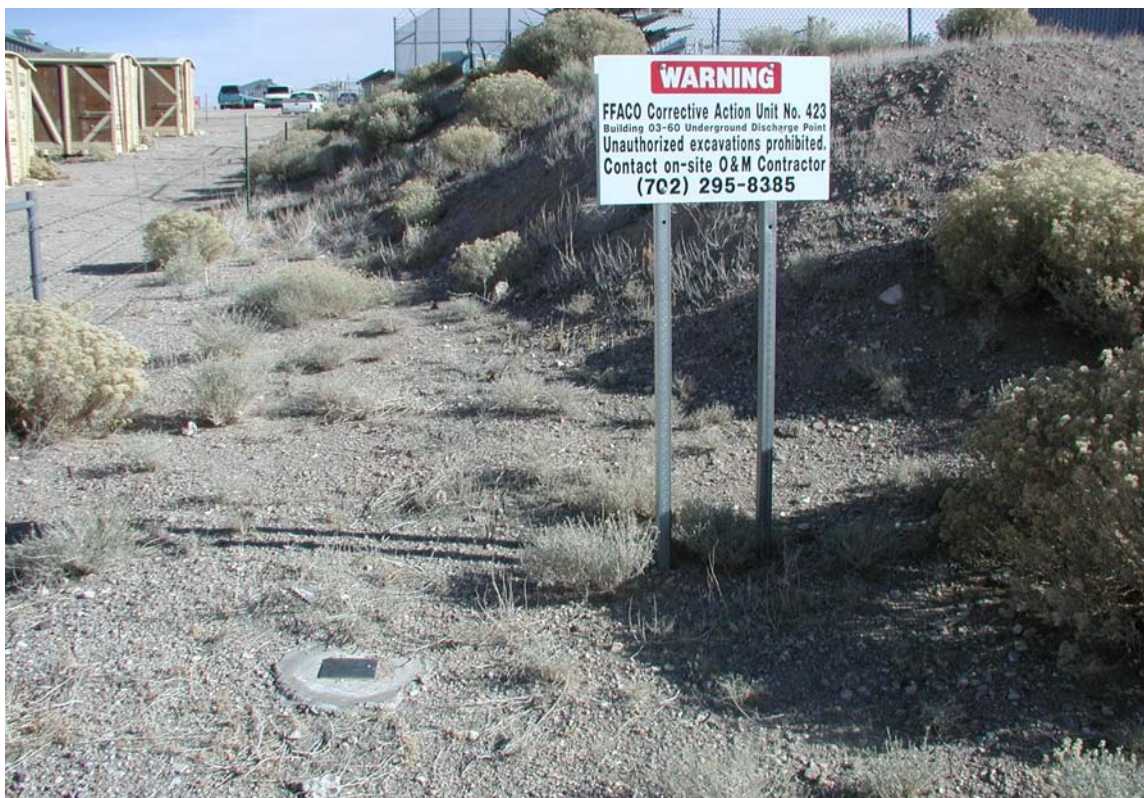
CAU 423 CAS 03-02-002-0308 (Underground Discharge Point)

Hydrocarbon-impacted piping and waste within an underground discharge point are present at this site.

Use restrictions have been implemented for the piping and underground discharge point. The use restriction is marked by a posting at the underground discharge point. The land-use restriction is inspected annually to ensure the area has not been compromised.

CAS 03-02-002-0308 (Underground Discharge Point) consists of the underground discharge point and associated discharge piping extending from Building 03-60 (Auto Maintenance Shop) in Area 3. The piping carried waste oil and other shop products to the underground discharge point. The underground discharge point consists of a buried corrugated metal culvert pipe that extends to a depth of approximately 20 feet below ground surface.

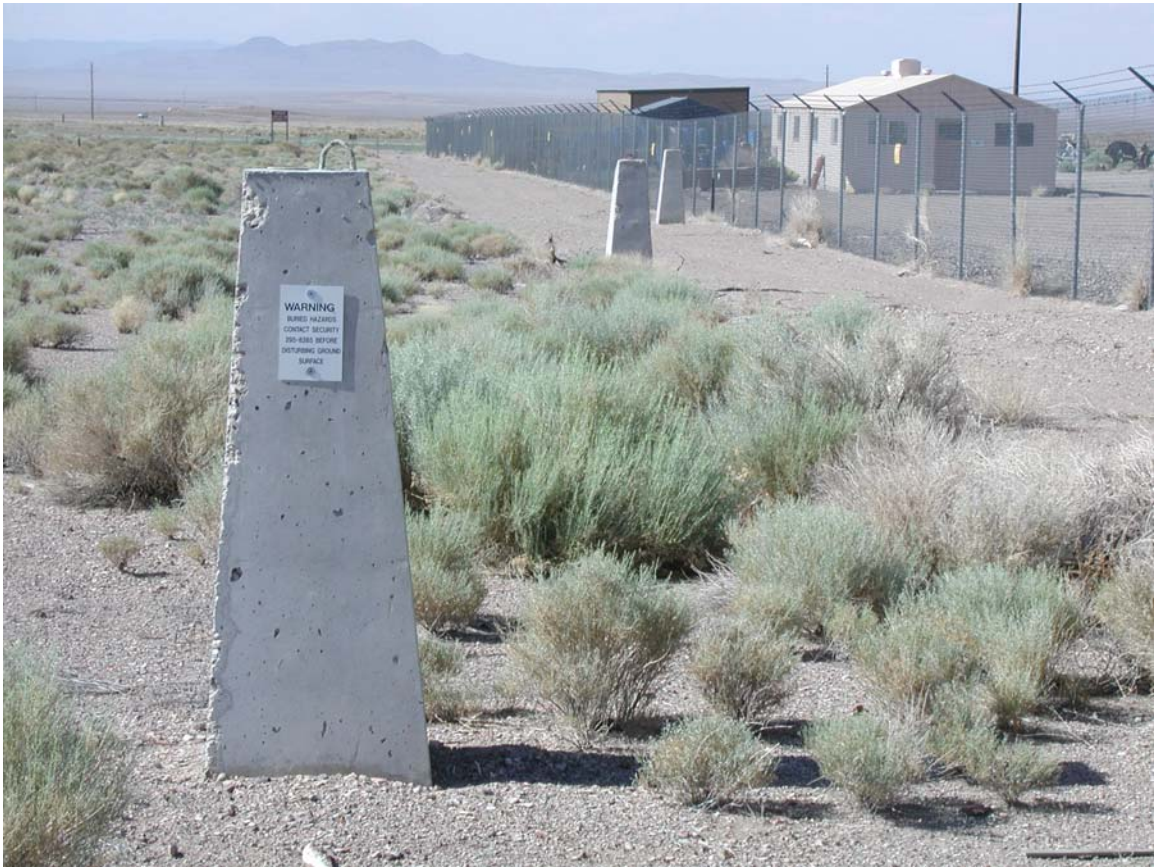
CAU 424 Land-Use Restriction Surface Monuments

All CASs have land-use restrictions and are marked by above-ground concrete monuments and signs indicating the presence of buried waste.

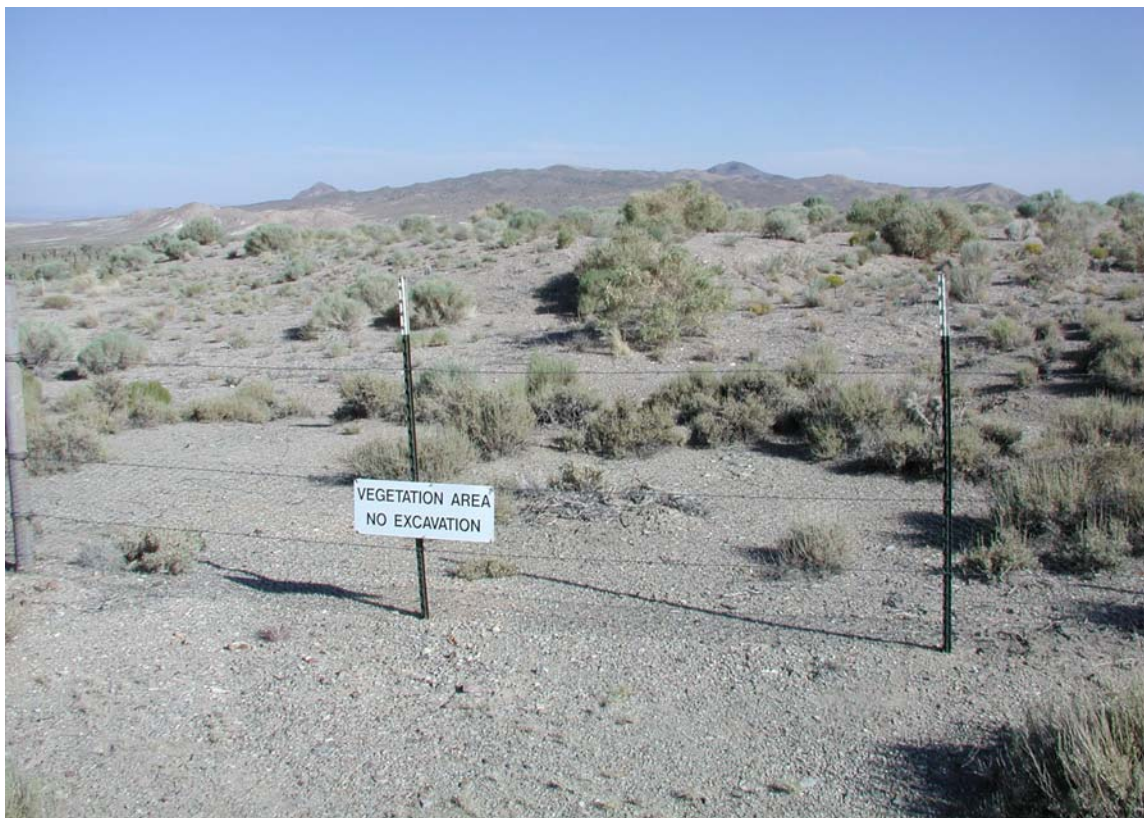
CAU 426 CAS RG-08-001-RGCS Cover and Fencing

Sanitary waste was the only material confirmed to be present within the waste trenches during the characterization activities. Investigation activities confirmed the presence of wood, glass, metal, animal bone fragments, and paint chips.

The waste trenches are covered by an engineered cover and the site is fenced.

CAU 426 consists of one CAS (RG-08-001-RGCS) comprised of four waste trenches located at Cactus Spring. The trenches were excavated to receive solid waste generated in support of Operation Roller Coaster, primarily the Double Tracks Test in 1963. The Double Tracks Test involved the use of live animals to assess the biological hazards associated with the non-nuclear detonation of plutonium-containing devices.

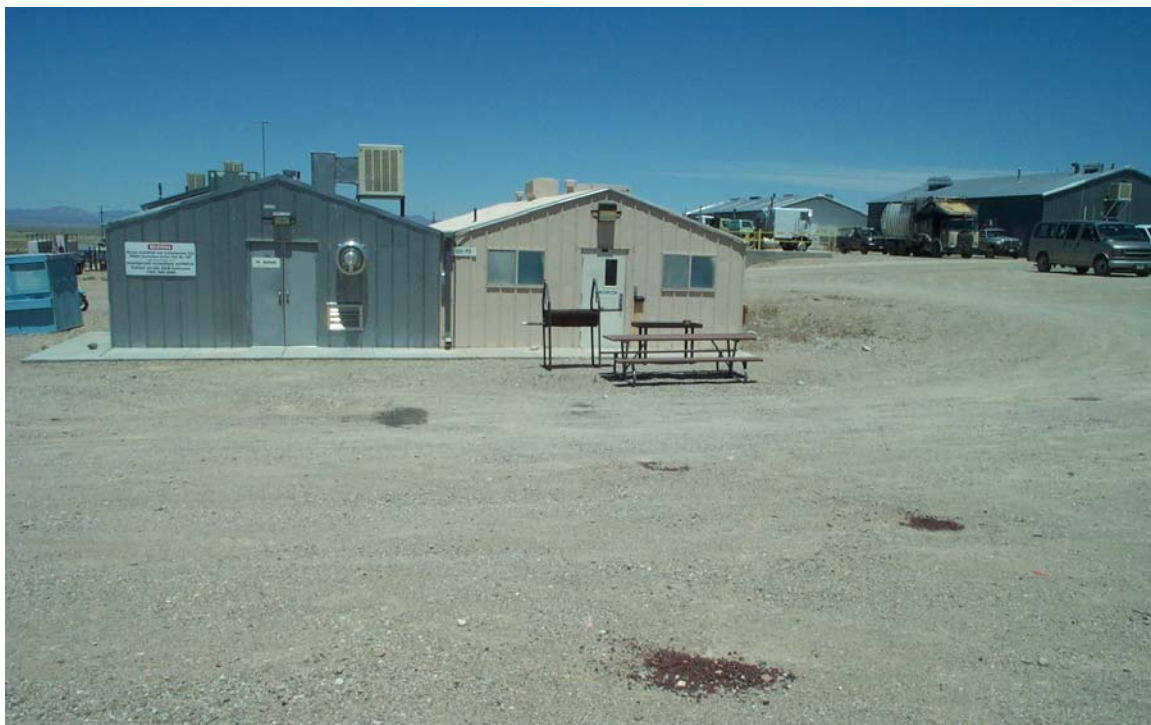
CAU 427 Septic System At-Grade Monuments

Leachfields and septic tanks are marked by at-grade monuments and are covered by red rock to aid in location during post-closure site inspections. The CAU is inspected annually to document the integrity of the site.

CAU 427 CASs are located within the Area 3 compound. The septic waste systems associated with CAS 03-05-002-SW02 and CAS 03-05-002-SW06 were installed to receive sanitary waste and industrial liquid waste generated from site maintenance and other daily operations conducted at the Area 3 compound from approximately 1960 through 1990.

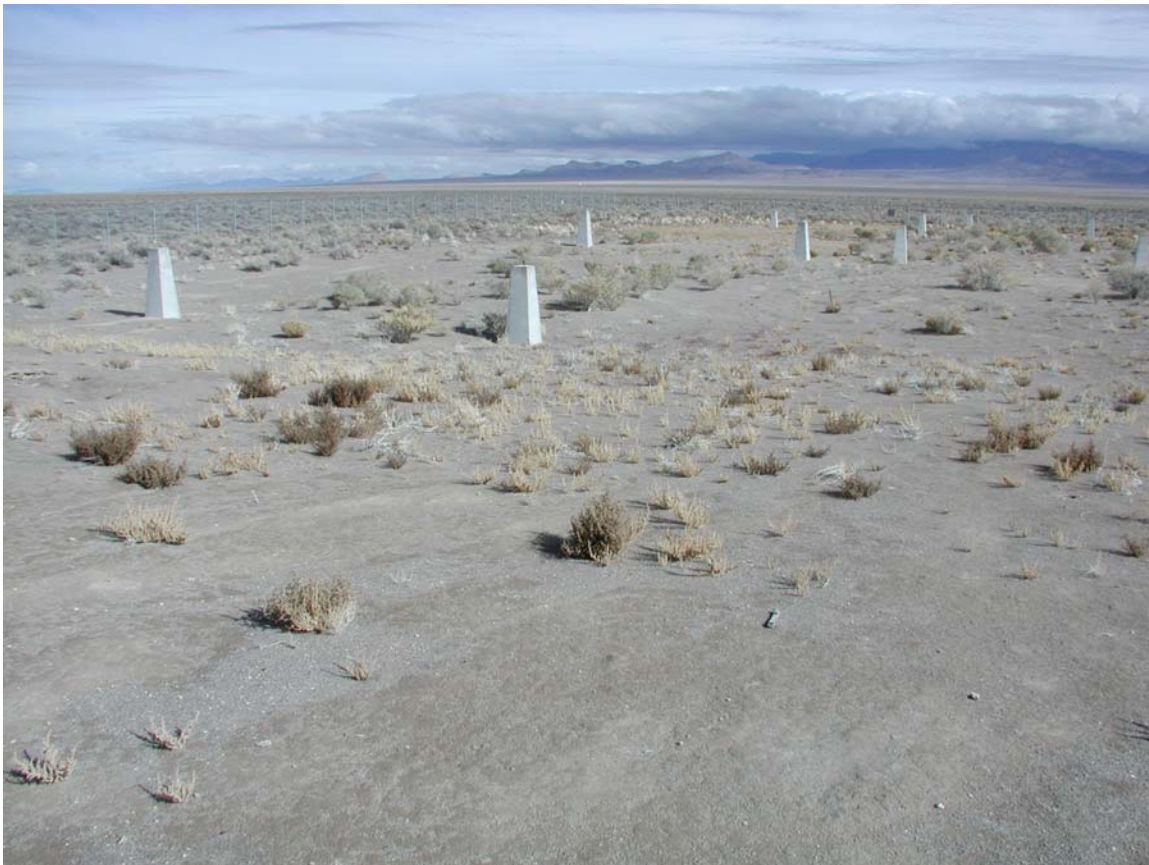
CAU 453 CAS 09-55-001-0952 Landfill Monuments and Fencing

The Area 9 UXO landfill (CAS 09-55-001-0952) is closed with land-use restrictions and is fenced. The landfill cells are marked by above-ground concrete monuments. The CAU is inspected annually to document the integrity of the site.

CAU 453 consists of CAS 09-55-001-0952, which is comprised of three waste cells located north of the Area 9 compound. The landfill cells were active from the early 1960s through 1993, and received waste generated from daily operations at Area 9 and from range clean up of weapons testing debris. The buried contents of the landfill cells were not investigated due to the potential of live UXO.

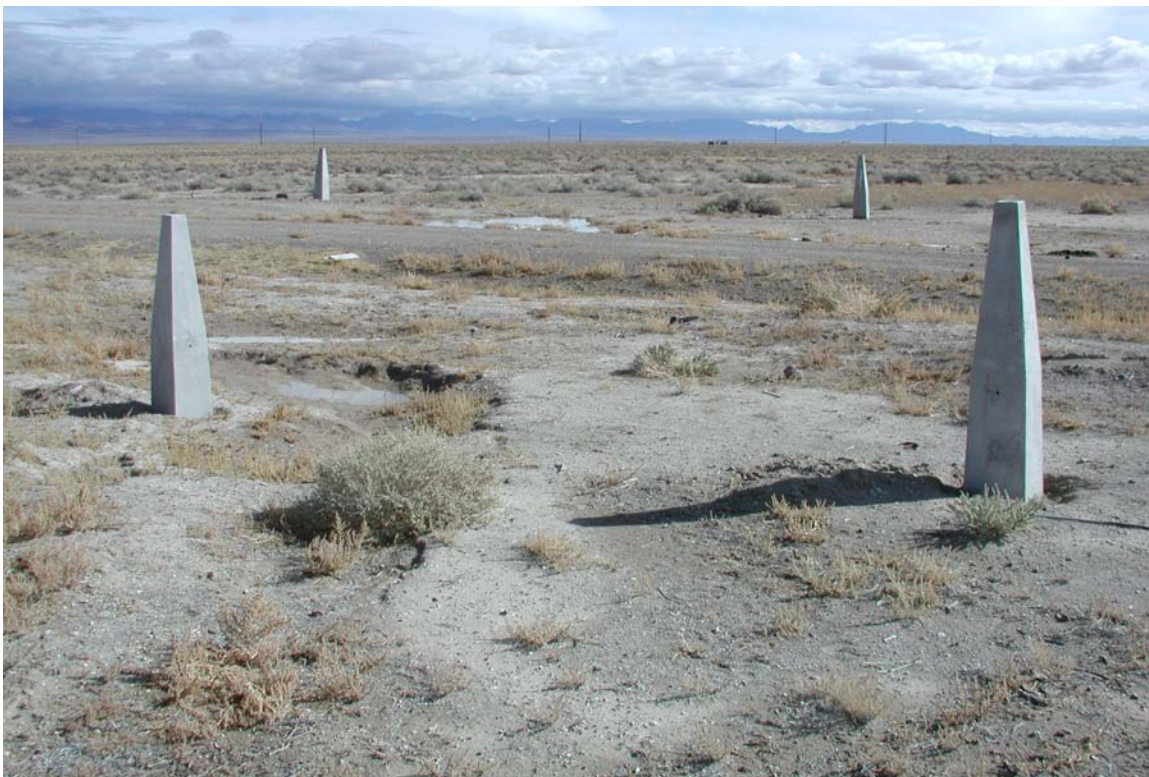
CAU 487 CAS RG-26-001-RGRV (Thunderwell Site) Monuments

Two locations at CAU 487 CAS RG-26-001-RGRV (Thunderwell Site) containing buried metal debris related to the Thunderwell tests have land-use restrictions and are marked by above-ground concrete monuments. The CAU is inspected annually to document the integrity of the site.

CAU 487 CAS RG-26-001-RGRV (Thunderwell Site) is located southeast of the intersection of Avenue 57 and Avenue 25, approximately 5 miles north of Area 3. The site was the location of a series of reentry vehicle explosive tests conducted from 1957 until the early 1960s. Geophysical surveys of the site located two primary locations of large buried debris which were closed in place. Numerous buried vertical metal tubes, approximately 6 feet in diameter, are also present at the site.
