# TESTING OF TMR SAND MANTIS FINAL REPORT

May 2007

Robotics, Remote & Specialty Equipment Section  
Engineered Equipment and Systems Directorate  
Savannah River National Laboratory  
Aiken, SC 29808

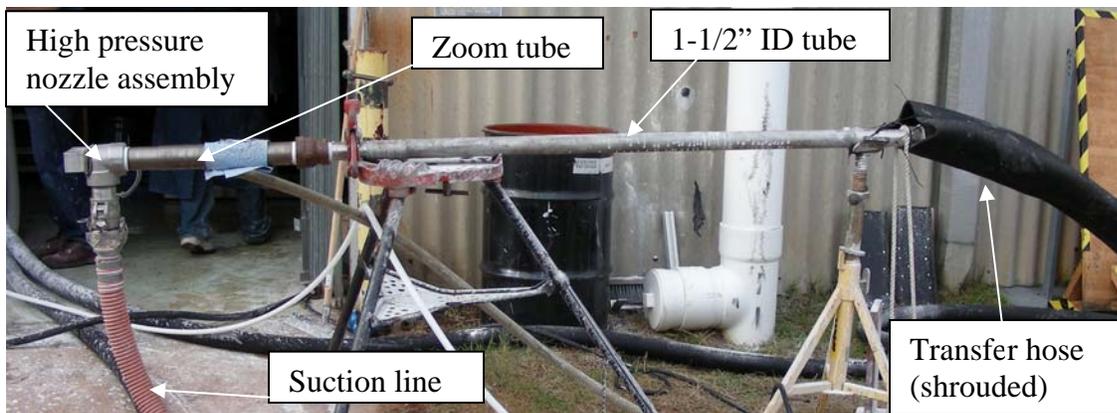
**Figure 1. Zoom Tube Assembly**

The Sand Mantis test setup centered on a high pressure stream developed by a 40,000 psi pump similar to the pump used by TMR. Most of the pertinent parts of the test setup are shown in Figure 1. A 0.034" diameter diamond orifice directs a 32,000 psi water stream into the zoom tube. A 65-inch long 1.5-inch tube downstream of the zoom tube represents the remaining length of the Sand Mantis body.

The 65-inch long stainless steel tube was connected to a 2-inch transfer hose, made of sections of Goodyear Allcrete Textile hose and clear PVC hose, in the following configuration (which mimics the configuration used in Denver and the expected transfer line configuration during field deployment):

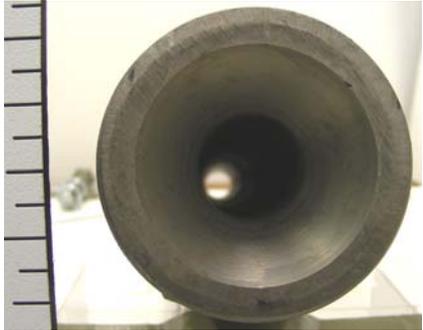
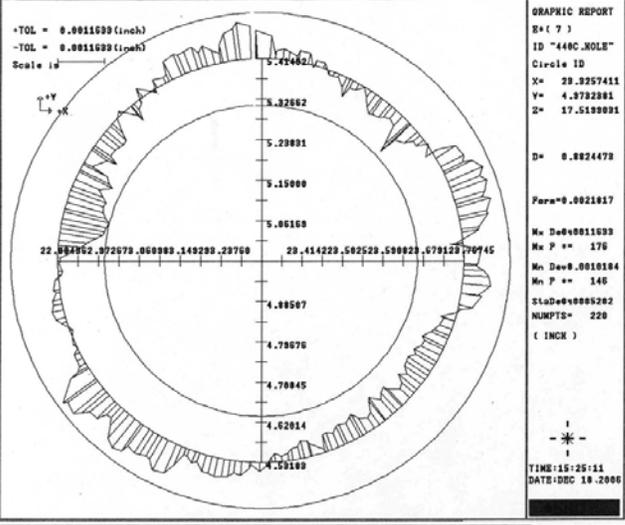
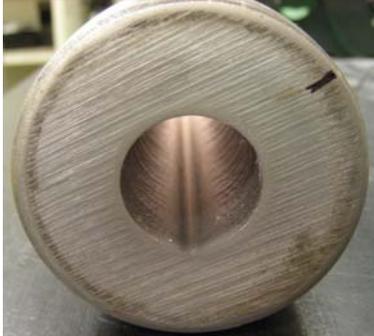
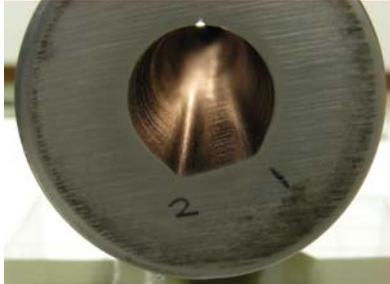
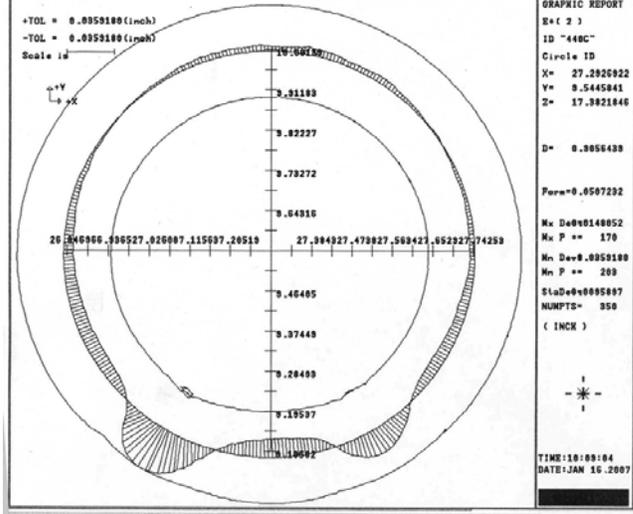
Table 1. Notes and measurements for erosion tests on 440C zoom tube

Baseline Data				
Zoom tube weight	9132.7 g

Hardness	HRC 53			
			Inlet profile (total out-of-roundness) = 0.002 inch	
<b>After 1<sup>st</sup> Batch</b>				
Batch size	1000 lbs sand

Max. wear depth	0.032 inch			
Wear location	Disch. end, ~5:00, ~6 inches long			
Final weight	9127.3 grams			
Weight change	4.6 grams loss			
<b>After 2<sup>nd</sup> Batch</b>				
Batch size	800 lbs sand

Max. wear depth	0.051 inch			
Wear location	Disch. end, ~7:00, ~6 inches long			
Final weight	9124.9 grams			
Weight change	2.4 grams loss			
			Outlet profile (total out-of-roundness) = 0.051 inch

After the first batch of simulant, wear was evident on each zoom tube. A groove was worn into the last several inches of the 440C and Goodyear hose zoom tubes. In addition, the adapter at the end of the Goodyear hose also contained a worn groove. A groove was worn near the entrance of the A2 zoom tube, extending several inches in length, and a second smaller groove was worn further downstream. The position of the grooves in the A2 zoom tube is attributed to a small metal chip that was found behind the high pressure orifice and disrupted the flow pattern for this run only.

After the second batch of simulant, additional wear was evident on the 440C and A2 zoom tubes. Due to a slight change in the nozzle orientation, a second groove was worn into the last several inches of the 440C zoom tube. Grooves of noticeable depth were also worn into the last several inches of the A2 zoom tube. A minor region of wear was also noted on the adapter at the end of the Goodyear hose zoom tube (away from the previous groove), but it was not obvious that additional wear occurred on the hose. The Goodyear hose is slightly ovalized, as shown in the profiles in Table 3. This effect was taken into account in identifying the depth of material loss after the tests.

For both the 440C and A2 zoom tubes, more zoom tube material was removed during the first batch than during the second batch. The weight loss for the A2 zoom tube during the first batch was more than triple that of the second batch. The magnitude of this difference suggests that material removal rates are increased if the stream is interrupted (in this case due to debris lodged in the orifice) to move the impact point of the stream closer to the nozzle.

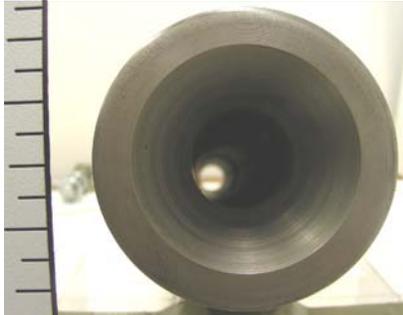
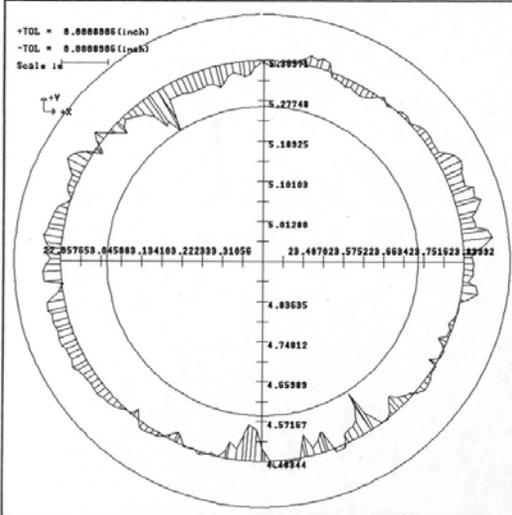
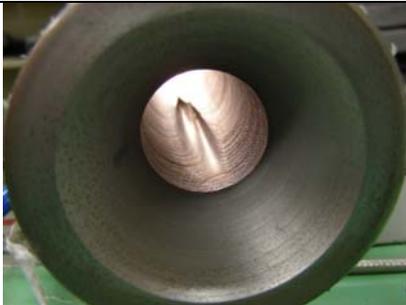
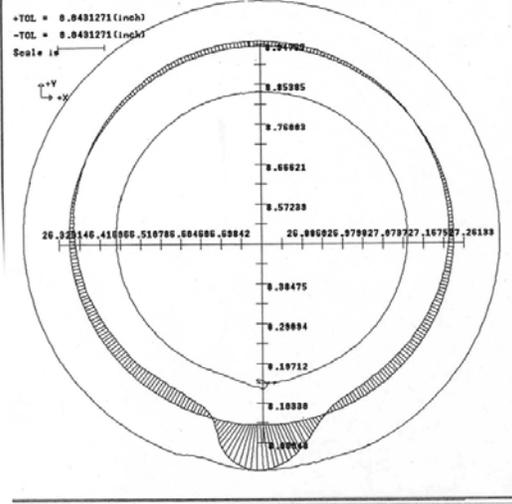
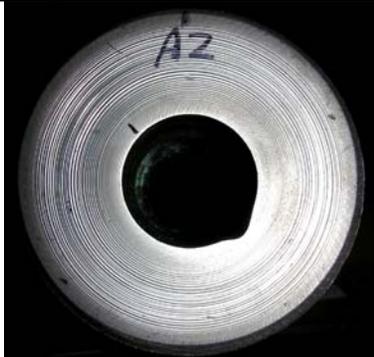
Table 2. Notes and measurements for erosion tests on A2 zoom tube

<b>Baseline Data</b>		
Zoom tube weight	9472.8 g

Hardness	HRC 58

Inlet profile (total out-of-roundness) = 0.001 inch
<b>After 1<sup>st</sup> Batch</b>		
Batch size	1000 lbs sand

Max. wear depth	0.063 inch	
Wear location	Inlet from just past cone, ~6:00, ~4 inches long, a second groove farther downstream	
Final weight	9459.4 grams	
Weight change	13.2 grams loss	
<b>After 2<sup>nd</sup> Batch</b>		
Batch size	1000 lbs sand

Max. wear depth	0.056 inch	
Wear location	Disch. end, ~5:00, ~4 inches long	
Final weight	9455.2 grams	
Weight change	4.2 grams loss

Outlet profile (total out-of-roundness) = 0.056 inch

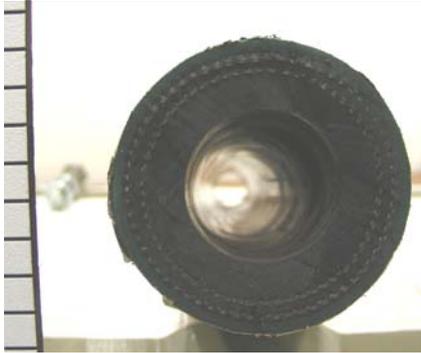
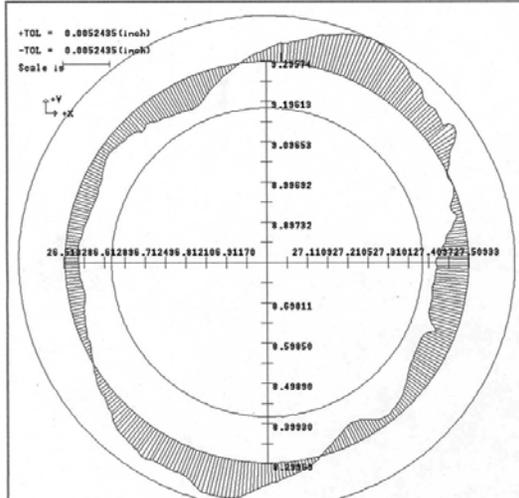
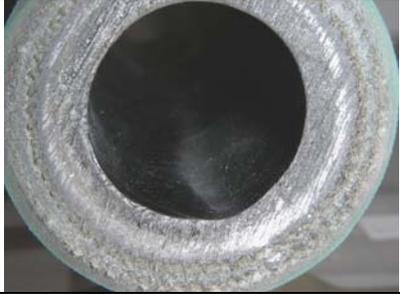
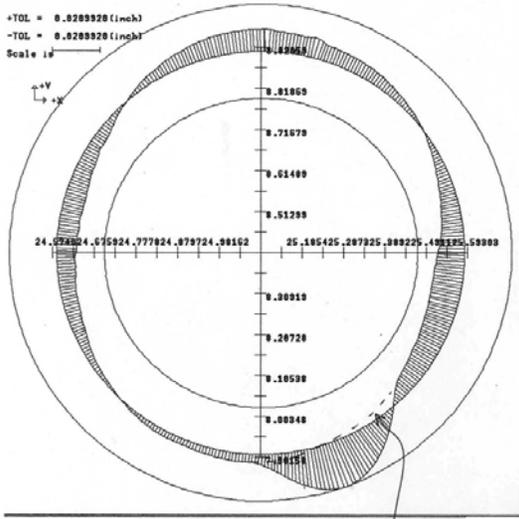
**Table 3. Notes and measurements for erosion tests on Goodyear hose zoom tube**

<p>GRAPHIC REPORT E= ( 5 ) ID "MOSE2.BASE" Circle ID X= 27.8129286 Y= 8.7982106 Z= 17.2199591  D= 0.9920136  Para=0.001909  Mx Dev=0.0038994 Mx P = 102 Mn Dev=0.0052495 Mn P = 25 StatDev=0.0026027 NUMPTS= 383 ( INCR )  + * - + * -  TIME:08:48:12 DATE:JAN 16 2007 17</p>
Zoom tube weight	723.8 g			
Hardness	40 Durometer A			
		<p>Inlet profile (total out-of-roundness) = 0.009 inch (from spare hose section cut from outlet end of tested hose)</p>		
<b>After 1<sup>st</sup> Batch</b>

Batch size	1000 lbs sand			
Max. wear depth	Not measured			
Wear location	Disch. end, ~2:00, ~3 inches long			
Final weight	724.3 grams			
Weight change	0.5 gram gain			
<b>After 2<sup>nd</sup> Batch</b>

<p>GRAPHIC REPORT E= ( 9 ) ID "MOSE" Circle ID X= 25.8852551 Y= 8.4836652 Z= 18.0419617  D= 1.0020888  Para=0.0342882  Mx Dev=0.010062 Mx P = 187 Mn Dev=0.020028 Mn P = 178 StatDev=0.0089312 NUMPTS= 387 ( INCR )  + * - + * -  TIME:10:00:08 DATE:JAN 16 2007</p>

Batch size	800 lbs sand			
Max. wear depth	0.021 inch			
Wear location	Additional wear not obvious			
Final weight	724.6 grams			
Weight change	0.3 gram gain			
		<p>Outlet profile (total out-of-roundness) = 0.034 inch (corrected for ovalization)</p>

The maximum depth of penetration after the second batch was 0.021 inch. Comparing the photographs after each batch, it appears that most if not all of this wear occurred during the first batch. The wear rate for the hose is therefore bounded by 0.021 inch / 1000 lb simulant. The inner wear layer of the hose is 5/16 inches thick (nominal). Approximately 7% of this thickness was penetrated with the transfer of 1000 pounds of simulant.

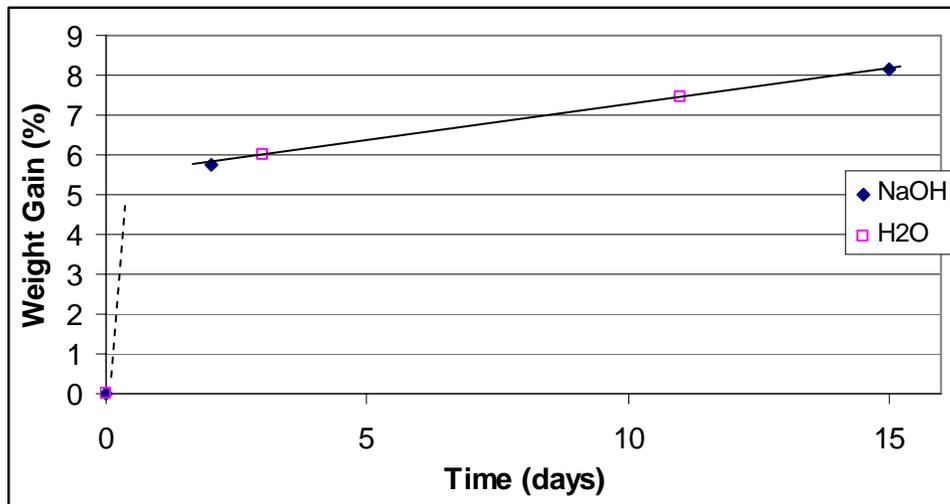
Figure 2. Weight gain for Goodyear hose sections

Sections of the Goodyear rubber hose were immersed in NaOH solution or in water. Both samples experienced significant increases in weight and thickness, and a modest decrease in hardness. The changes were comparable for the two solutions (NaOH and water), indicating there was no significant chemical degradation from the NaOH. Figure 2 shows the relative weight gain for the two solutions, with an increase of ~8% over a 15 day period. The majority of this weight gain appears to be almost immediate, with a much slower continuing weight increase over time. The thickness increase was ~2%.

The Goodyear Plicord Blast hose contains an internal layer of Tufsyn, a synthetic rubber typically used in tires. Vendor data identifies it as suitable for continuous service in NaOH solutions at concentrations and temperatures exceeding the Tank 19 environment. It is also acceptable in a number of other chemicals, such as sodium nitrate, sodium sulfate, sodium chloride and sulfuric acid, which contain ionic species that may also be present in Tank 19 [9, 10]. Erosion behavior for this material may be significant in some circumstances. While this and similar hose products are marketed for handling hard abrasive materials such as sand, they are generally pumped at relatively low velocity. Under higher velocity and varying impact angles, physical damage to the material is possible. This has been noted in Neoprene, a similar material [11]. Tested in coal slurry with a 20 degree impact angle, the material was found to be very resilient to the impact of solid particles. However, it did not resist the tearing action of angular particles.

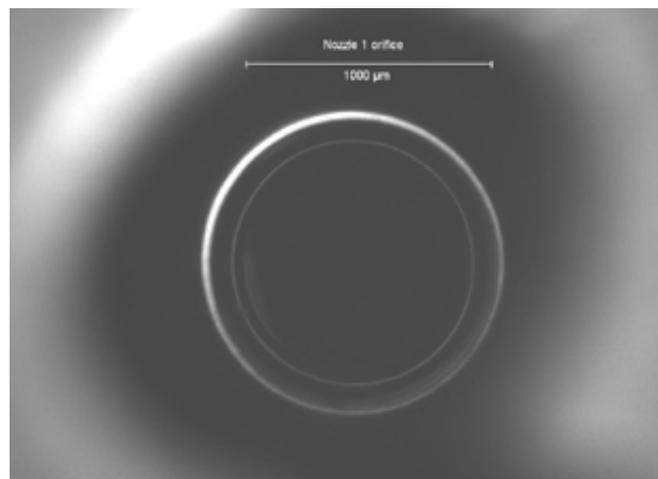
All testing was performed with nozzle 1. The baseline ID for the nozzle 1 insert was 0.03350 inch. A second nozzle had a baseline ID of 0.03355 inch. No wear is evident on the nozzle 1 diamond insert following testing. The inside diameter of the insert was essentially unchanged and the exit edge is visually sharp (Figure 3). However, the steel holder has experienced some wear on the discharge side. Some wear was observed prior to testing. Figure 4 shows the discharge side before and after testing. None of the observed wear on the nozzle discharge face was significant in terms of impacting performance. The testing performed was not sufficient to estimate an expected service life for the nozzle.

**Figure 3. Nozzle 1 diamond insert (center rings) after testing showing no measurable degradation, photographed at 40X. The stainless steel face is around the edge and out of focus.**

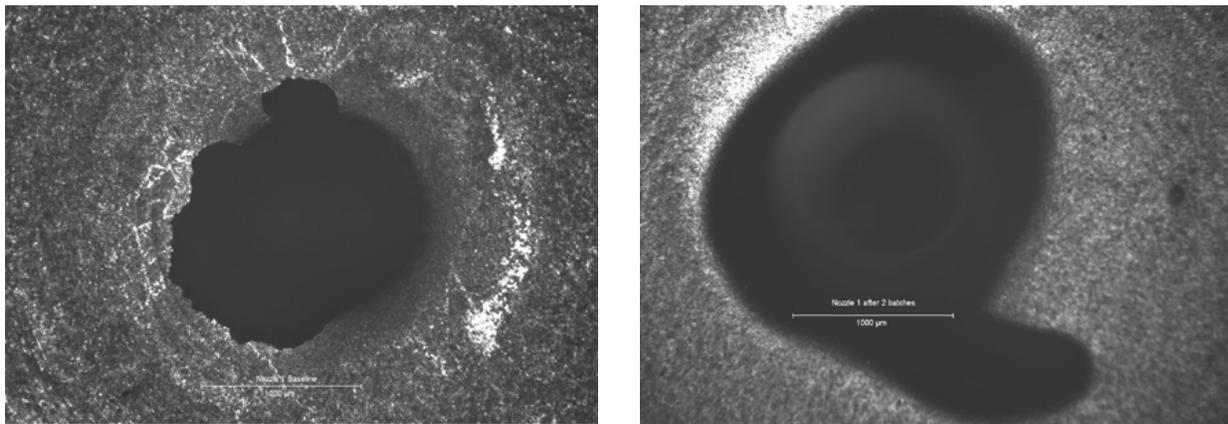
**Figure 4. Nozzle 1 stainless steel insert face before and after testing, photographed at 40X.**

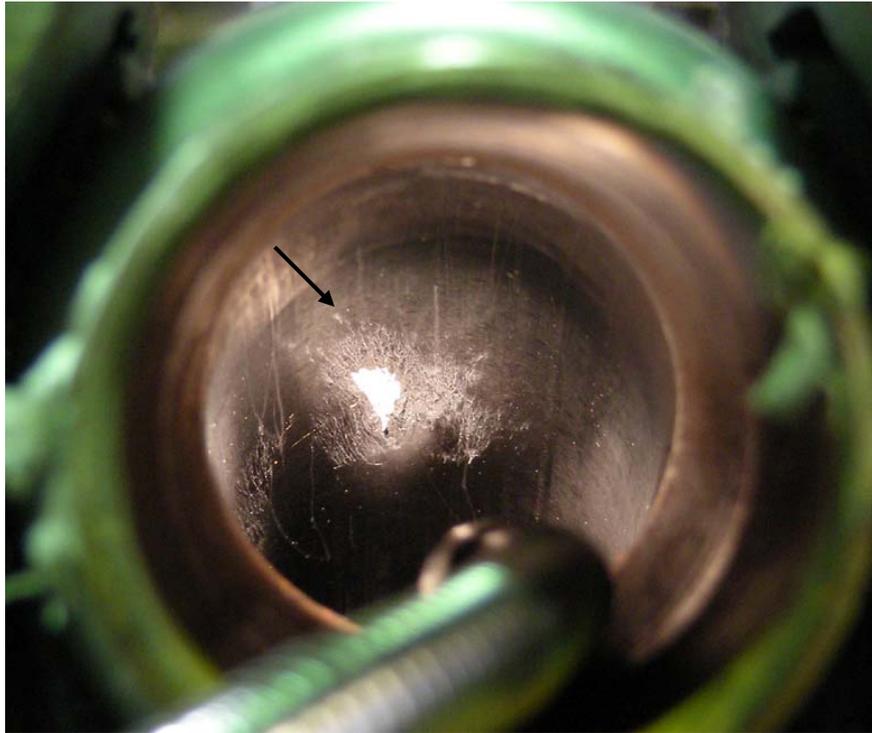
An initial effort to perform the screening tests led to a rupture of the discharge pipe after approximately 7 minutes of operation. To perform the screening tests the length of discharge hose was increased significantly (from 40 to 570 feet) to match the length of hose successfully demonstrated during TMR testing in Denver. Following the screening tests, the hose was inspected and was found to have been partially penetrated in the same manner as the initial breach (Figure 5). In addition, some wear was observed inside the 65 inch long tube (Figure 6).

**Figure 5.** Wear of discharge hose following screening tests. The central white region is sand which was left embedded in the hose wall.

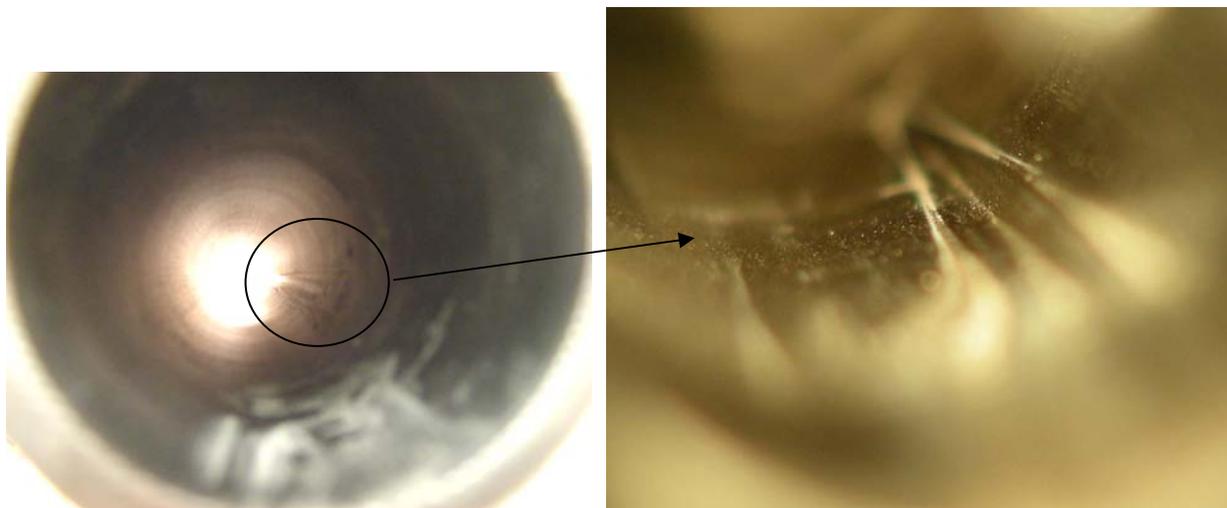
**Figure 6.** Wear of 65-inch-long tube following screening tests

- The most pronounced wear patterns appeared just upstream of expansions in the piping; while there was much less wear noticeable downstream. It is inferred from this that the arrangement and geometry of these changes can influence the shape/orientation of the main jet as it flows through the machine.
