### An Innovative High-Temperature High-Pressure Measurement While Drilling (MWD) Tool

Submitted by:  
Schlumberger Technology Corporation  
110 Schlumberger Dr.  
Sugar Land, TX 77478

***Final Technical Report***

**DE-FC26-03NT41835**

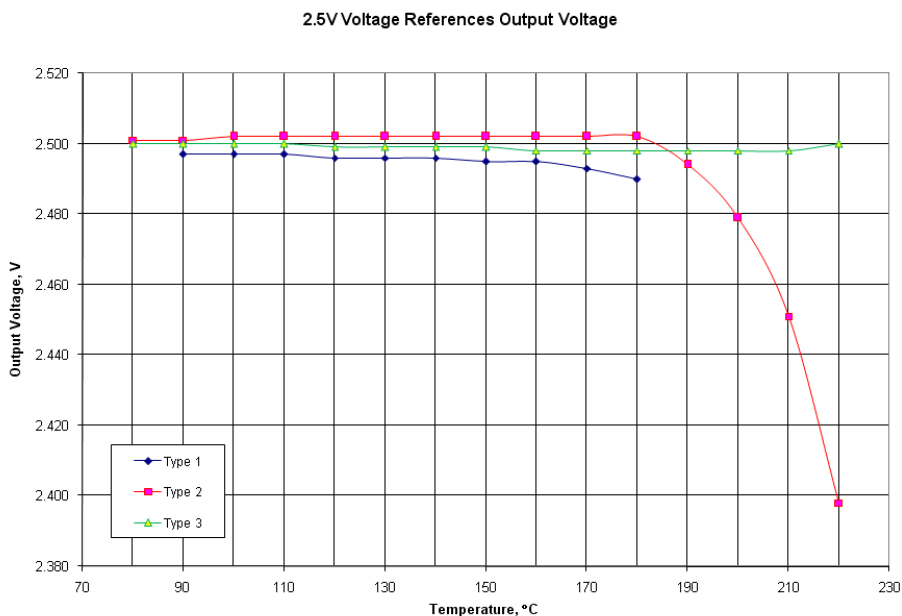
As part of the project in Phase I, candidate system electronics consisting of controllers, program memory, nonvolatile data memory, clock oscillators, and glue logic were identified and tested to 200°C (392°F) or more. As expected, some candidate parts did not function at 200°C (392°F), some exhibited significantly decreased performance, and some showed little or no degradation. As an example, a selection of three different manufacturers' voltage reference parts is shown in Figure 1 below.

**Figure 1. Type 3 voltage reference maintains performance vs. temperature.**

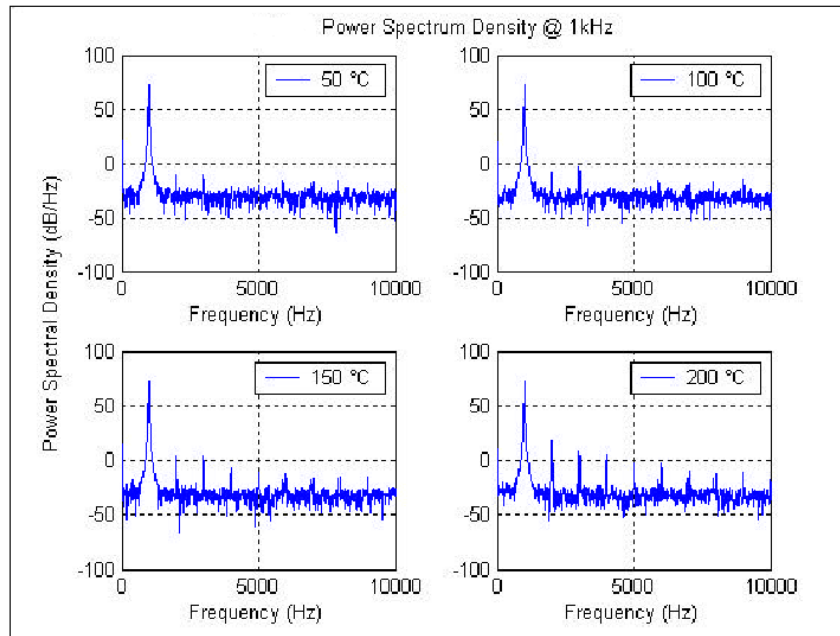
Based on previous experience with other projects, a 16-bit, successive-approximation, analog-to-digital converter (ADC) suitable for general purpose data acquisition was tested to 200°C (392°F). A power spectral density plot of the ADC at various elevated temperatures in Figure 2 shows decreased but acceptable performance at the target temperature. Also, since the recipient was a member of the DOE/NETL-Honeywell Joint Industry Project (JIP) to produce very-high-temperature electronics, it was anticipated that the 18-bit sigma-delta ADC under development in that program would be incorporated in the HPHT MWD tool. That ADC was not available during the execution of this project and, as a result, was not used.

**Figure 2. ADC power spectral density decreased performance vs. temperature.**

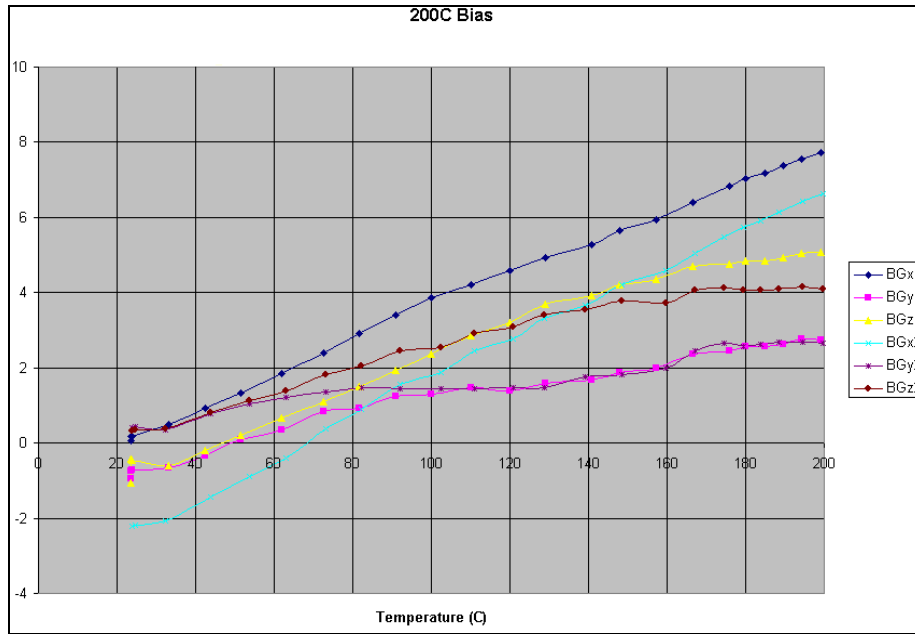
The 200°C (392°F)-rated accelerometers proposed for use in the direction and inclination subsystem passed initial temperature and shock screening, but one of three later failed environmental qualification during shock testing. Figure 3 shows the sensor bias in  $\mu\text{A}$  of the three units before (BGx, BGy, and BGz) and after (BGx2, BGy2, and BGz2) environmental testing, showing unacceptable drift of the bias models. Failure analysis by the vendor revealed an atypical failure not normally associated with high shock, so this failure was apparently a manufacturing defect. Additional parts were ordered for follow-up testing that took place in Phase II.

**Figure 3. Accelerometer bias vs. temperature shows unacceptable drift.**

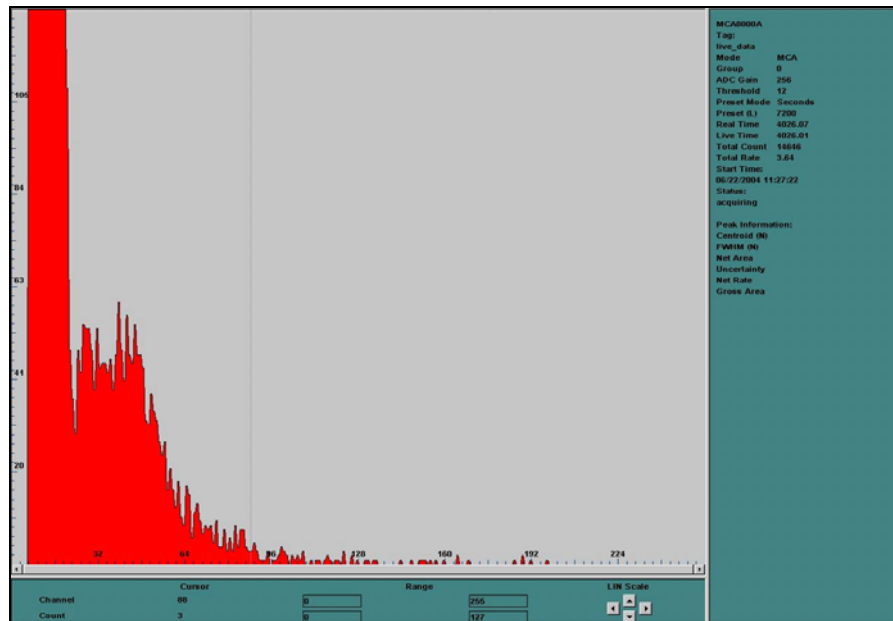
A gamma ray crystal detector, scintillation counter, and high-voltage power supply were all tested to 205°C (401°F). A discriminator and counting circuit was not developed in Phase I because it was anticipated that a high-temperature version of that circuit would be readily adapted from available components already known to perform to 205°C (401°F). A commercial vendor was developing a higher-temperature detector targeted for around 220°C (428°F) that was to be incorporated into the tool when it became available. These changes were partially successful and were integrated in the tool Phase II. Figure 4 shows a spectrum of response versus energy level of the gamma ray detector system.

**Figure 4. Gamma ray spectrum at 200°C.**

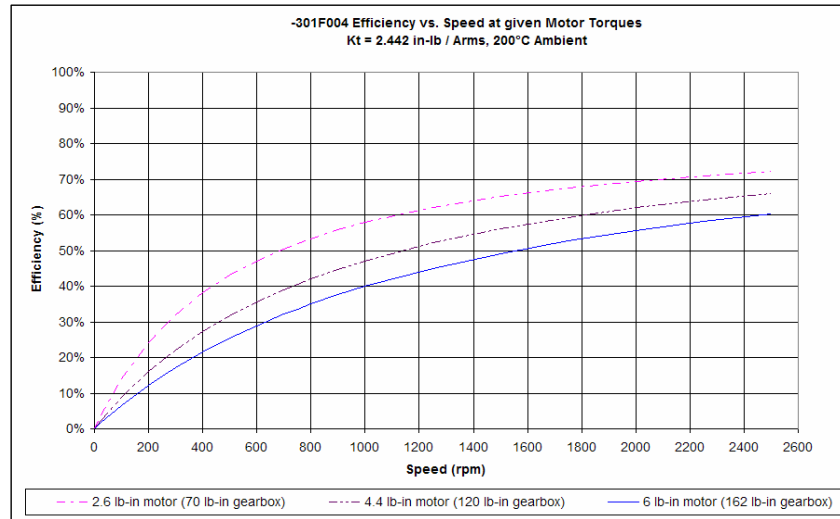
Materials for the modulator/generator were identified and tested for effectiveness at high temperature. A motor for driving the modulator/generator was tested to 200°C (392°F). Figure 5 shows a plot of the motor efficiency at 200°C under various torque loads, indicating acceptable performance at the loads anticipated in the design. Simulations indicated that the modulator could generate sufficient downhole signal strength to allow effective data transmission for the targeted mission profile.

**Figure 5. Motor efficiency at 200°C.**

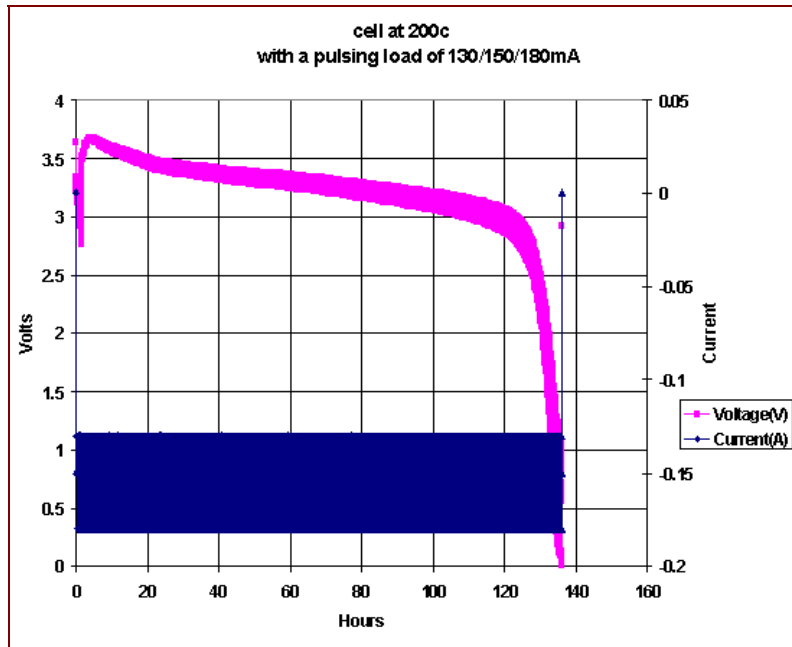
Battery chemistry was identified and tested to 200°C (392°F). Life testing and low-temperature performance verification tests were in progress in Phase I. Figure 6 shows a plot of voltage vs. time for a single cell tested at 200°C (392°F). Indications were that the operational temperature safety margin at 200°C (392°F) was unacceptably small and operation even slightly above 200°C (392°F) could cause the batteries to fail catastrophically. Additional development to improve the safety margin of these batteries was undertaken in Phase II.

Figure 6. Battery testing at 200°C.

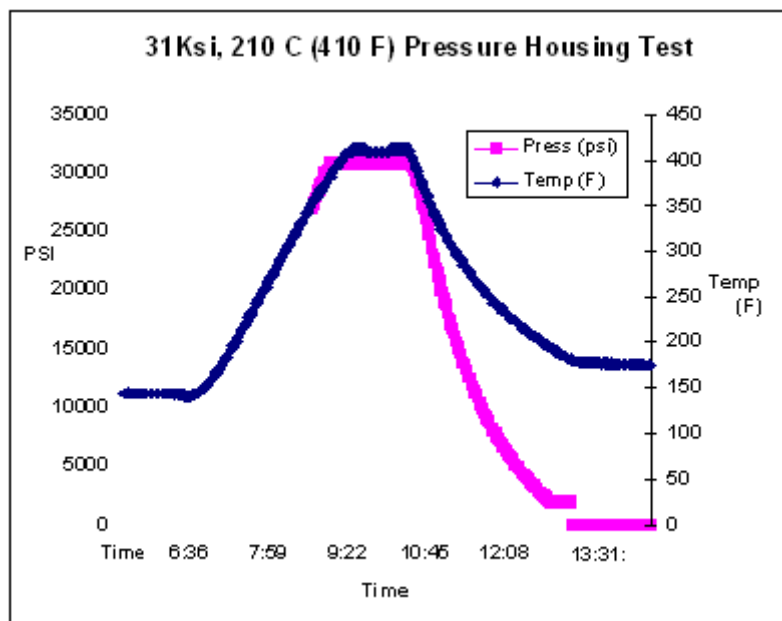
Housing material to meet the requirements for the anticipated pressure housing size was identified, sourced, and successfully tested to 213 MPa (31,000 psi) and 210°C (410°F). Figure 7 shows the temperature and pressure traces from the combined test. Lead times and availability of this material prevented more extensive testing in Phase I. Housing material with a lower pressure rating was used for tool assembly in Phase II until the higher strength material was delivered.

Figure 7. Housing combined pressure and temperature testing.

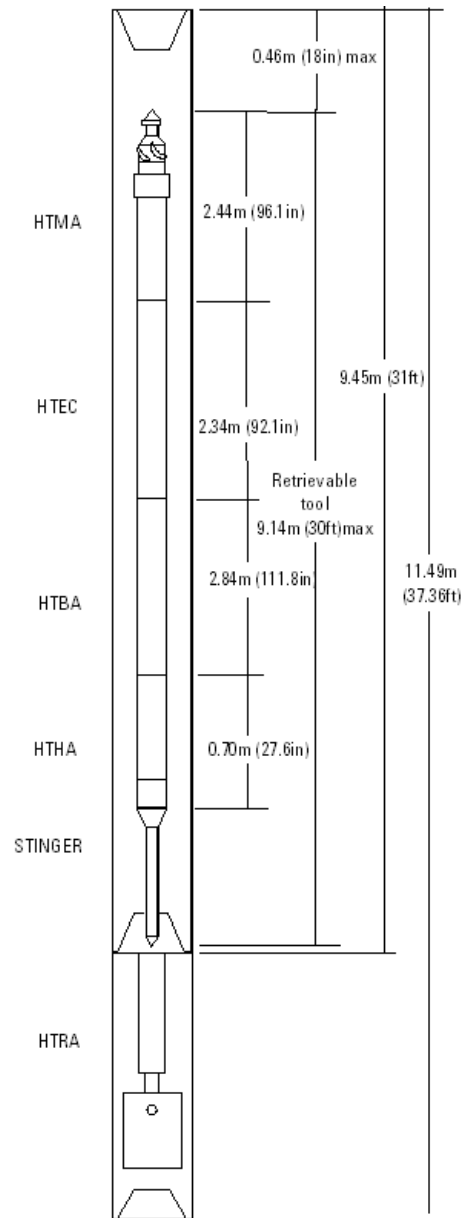
- HTRA (HPHT Remote Assembly). The HTRA is a smaller collar (sub) that houses internal and annular pressure sensors, front-end signal amplification electronics, and the nonretrievable part of the coupling used for interfacing with the HTHA assembly.

**Figure 8. HPHT MWD in NC38-47 collar with pressure sub.**

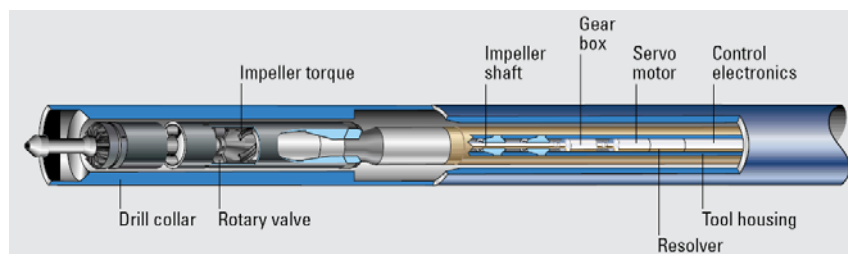
The HPHT modulator assembly was developed using the materials and components identified in Phase I of the project. The mechanical design of the modulator was based on an existing retrievable MWD tool with lower temperature and pressure rating developed by the recipient in the 1990s, as shown in Figure 9. As the HPHT tool was intended for deeper wells, the signal output from the modulator had to be significantly increased to the levels specified by the calculations performed in Phase I. This was achieved by increasing the effective relative flow area in the rotary valve restriction section. Special materials were used for the mechanical valve parts to ensure that the erosion of the components was kept to a manageable level. Along with flow loop and erosion tests performed in the on-site test facilities mentioned above, finite element analysis (FEA) simulations confirmed the required signal levels and erosion characteristics.

**Figure 9. HPHT MWD modulator mechanical architecture.**

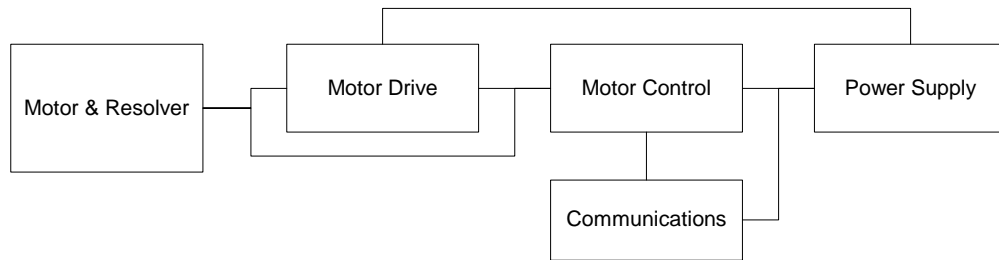
The HTMA electronics section consists of a motor control circuit, motor drive circuit, power supply, and communications circuit. It connects to a motor and resolver for modulation control (Figure 10).

**Figure 10. HTMA electrical architecture.**

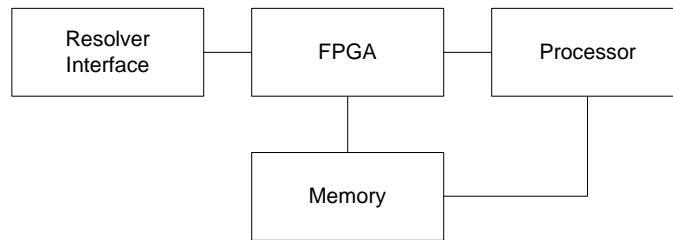
**Figure 11. Motor control circuit.**

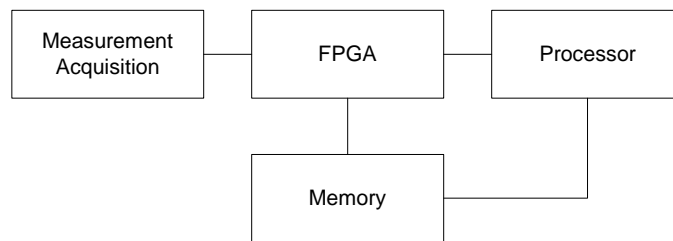
The main controller circuit (Figure 13) was also reused from the earlier project after component testing in Phase I and prior test data revealed that this circuit would be appropriate for this application. The system consists of a microprocessor; program, data, and recording memories; an FPGA that provides interfacing; and an analog acquisition circuit to acquire health monitoring status of the tool such as temperature, battery current, and shock measurements. It also contains a counter for the gamma ray detector and communication circuits to gather data from the directional module described below. The main controller suffered from the same memory weakness as the motor control circuit described above, and the same workaround was applied to it to allow operation in the prototype. A redesign of this circuit was started but not completed during the scope of the project.

**Figure 13. Main controller circuit.**

This circuit serves as the central intelligence point of the entire tool, gathering data from subsystems, performing any necessary processing of that data, and formatting it properly for transmission to the surface. It also controls what modulation schemes will be used, what data will be sent depending on operation parameters such as inclination and rotation, when to acquire data such as pressure, and when to take survey measurements and transmit them to the surface.

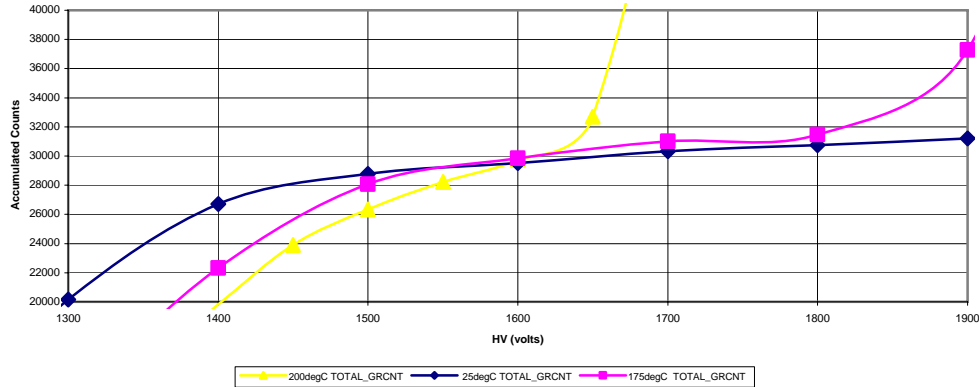
The additional work to optimize and increase the reliability of the gamma ray sensors at maximum operating temperature rating was partially successful. The new gamma ray detectors were tested to alleviate concerns that thermionic noise and light leakage might cause unacceptable performance or significantly reduced life. Acceptable performance was achieved, but life at maximum temperature was still lower than hoped. However, the life (>100 hours) achieved at temperature was deemed acceptable for viable tool operation. Additional information gathered in this effort was used to determine the maximum number of high-temperature operating hours before replacement to ensure reliable and uninterrupted service. Sample high voltage plateaus showing decreasing plateau length with increasing temperature measured as part of complete tool system testing are shown in Figure 14.

**Figure 14. Gamma ray detector plateau.**

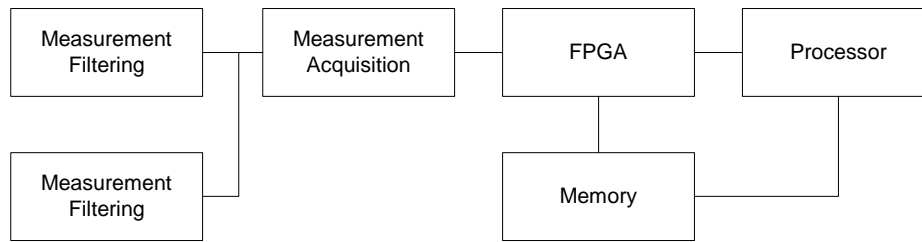
**Figure 16. Data acquisition and processing circuit.**

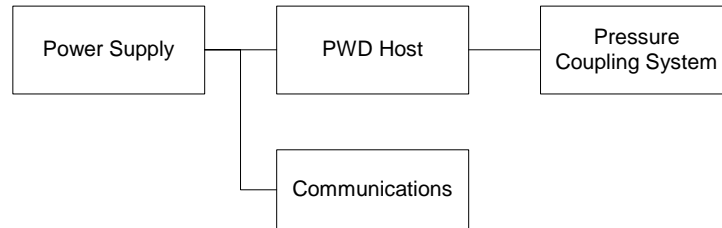
The HTHA is the bottom-most section of the HPHT MWD retrievable tool. It is an assembly that consists of a power supply and communications circuit, as with the HTMA and HTEC above, and a pressure while drilling (PWD) host circuit (Figure 17). In addition, a switch circuit (not shown in the block diagram) designed to help manage battery life interrupts the battery current and operates independently from the rest of the HTHA circuitry.

**Figure 17. HTHA block diagram including pressure coupling.**

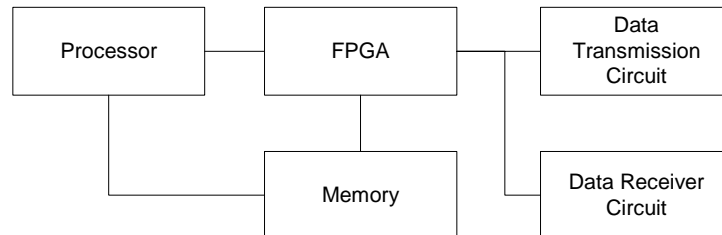
The PWD host circuit (Figure 18) serves as the interface between the main electronics of the tool (HTEC) described above and the pressure system coupling described below. This circuit was designed using the best practices learned from design and testing of the motor control, main control, and direction and inclination acquisition circuits and did not have any temperature-related problems.

**Figure 18. PWD host block diagram.**

The function of this circuit is to transmit power and data, using the data transmission circuit, over the pressure interface to the HTRA described below. Following the data and power transmission, the host circuit waits a specified amount of time for the HTRA to transmit data back over the pressure interface. This data is received by the host processor

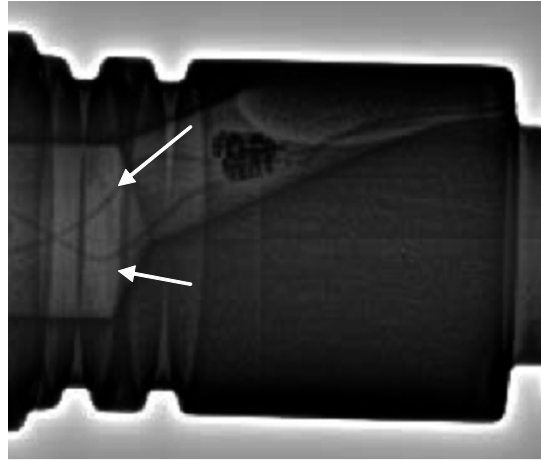
result, the male assembly ultimately passed the 241 MPa (35,000 psi) and 200°C (392°F) test in December 2006. Figure 20 shows an X-ray image of the male coupling with arrows showing typical failure points encountered during testing. Further work outside the scope of this project will be required to validate the consistency of the manufacturing process and apply the design/process changes to the female design. At the conclusion of the project, the female coupling design had not successfully been qualified.

**Figure 20. X-ray of the male coupling.**

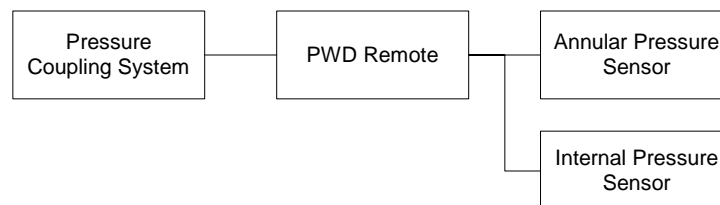
The remote pressure assembly (HTRA) consists of the female portion of the pressure coupling system, a PWD remote circuit, and two pressure sensors (Figure 21). The mechanical architecture of the HTRA is such that there is no fluid connection between the inside of the collar where the pressure communication coupling is located and the collar annulus where the annular pressure measurement is taken. This allows the retrievable portion of the tool to be retrieved while maintaining the inside-to-outside pressure integrity of the collar. The HTRA has no battery as its power comes from the retrievable tool over the pressure coupling. This allows the HTRA to safely remain in place at the wellbore temperature, which might exceed the safe temperature rating of the retrievable tool or tool battery when the retrievable tool is being retrieved or replaced.

**Figure 21. HTRA block diagram including pressure coupling.**

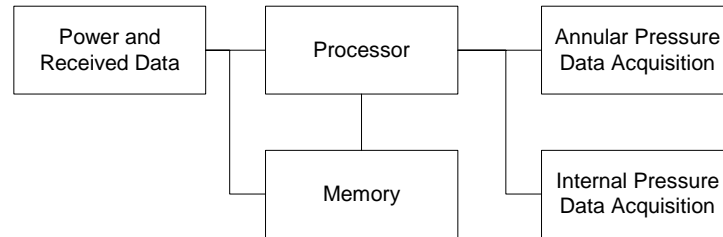
PWD host assembly as mentioned above. This system receives power from the retrievable tool over the coupling system, excites the pressure transducers, and makes readings of pressure and temperature through the data acquisition circuitry. It then transmits the readings and appropriate calibration data to the PWD host assembly through the pressure coupling system for further processing and transmission uphole.

**Figure 22. PWD remote block diagram.**

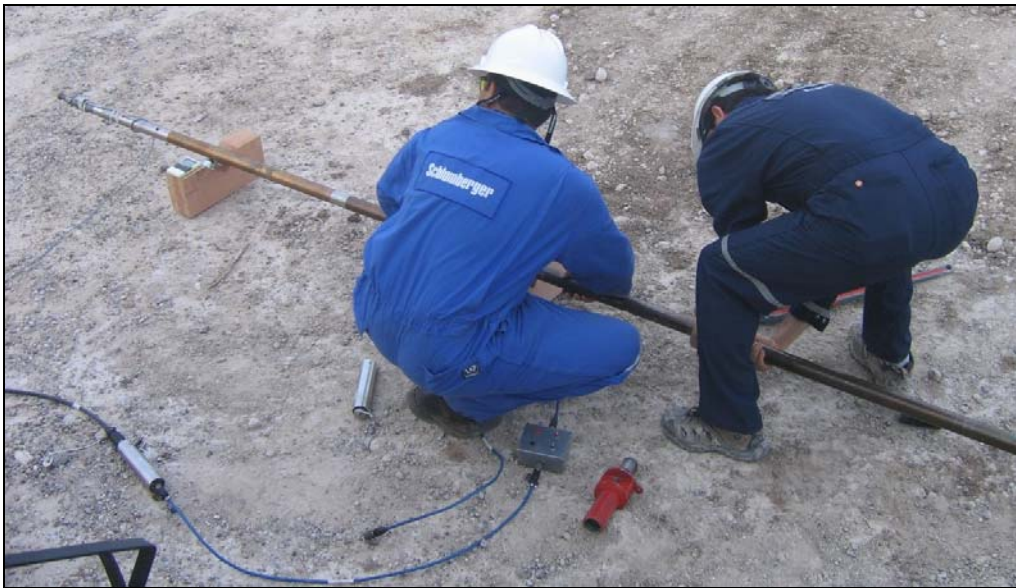
- 0730 h The engineers initialized and tested the HPHT MWD tool with a 150°C (302°F)-rated battery. This “basket test” (Figure 23) was successful and the tool was powered down.

**Figure 23. Surface testing the HPHT MWD tool.**

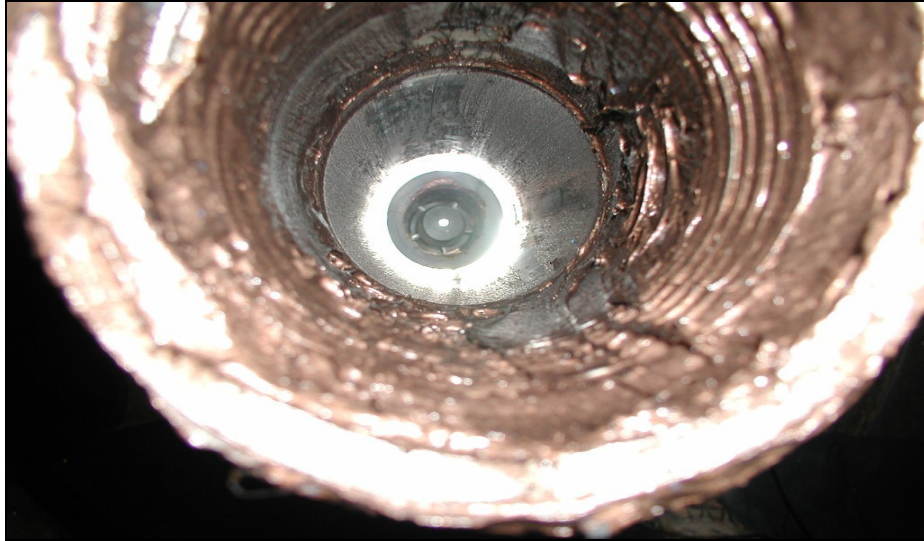
- 0830 h The retrievable portion of the tool was inserted in the NC38-47 HTSA collar assembly to ensure all equipment was correct before running in the well. It was immediately realized that the spear-point top of the HPHT MWD tool was positioned far above the collar's flow sleeve, indicating that the incorrect collar had been shipped to the wellsite. This occurred because the HTSA assembly is indistinguishable from the outside from the equivalent collar used in the recipient's commercial tool but has slightly longer internal parts. The engineers contacted personnel at the engineering center and arranged for transport of the correct collar to the wellsite.
- 1800 h The correct collar was received at the wellsite and the retrievable tool was installed to confirm correct position in the collar's flow sleeve (Figure 24).

**Figure 24. HPHT MWD spearpoint positioning in the flow sleeve.**

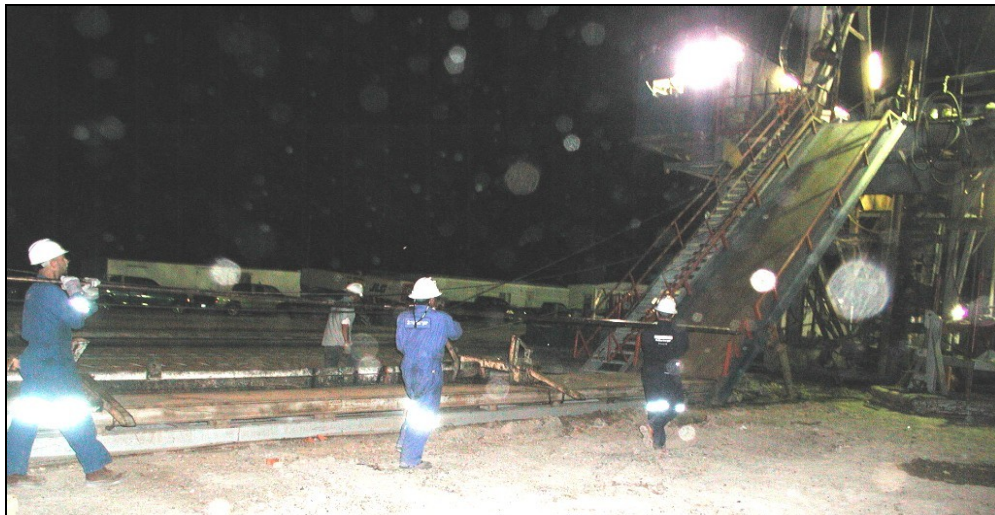
**Figure 25. Carrying the tool to the catwalk.**

2100 h The HPHT MWD tool was powered up by installing the 150°C (302°F)-rated battery. The retrievable tool string was carried to the catwalk in preparation for running in the well (Figure 25).

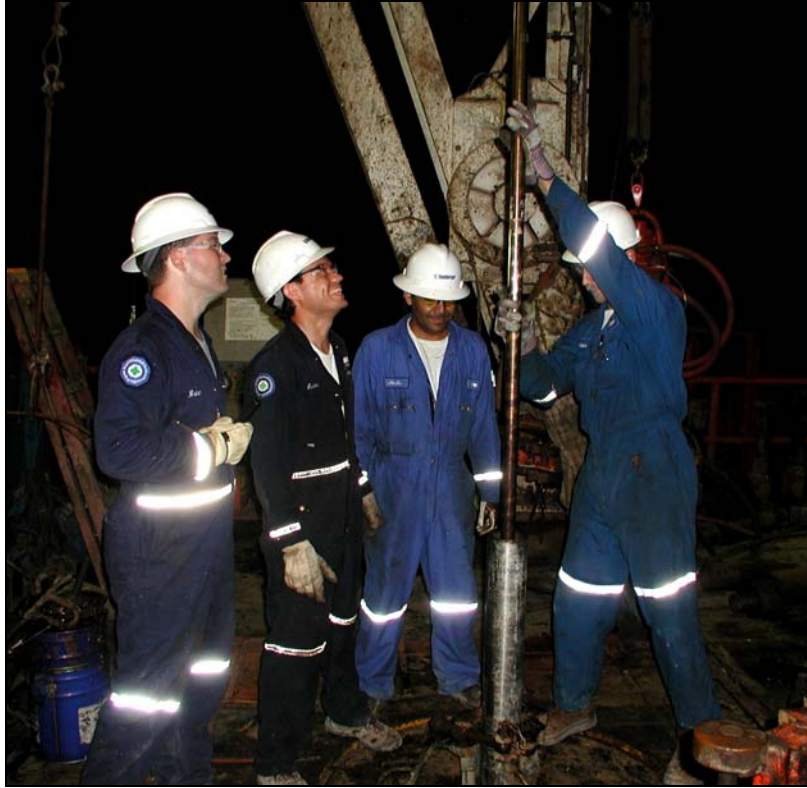
**Figure 26. Installing the HPHT MWD tool in the NC38-47 collar.**

2350h The retrievable tool assembly was installed in the collar and the whole assembly descended below the rotary table (Figure 26).

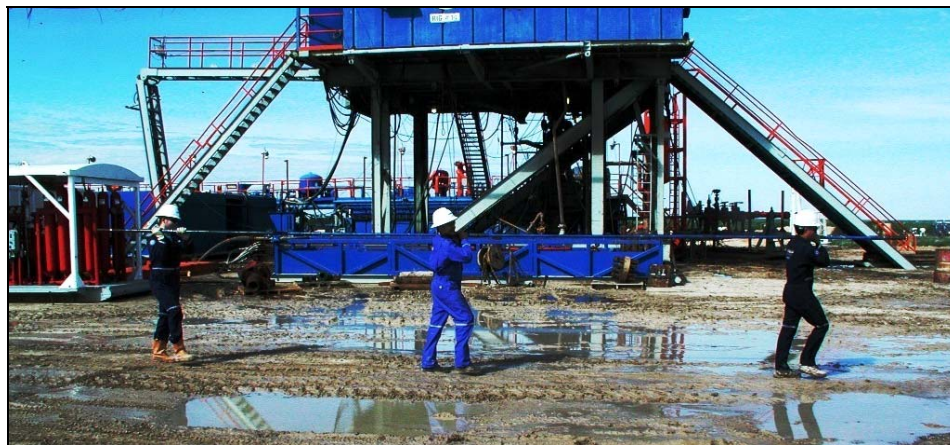
1145 h While the operator was trying to establish control of the well, it was decided to replace the battery in use with a fresh one as the tool had been running for approximately 40 hours. The engineers assembled the fishing tool (Figure 27) and began a slickline operation to retrieve the tool from the BHA (Figure 28). The operation went smoothly except for some delays related to tangling of the wire on the slickline unit while running in.

**Figure 27. Moving the fishing tool to the slickline unit.**

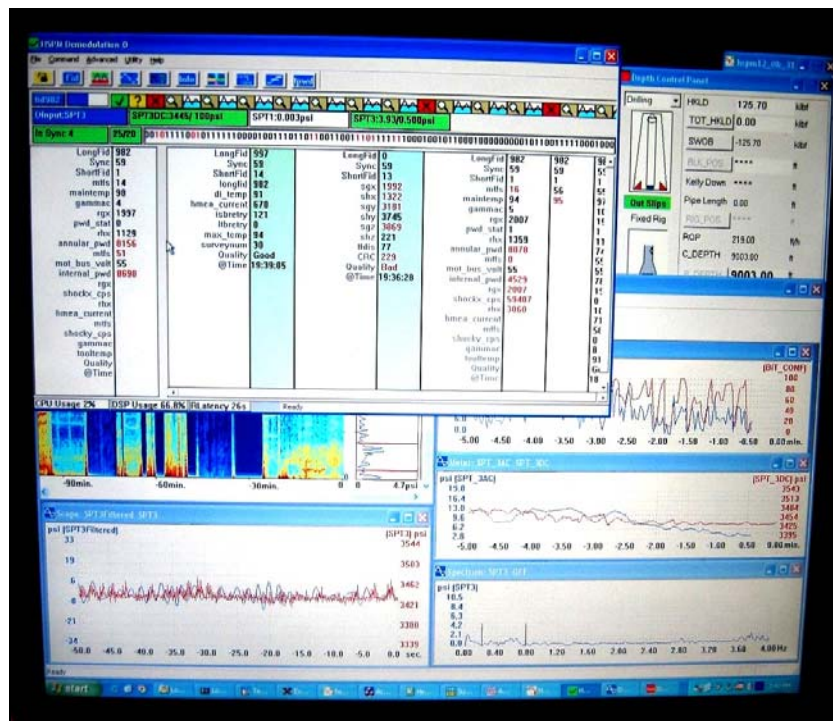
Figure 29. Snapshot of real-time demodulation.

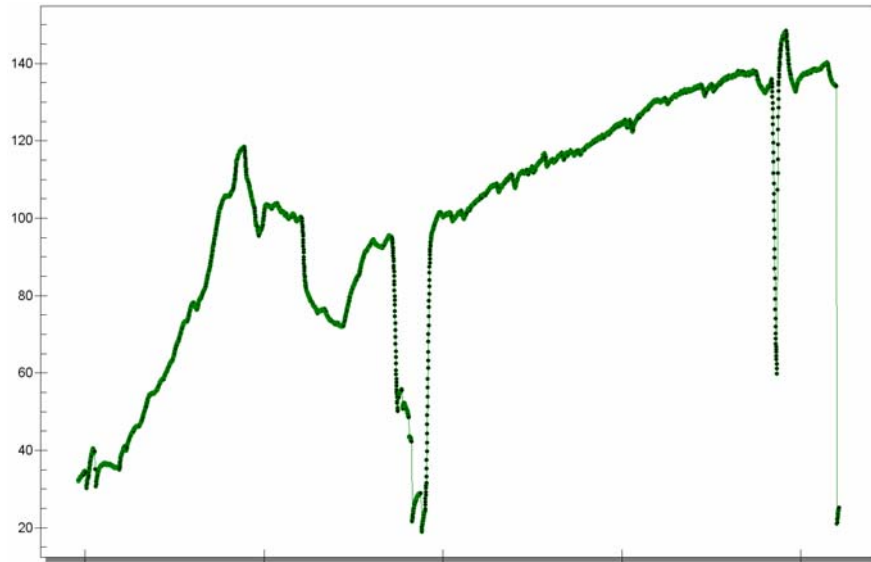
The retrievability and reseatability of the tool were also tested. The tool was successfully retrieved three times and reseated twice. The first operation allowed the rig operator to pump LCM and also replacement of the 150°C (302°F)-rated batteries to reduce the risk that they would deplete during the run. The second operation executed replace the 150°C (302°F) batteries with 200°C (392°F) batteries because the operational temperature limit of the 150°C (302°F) batteries was approaching. The third operation retrieved the tool after the 200°C (392°F) battery depleted.

**Figure 30. HPHT MWD temperature (°C) vs. time (days) during the field test.**

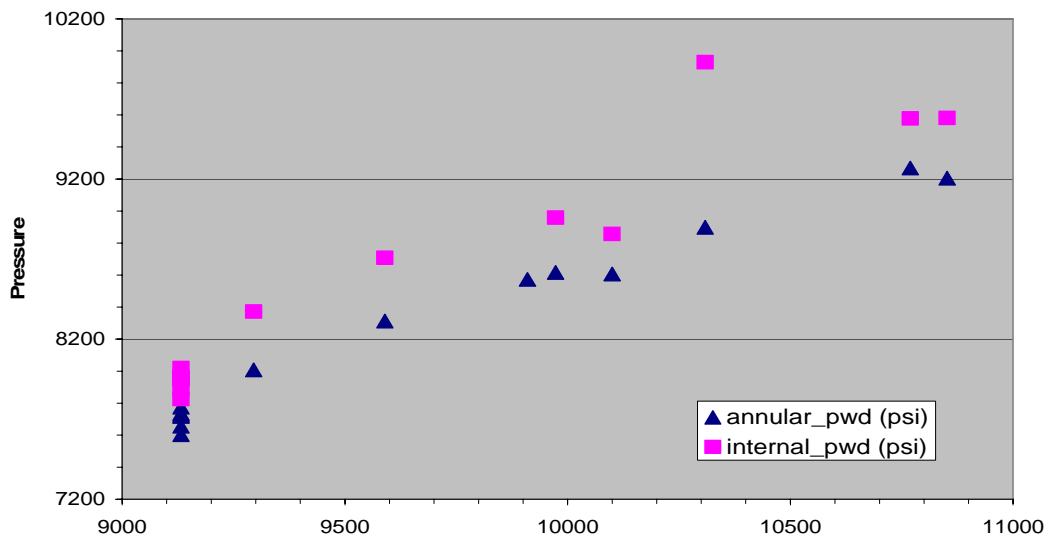
The pressure measurement and communication methodology in the tool was validated. Analysis of the pressure measurements indicated that not only were the measurements consistent with mud weight and depth (Figure 31). In addition, lost circulation was detected at 2783 m (9,132 ft) with analysis of equivalent circulating density (ECD) (Figure 32) as shown by the decreasing ECD calculations with repeated measurements at the same depth.

**Figure 31. Pressure (psi) vs. depth (ft) consistent with mud weight**

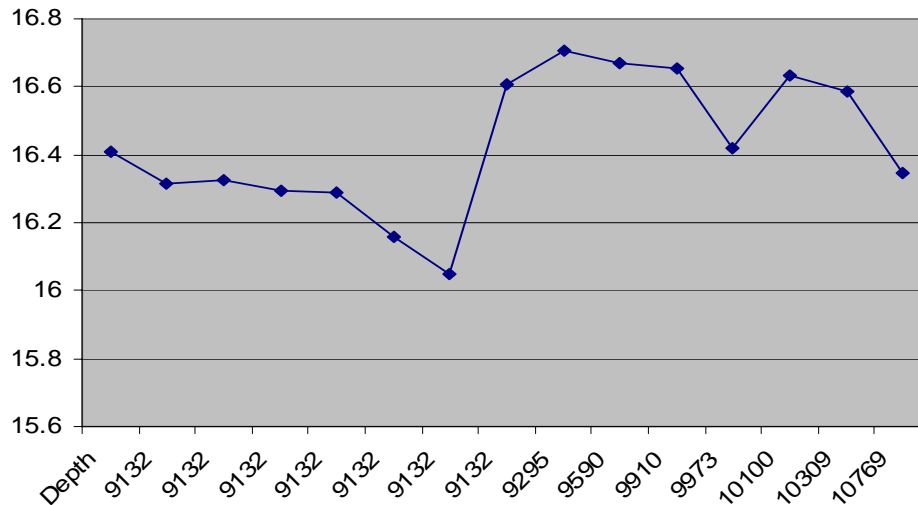
**Figure 32. ECD (ppg) vs. Depth (ft) shows lost circulation**

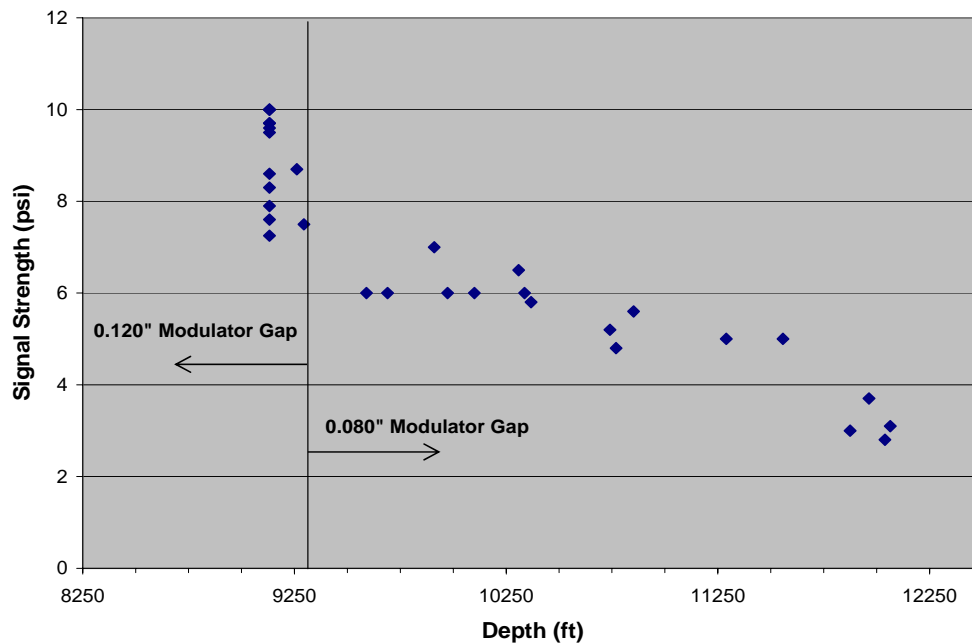
**Figure 33. Modulator signal strength vs. depth.**

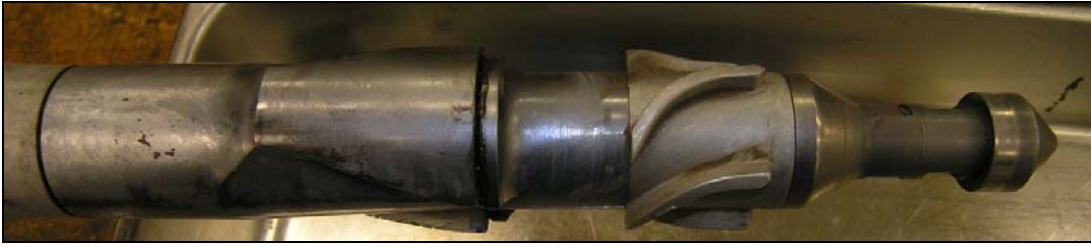
though a new design has been built and is being tested outside the scope of this project with expected delivery in 2009.

**Figure 34. Separation Between Modulator Stator and Stator Adapter**

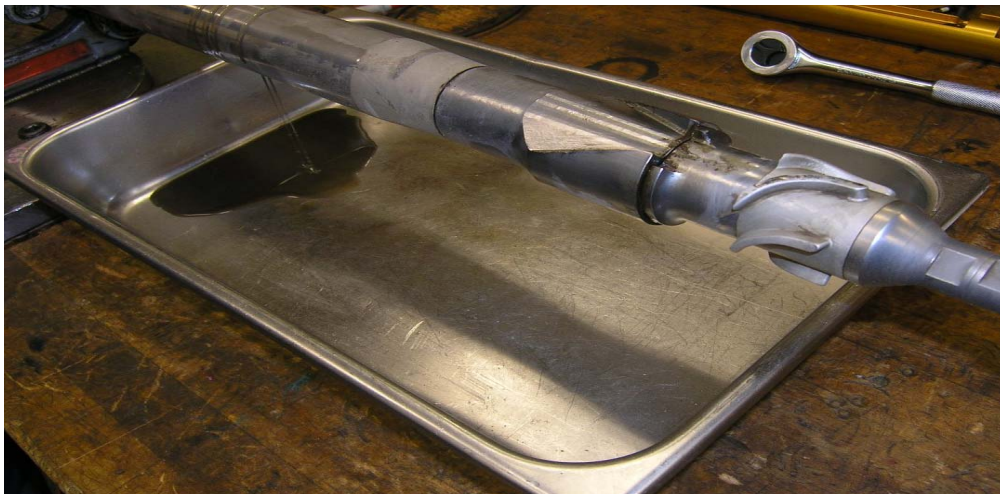
On further inspection of the modulator assembly, it was realized that the primary oil compensator volume was flooded with mud (Figure 35), even though this had not been noted at the well site. On disassembly, it was obvious that the primary rotating seals, excluder seal, and oil compensation bladder were invaded with drilling mud. As expected, the secondary oil compensator volume was not flooded with drilling mud (Figure 36), as the primary compensator is largely sacrificial and is designed to protect the secondary compensator.

**Figure 35. Primary compensator oil volume, mud invaded.**

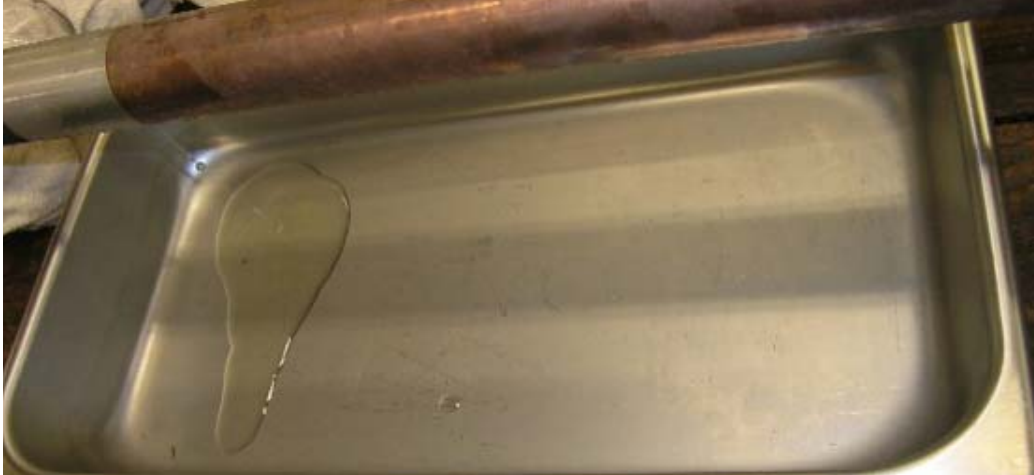
**Figure 36. Secondary oil compensator volume, not mud invaded.**

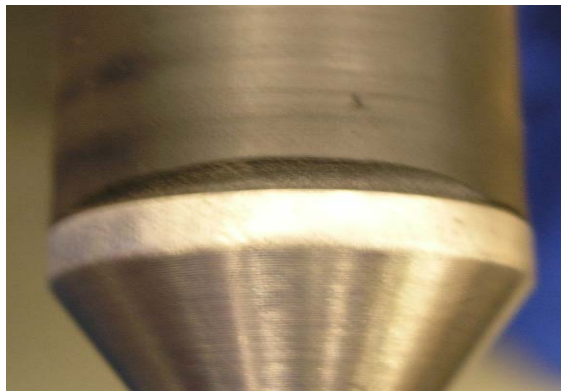
Inspection of the inductive stinger and coil showed no critical damage. A small tear or possible erosion was noted in the rubber of the inductive stinger tip (Figure 37). Engagement between the male and female portions of the inductive stinger assembly was initially impossible by hand, primarily because of the buildup of mud in the female coil (Figure 38), and to a lesser extent to swelling of the rubber on the stinger tip. Once the mud was cleaned, the stinger and coil interface was possible, though engagement was tighter than before the field test.

**Figure 37. Inductive stinger tip damage.**

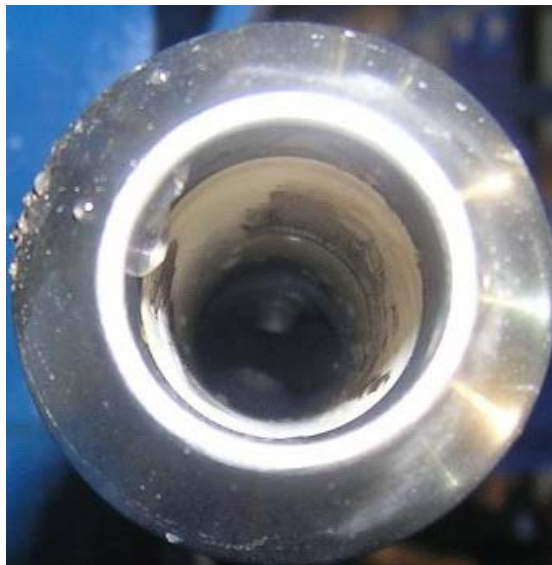
**Figure 38. Inductive coil with internal mud buildup.**

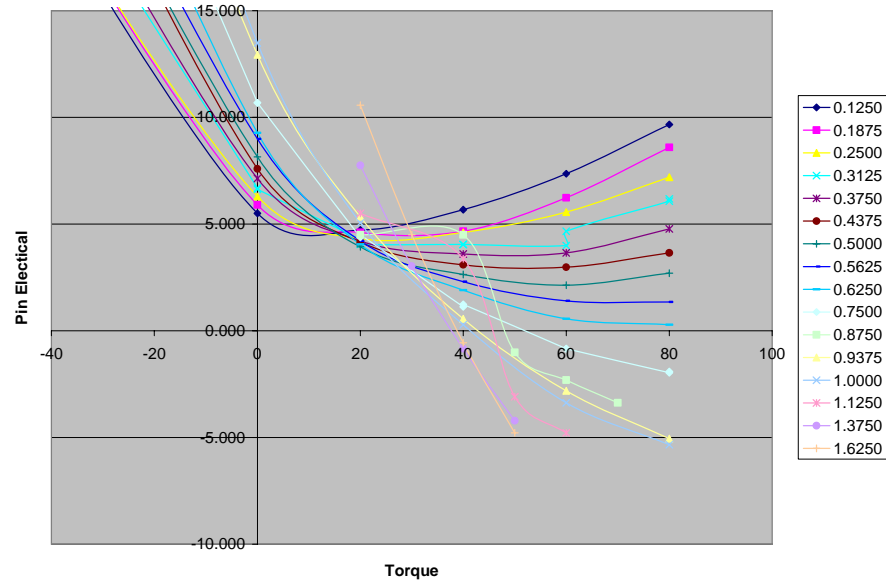
into the analysis of the ability of the tool to operate on battery for a period of time at different operational conditions.

**Figure 39. Modulator electrical power vs. torque for various telemetry rates.**

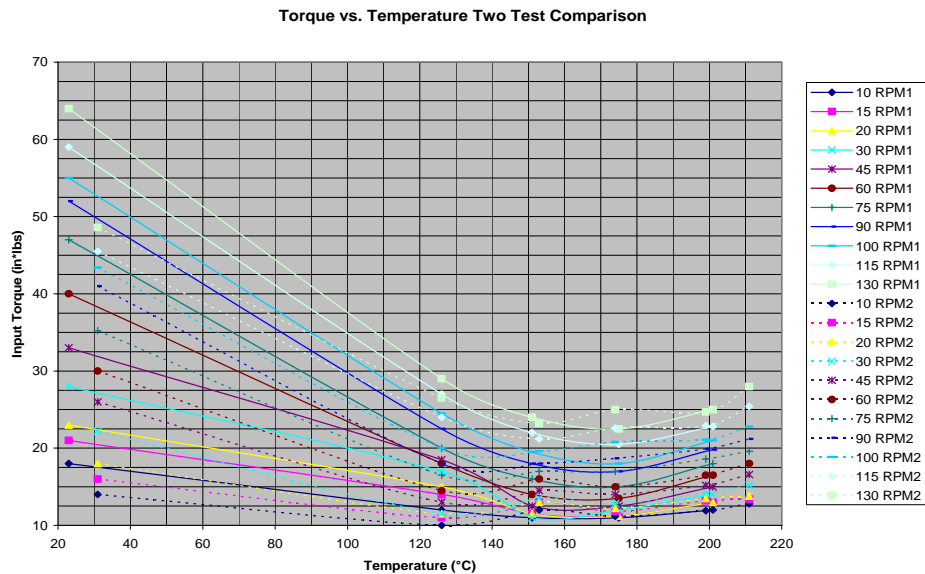
A second outcome was a characterization of required unloaded torque against temperature of the modulator at various telemetry rates (Figure 40). This quantitatively verified assumptions regarding power consumption of the modulator and also served as an important input into calculations of tool operational life.

**Figure 40. Modulator torque vs. temperature for various telemetry rates.**

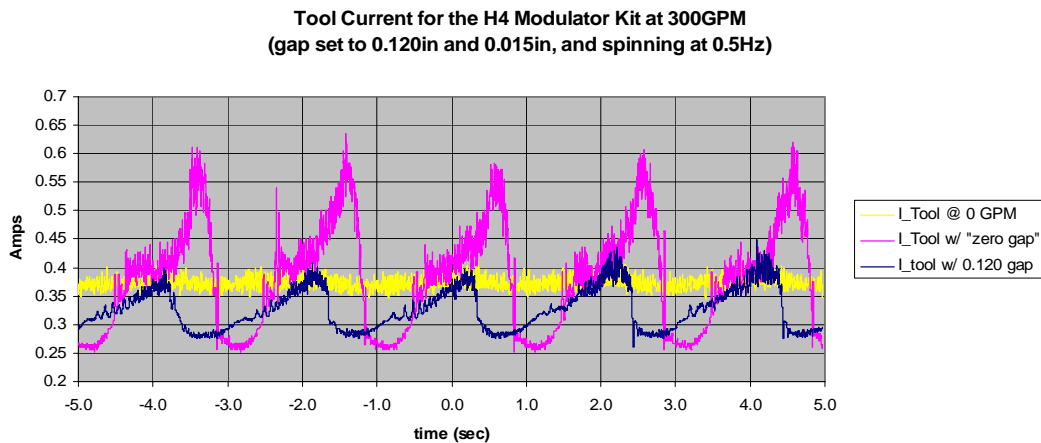
The last outcome was the discovery that with a 0.38 mm (0.015 in) gap, the modulator required a significantly larger amount of current to rotate under flowing mud conditions than previously anticipated. Figure 41 shows a plot of supply current against time for the same modulator with no flow (yellow), with flow at a 3 mm (0.120 in) gap (blue), and with flow at a 0.38 mm (0.015 in) gap (magenta). The regenerative power of the modulator can be seen by the lower average power in the 3 mm (0.120 in) gap as compared to the no-flow condition. The increased average power can be seen in the 0.38 mm (0.015 in) gap as well as the high peak current draw. The significance of this high peak current draw was that it was suspected, and later confirmed, that the battery could not provide sufficient current to turn the modulator in those conditions. This meant that the smaller gap was not feasible for use with the battery-powered tool, because the larger gap cannot generate sufficient signal strength to operate at extreme depths, the operational measured depth of the tool would be restricted to 6,096 m (20,000 ft) rather than the planned 9144 m (30,000 ft).

**Figure 41. Modulator current draw vs. time for various gap conditions.**
