## **300 Area D4 Project Fiscal Year 2008 Building Completion Report**

**December 2008**

**Washington Closure Hanford**

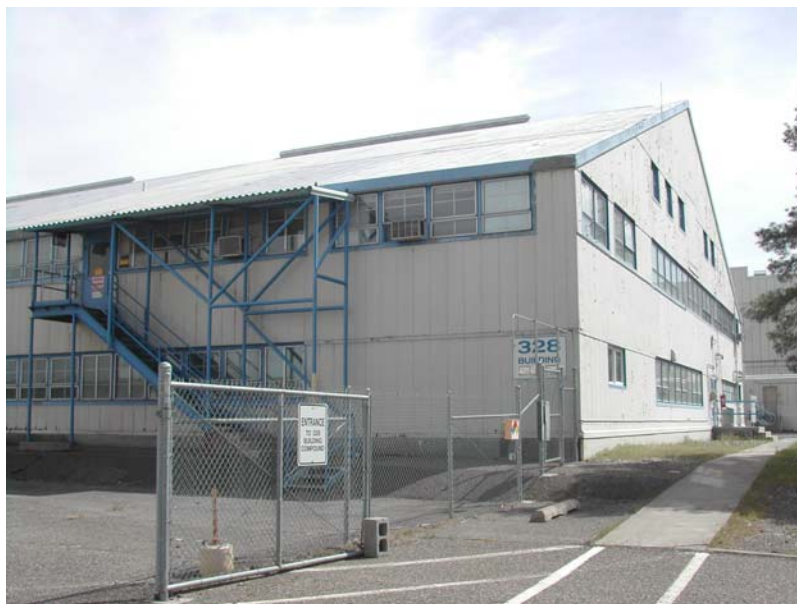
**Figure 1. 328 Building.**

The 328 and 328A Buildings were known as the Mechanical Development Building; the Engineering Services and Safety Building; the Engineering, Management, and Technical Shops; and Annex Building (Figure 1).

The 328 Building was rectangular with a bolted steel- frame. The original building (built in 1952) was 33.5 m by 67.7 m by 12.8 m (110 ft by 222 ft by 42 ft). In 1960, a 14 m by 14.6 m (46-ft by 48-ft) concrete block millwright's shop was added to the south end of the east facade. A year later a large concrete block annex known as the 328A sheet metal shop, measuring 7.6 m by 14.6 m (25 ft by 48 ft), was added to the north end of the east facade. With the additions, the facility dimensions were 33.8 m by 82 m by 12.8 m (110.8 ft by 270 ft by 42.25 ft) high with two concrete block additions on its east facade. The exterior walls were smooth steel insulated panels. The gable roof was built-up, covered with insulated, three-ply, asphalt felt. A plain metal cornice extended along the entire roofline. A reinforced concrete first floor supported a large shop area. The first floor contained a kitchen, lunch room, receiving room, tool crib, shops, conference room, mechanics room, restrooms, and welding shop.

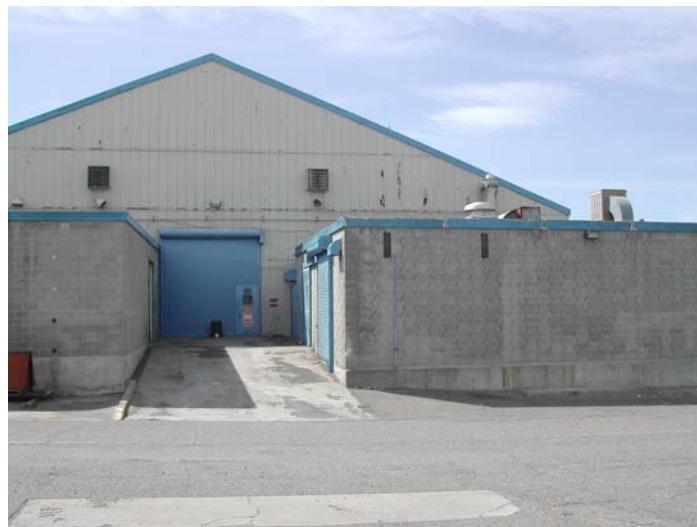
**Figure 2. 328A Building.**

The 328A Building was built in 1961 and was constructed of plain and decorative concrete block. The southern wall of 328A contained a large sliding plain metal door at its center with a corrugated metal roll-up door on either side of it. The building consisted of a concrete block annex and was known as the sheet metal shop. It measured 7.6 m by 14.6 m (25 ft by 48 ft).

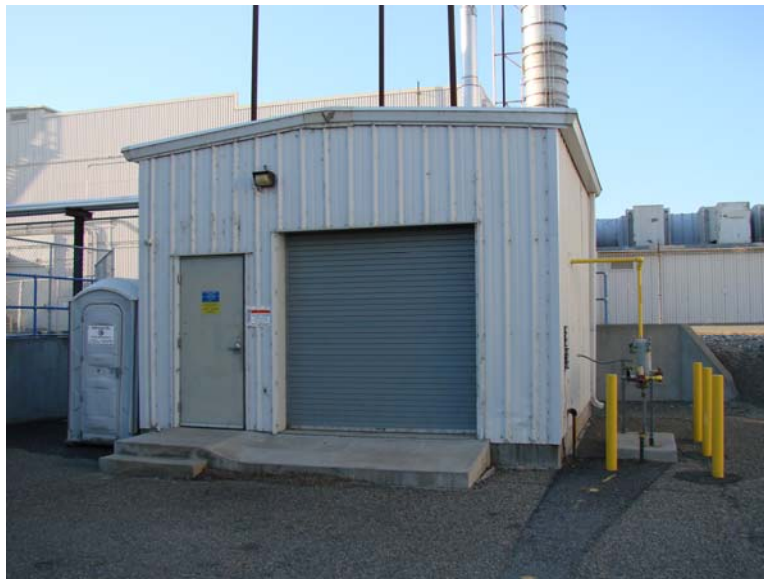
**Figure 3. 328BA Building.**

The 328BA Boiler Annex was built to supply steam to the 328 Building (Figure 3). All of the 300 Area boiler annexes were pre-engineered metal buildings on concrete slabs. The building was 5.3 m by 5.3 m by 3.7 m (17.5 ft by 17.5 ft by 12 ft). Each annex had 3-in. curbing around the sump and water softener. The buildings are electrically heated with one or two corner units installed in each annex.

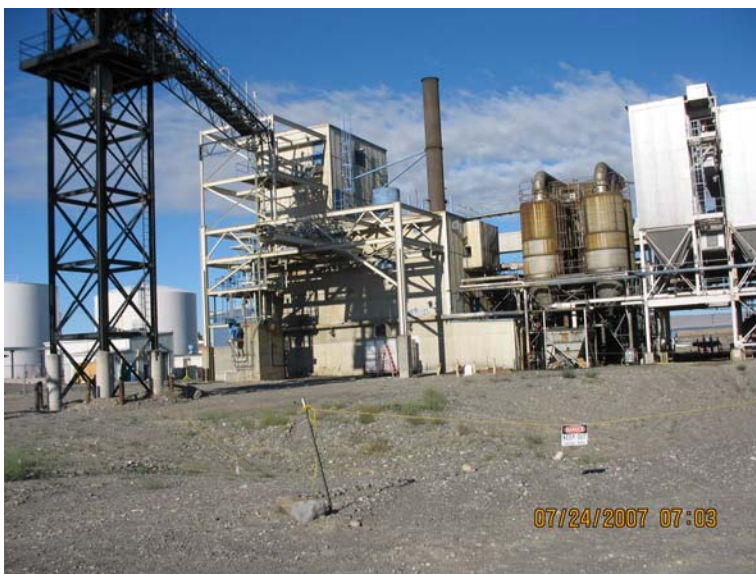
**Figure 4. 384 Building.**

The 384 Building was known as the Power House and the Heating Plant (Figure 4). The building was constructed in 1943 to provide process, heating steam, and compressed air to the 300 Area. The original equipment configuration consisted of two 300 HP cross-drum boilers with horizontal stationary grates. Large double-swing doors were opposite each boiler, in the east end of the building, so coal could be hauled in on two-wheeled buggies. These buggies were hoisted up on a monorail system that ran above the front of the boilers; the coal was then dumped into a dual stoking unit that was above each boiler. The fire box was divided into two sections so that ash could be emptied into wheelbarrows from one while the other continued to provide heat. Steel breeching ran above the roof connecting the two boilers to the 45.7 m (150-ft) brick stack (stack was removed in approx. 1987). At the west end of the building, a concrete platform with grating walkways surrounds the boilers at the 4.9 m elevation (16 ft). This platform supports a deaerator and flash tank. Beneath this at ground level were various

service and boiler feedwater pumps. Water softening equipment was located in the west end of the building and a wooden tank with treated water for the boilers was located outside just west of this equipment.

The 384 Building's original construction consisted of steel framing, reinforced concrete, and concrete block. The foundation was reinforced concrete extending 1.2 m to 1.5 m (4 ft to 5 ft) below ground level and supported a 6-in. reinforced concrete floor. The original building dimensions were 31.85 m (104.5 ft) by 12.6 m (41.5 ft) by 9.91 m (32.5 ft). The walls consisted of concrete block, and the roof was pre-cast concrete slabs covered with tar and gravel supported by structural steel framing. The pre-demolition dimensions of the main building were approximately 27.1 m (89 ft) by 63.4 m (208 ft) by 8.8 m (29 ft).

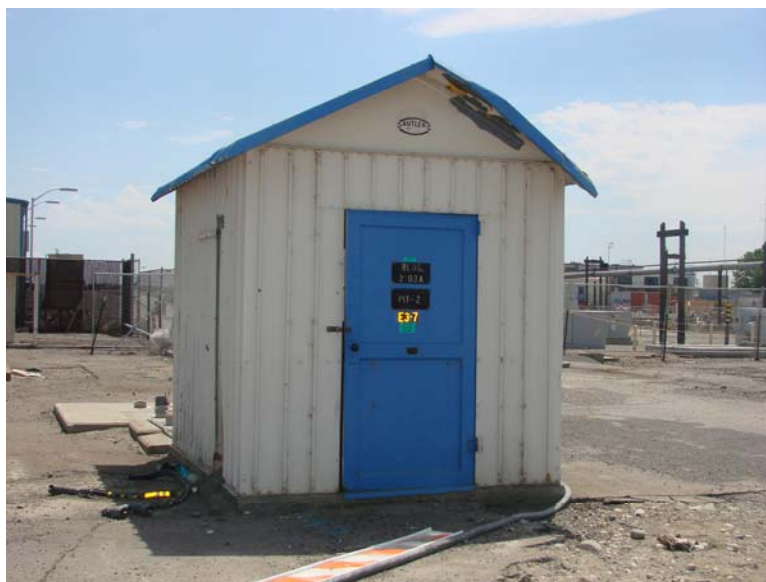
**Figure 6. 3503A Building.**

The 3503A Building, also called Pit #2, was used to house electrical equipment connecting the 384 Building to the substation northwest of the 313 Building site (Figure 6). 3503A was a small rectangular structure with fluted metal walls and roof. The roof is gabled and oriented north-south. On the north wall, there is a single metal entry door. A four-pane, fixed window is located in the center of the south wall. No features are on the east or west walls except for fluted metal barriers connected to the walls.

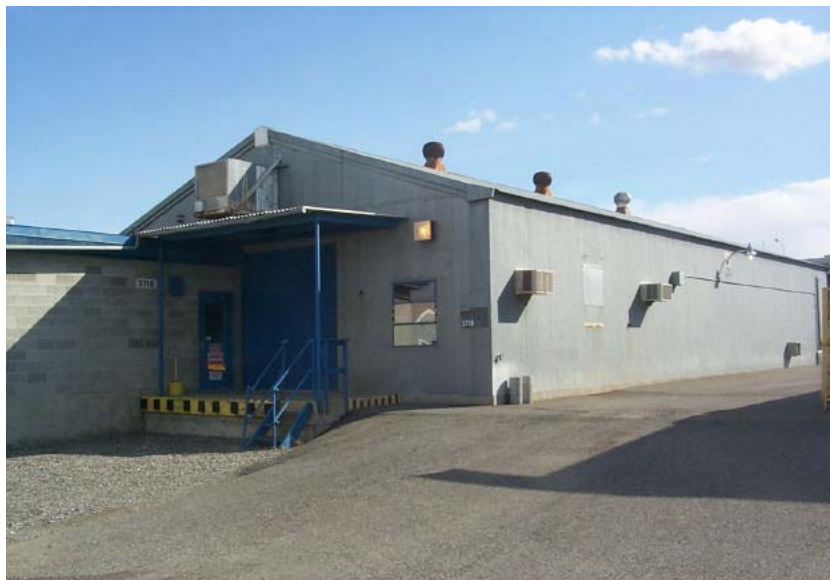
**Figure 7. 3718 Building.**

The 3718 Building was known as the Operation Support Services - Mechanical Building, the Central Storage Facility, and the Fast Reactor Thermal Engineering Facility (Figure 7). This building was constructed in the early 1960s and was a 24.4 m (80-ft) by 12.2 m (40-ft) by 5.5 m (18-ft) prefabricated metal storage building with gable roof, set on a 10.2 cm (4-in.) reinforced concrete slab foundation with footings. An office facility was added to the northeast corner of the building around 1963 and was 8.5 m (28 ft) by 6.7 m (22 ft) by 3.7 m (12 ft). This was constructed of concrete block set on a 10.2 cm (4-in.) reinforced concrete slab foundation with footings, and the roof was a 3-ply built up flat roof.

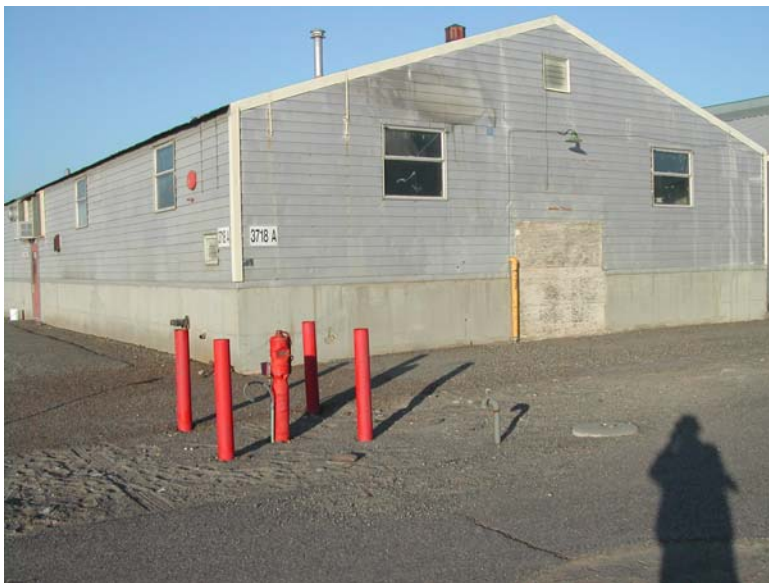
**Figure 8. 3718A Building.**

The 3718A, 3718B, and 3718C Buildings were known as the Laboratory Equipment Pool Buildings (Figure 8). The 3718A and 3718B Buildings were constructed in the late 1950s and were built next to each other. Later a reinforced concrete slab was poured between the buildings so the two buildings could be joined together with a roofed annex. Each of the two buildings had dimensions of 12.2 m (40 ft) by 24.4 m (80 ft) by 5.5 m (18 ft).

3718A was constructed of metal framing placed on a reinforced concrete slab with partial concrete walls. The inside was sheet-rocked from the top of the partial wall to where the roof joists started. The outside consisted of metal siding and the roof was a metal roof. The annex that was built between 3718A and 3718B consisted of metal framing, siding on the ends, and metal roofing.

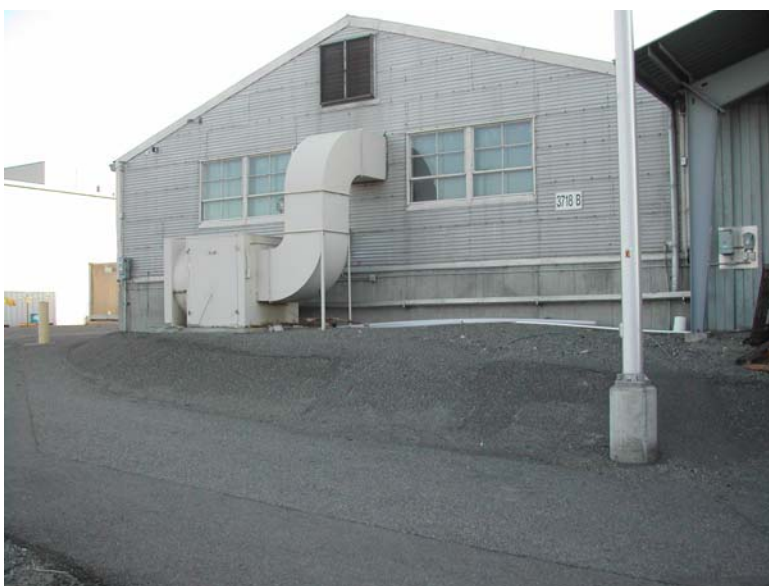
**Figure 9. 3718B Building.**

The 3718A, 3718B, and 3718C Buildings were known as the Laboratory Equipment Pool Buildings (Figure 9). The 3718A and 3718B Buildings were constructed in the late 1950s and were built next to each other. Later a reinforced concrete slab was poured between the buildings so the two buildings could be joined together with a roofed annex. Each of the two buildings had dimensions of 12.2 m (40 ft) by 24.4 m (80 ft) by 5.5 m (18 ft).

3718B was constructed similarly to 3718A and consisted of metal framing placed on a reinforced concrete slab with partial concrete walls. The inside was sheet-rocked from the top of the partial wall to where the roof joists started. The outside of the building consisted of metal siding and the roof was a metal roof. The annex that was built between 3718A and 3718B consisted of metal framing, siding on the ends, and metal roofing.

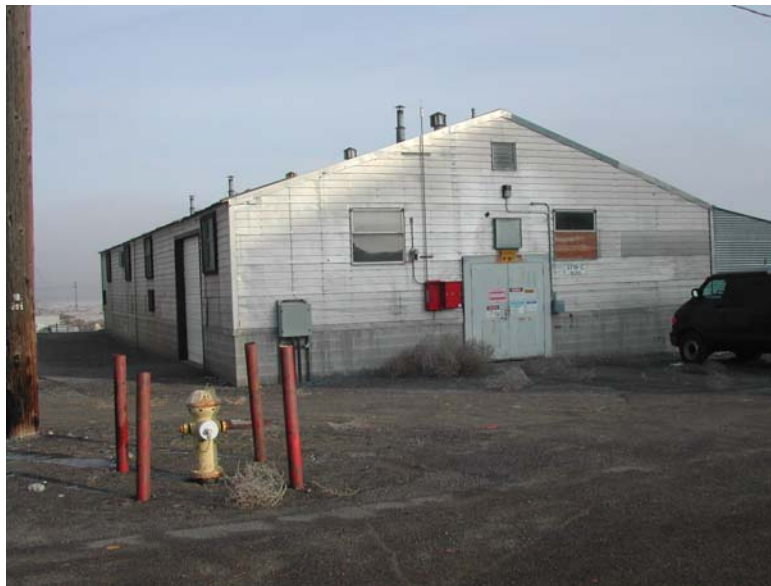
**Figure 10. 3718C Building.**

The 3718A, 3718B, and 3718C Buildings were known as the Laboratory Equipment Pool Buildings (Figure 10). The 3718C Building was of a similar construction as 3718A and 3718B and had dimensions of 40 ft by 80 ft by 18 ft. On the east side of the building, a covered area and enclosed storage area were added to the building during the 1960s. The total addition was 16 ft by 80 ft by 12 ft high and was set on a 6-in. reinforced concrete slab with footings. The addition was constructed of metal framing and corrugated metal on the sides and roof. The enclosed storage area was insulated with spray-on insulation.

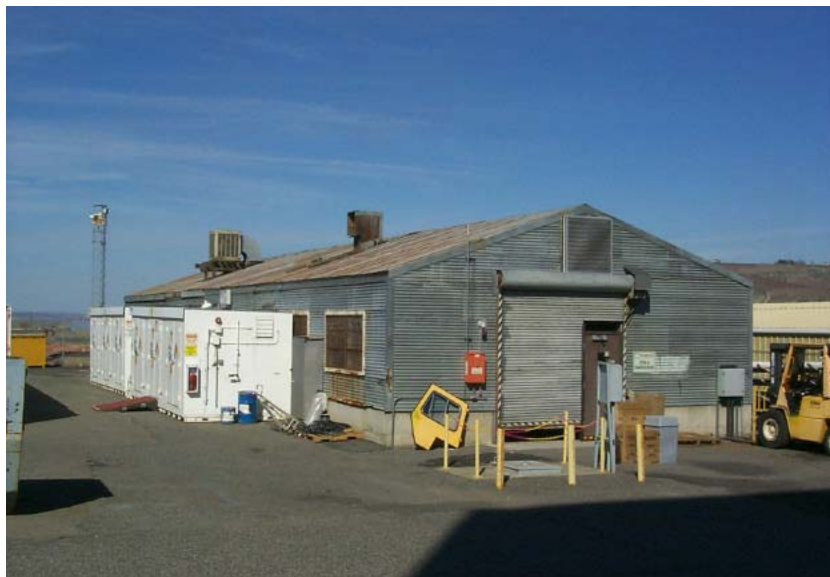
**Figure 11. 3718E Building.**

The 3718E Building was an open truss structure with sheet metal siding and roof and it rested on a 2.5-ft-high concrete foundation wall (Figure 11). The floor of the 3718E Building was a concrete slab with a footprint of 3,000 ft<sup>2</sup>.

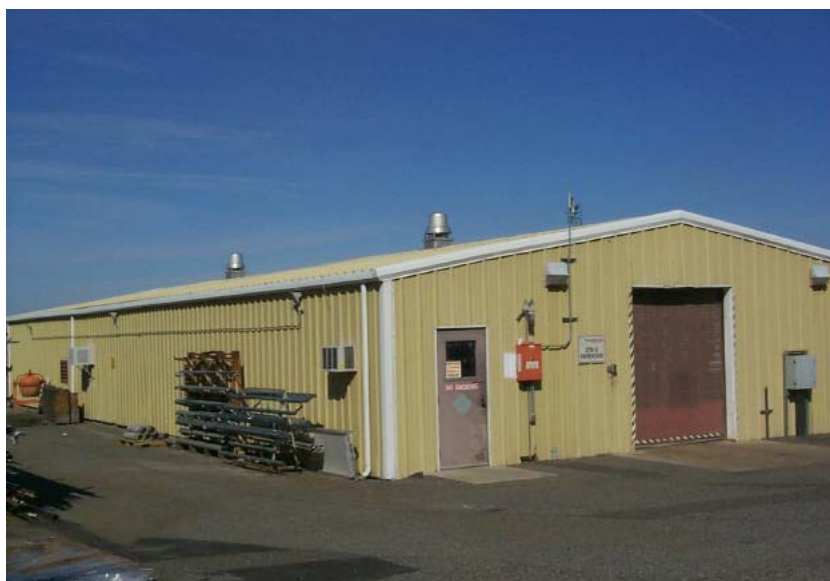
**Figure 12. 3718G Building.**

The 3718G Building was a rectangular one-story all metal pre-manufactured building erected on concrete foundations and slab (Figure 12). The footprint of the 3718G Building was 4,000 ft<sup>2</sup>.

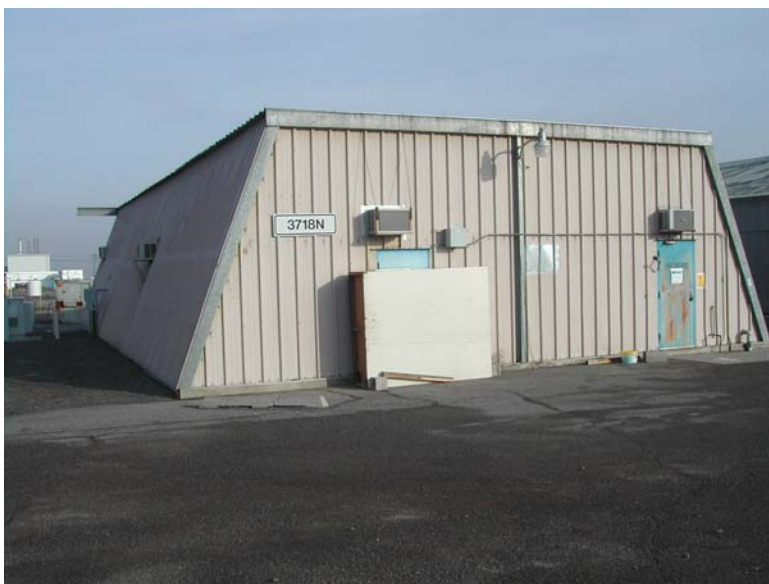
**Figure 13. 3718N Building.**

The original purpose of the 3718N Building, which was built around 1975, was to support electrical maintenance personnel with offices, storage, and equipment (Figure 13). The most recent usage of the building was by Fluor Hanford's vegetation management operations, where herbicides were stored. This building was a 73-ft by 40.5-ft by 14-ft prefabricated metal storage building with a flat roof and sloped sides. The building was set on a 6-in. reinforced concrete slab with footings.

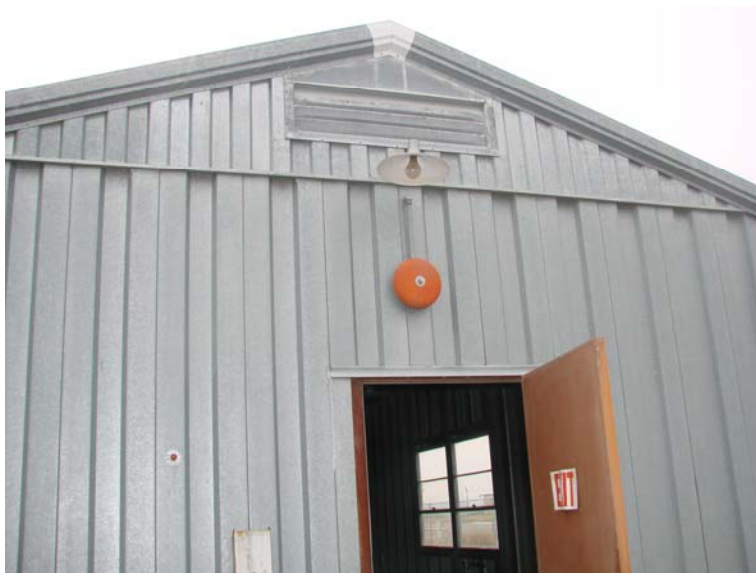
**Figure 14. 3718S Building.**

The 3718S Building was a single-level warehouse used principally as a research storage building (Figure 14). The 3718S Building was a 12 m (40-ft)-long by 6.1 m (20-ft)-wide metal building with a peaked roof and a concrete slab floor. It was located about 3 m (10 ft) west of the 321B Building. The electrical distribution and control systems for the 321, 321B, and 321C test facilities were removed from the 352D Building in 2002. The building was reallocated for storing chemicals and was renamed 3718S.

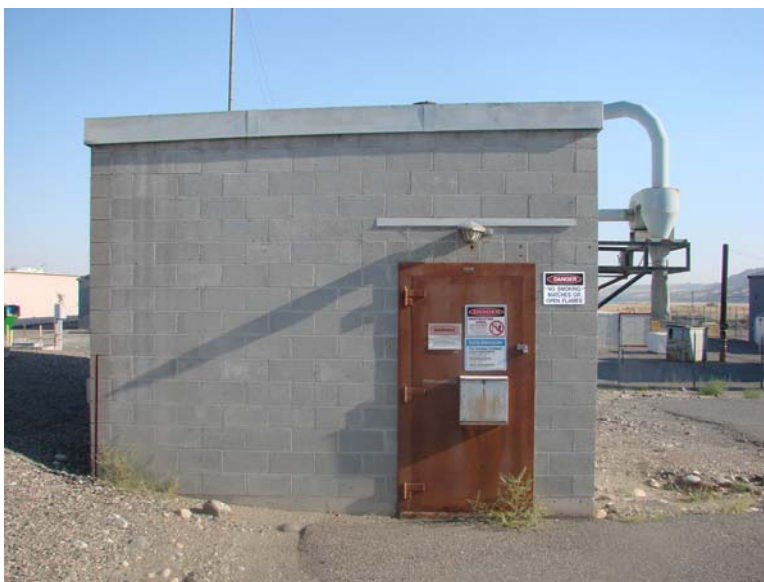
**Figure 15. 3721 Building.**

The 3721 Building was generally referred to as the 300 Area Classified Scrap Incinerator (Figure 15). The 3721 Building was located in the central portion of the 300 Area. The building was constructed in 1965 as a concrete block structure with an on-grade concrete floor slab. The one-story building consisted of one single room that housed a paper incinerator. In 1982, the incinerator was replaced with a paper shredder and disintegrator.

The overall dimensions of the 3721 Building were 18 ft long (north-to-south) by 14 ft wide (east-to-west).

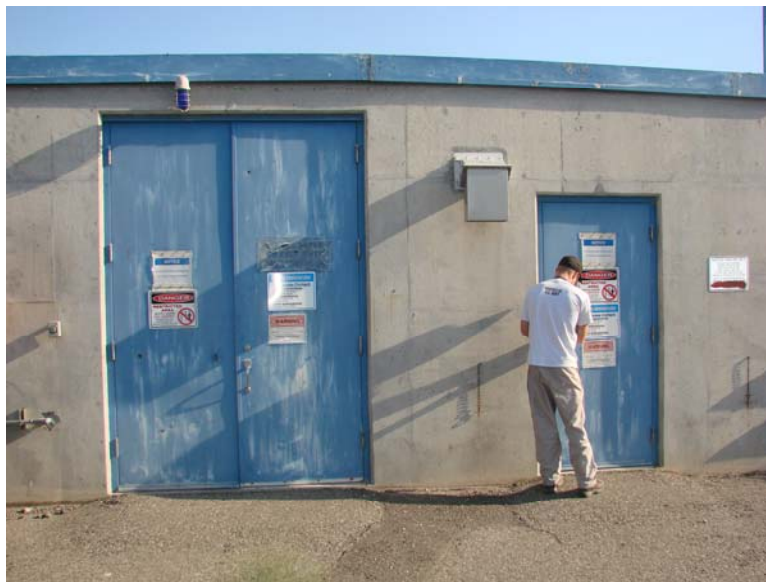
**Figure 16. 3727 Building.**

The 3727 Building was used for the secure storage of classified documents and fuel pins (Figure 16). The 3727 Building was also equipped with storage racks designed for holding fuel pins until they were needed. Fuel pins held nuclear fuel and were formed when pellets were placed into rods. Fuel pins would be placed into bundles and delivered to the reactors.

The 3727 Building was a concrete block structure with a concrete floor and flat roof. The building dimensions were 37.1 ft by 23.2 ft. The walls were 1-ft-thick concrete and the building sat on a poured concrete foundation. The building had no windows. Access was obtained through the double doors on the south wall; this door led to the vault foyer, a room that served as a buffer between the outside of the building and the vault door. This room contained a half-ton hoist on a ceiling track that ran north-south between the double doors and the wall just to the east of the vault door. The actual vault was accessed through a thick metal combination door. The northwest corner of the vault was enclosed with metal wire locked fencing that spanned from floor to ceiling.

The mechanical/electrical room was located in the southeast corner of the building. This room was accessed through a separate door and contained air conditioning, electrical equipment, and control boxes for the building.

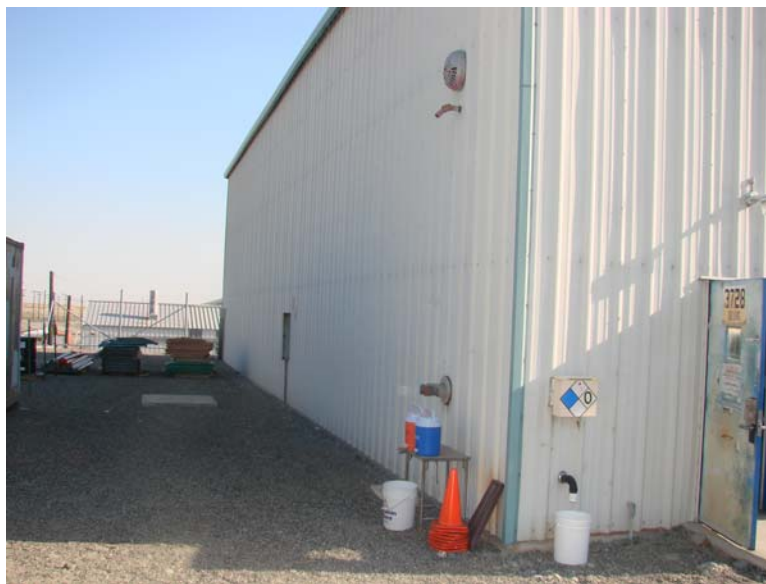
**Figure 17. 3728 Building.**

The 3728 Fast Flux Testing Facility (FFTF) Test Articles Storage Facility Building was built in 1980 (Figure 17). Minor modifications for the facility were planned during 1991 for use as the 3728 Geotechnical High-Bay Building. Since 1996, the 3728 Building has been used as an Environmental Sample Storage and Shipping Facility. The 3728 FFTF Test Articles Storage Facility was constructed in 1979 over the site of the demolished 3718-D Storage Building. The building was constructed for the purpose of storing full shipping containers used to transport test articles assemblies associated with FFTF operations. The test article shipping containers were to be stored at the 3728 Building until testing in the 300 Area was performed on them. The cover blocks for the vaults within the facility could be removed, and the shipping containers placed in the vaults using a rail-mounted A-frame-type crane. The edges of the cover blocks appear to be stepped to provide shielding for the test article shipping casks. No documentation could be found to determine if 3728 Building storage vaults ever were used to store shipping containers.

The 3728 Building was a pre-engineered metal building with an overall length (north-south) of 24.4 m (80 ft), a width of 14.2 m (40 ft), and a height of 6.7 m (22 ft) at the eave of the low peak roof. The building had a concrete floor 15 cm (6 in.) above grade. The center of the floor had a below-grade concrete vault area that was 15.2 m (50 ft) long by 8 m (26.5 ft) wide by 1.8 to 2.1 m (6 to 7 ft) deep from building floor level to top of 0.3 m (1-ft) -thick vault concrete floor. The vault area had four storage vaults with approximately 0.305 m (1-ft)-thick concrete cover blocks that were sealed with grout for the most recent use of the facility. Until approximately 1996, a wheeled A-frame crane was in the facility for the removal of the vault cover blocks. This crane could be moved within the facility on steel rails located along the west and east walls of the building.

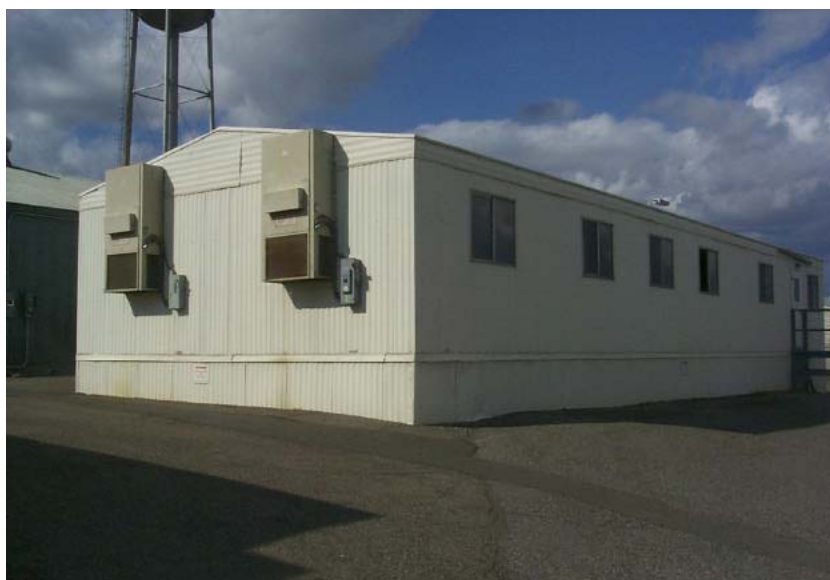
**Figure 18. MO-036 Building.**

MO-036 was manufactured in 1978 and brought on the Hanford Site in 1984 for use as offices for staff associated with the 340 facilities (Figure 18). MO-036 was placed inside the 340 compound midway along the western fence line. Because of the contents of the 340 facility, the compound was totally fenced with access restricted by locked vehicle gates and personnel gates that used Omni locks. From the acquisition date until the late 1990s, the trailer was used by the 340 organization; in the late 1990s the 340 facility was shut down and the staff was relocated to the 310 Treated Effluent Disposal Facility. At that time, the 327 project began using the trailer as office space for support staff. This continued for approximately 3 years until the 327 organization was reduced in size and moved into the 324 facility.

MO-036 was a double-wide trailer that contained six rooms used as offices, two rooms that were restrooms, one room used as a kitchen/lunchroom, and one closet that was used as the terminal for telephone and computer communication equipment. Construction was wood framing with a sheet metal exterior. The offices were wood paneled with carpeted floor. The flooring in the lunchroom and bathrooms was sheet vinyl. The roof was also sheet metal. The physical size of the trailer was 24 ft by 56 ft.
