GRANDE RONDE BASIN FISH HABITAT ENHANCEMENT PROJECT

2007 ANNUAL REPORT

Project No. 198402500

Oregon Department of Fish and Wildlife
107 20th Street
La Grande, OR 97850

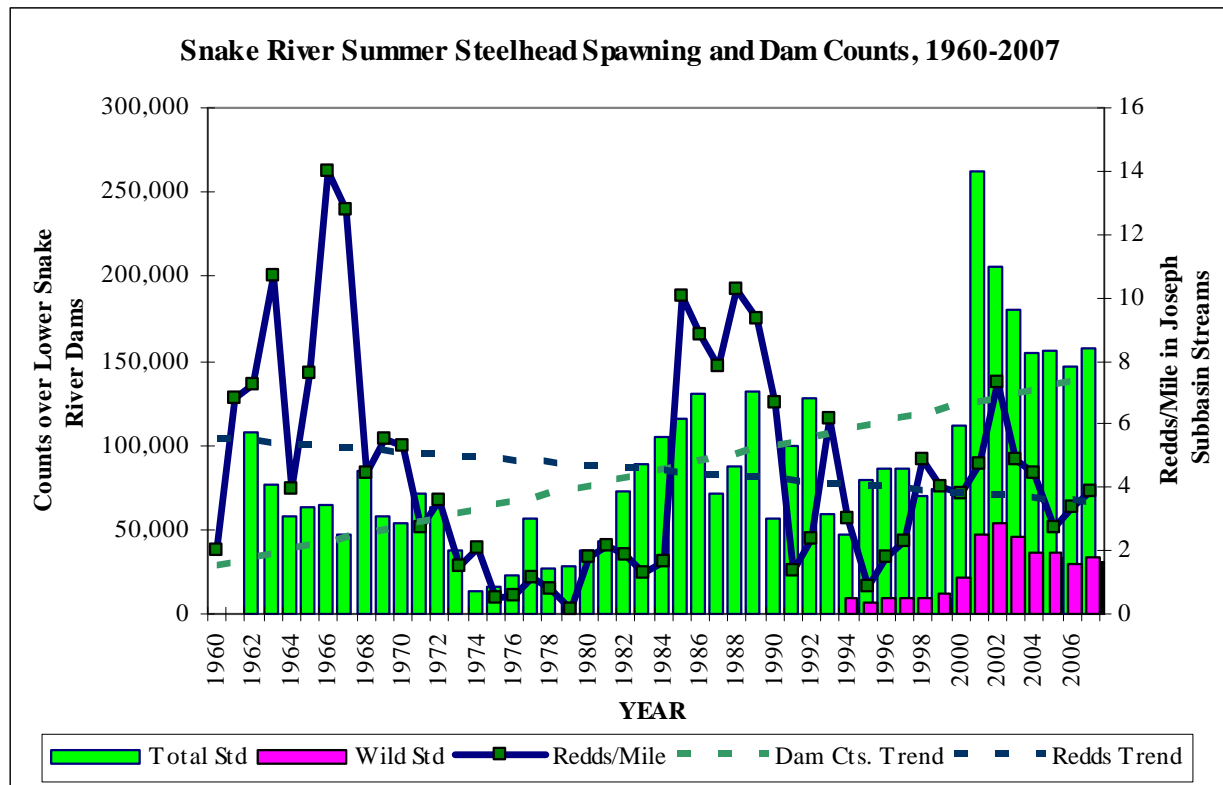
Figure 1. Snake River Summer Steelhead adult counts over Lower Snake River dams, and spawning ground counts in index Joseph subbasin streams, 1960-2007.

NOTES: The 1962-1974 dam counts are at Ice harbour and Little Goose, the 1975-2005 counts are at Lower Granite dam. Counting of wild steelhead separately from hatchery origin began in 1994. Joseph Creek subbasin index steelhead spawning ground counts include Butte, Chesnimnus, Crow, Devil's Run, Elk, McCarty Gulch, Peavine, Swamp, Summit and TNT Gulch Creeks.

stocks entering Oregon and Idaho) has fluctuated a great deal but showed substantial improvements after 1981 when fish passage improvements were initiated (Figure 1). Total returns over Lower Granite have remained in excess of 100,000 fish since 2000, with the 2001 counts being the highest on record. However, counts of the wild portion of the run, which began in 1994, remain relatively low, averaging only 18.2% of the total run in the last 14 years.

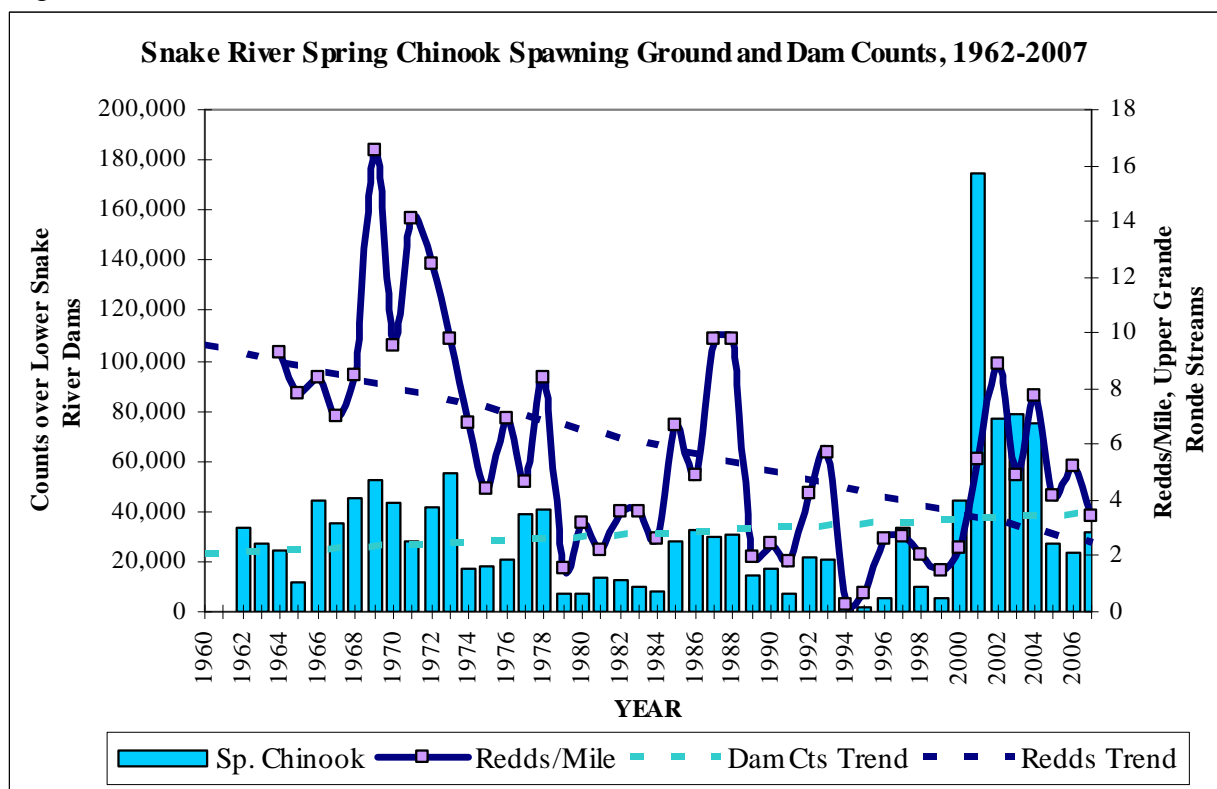
Figure 2. Snake River Spring Chinook adult and jack counts over Lower Snake River dams, and spawning ground counts in index Upper Grande Ronde subbasin streams, 1960-2007.

NOTES: Spring chinook dam counts include adults and jacks. Fish passage improvements and smolt transports began after 1981. Streams in this graph include ODFW index spawning ground counts of wild and hatchery fish in Catherine Creek, the Upper Grande Ronde River, and Sheep Creek, and wild fish in the Minam and the Little Minam rivers.

observed in the late 1960's and early 1970's (Figure 2). The streams illustrated represent a mixture of wild and hatchery stocks. The 1994 and 1995 redd counts were the lowest on record since extensive surveys were initiated in 1986 (Carmichael, 1994). Some improvement has occurred beginning in 2001, and counts reached 8.9 redds/mile in 2002. Up until 2004 the majority of the redds were counted in the Minam River, which is in unmanaged wilderness. In 2004 there were 98 redds found in the Upper Grande Ronde River as a result of a successful captive broodstock program (Carmichael, 2004). However, the UGR River counts dropped to 4 and 0 redds in the same index reaches in 2006 and 2007 respectively.

Spring chinook returns over Lower Granite dam (which includes hatchery and wild fish) have averaged 31,000 fish/year since counting began. The 1995 returns were the lowest run counts on record at 1,478, but increased over several years to a record high of 175,093 adults and jacks in 2001. The overall trend is up slightly, but with below average returns in the last few years (Figure 2).

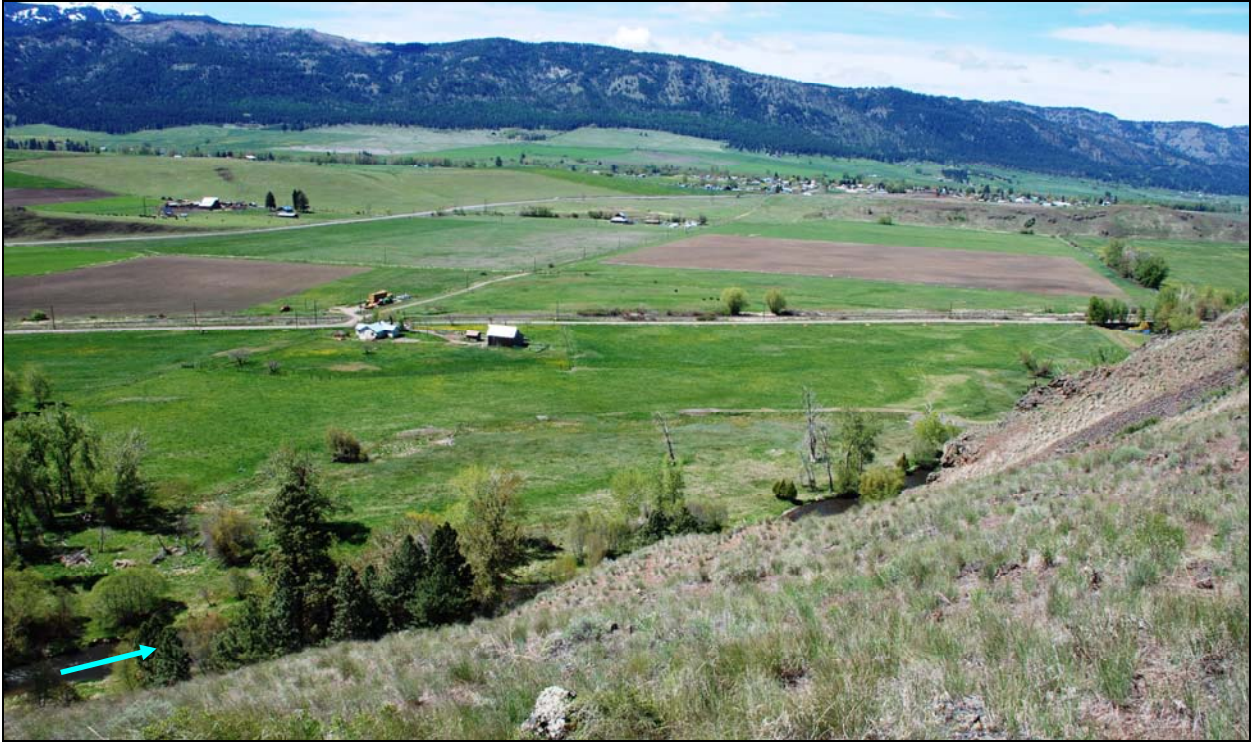
Figure 4. Wallowa River/McDaniel Reach 2, Ppt. 2, May 7, 2007. The photo was taken from the hillslope on the east side of the river looking down valley and to the west, prior to construction. The existing river is located at the base of the hill (blue arrow).

- Construction of 2,100 feet of new channel that will replace 1,784 feet of existing channel
- Installing 64 trees in revetments at 5 sites for lateral channel stability and habitat complexity
- Constructing 5 cross vanes for vertical channel stability
- Placing 10,222 ft² of sedge/rush mats along outside meanders
- Constructing one blended terrace using 3,090 yards of topsoil for flood control
- Removing 485 feet existing dike, consisting of about 1,500 yards of material
- Sorting of 5,632 yards gravels which will be hauled off to South Fork Ready Mix
- Seeding with 125 lbs. of seed mix

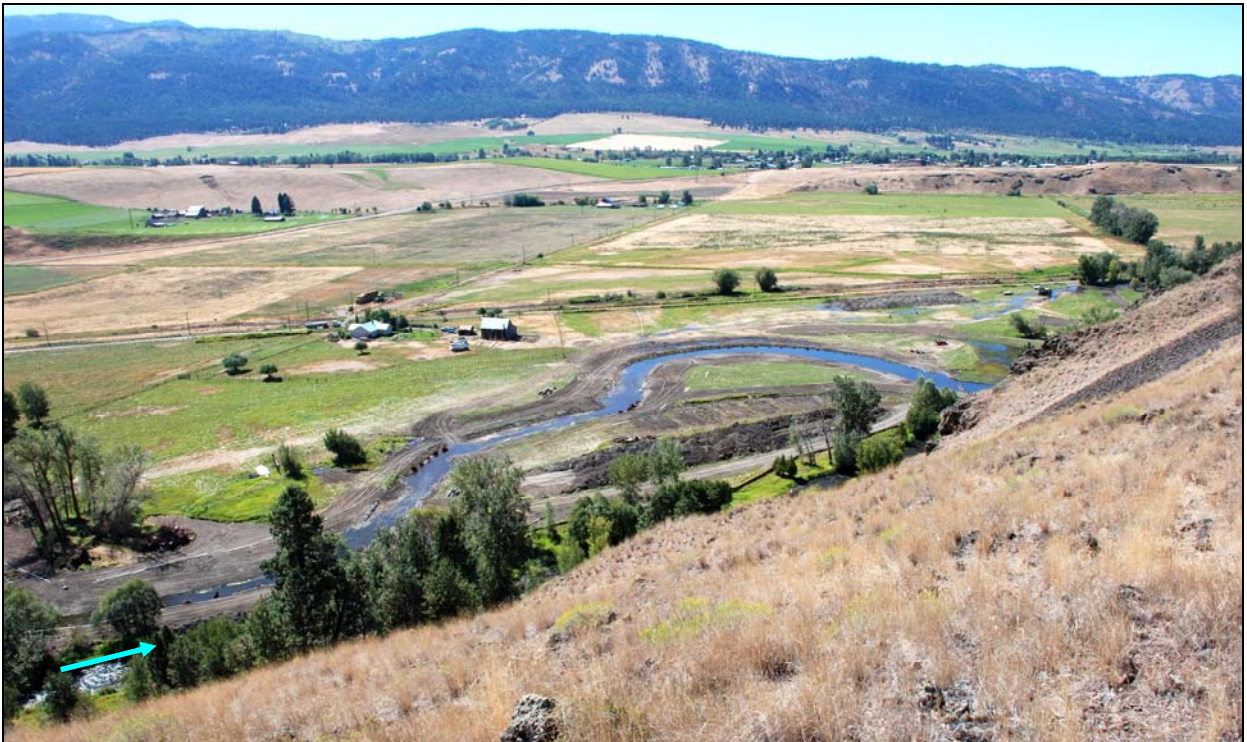
Figure 5. Wallowa River/McDaniel Reach 2, Ppt. 2, August 27, 2007. Phase I of construction complete.

Phase 2 will be completed in 2008, and will include connecting the channels at the upstream and downstream ends, extensive planting and conducting fish salvage.

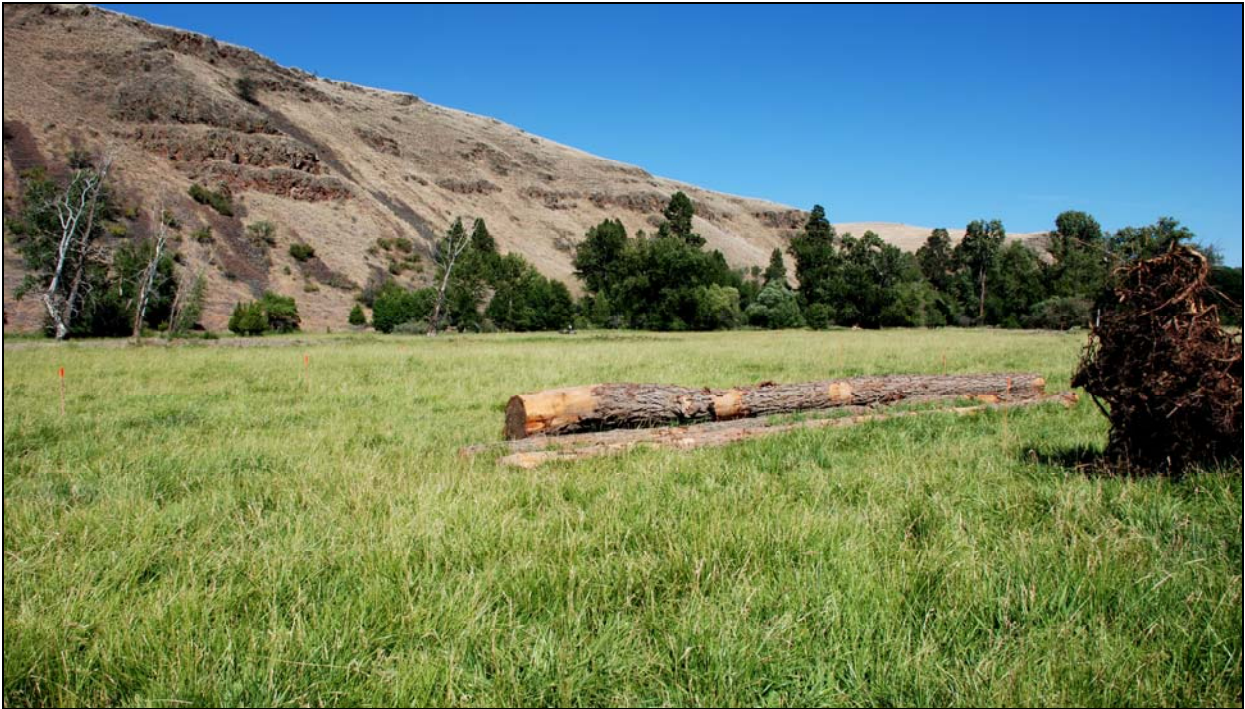
Figure 6. Wallowa River/McDaniel Reach 7a, Ppt. 2, July 9, 2007. Prior to construction.

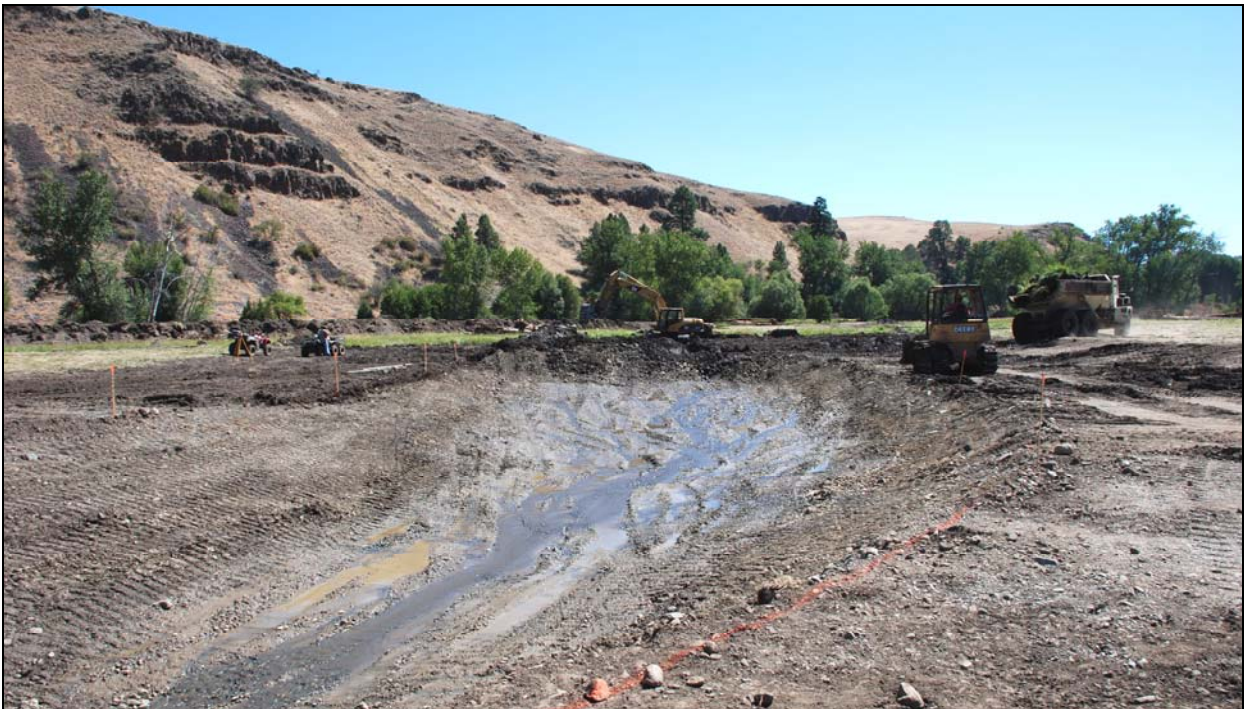
Figure 7. Wallowa River/McDaniel Reach 7a, Ppt. 2, August 2, 2007. LD Perry Construction crews complete the initial excavation of the channel and floodplain cuts.

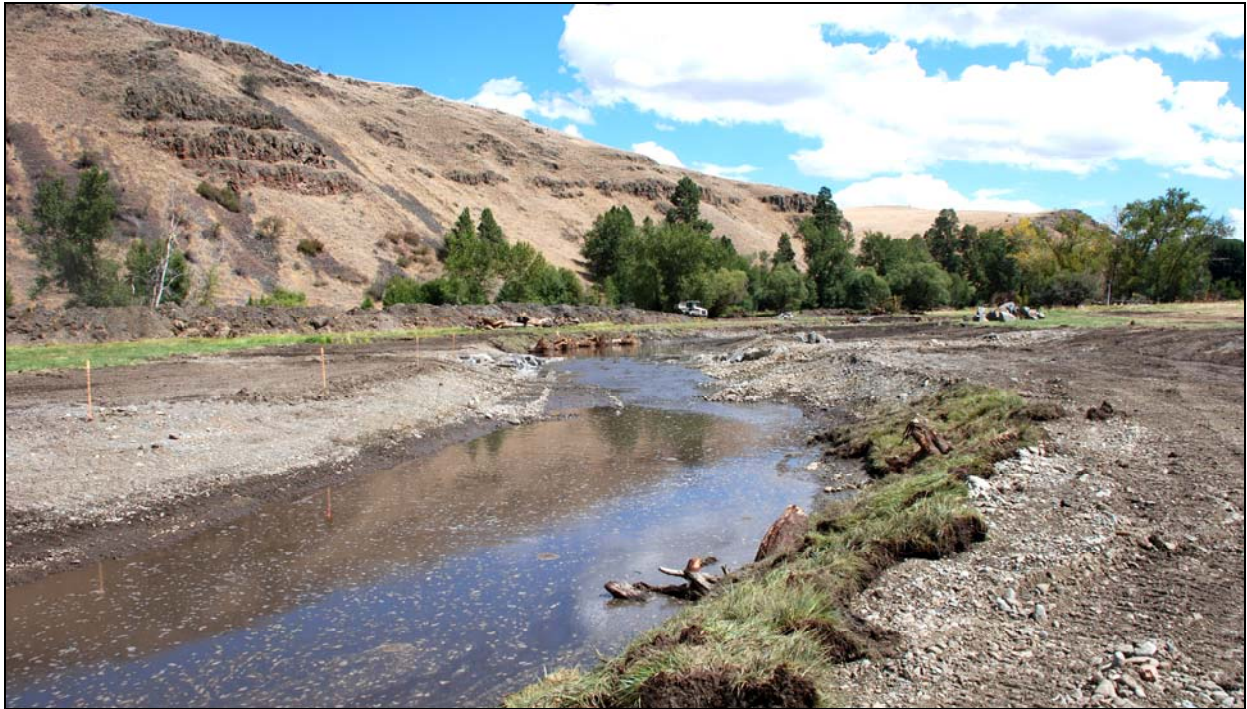
Figure 8. Wallowa River/McDaniel Reach 7a, Ppt. 2, August 21, 2007. Phase I of construction is completed illustrating sedge/rush transplants placed along a rootwad revetment bank. This technique provides lateral channel stability (prevents erosion of the near bank) as well as complex hiding cover for fish. The channel has not yet been connected (scheduled for 2008), but groundwater seepage has begun filling the pools.

In addition to the 10,222 ft² of sedge/rush mats noted above (Figure 8), the Wallowa River/McDaniel Reach 2 project was seeded with 125 lbs. of riparian seed mix. ODFW personnel transferred aluminum pipe from End Creek to this project and set up an irrigation system along the floodplain cuts. The site was watered 1-2 times per week using 4-inch trash pumps with fish screens. A small portion of the Reach 1 project, near station 11+00 was also irrigated at the landowner's request.

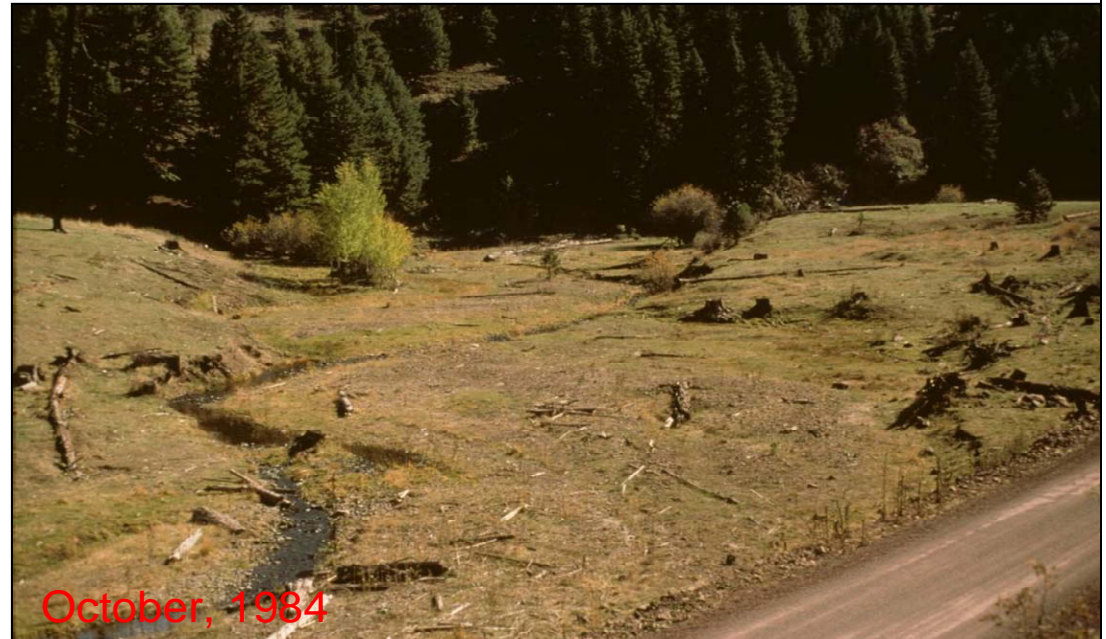
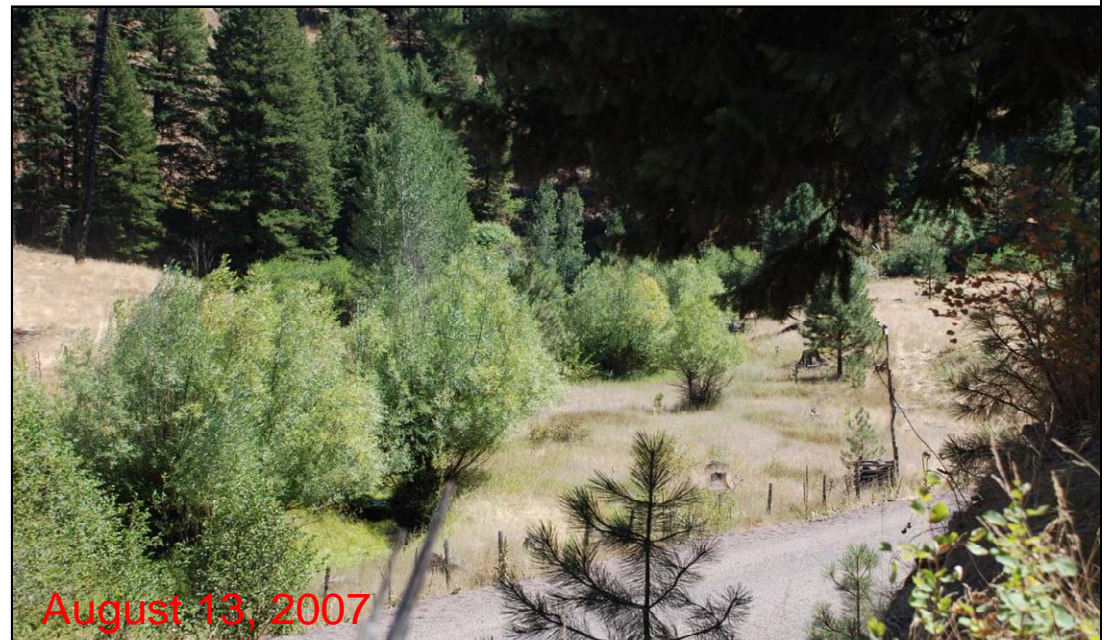
Figure 10. Example of project photopoint comparison on one of our oldest projects.

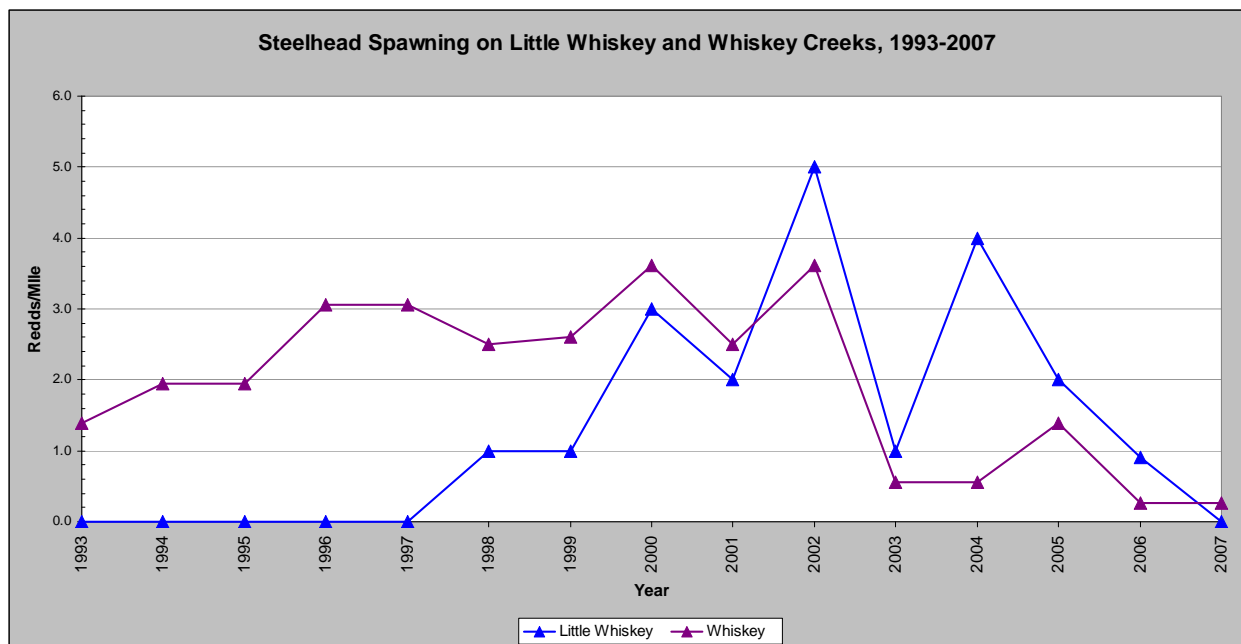
**Figure 10.** Redd counts on 4.6 miles of Whiskey Creek and Little Whiskey Creek, 1993-2007.

Steelhead spawning surveys were completed on 25.6 miles of streams in May and June 2007. Water conditions for conducting spawning surveys were less than ideal this year with higher than normal spring rains and poor water clarity. Redd counts overall have shown a downward trend beginning in 2003. The 2007 counts averaged 1.42 redds/mile (Table 2), compared to 1.15 redds/mile in 2006, 0.5 redds/mile in 2005, 0.7 redds/mile in 2004, 1.1 redds/mile in 2003, and 1.8 redds/mile in 2002. Redd counts on Whiskey and Little Whiskey creeks also dropped off considerably in 2003-07 (Figure 10).

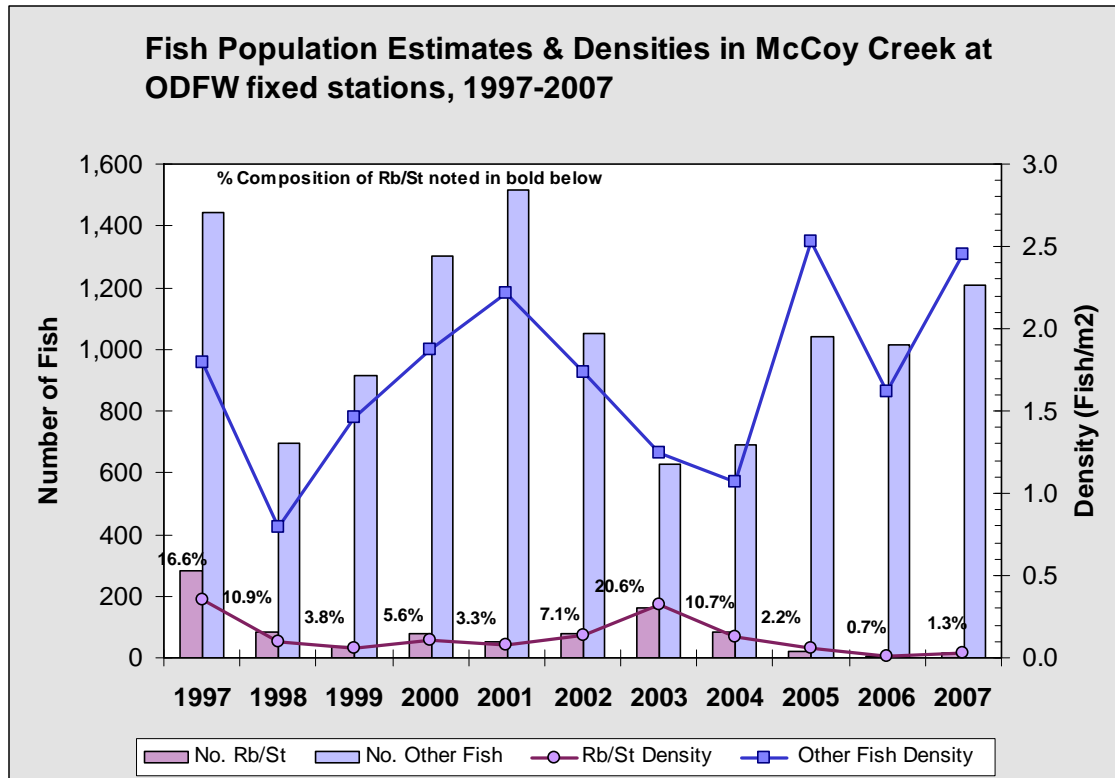
Figure 11. Fish population estimates and densities of Rb/St and other species in McCoy Creek, 1997-2007.

We intend to abandon the electrofishing study on McCoy Creek for a number of reasons. The original design was somewhat flawed (no pre-project data was collected, sample areas were not well thought out, and the time of year sampled is when temperatures are rapidly on the increase and fish are likely on the move). In addition, it is becoming more time consuming tracking and reporting the results of electrofishing studies to NOAA fisheries, and salmonid sampling mortality on this stream is unusually high. We may consider repeating these surveys in year's ahead, but only if redd counts or temperature data indicates that distinctive changes in habitat conditions are occurring.
