# Hungry Horse Mitigation Flathead Lake

Annual Progress Report 2008  
Project 9101901

## As-built Report

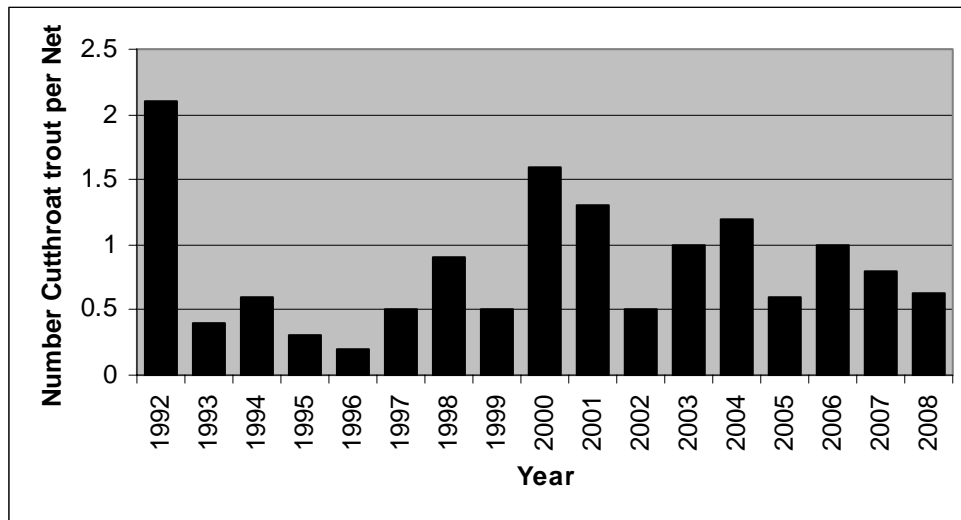
Figure 1. Number of westslope cutthroat trout caught per floating net during spring in Flathead Lake, 1992-2008.

We set six floating and six sinking gillnets in Flathead Lake in cooperation with Montana Fish, Wildlife and Parks during spring 2008. The data generated by this sampling program contributes to a long-term monitoring index of abundance of westslope cutthroat trout (Figure 1) and bull trout (Figure 2) in the Flathead system. This monitoring tool is intended to be one measure of the effect on native adfluvial trout of mitigation projects taking place throughout the basin. Capture rates during the period of sampling are highly variable and provide no clear evidence of a trend in abundance of either species since sampling began.

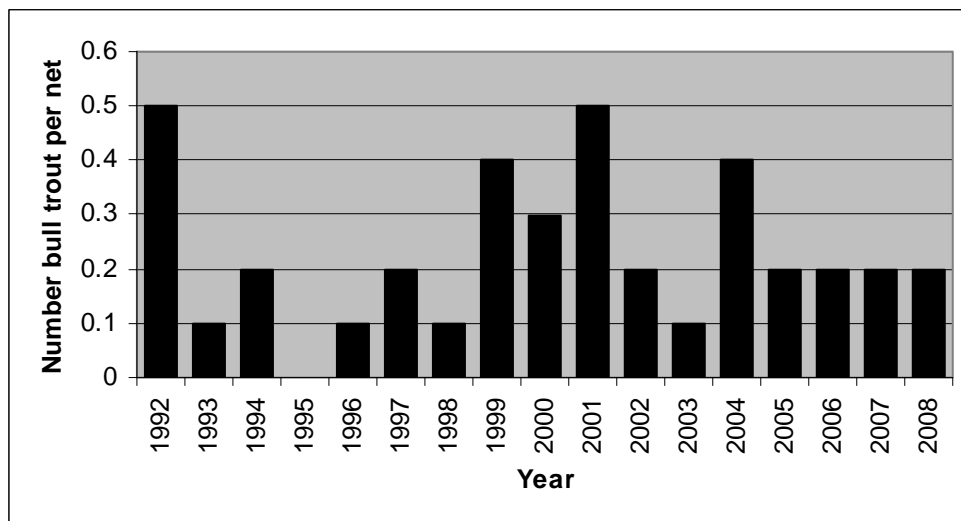
Figure 2. Number of bull trout caught per sinking net during spring in Flathead Lake, 1992-2008.

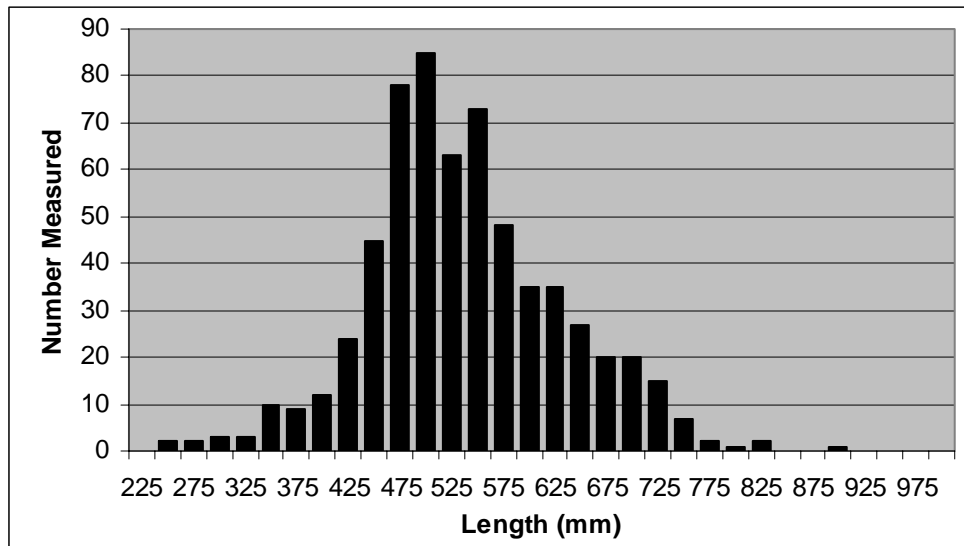
Figure 1. Lengths of lake trout measured during creel survey, 2008.

The creel survey is another tool to measure the effect on native adfluvial trout of mitigation projects throughout the basin. Its primary use though has been to monitor the harvest of lake trout which currently exert the greatest control over native adfluvial trout abundance. During 2008 we interviewed 1289 parties of anglers and conducted 206 aerial and ground counts of anglers. The average length of lake trout caught by anglers was 526 mm TL (Figure 1) and age 7 fish were the most abundant year class in the catch (Figure 2).

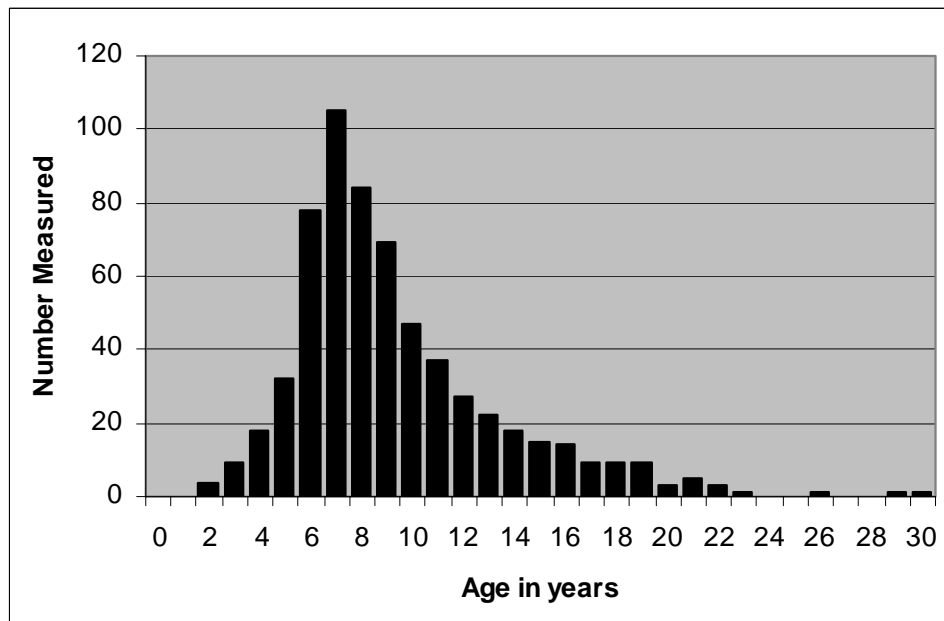
Figure 2. Ages of lake trout measured during creel survey, 2008.

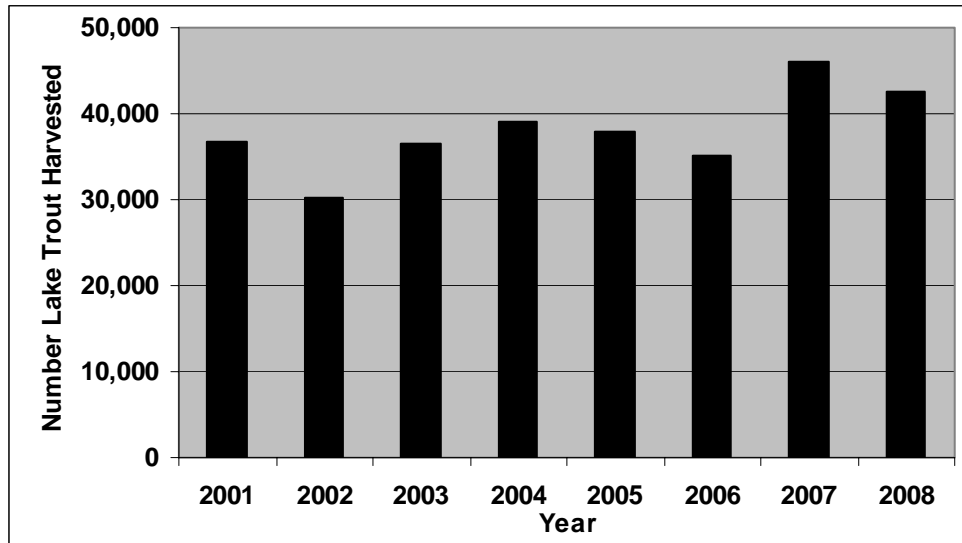
Figure 3. Estimates of annual harvest of lake trout, Flathead Lake, 2001 to 2008.

total harvest of 45,196 lake trout. We estimated that total pressure equaled 163,867 angler hours during 2008. We also estimated the harvest during 2008 of 19,435 lake whitefish, and 38,953 yellow perch. Annual harvest of lake trout is trending upward slightly, but has not increased sufficiently to reach the desired management target for harvest (Figure 3).

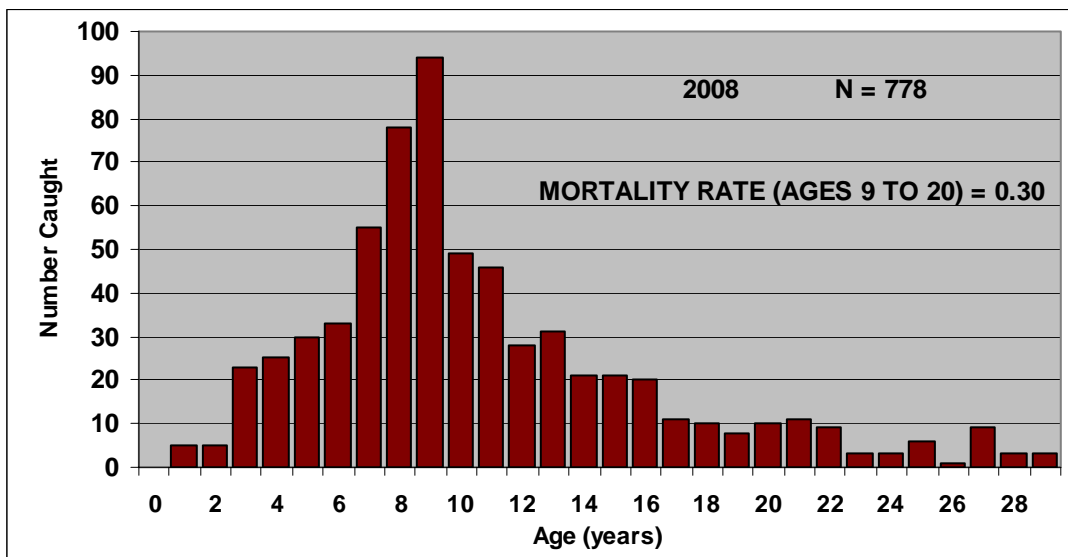
Figure 1. Estimated age structure of Flathead Lake lake trout derived from gillnetting samples, 2008.

We assigned the catch to age classes based on an age key developed from scales read in 2005. A fairly uniform decline in survival between age 9 and 20 is evident, representing a mortality rate of 0.30 as computed by the Robson Chapman method (Figure 1). This mortality rate has been very consistent over the last ten years and is substantially below the 0.50 target level identified by many researchers as necessary to reduce the lake trout population (Healey 1978, Nieland et al. 2008). Length-at-maturity for male lake trout has been trending upward since 1996, indicating that the population has reached or is near carrying capacity based on the supposition that the population requires increasingly more time to accumulate the resources necessary to reach maturity (Figure 2). A parallel trend has been quantified for growth rates in which decreasing growth has been measured over the period from 1986 to 2005 (Figure 3). These growth data were developed from a technique under development in which age is determined from the weight of the otolith based on a comparison with the total length to otolith mass relationship derived from fish collected in 2005. Increasing otolith weights relative to length indicate decreasing growth rates.

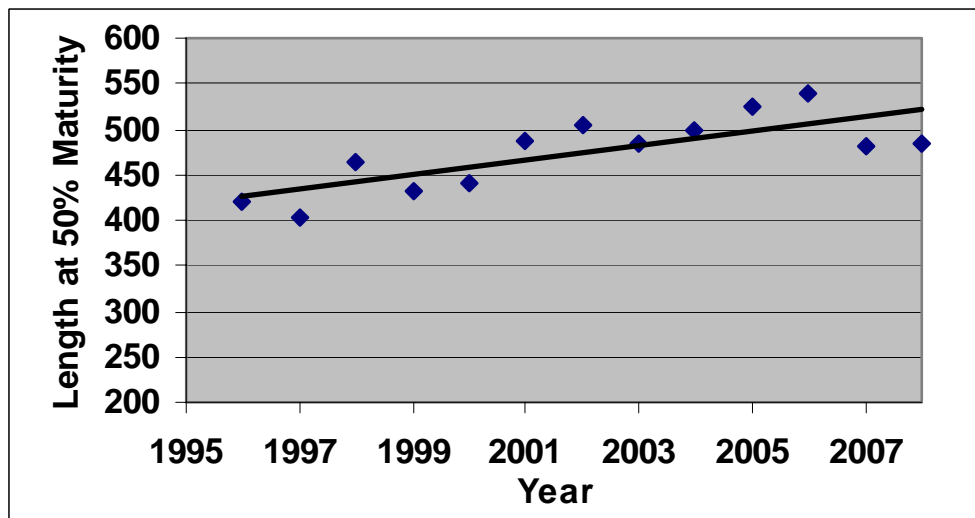
Figure 2. Lengths of male lake trout at 50% maturity in Flathead Lake, 1996 to 2008.

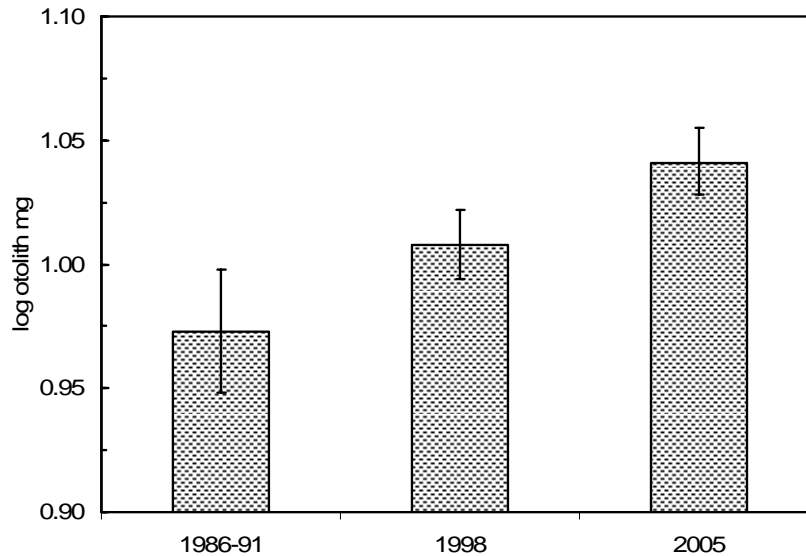
Figure 3. Marginal means of log otolith mg (at log TL mm = 2.636) from 1986-91, 1998, and 2005 for lake trout with TL ranges = 294-538 mm. Bars denote 95% confidence intervals.

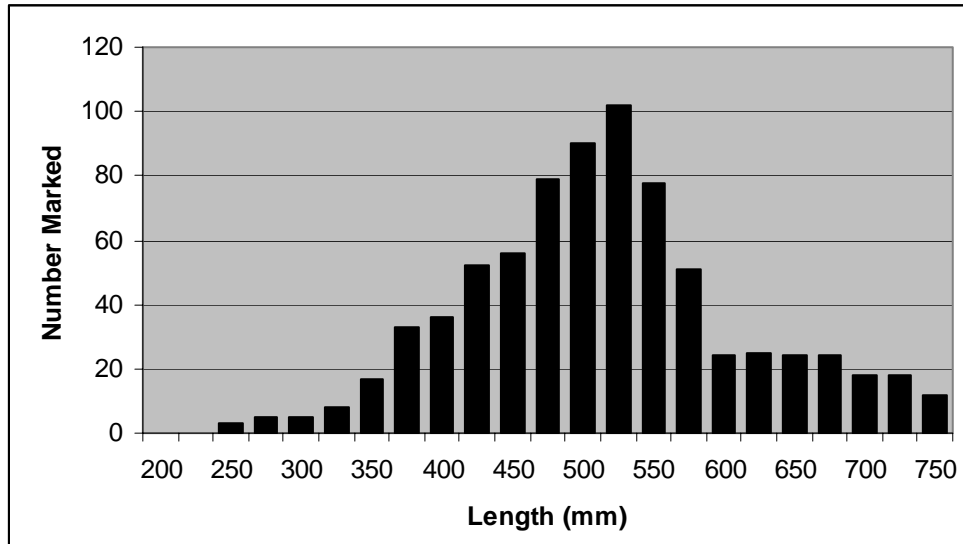
Figure 1. Lengths of lake trout marked for recapture during fall 2007.

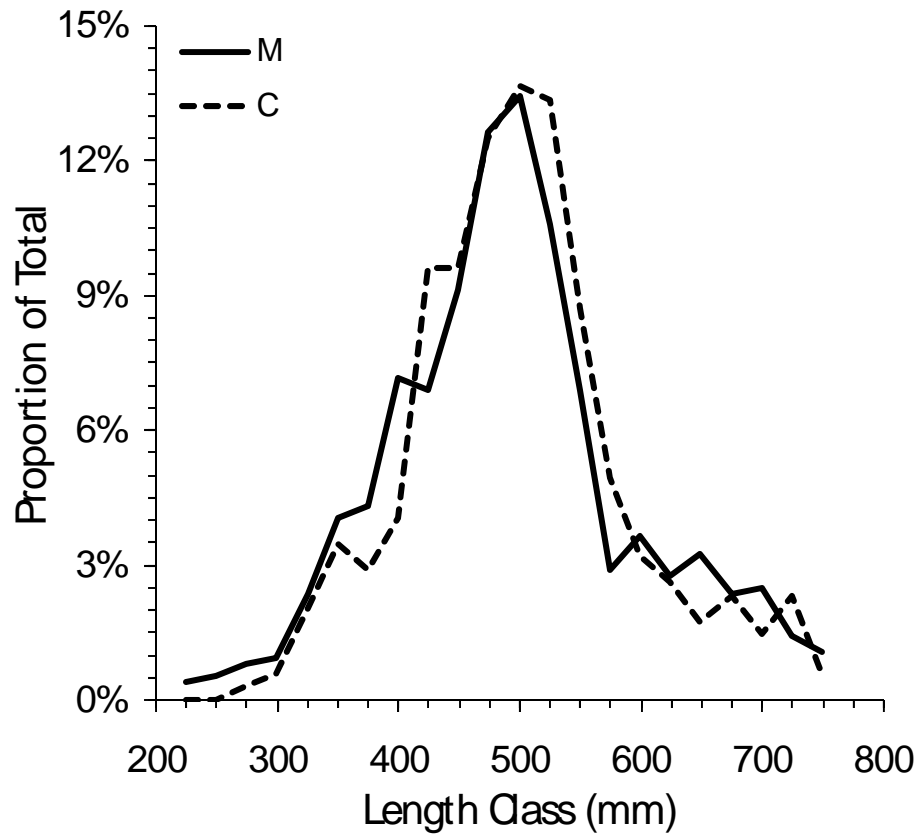
FIGURE 1.—Length-frequency of lake trout captured for marking by angling and gill netting from 5 October 2007 through 10 March 2008 (M) and examined for marks by angling during 3–16 October 2008 (C) in Flathead Lake, Montana.

**Results** – Angling and gillnetting from 5 October 2007 through 10 March 2008 resulted in a sample of 856 lake trout marked ( $M$ ), while angling in a derby during 3–16 October 2008 resulted in a sample of 10,108 lake trout examined for marks ( $C$ ), of which 21 were previously marked ( $R$ ). The length frequency of lake trout in samples of fish marked and recaptured were quite similar, though the overall length frequency of the recapture sample ( $C$ ) was shifted slightly to the right in relation to the marked sample ( $M$ ; Figure 2), likely because fish grew between the spring marking period and the autumn recapture period. The fraction of fish marked in the recapture sample ( $R/C$ ) was constant across size classes (Figure 3), which indicated that size selectivity of sampling was nearly the same between marking and recapture. The mark-recapture estimate of lake trout abundance was nearly 400,000 fish in Flathead Lake on 10 March 2008, whether based on pooled samples of all size classes or separate estimates for different size classes (Table 1), which reflects the relatively constant vulnerability to capture of all sizes of lake trout during marking and recapture (Figure 2). Population density for lake trout in Flathead Lake was relatively high, compared to Lake Pend Oreille, Idaho, Wisconsin waters of Lake Superior, and other North American lake trout populations (Figure 4).

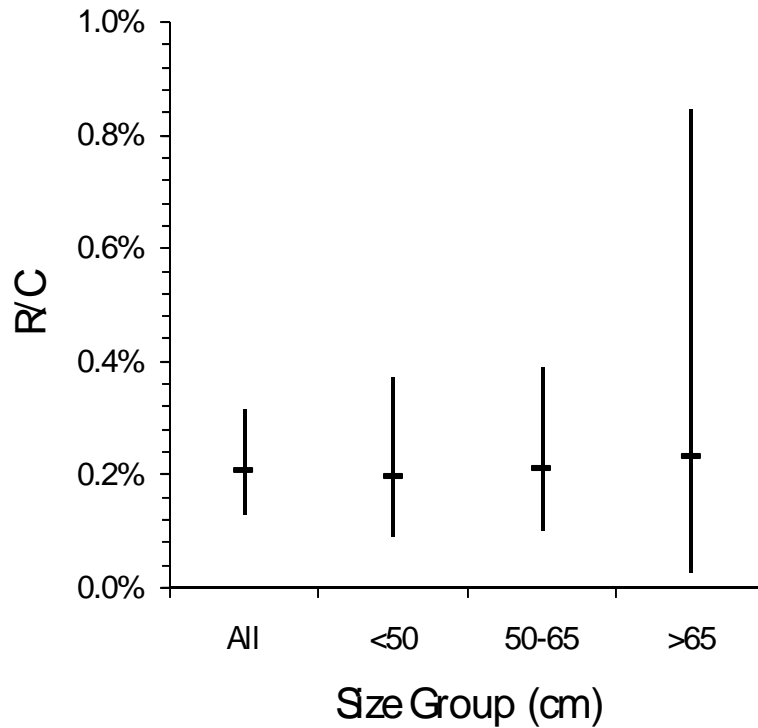
FIGURE 2.—Proportion of marked individuals ( $R$ ) in samples examined for marks ( $C$ ) in an angling tournament for all size groups and three different size groups of lake trout in Flathead Lake, Montana during 3–16 October 2008.

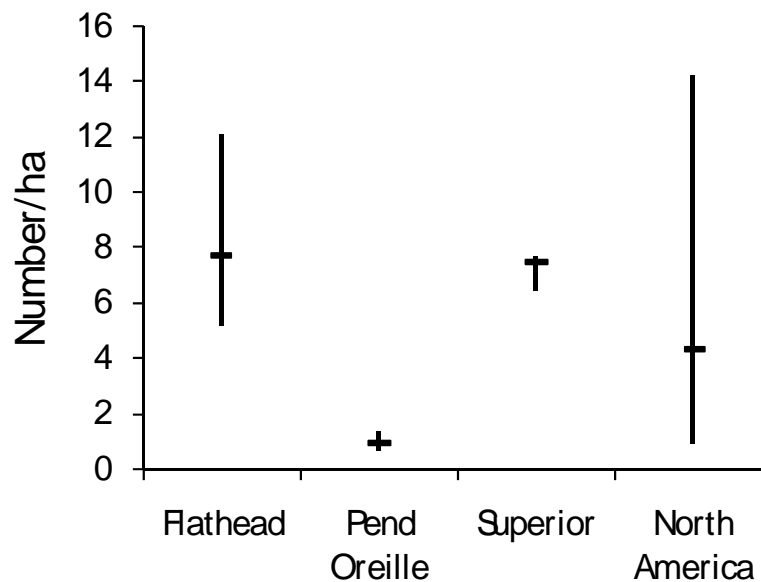
FIGURE 3.—Population density (number/ha) of lake trout in Flathead Lake, Montana, on 10 March 2008 (this study;  $\pm$  95% confidence limits), Lake Pend Oreille, Idaho, on 15 December 2005 (Hansen et al. 2008;  $\pm$  95% confidence limits), eastern Wisconsin waters of Lake Superior at carrying capacity (Nielland et al. 2008;  $\pm$  95% simulation error), and in North American lake trout lakes (Healey 1978; Martin and Olver 1980;  $\pm$  range of estimates).

**Discussion** – The lake trout population in Flathead Lake is likely near carrying capacity, based on the estimated population density in spring 2008. For example, the lake trout population in eastern Wisconsin waters of Lake Superior (i.e. the Apostle Islands region), when recovered to carrying capacity, was simulated to be at a similar density as in Flathead Lake. In contrast, the lake trout population in Lake Pend Oreille, Idaho was much lower at its peak in autumn 2005, before targeted netting and angling suppressed the population since 2006. In Lake Superior and Lake Pend Oreille, 45% annual fishing mortality was the primary cause of lake trout population declines. In comparison, a harvest of 10,108 lake trout from a population of nearly 400,000 lake trout represents an exploitation rate of only 2.6% in Flathead Lake in 2008.

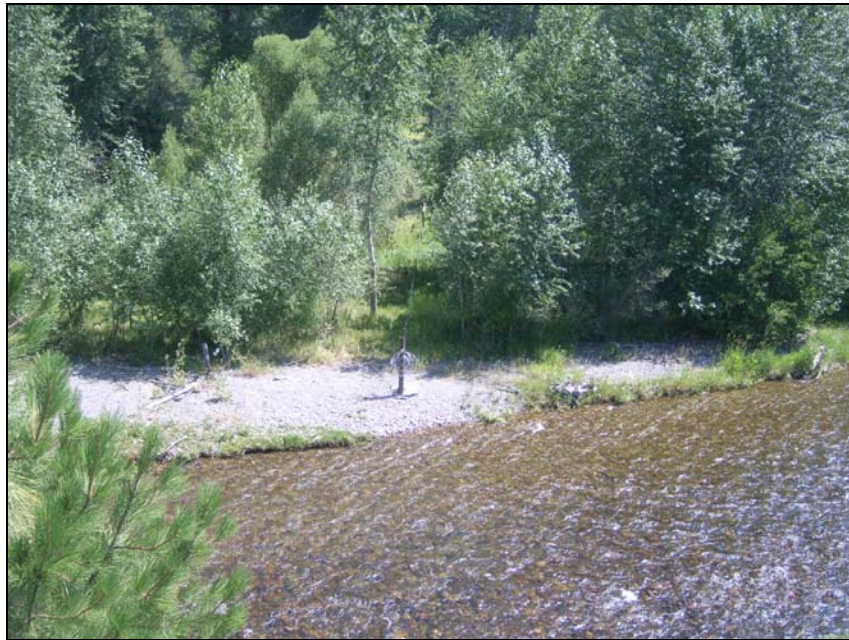
Figure 1. Perimeter fence on Bogage property. The coiled wire hanging from the post is stretched across the Jocko River after peak flows have receded to prevent cattle from entering the property via the river channel.

We constructed a new fence along the perimeter of the Bogage property (2900 ft in length) to protect this acquisition from trespass cattle (Figure 1). This project will ensure that the habitat quality of this acquisition will not be diminished by unauthorized grazing.

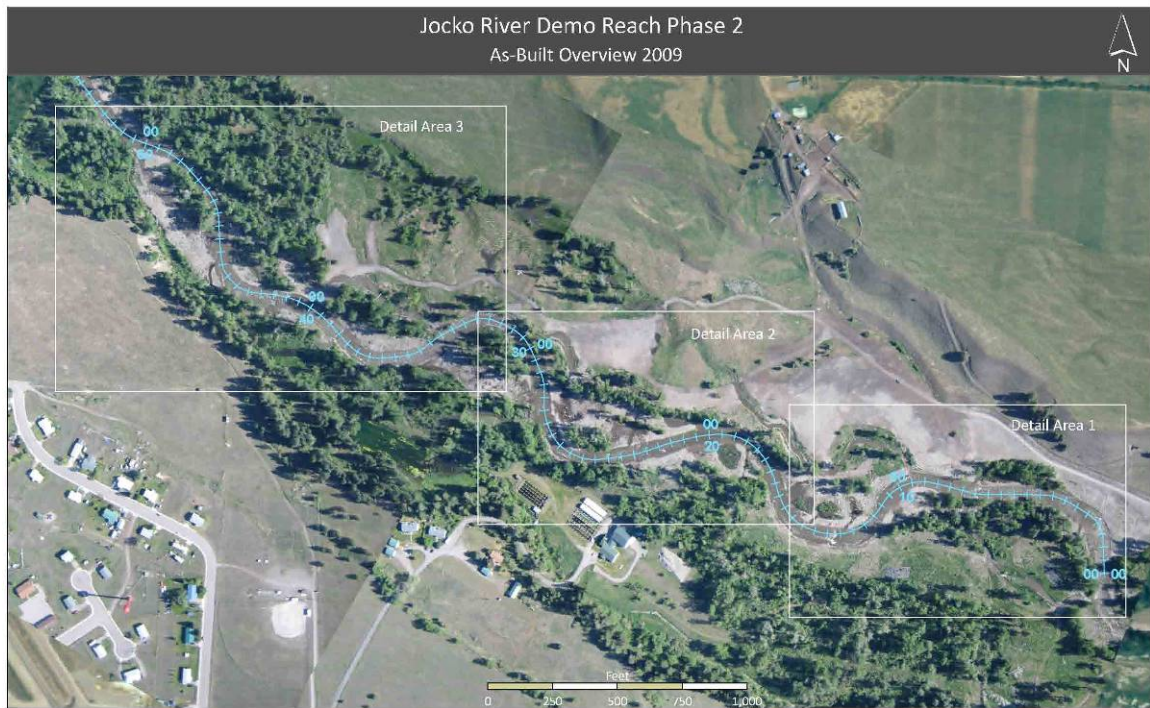
Figure 3. Jocko River Demonstration Reach Phase II reconstructed channel alignment. Detail areas are shown in Figures 16, 17, and 18 below.

Throughout the Demonstration Reach Phase II project area, the pre-disturbance morphology was reconstructed to achieve project objectives described above. Design dimensions are shown in Table 1. Figure 2 shows a pre-project overview of the channelized and diked river channel. Figure 3 shows the constructed channel center line and stationing superimposed on an aerial photo from late May 2009.

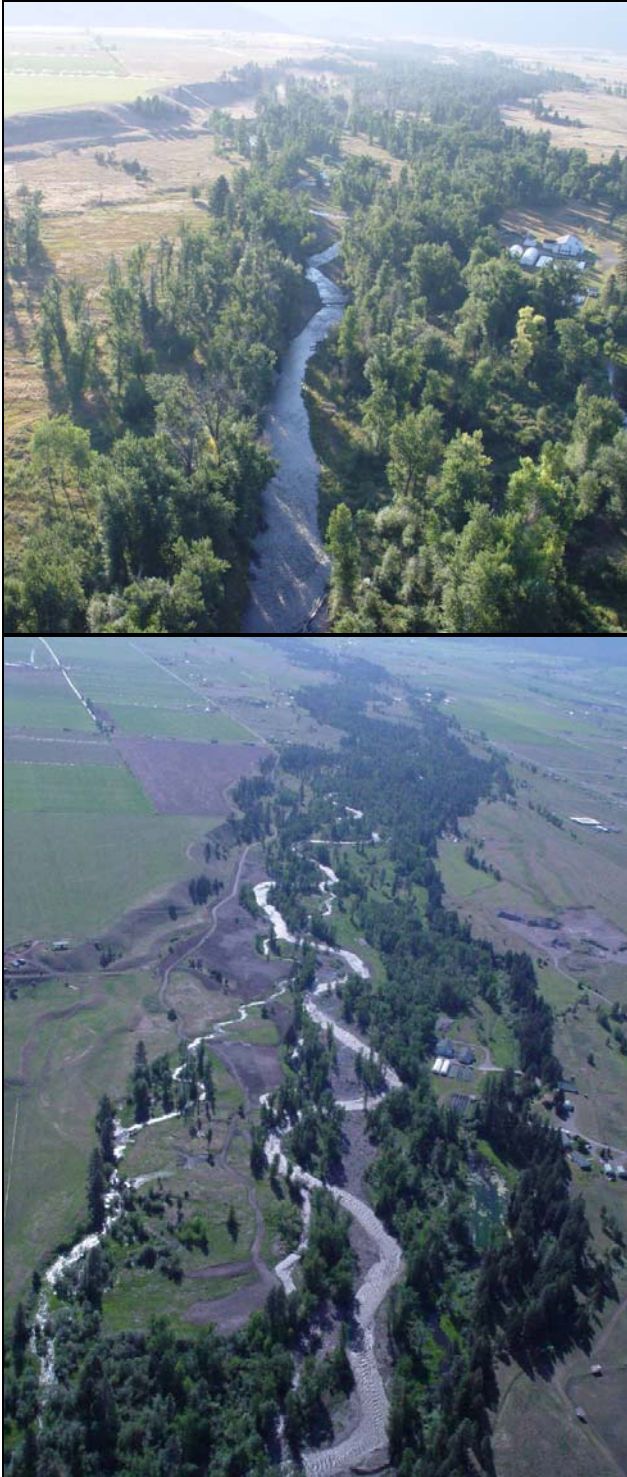
**Figure 4. Aerial photo of the Jocko River through the Demonstration Reach Phase II project area prior to channel re-construction (left) and after channel reconstruction (right). In the post-construction photo, secondary channels are visible in the floodplain.**

In addition to the main channel, secondary channels (approximately 20-40 ft wide and 0.5 to 1.5 ft deep) were constructed in the floodplain to convey portions of flows at various higher discharge levels. Different secondary channels were designed to convey flows at different discharge levels. Figure 4 shows the Jocko River before and after channel reconstruction. The “after” photo shows secondary channels flowing during high water in late May 2009.

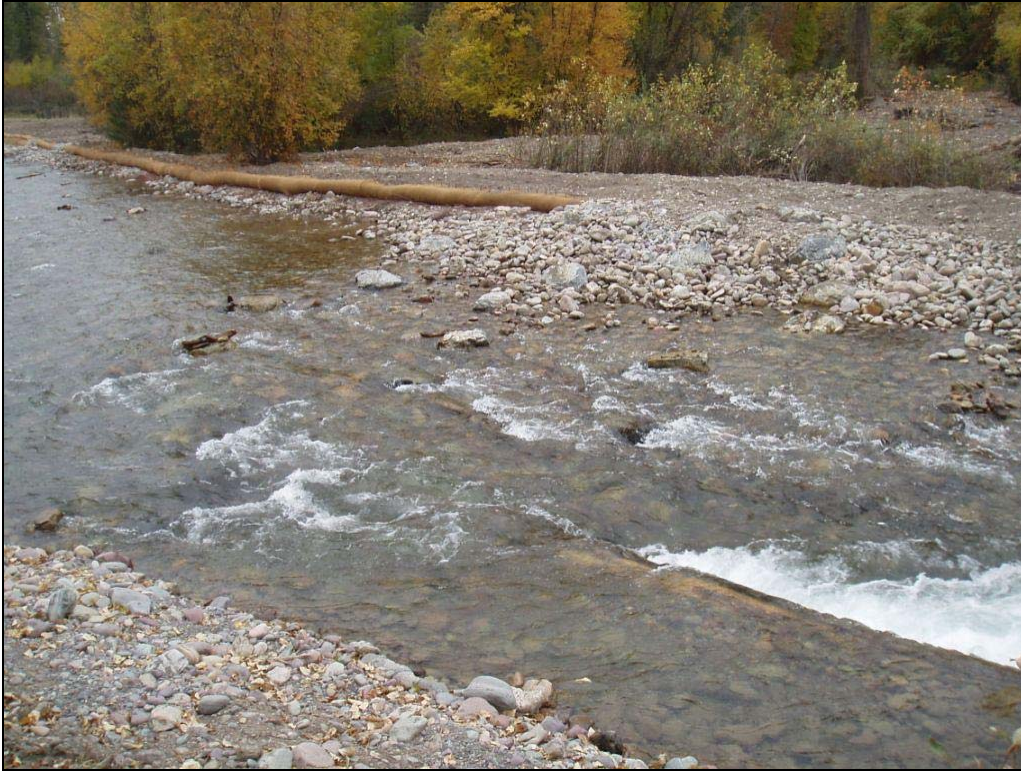
**Figure 5. Submerged boulder energy dissipater during construction**  
**Bank Protection**

Thirteen submerged boulder grade control structures were installed along approximately 930 feet of channel bed as part of the Demonstration Reach Phase II restoration project. The intent of the submerged boulder/cobble grade control structure is to ensure that flood waters access the floodplain at or near the design bankfull discharge and fish passage is maintained. The structure is designed to maintain interim streambed grade control in riffle, run and glide features until natural armoring/sorting processes develop and control long-term vertical stability. The structure is similar in appearance to the submerged boulder energy dissipater, but is typically constructed over a longer length of channel.

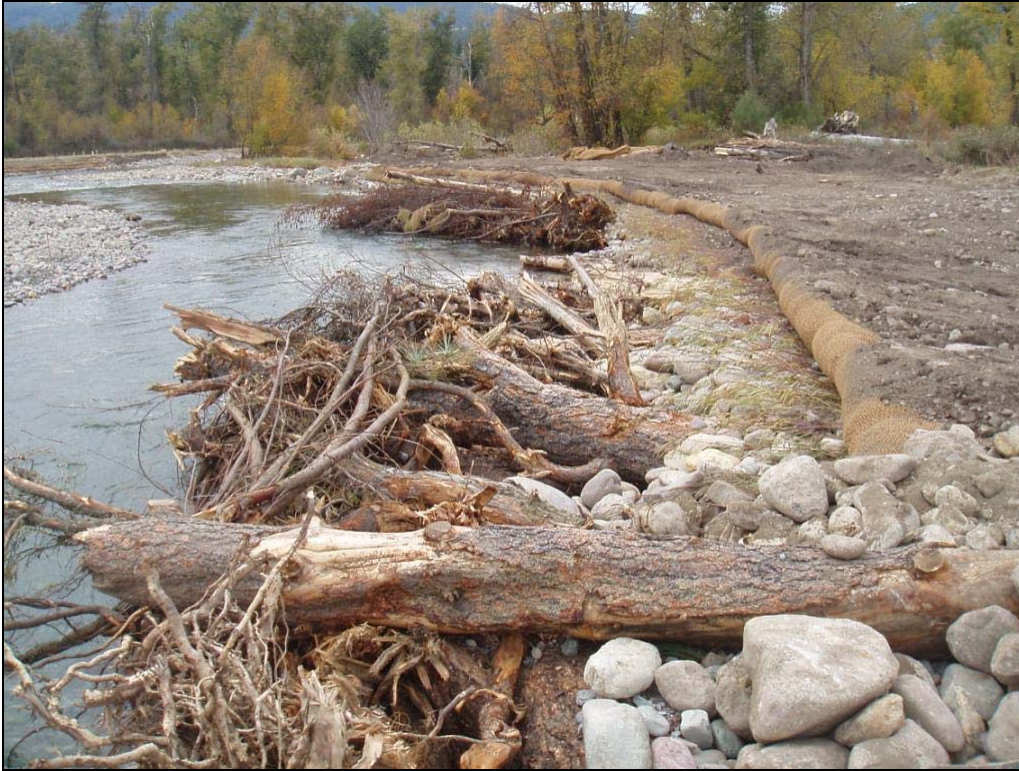
Figure 6. **Engineered log jam tied in with streambank bioengineering.**

Nineteen engineered log jams were installed on meander bends to provide temporary bank stabilization by reducing near-bank stress and redirecting flow away from the bank. Engineered log jams were installed in association with bioengineering structures (described below) and other grade control and bank stabilizing structures. These structures were placed in pool features and each extends approximately 20 feet along the bank and 5-10 feet into the channel. Over time, these structures will degrade and the bank protection function will be replaced by native woody vegetation. Figure 6 shows an example of an engineered log jam installed as part of the Demonstration Reach Phase II restoration project.

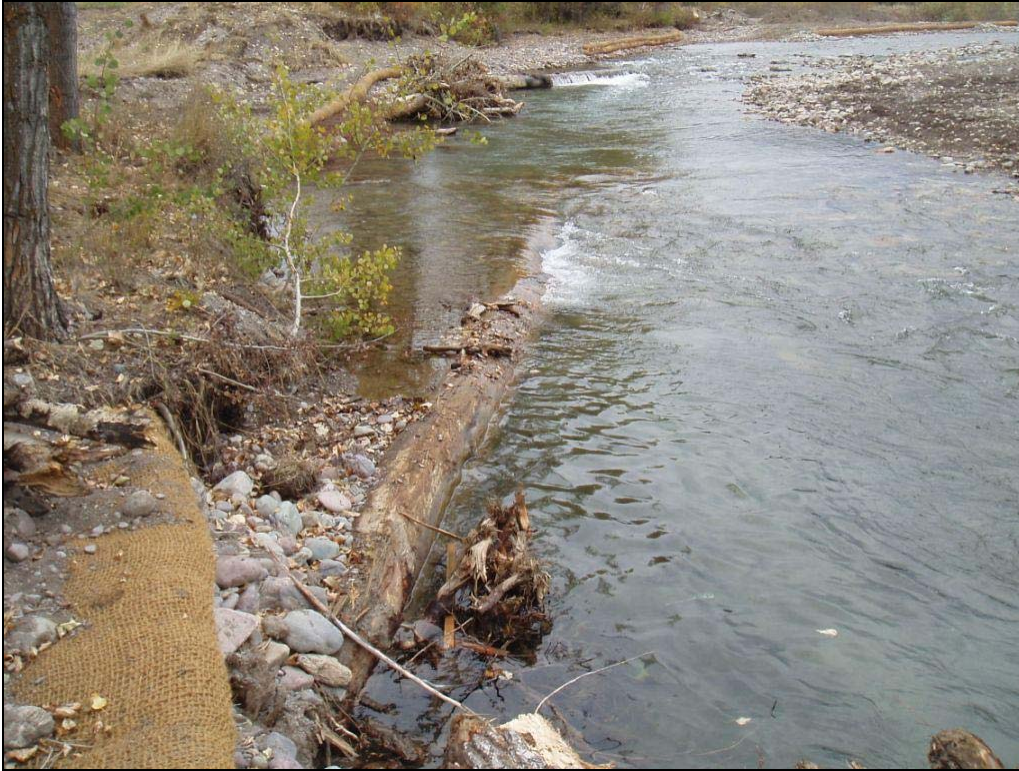
Figure 7. **Log vane after channel construction.**

Fifteen log vanes were installed at run-pool or riffle-run transitions with the intent of providing bank protection by reducing near-bank stress and redirecting flow away from the bank and into engineered log jams. These structures also function to dissipate energy because they typically form a scour pool on their downstream side. Log vanes are set low in the water to minimize abrupt affects on the water surface. They extend approximately 20 feet into the channel, leaving about 60 percent of the channel unobstructed for bedload transport and recreational passage. Figure 7 shows an example of a log vane installed at the Demonstration Reach phase II project.

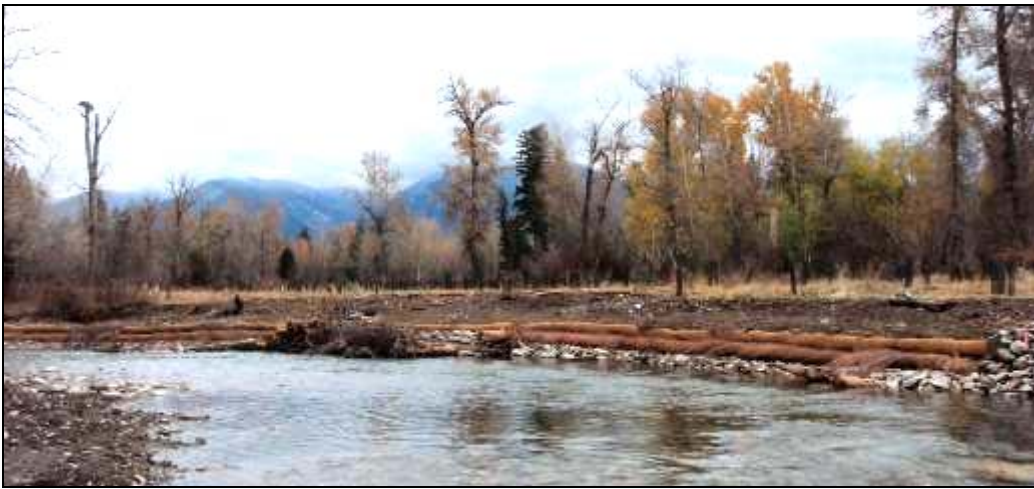
**Figure 8. Photograph showing a typical vegetated soil lift sequence on an outer meander bend. Vegetated soil lifts were installed in conjunction with other bank protection treatments such as engineered log jams.**

aquatic habitat, and help sustain balanced channel morphology over time. All vegetated soil lifts were constructed with cobble and wood toes to prevent scour and slumping in the short term while vegetation becomes established. Willow cuttings were installed between lifts and in some locations under the bottom lift and above the top lift where conditions appeared conducive to willow growth. A combination of four pound per cubic foot density, ten foot by twelve inch diameter coir wattles, aspen excelsior logs, and seven pound per cubic foot density, ten foot by twelve inch diameter coir logs were used to face the vegetated soil lifts. In some locations, containerized plants, primarily sandbar willow (*Salix exigua*) and black cottonwood (*Populus balsamifera*) were installed behind and on top of structures. Plants were installed using the Stinger attachment mounted on an excavator to allow planting through woven coir fabric. Figure 8 shows a typical vegetation soil lift sequence in the project area.

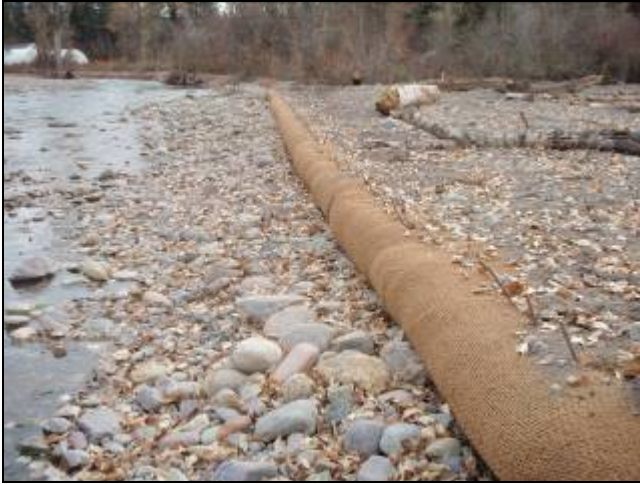
Figure 9. **Completed wrapped coir log with vertically installed willow cuttings.**

Wrapped coir logs were installed along riffle-run features to provide temporary protection and retain moisture along cobble dominated channel margins while native woody vegetation with deep binding root mass develops. Wrapped coir logs were installed primarily along the banks of the new channel at the upstream and downstream ends of abandoned sections of the channel. Wrapped coir logs were installed using nine pound per cubic foot density, ten foot by sixteen or twelve inch diameter coir logs and wrapped with a single layer of woven coir fabric. The coir logs were placed on narrow cobble benches that sloped away from the channel. Various plant materials were incorporated in wrapped coir log structures including stinger installed container plants (cottonwoods and willows) and willow cuttings placed both vertically and horizontally. Figure 9 shows a wrapped coir log installation within the project area.

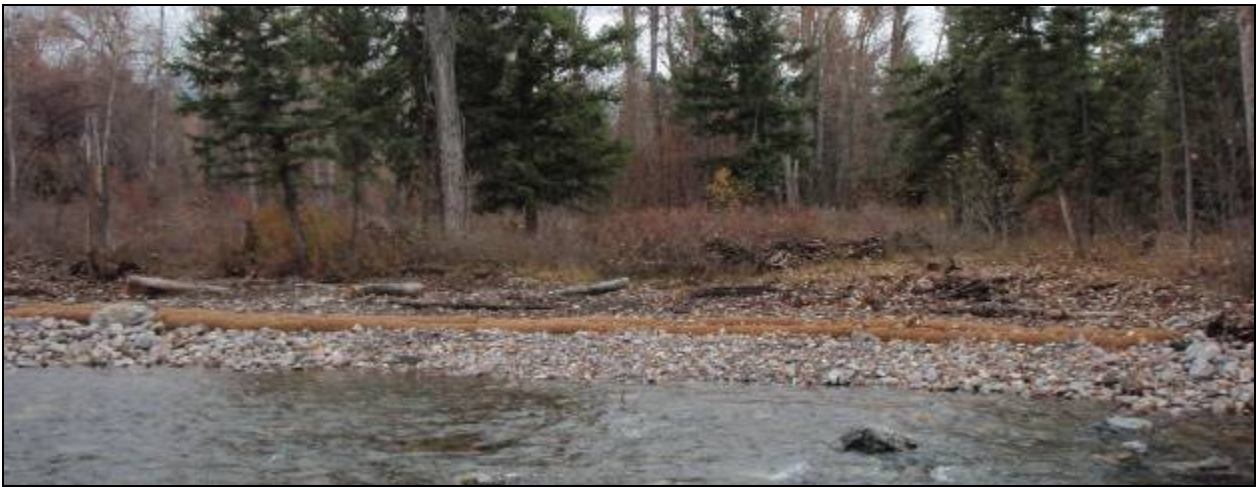
Figure 10. **Photograph shows double layer anchored coir log tying into existing vegetation at the downstream end (at photo right).**

Anchored coir logs were installed along riffle-run sections to provide temporary protection and retain moisture along cobble dominated channel margins while native woody vegetation with deep binding root mass develops. Anchored coir logs were constructed on cobble benches using nine pound per cubic foot density sixteen or twelve inch diameter, ten foot long coir logs. Coir logs were secured in place using duckbill earth anchors and wire cable. Both single and double layer anchored coir logs were constructed. Willow cuttings were installed vertically behind and between the coir logs. Figure 10 shows an anchored coir log installation within the project area.

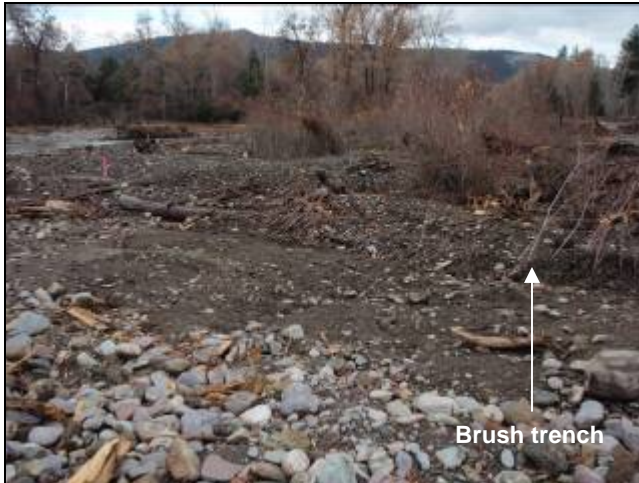
**Figure 11. Brush trench incorporates woody debris, willow cuttings and mature plant material to create floodplain roughness and microsites for woody vegetation establishment.**

plant community succession on newly constructed floodplain surfaces. This treatment includes excavating a trench parallel to the channel approximately to the depth of baseflow or slightly lower. Willow cuttings, woody debris and low density coir logs are placed in the trench and the trench is back-filled with alluvium. Willow cuttings placed in the trench extend between 1 and 3 feet beyond the finished grade surface. Figure 11 shows a brush trench constructed in the project area.

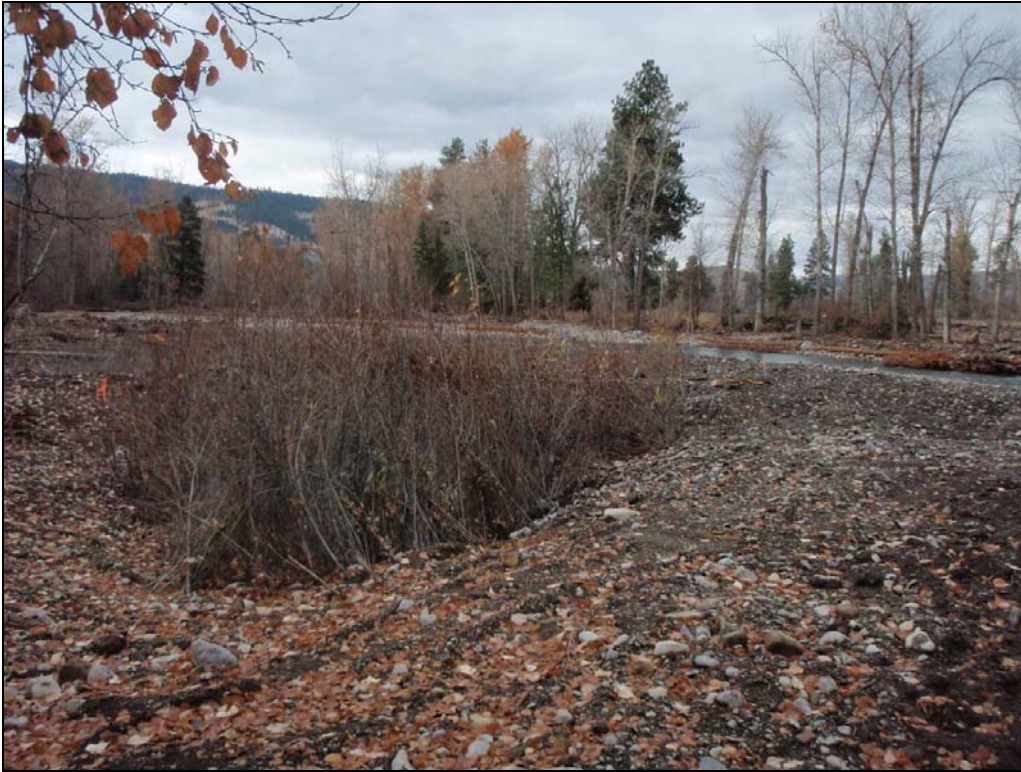
Figure 12. **Vegetation preservation area within the constructed floodplain.**

that might cause young cottonwoods and willows to drown. Over time, these areas are expected to fill with sediment to match the surrounding floodplain elevation.

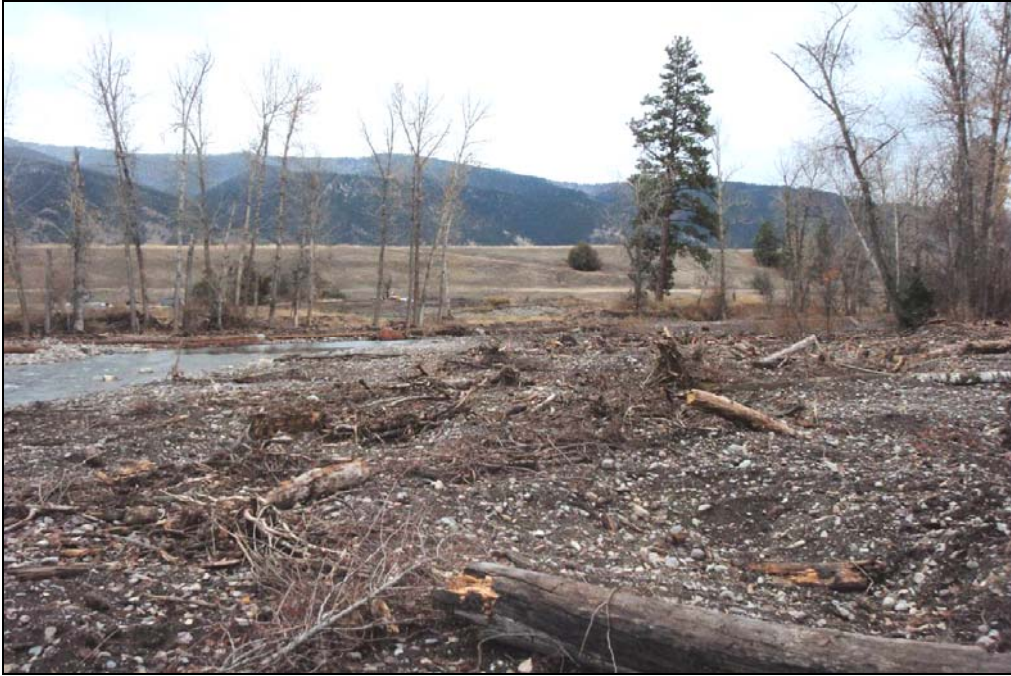
Figure 13. Floodplain microtopography including swales, woody debris and a rough, finished surface.

Floodplain microtopography included construction of swales features, placement of woody debris and leaving finished surfaces with undulating topography (Figure 13). Swale features were incorporated into all constructed floodplain surfaces and were generally perpendicular to the channel and with the following approximate dimensions: 25 feet long, eight to ten feet wide, 3:1 side slopes, and bottom elevation at baseflow or slightly above (approximately two feet below bankfull). Swales are irregularly shaped to mimic natural depressions. Small to large diameter woody debris was placed in swales and on or partially buried in the floodplain surface. Rough graded floodplain surfaces vary between 0.5 feet above and 0.5 feet below the design floodplain surface elevation. Topsoil was placed on some constructed floodplain surfaces, primarily outer meanders and some filled sections of abandoned channel to facilitate seed establishment.

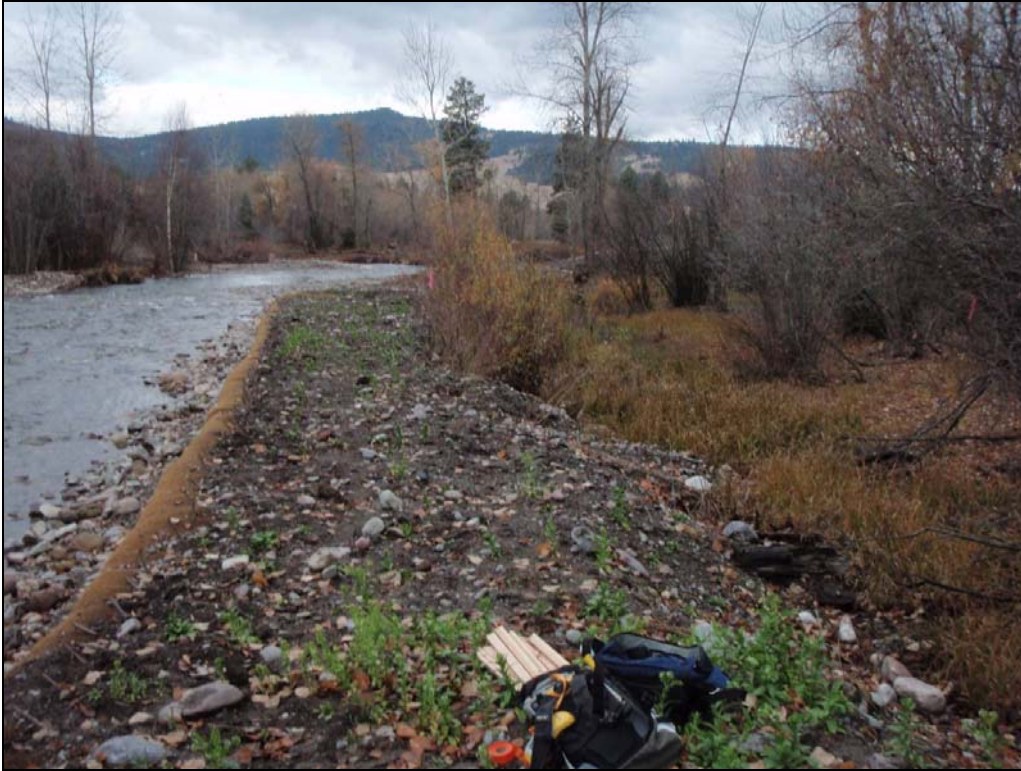
Figure 14. **Stinger planted riparian tree and shrub seedlings behind a wrapped coir log.**

In some areas, particularly behind bioengineering structures, containerized, native woody plants were installed using an excavator-mounted stinger attachment. Species planted included cottonwoods, willows and other riparian shrubs. Figure 14 shows stinger plantings behind a wrapped coir log.

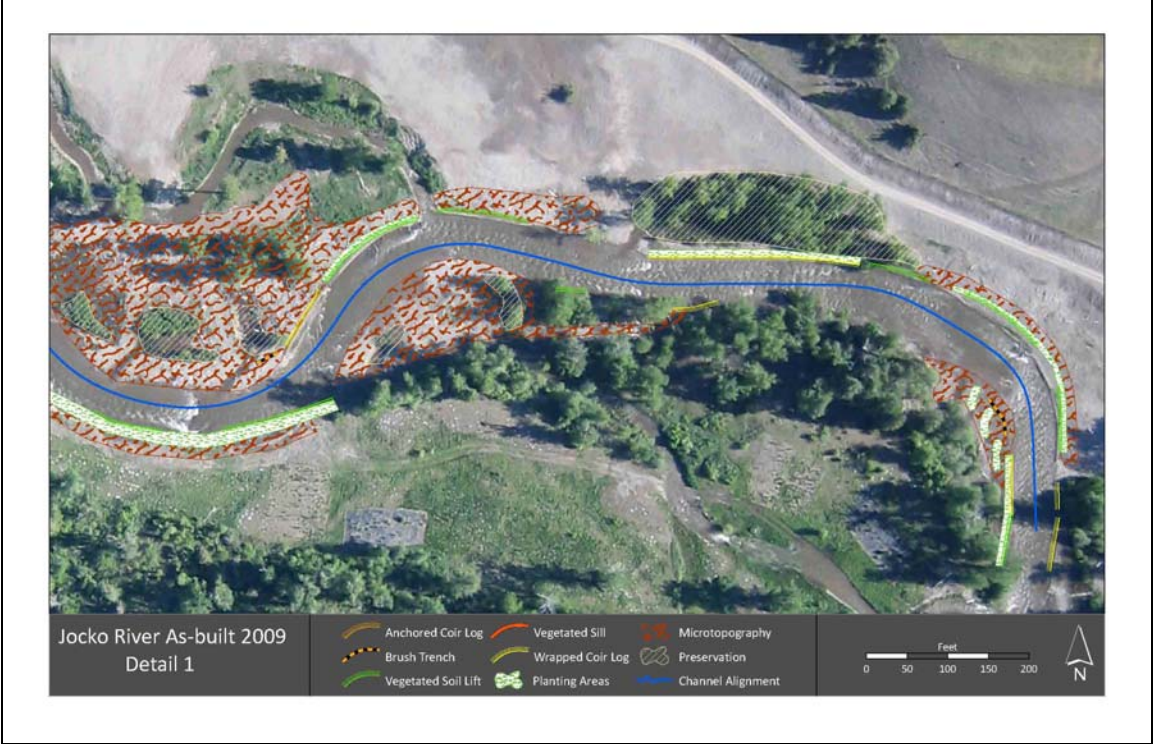
Figure 16. Detail figure of as-built conditions at the upstream end of the Demonstration Reach Phase II.

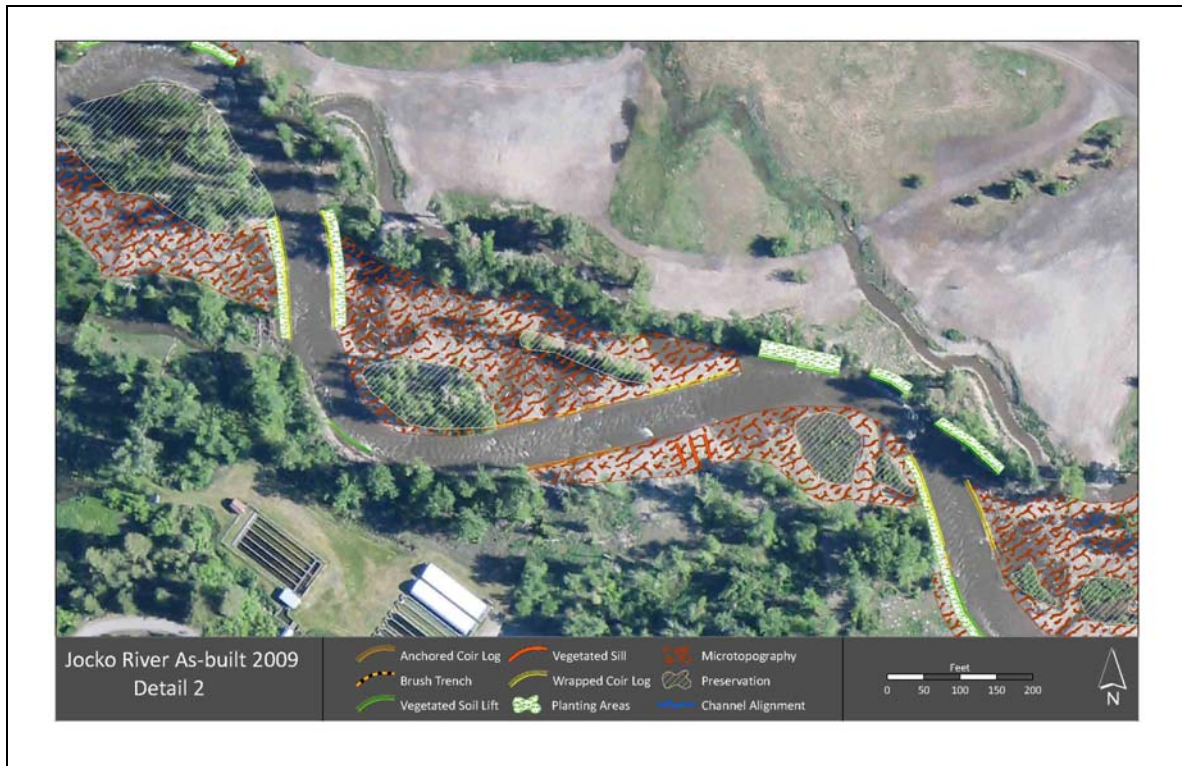
Figure 17. Detail figure of as-built conditions in the middle section of the Demonstration Reach Phase II.

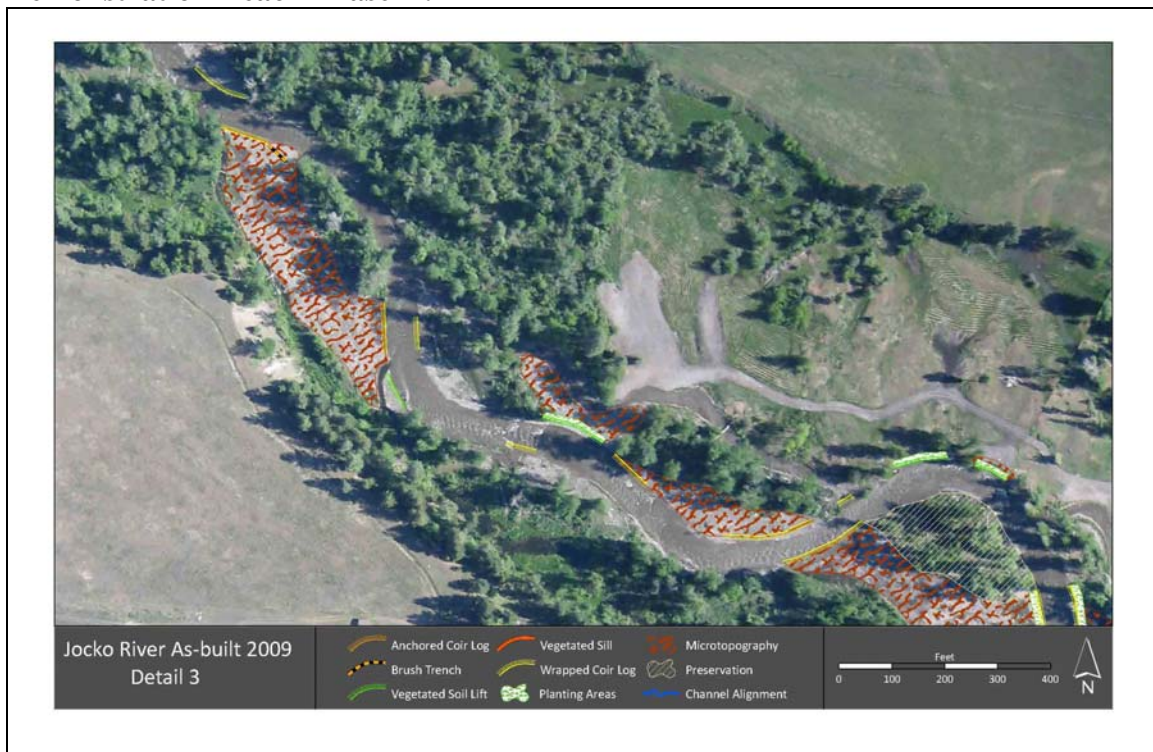
Figure 18. Detail figure of as-built conditions at the downstream section of the Demonstration Reach Phase II.
