# Hungry Horse Mitigation Flathead Lake

Annual Progress Report 2008  
Project 9101901

## As-built Report

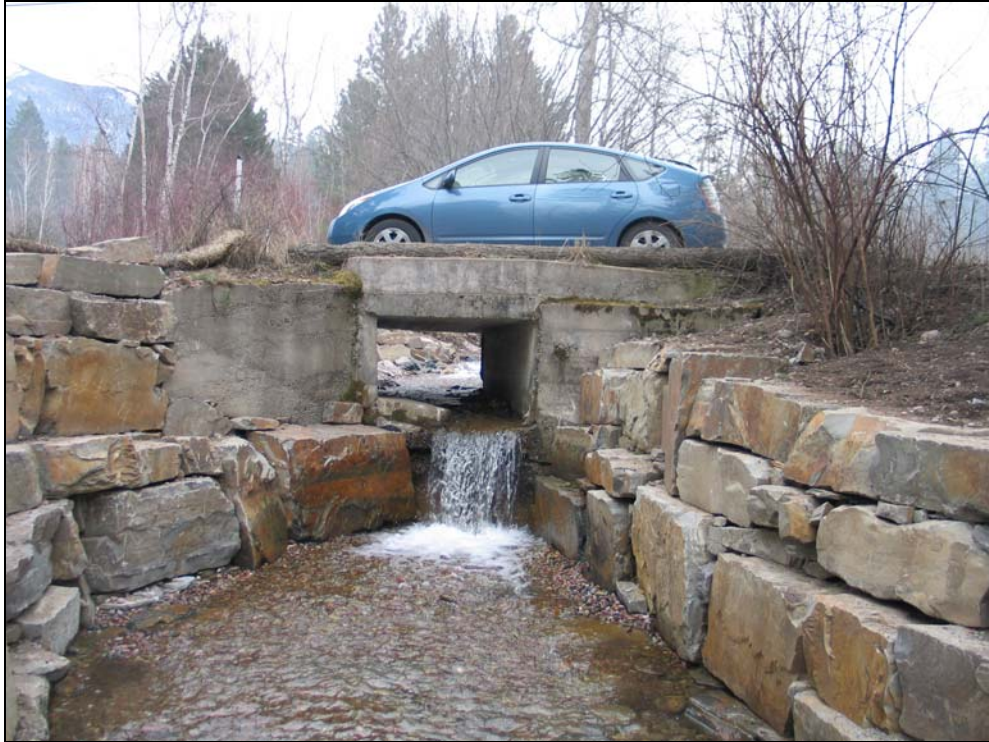
Figure 1. Constructed passage barrier near the mouth of Skidoo Creek, 2008.
