JAEA Fatigue Analysis of EBR-II Duplex Tubing

J. H. Jackson
D. L. Porter
W. R. Lloyd

July 2009

**Prepared for the
Japanese Atomic Energy Agency
WFO Contract 08901
Under DOE Idaho Operations Office
Contract DE-AC07-05ID14517**

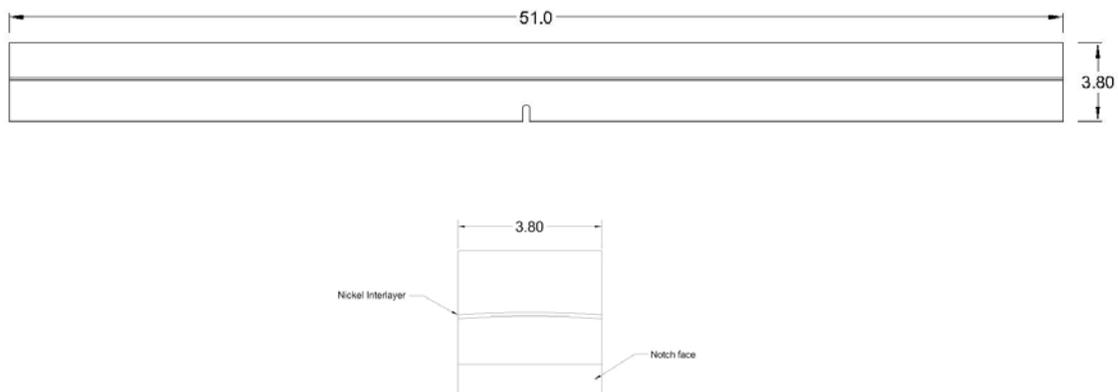
Figure 1: Typical fatigue specimen.

To establish confidence in the ability to measure fatigue crack growth in non-typical fracture specimens (Charpy v-notch) using the DC Potential drop method with Johnson's equation for crack length prediction, several 2 ¼ Cr-1Mo steel surrogate specimens were fatigued. The typical specimen geometry is shown in Figure 1. It should be noted that these specimens are non-standard in that the width "W" is small, relative to thickness "B" and load span "S" according to ASTM Standard E647 for fatigue testing of metals, and the notch radius is atypically large relative to the dimension "W". Additionally, the effect of the presence of the nickel interlayer, which creates a non-homogenous electrical cross section, is unknown. As such, several fatigue tests were performed using surrogate specimens that were fabricated entirely from 2 ¼ Cr-1Mo steel to ensure that there was not a major effect caused by the electrical inhomogeneity. It is assumed that the minor effect of the atypically large notch radius was only an issue for the very beginning of the crack growth.

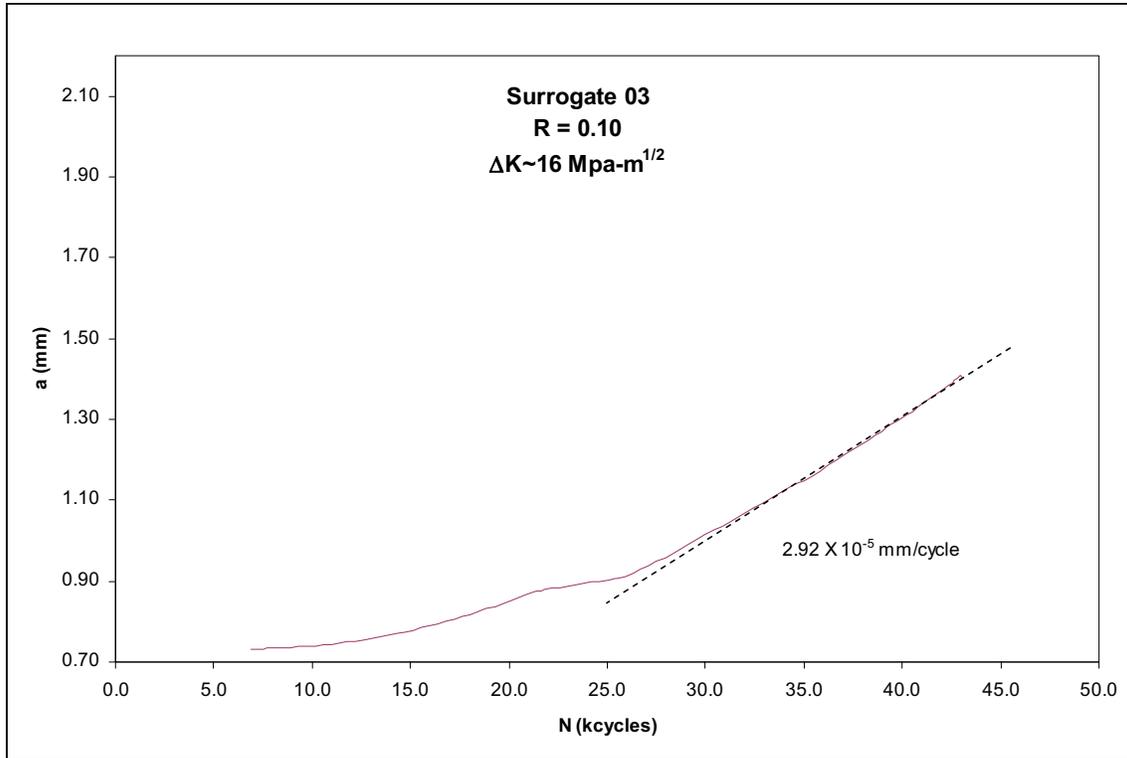
Figure 2: Crack growth vs. cycles for surrogate sample.

Several specimens were machined from 2-1/4 Cr-1Mo steel to the same dimensions as the pre-existing steam generator tube specimens and fatigue tested in order to establish a test procedure and to provide a baseline for the DC-Potential Drop crack size data. These were tested at a nominal ΔK of 16 MPa- $m^{1/2}$ and load ratio of $R=0.1$ to obtain steady-state Paris Law behavior. The resulting fatigue crack growth rate at this applied ΔK and load ratio stabilized at approximately 2.92×10^{-5} mm/cycle. This compares well with the fatigue crack growth rates noted in [1] for base 2-1/4 Cr-1Mo steel. Figure 2 shows this trend for one of the surrogate specimens. The initial loading slope is noticeably slower than the steady-state crack growth rate due to anomalies related to the large notch radius relative to the width (W) of the specimen. This is expected in all specimens to be tested in this study and is not of concern since it only affects the first ~0.1-0.2 mm of crack growth.

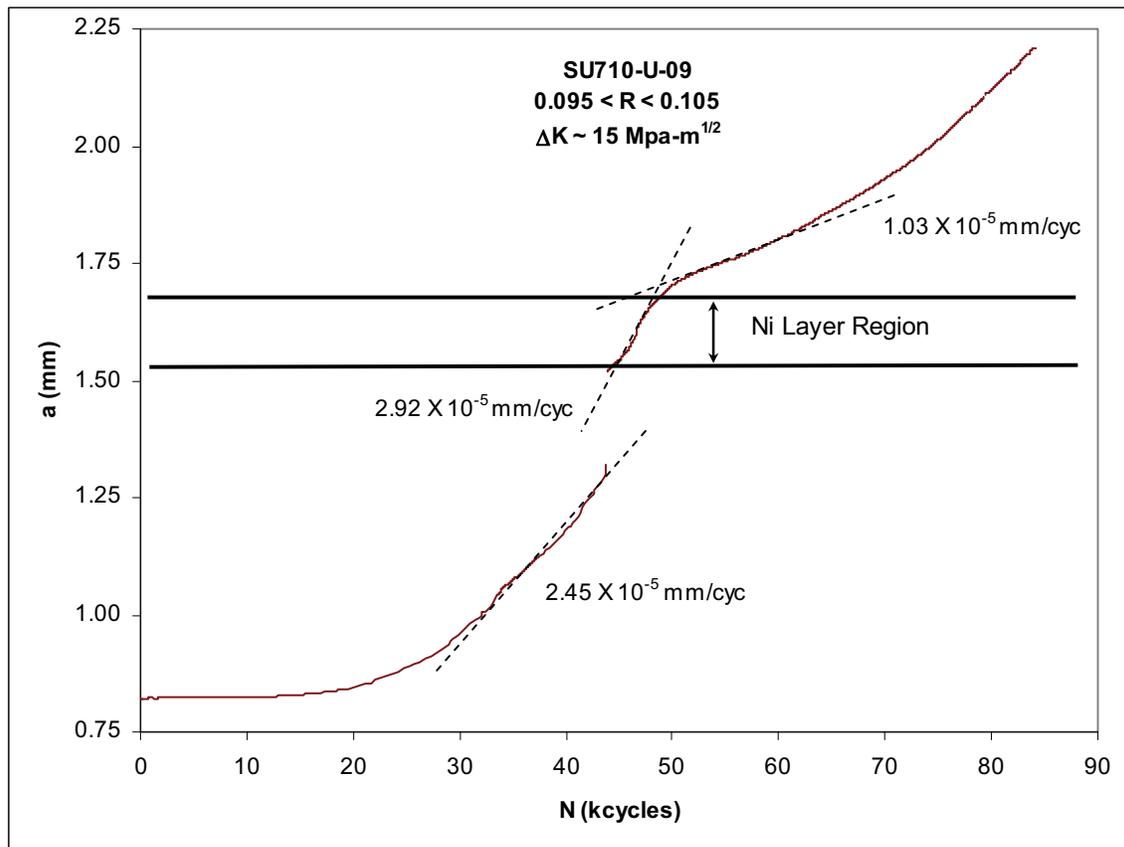
Figure 3: Fatigue behavior under Paris Law conditions ($\Delta K=15 \text{ MPa}\cdot\text{m}^{1/2}$) showing characteristic retardation of crack growth following nickel interlayer.

In order to ensure consistency with previously performed work at INL, one specimen from the upper part of the heat exchanger was fatigue cracked at a constant, nominal ΔK of $15 \text{ MPa}\cdot\text{m}^{1/2}$. The previous work had noted typical fatigue behavior within this Paris law region of the da/dN - ΔK curve to be approximately $2.5 \times 10^{-5} \text{ mm/cycle}$ up to the nickel interlayer. This was followed by a rate increase through the interlayer to approximately $3.5 \times 10^{-5} \text{ mm/cycle}$, and then was retarded to a growth rate of slightly less than $1.0 \times 10^{-5} \text{ mm/cycle}$ for a short distance beyond the nickel interlayer.

The specimen fatigued in the current study at a nominal ΔK of $15 \text{ MPa}\cdot\text{m}^{1/2}$ followed roughly similar trends of a constant rate followed by an acceleration through the nickel interlayer and a retardation on the opposite side of the interlayer. The rates observed in the current study were $2.5 \times 10^{-5} \text{ mm/cycle}$, $2.92 \times 10^{-5} \text{ mm/cycle}$, and $1.03 \times 10^{-5} \text{ mm/cycle}$ for the regions prior to, within, and beyond the nickel interlayer respectively. Figure 3 shows this behavior in a crack length vs. number of cycles (a -vs- N) plot for constant ΔK . It is noted that there is a gap in the data due to a correction made based on visual observation of the crack length the specimen surface through an optical microscope. This peculiarity does not affect the overall observed fatigue behavior.

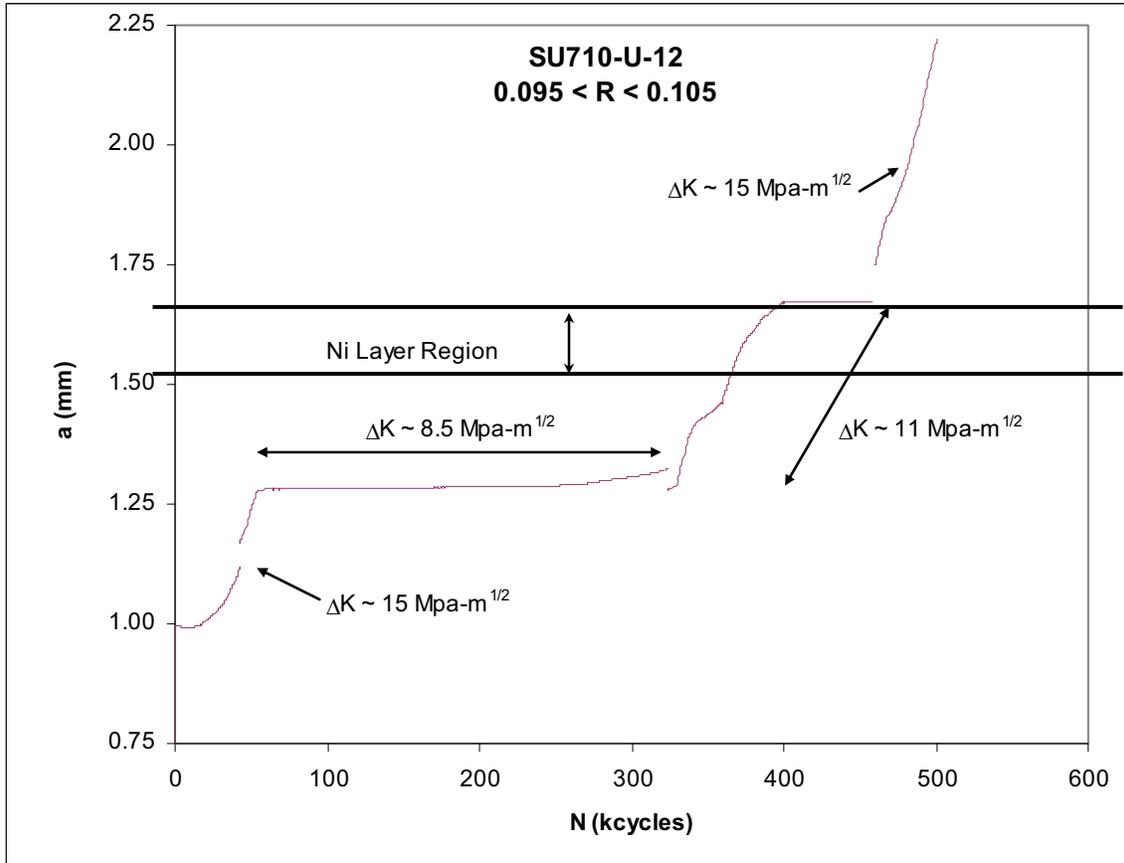
Figure 4: Near threshold crack arrest after nickel interlayer and ensuing crack growth with increased ΔK .

As seen in Figures 4 and 5, fatigue cracks were arrested when the ΔK level was held to near-threshold values ($\Delta K_{th} \approx 10 \text{ MPa}\cdot\text{m}^{1/2}$ [3]). Specimen SU710-U-12 (Figure 4) exhibited full arrest after passing through the nickel interlayer at $\Delta K=11 \text{ MPa}\cdot\text{m}^{1/2}$, followed by re-initiation and growth when a larger, $\Delta K=15 \text{ MPa}\cdot\text{m}^{1/2}$ was applied. Specimen SU710-U-15 (Figure 5) exhibited practical arrest after passing through the nickel interlayer at $\Delta K=10.5 \text{ MPa}\cdot\text{m}^{1/2}$, with the crack growth rate slowing to an almost negligible $4.15 \times 10^{-8} \text{ mm/cycle}$. At this point the test was stopped so that the crack tip could be studied.

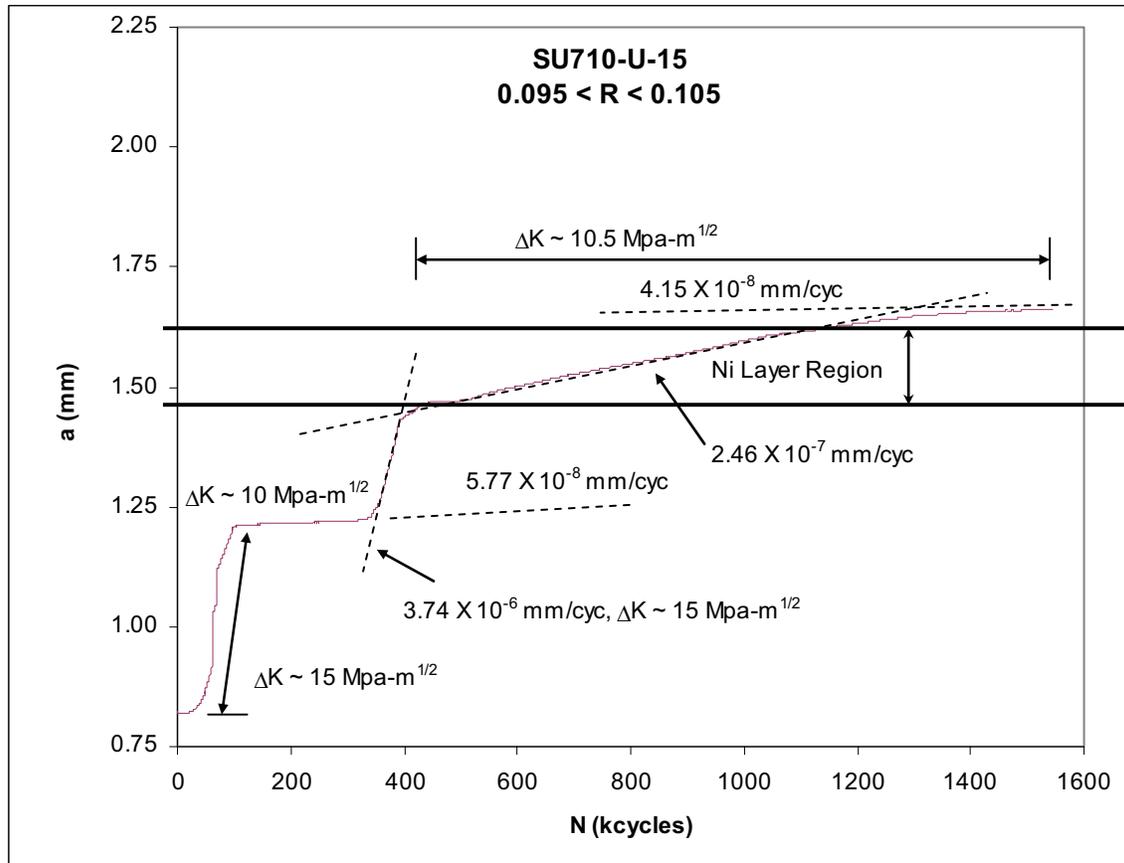
Figure 5: Practical crack arrest after nickel interlayer at near threshold $\Delta K = 10.5 \text{ MPa}\cdot\text{m}^{1/2}$.

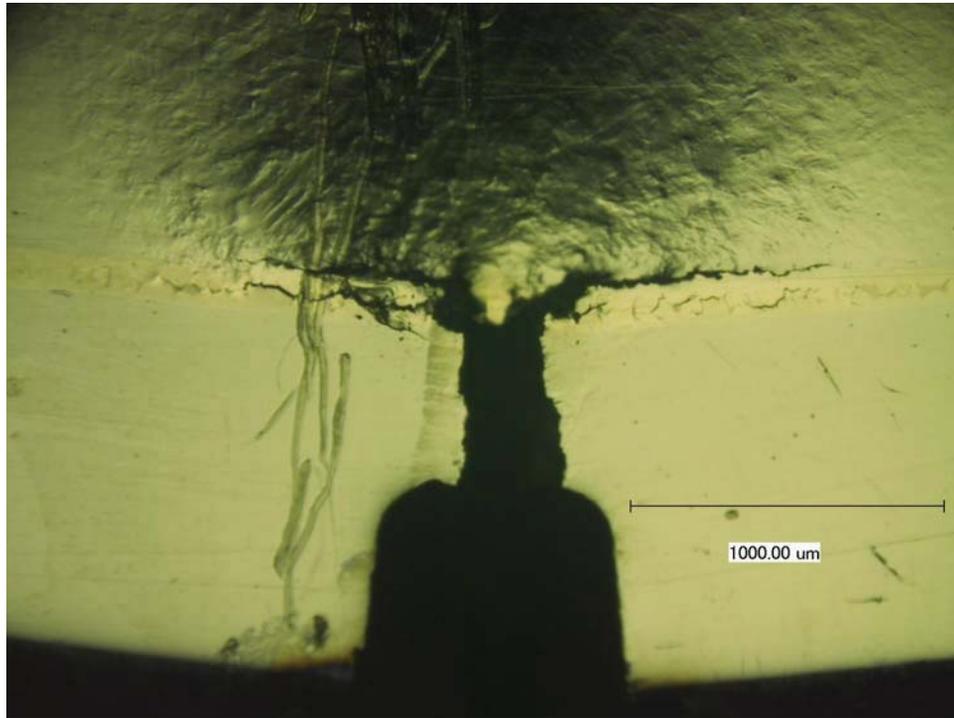
Figure 6: 100X micrograph of specimen SU710-L-6 showing delamination of the nickel interlayer following monotonic loading to $K \approx 28 \text{ MPa}\cdot\text{m}^{1/2}$.

approximate fracture toughness, $K_Q \approx 28 \text{ MPa}\cdot\text{m}^{1/2}$. A J-integral approximation is inappropriate because the crack immediately branched. Both specimens exhibited an altered crack path upon encountering the nickel interlayer, with the first (SU710-L-6) exhibiting a marked delamination at both the inner and outer borders of the interlayer, and the second (SU710-L-8) exhibiting an interesting pattern of several vertical cracks appearing in the interlayer. Figure 6 is a 100X optical micrograph of the crack tip region for specimen SU710-L-6, showing the clear delamination that was observed. Figure 7 is a 100X optical micrograph of the post-test crack tip region for specimen SU710-L-8, showing a formation of cracks within the nickel interlayer and a bifurcation of the main crack to join these smaller cracks. Figures 8 and 9 are 500X optical micrographs of the crack tip regions of specimens SU710-L-6 and SU710-L-8, respectively, showing the observed phenomenon more clearly. The 500X photo of SU710-L-6 is of the right hand wing of the crack.

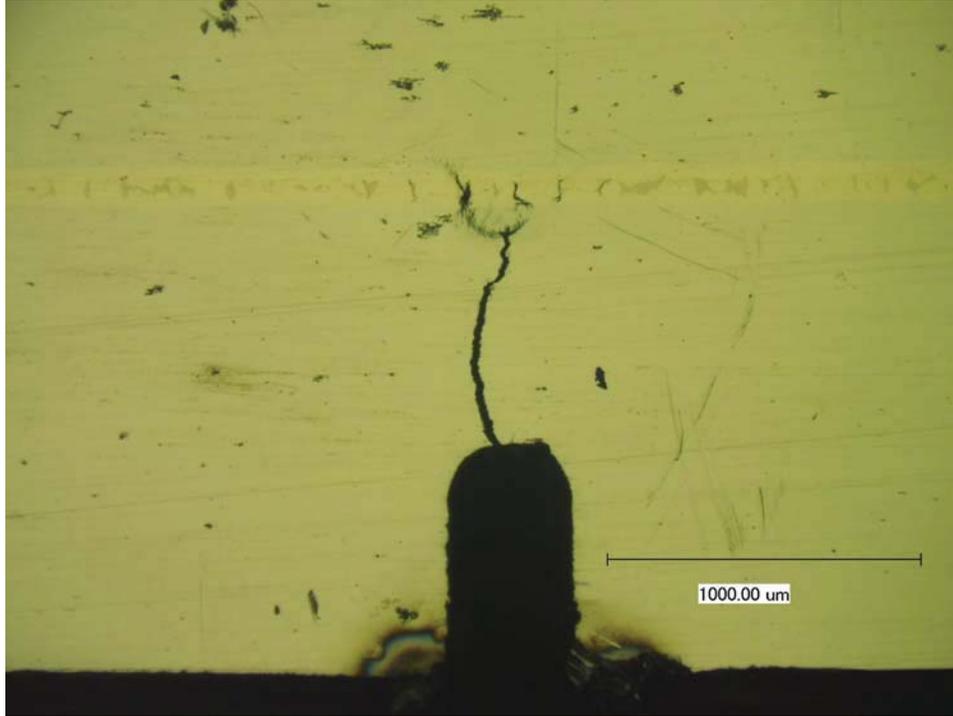
Figure 7: 100X micrograph of specimen SU710-L-8, showing vertical cracks appearing in the nickel interlayer following monotonic loading to $K \sim 28 \text{ MPa}\cdot\text{m}^{1/2}$.

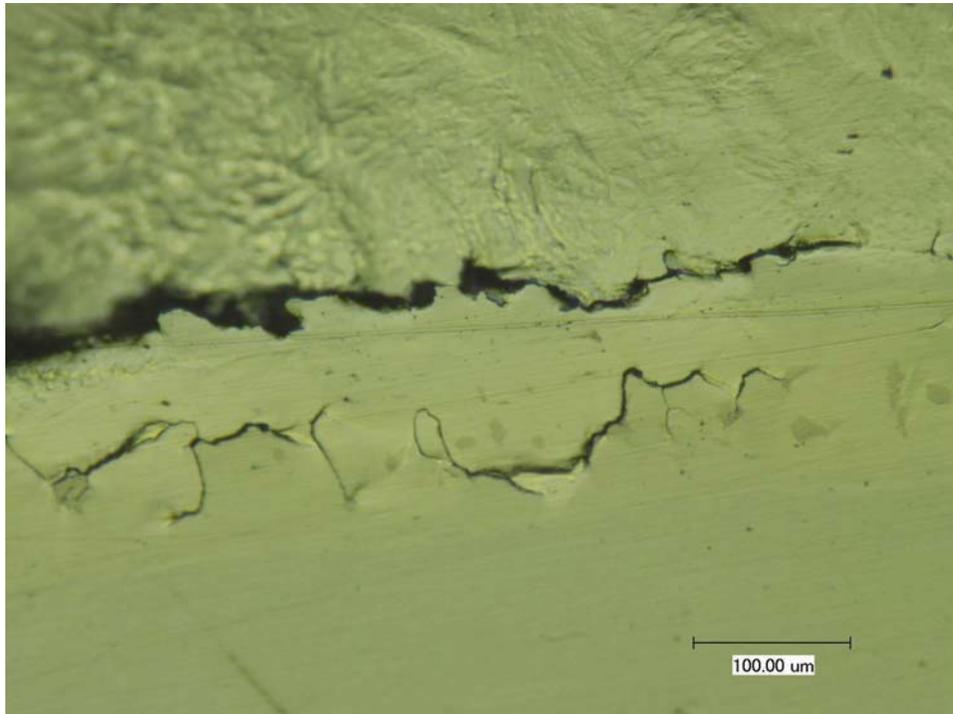
Figure 8: 500X optical micrograph of the right "wing" of the crack in specimen SU710-L-6 following monotonic loading.

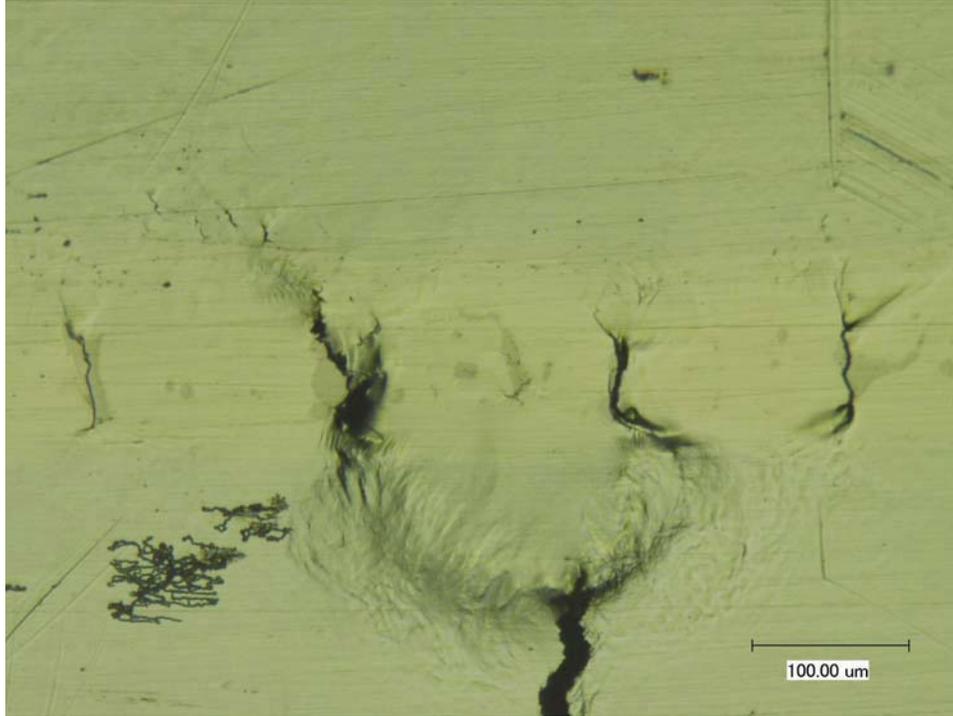
Figure 9: 500X optical micrograph of specimen SU710-L-8, showing appearance of vertical cracks following monotonic loading.

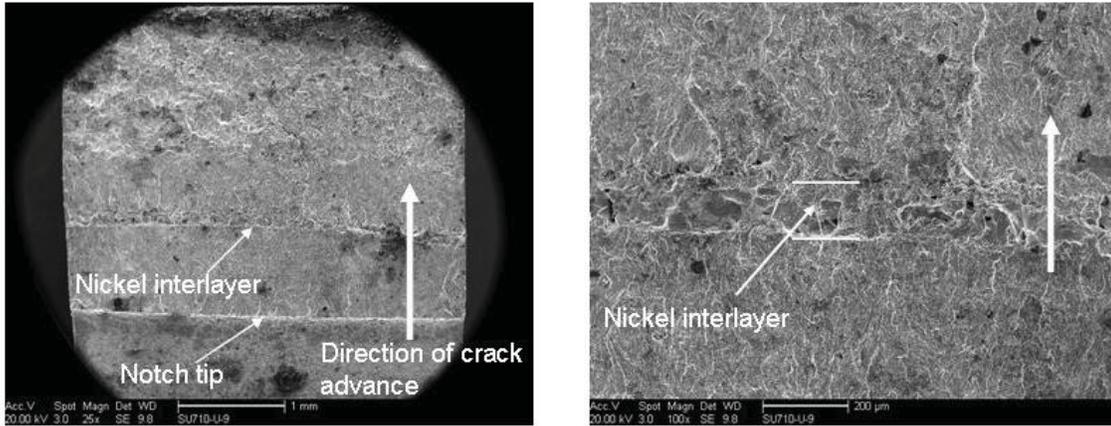
Figure 10: SEM overview of fracture surface on specimen SU710-U-9 showing fracture morphology following nickel interlayer.

Following fatigue testing, specimen SU710-U-9 was broken open using liquid nitrogen and the fracture surfaces were photographed using a Scanning Electron Microscope (SEM). The fracture surface does not exhibit a marked increase in fracture surface roughness on the far side of the nickel interlayer where the fatigue crack exhibited a temporary retardation of crack growth rate as was noted in [3]. The fracture appears to retain similar morphology on both sides of the nickel interlayer with a very slight increase in roughness. Figure 10 is a SEM overview of the fracture surface showing a 25X overview and a 100X closeup of the fracture morphology surrounding the nickel interlayer. Here, the crack grows from bottom to top.

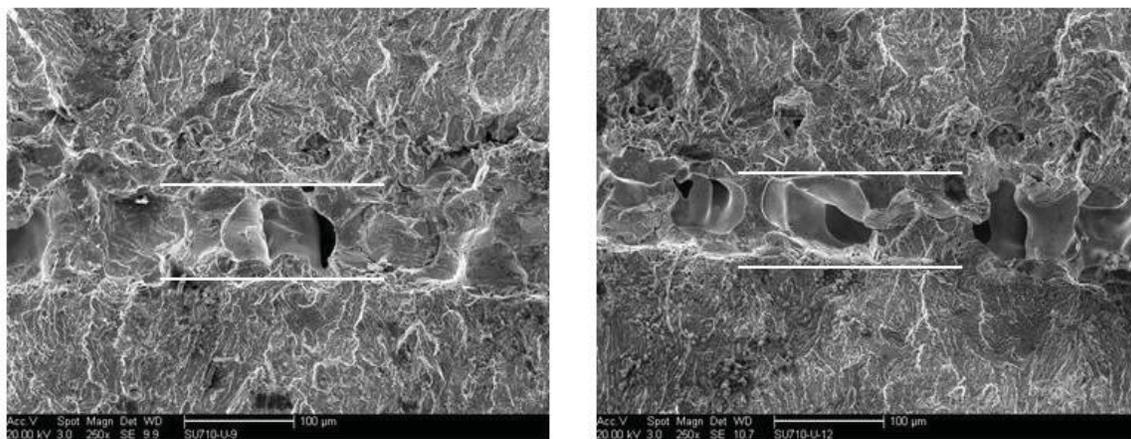
Figure 11: Comparison of morphology in nickel interlayer for steady state ΔK crack growth (left) and near threshold ΔK crack growth (right).

The tortuous nature of the crack growth path in the nickel interlayer due to voids is also noted in this study. Figure 11 shows a SEM close-up of the nickel interlayer on the fracture surface of specimen SU710-U-9 (on the left) and SU710-U-12 (on the right). The voids are more evident in the SEM photograph of the nickel interlayer of specimen SU710-U-12, which was run at a near-threshold ΔK and exhibited full arrest. Additionally, the small, regular voids along the edge of the interlayer, noted and attributed to a Kirkendall effect in [1] and [4] are seen in Figure 12, an optical micrograph of the surface of specimen SU710-U-9. Figure 12 also shows the typical, large voids present within the nickel interlayer.

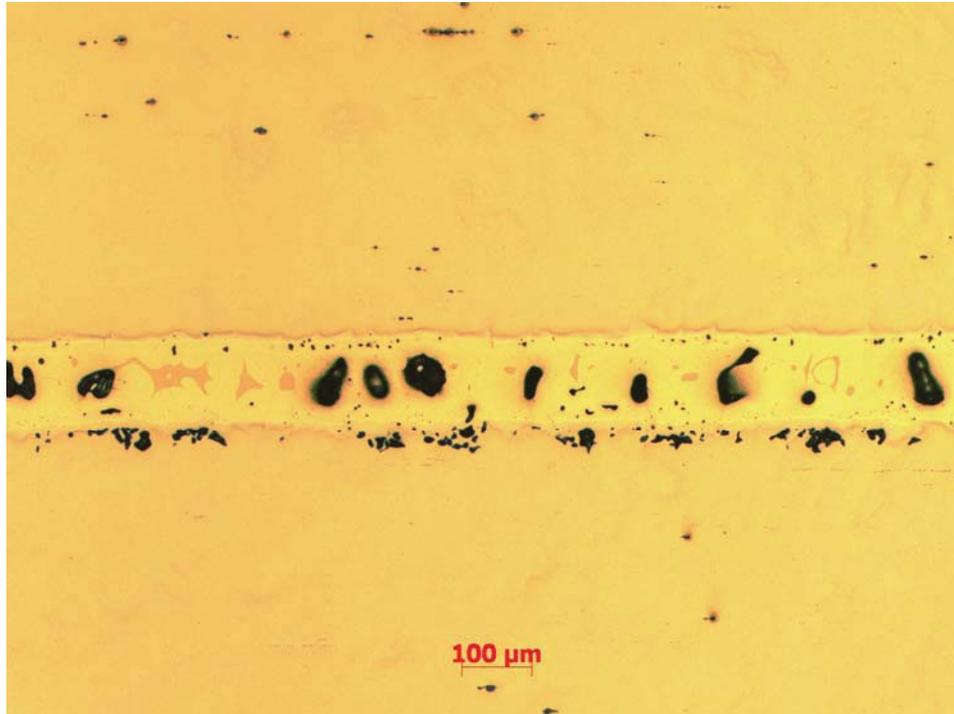
Figure 12: 50X Optical micrograph of specimen SU710-U-9 showing voids in nickel interlayer.

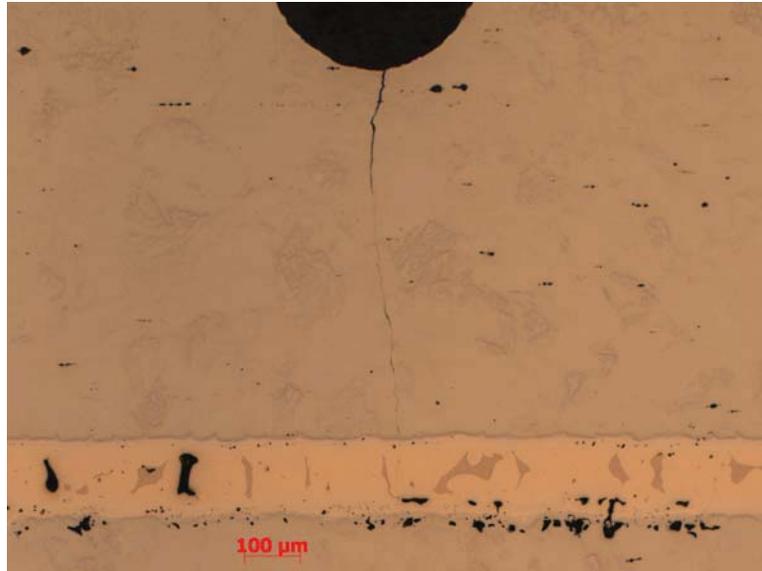
Figure 13: 100X Optical micrograph of the surface of specimen SU710-U-15 showing crack path and arrest on far edge of nickel interlayer (growth direction is top to bottom).

As mentioned previously, following testing to arrest, specimen SU710-U-15 was polished in several stages, and photographed to observe the nature of the crack tip through the thickness of the specimen since crack tip oxidation was noted as a possible cause of crack arrest in a single case in [3]. The optical micrographs show a clear appearance of a void at the crack tip in all of the micrographs. Thus the crack arrest is likely due to the presence of this void, however, no oxidation is noted here. Figure 13 is a 100X micrograph of the surface of specimen SU710-U-15, showing the crack path. Figure 14 is a compilation of images showing the crack tip at 500X magnification at the surface, 1/8 thickness, 1/4 thickness, 3/8 thickness, and 1/2 thickness planes. In each micrograph, the crack path appears to preferentially orient itself toward voids, and appears to end in a void at each thickness plane.

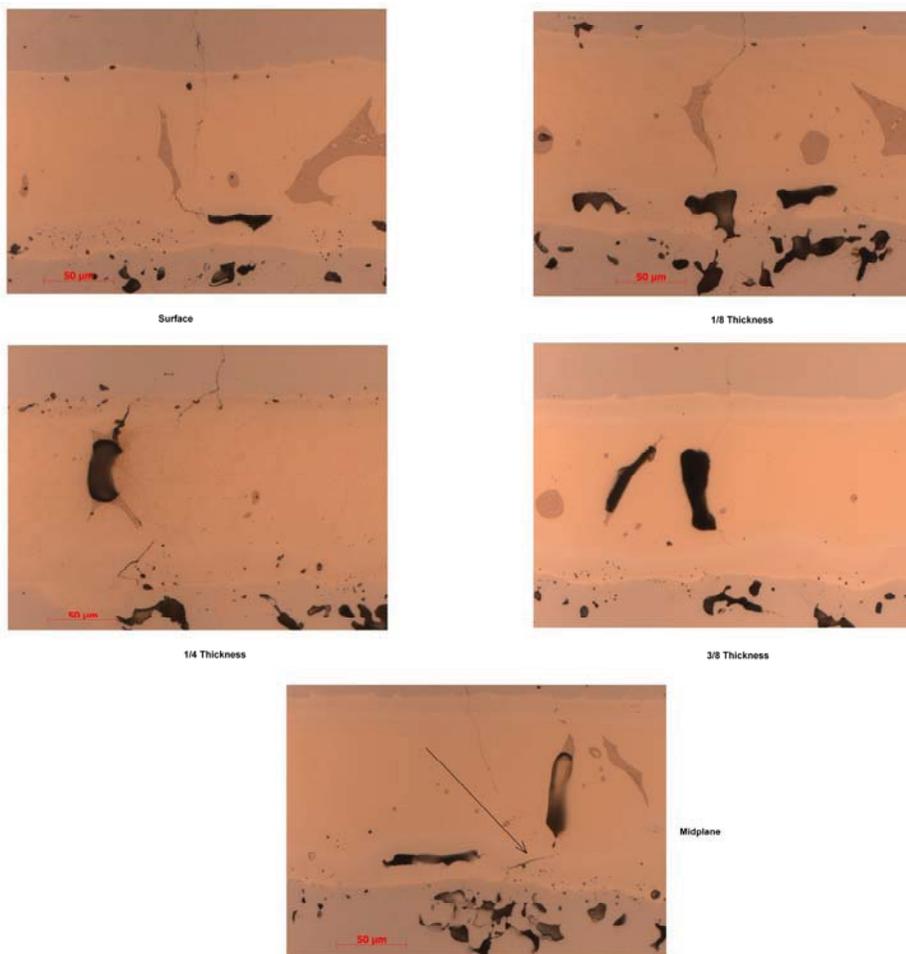
Figure 14: 500X montage of crack tips for several through-thickness planes in specimen SU710-U-15.

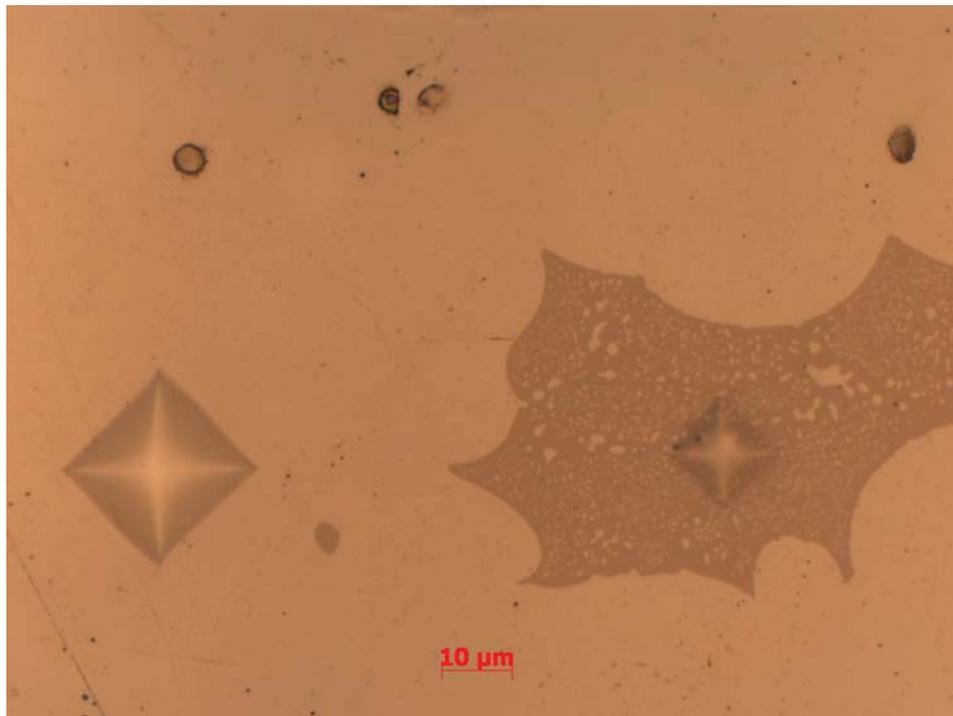
Figure 15: 1000X optical micrograph showing the relative size of hardness indentations in base nickel and Ni-Ni₃P eutectic inclusion.

Table 1 shows the hardness measurements taken in both the base material and nickel interlayer. It is noted that there was no hardening of the 2-1/4 Cr 1 Mo (ASME SA213 T22) base material in service; the average values of 191 Hv and 189 Hv for SU710 U-9 and U-12, respectively are reasonable compared to the required sub-200 Hv required for ASME SA213 Gr T22 steel [6]. The average post service hardness values of 196 Hv100, and 219 Hv100 for the nickel interlayer in the two specimens are surprisingly low compared to the expected values. There were sporadic measurements in the 700 Hv100 range, but these were assumed to have been spurious results as some of the micro-indentations fell on the previously observed [1] Ni-Ni₃P eutectic inclusions. Figure 15 shows two microhardness indentations in a 1000X optical micrograph, one in the base nickel and one falling on a Ni-Ni₃P inclusion.

The currently measured values were 196-219 Hv100 and therefore imply a softening during service. These values (~200 Vickers Hardness) are more typical of commercial pure nickel with a moderate (40-50%) amount of coldwork [5], suggesting that the phosphide originally present in the nickel braze may have precipitated almost entirely to the previously observed Ni-Ni₃P eutectic inclusions. The occasional hardness value measured in the current study of ~700 Hv100 would lend credence to this possibility as these high values were obtained when a hardness indentation fell on an inclusion. Original hardness data for the nickel interlayer is unavailable.
