**Pacific Northwest
National Laboratory**

Sampling and Hydrogeology of The Vadose Zone Beneath the 300 Area Process Ponds

BN Bjornstad

August 2004

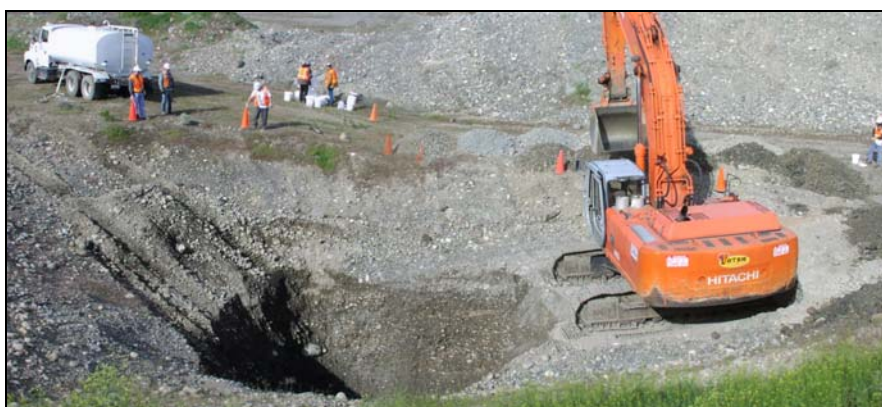
Figure 1. Excavation at South Process Pond Pit #1.

Four open pits were excavated with the aid of a backhoe (Figure 1) beneath the 300 Area Process Ponds in April, 2003.

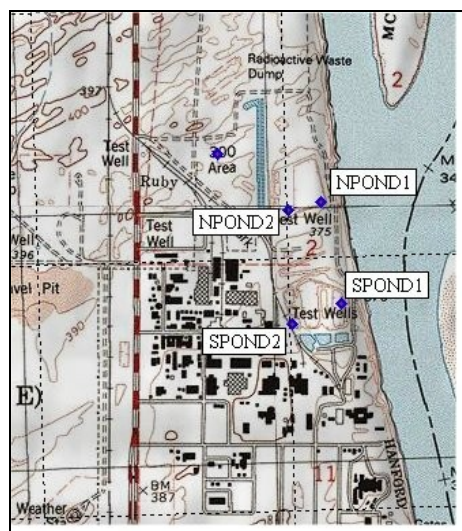
Figure 2. Location of four excavated pits within the 300 Area Process Ponds.

A map showing the locations of the four pits is presented in Figure 2. These excavations provided an excellent opportunity to evaluate the hydrogeology and geochemistry of the vadose zone beneath the recently remediated waste-disposal ponds.

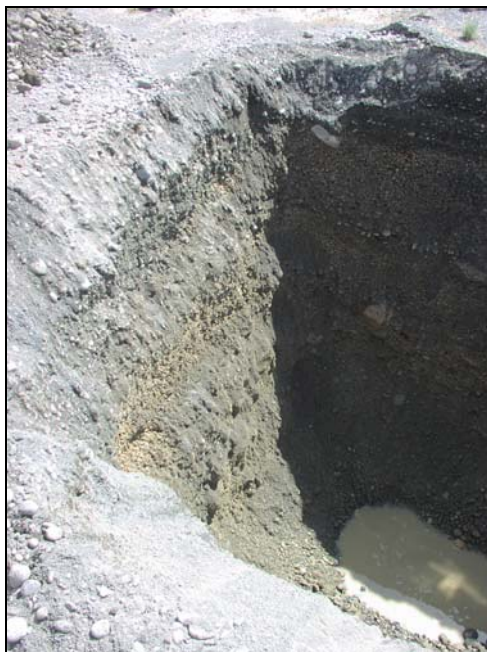
Figure 3. View looking into South Process Pond Pit #2 from cab of backhoe. Pool of water at the bottom is the top of the water table, which was 18 feet below ground surface at this location.

Pits were excavated to the water table between 10-22 ft bgs (Figure 3). Since the water table is essentially flat in this area, the differences in water table depth beneath the excavations must be a result of variable surface elevation.

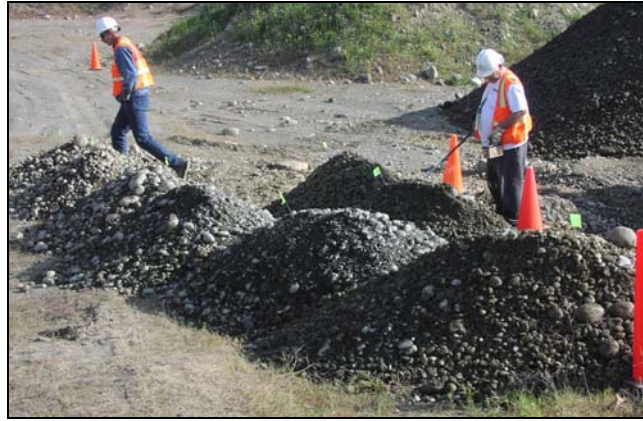
Figure 5. Excavated sediment piles being surveyed at South Process Pond, Pit #1.

As pits were excavated, representative sediment samples were collected with the backhoe at two-foot increments and laid into piles on the ground next to the pit. The sediment piles were immediately surveyed for radiological contamination (Figure 5). With one exception, no radiation above background levels was detected with hand-held instruments. The single exception occurred at the North Process Pond, Pit #2, which registered some near-surface contamination.

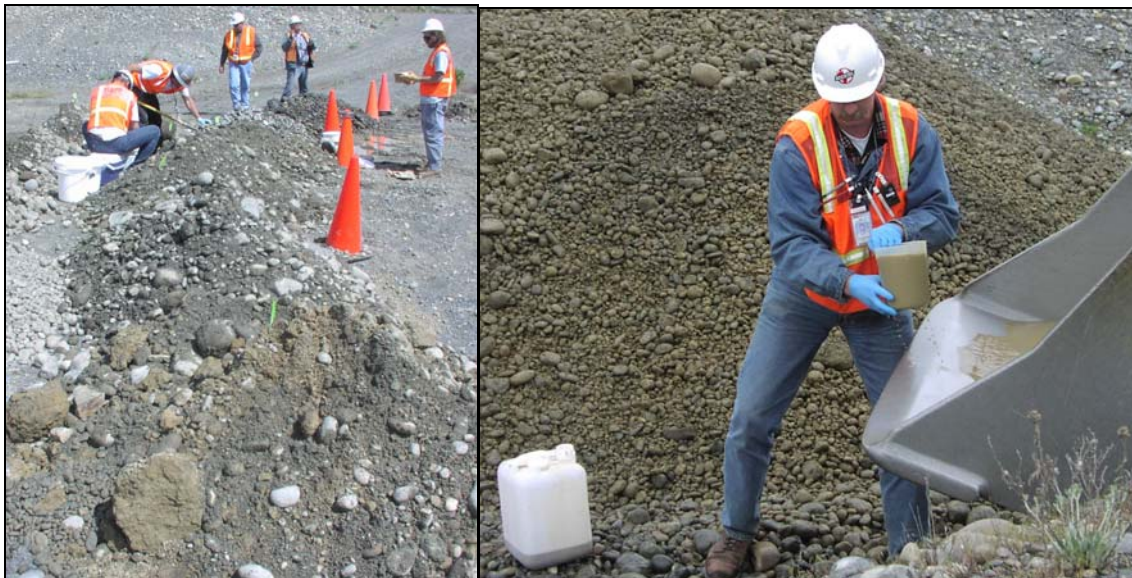
Figure 6. Sampling at the South Process Pond. Left: Sediment samples were laid out in separate piles every two feet as pits were deepened. Each pile was labeled according to the depth onto a pin flag. Right: muddy groundwater samples, removed from the bottom of the pits, were collected from the bucket of the backhoe.

After each pit was excavated, sediment samples were collected about every four feet from the sediment piles (Figure 6, left), and a water sample collected by the backhoe from the bottom of the pit (Figure 6, right). Samples removed from below the water table generally lacked particles smaller than fine sand; this is because fines were washed out these unconsolidated materials and went into suspension in the pool of water at bottom of the pit during excavation. The material in each of the piles was examined and logged for the following characteristics:

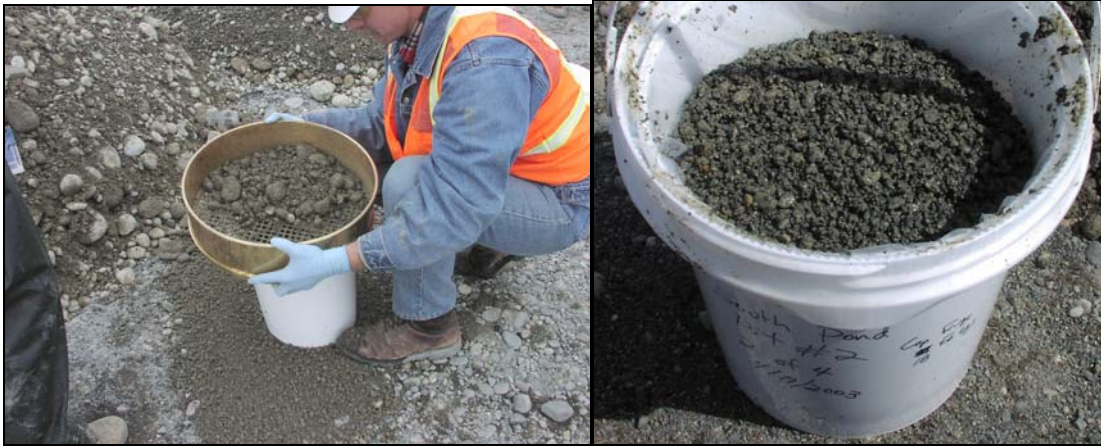
Figure 7. Four sediment samples, one about every four feet, were collected from the vadose zone in each pit. The coarser gravel fraction was removed by passing through a coarse wire-mesh screen. Right: coarser fraction sieved out.

Only sediment passing through a coarse, wire-mesh screen was included in samples that went into the plastic buckets (Figure 7). This included particles less than or equal to the size of small pebbles.

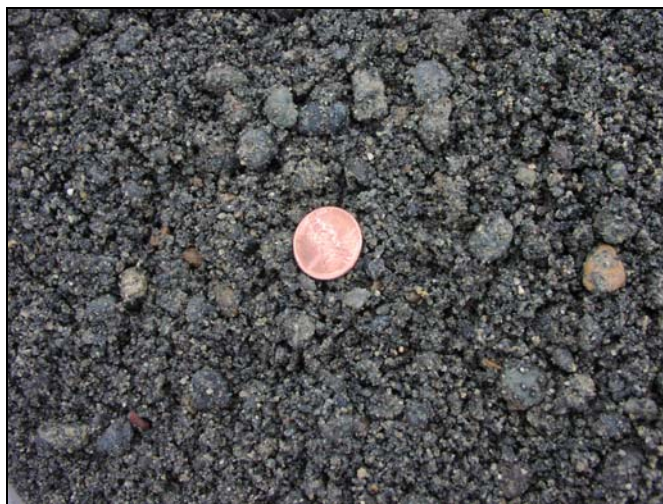
Figure 8. Coarser sediment grains consist of predominantly basaltic rock fragments. Penny for scale.

The vadose-zone sediments within the 300 Area consist entirely of coarse-grained Hanford formation, which was deposited during one or more Pleistocene cataclysmic floods. Generally loose, clast-supported, muddy sandy gravel was the predominant sediment type; lenses of matrix-supported gravelly sand occurred sporadically. The terms “mud” and “muddy” are used to describe undifferentiated silt- to clay-sized particles. Gravel clasts ranged from pebble to boulders up to several feet in diameter; most are subangular to subrounded and covered with a thin coating of mud. Material filling the matrices between gravel clasts was highly variable and consisted of a poorly to moderately sorted mixture of mud and/or fine to coarse sand. The mineralogy of the sand-sized particles consisted of 70-90% dark gray to black basalt (Figure 8), typical for the Hanford formation in this area.

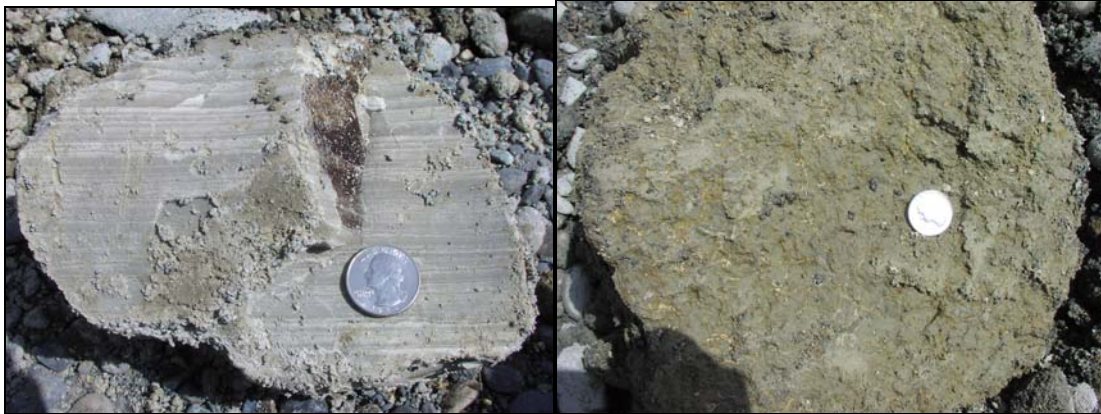
Figure 9. Two types of rounded Ringold Formation rip-up clasts. Left: compact, finely laminated, lacustrine mud (i.e., undifferentiated silt and clay). Right: massive, pedogenically altered and weathered mud. Note abundant root traces filled with reddish iron oxide and white calcium carbonate, which developed in a floodplain-paleosol-type of environment during Ringold time around 3-5 million years ago. Identical sediment types are exposed in the White Bluffs across and upstream of the 300 Area. These semi-consolidated, detrital clasts were eroded off the White Bluffs and transported to the 300 Area during one or more cataclysmic, Ice-Age floods.

carbonate-cemented caliche, as well as clasts of compacted mud, originally deposited during Ringold time in either floodplain or lake environments (Figure 9). These same types of sediment are exposed in the Ringold Formation within the White Bluffs immediately across the river, as well as upstream of the 300 Area. Generally, Ringold rip-up clasts are larger than adjacent clasts (Figure 10), reflecting their short transport distance and lower bulk density, in contrast to lithified clasts. The fact that the rip-up clasts are rounded indicates they were transported as detrital material, along with other materials, during flooding.

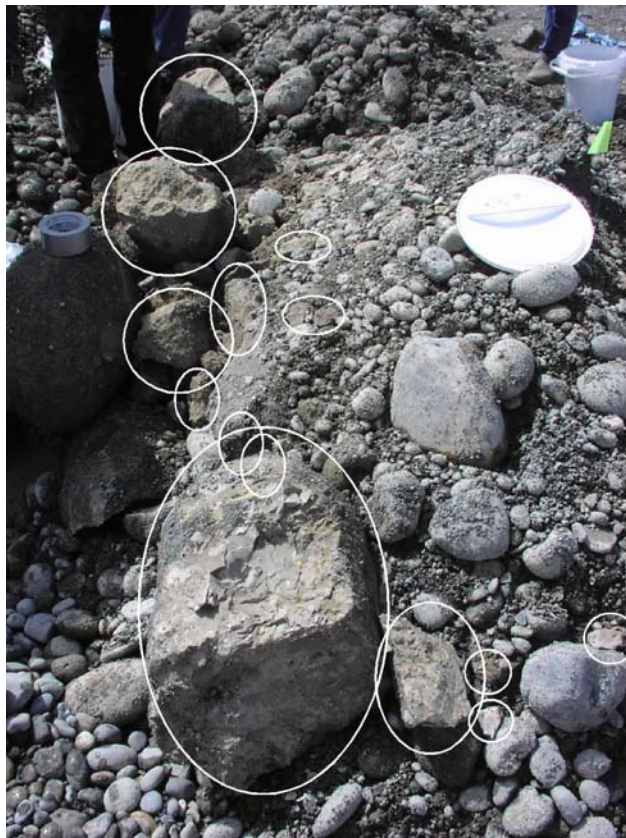
Figure 10. Concentration of Ringold rip-up clasts (circled), which rolled off the top of sediment pile. From 10 ft depth in South Process Pond, Pit #2. About half the volume from the backhoe bucket at this depth was composed of Ringold rip-up clasts. Notice most rip-up clasts are significantly larger than other clasts. Some of the less-consolidated rip-up clasts broke apart during excavation.

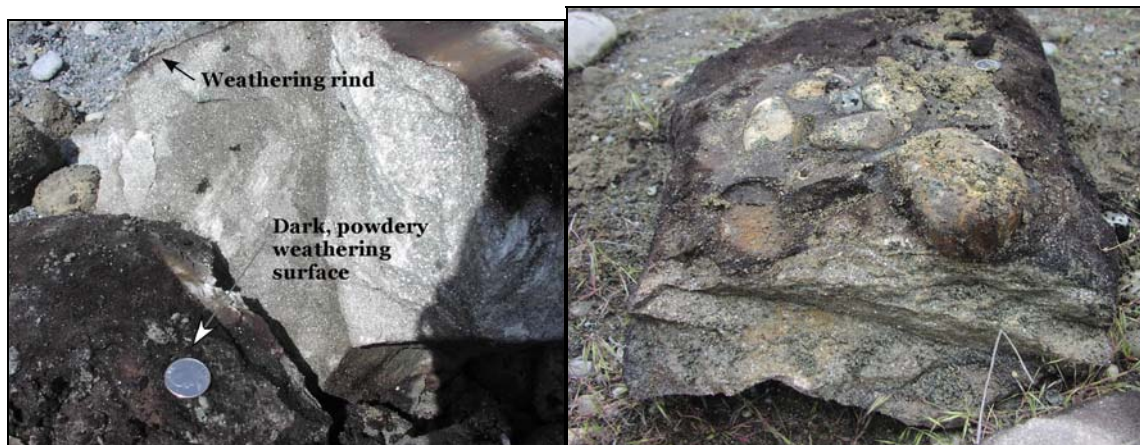
Figure 12. Unusual weathering rinds on cemented Ringold clasts. Left: 2-ft diameter, micaceous, cemented sandstone boulder from 17 ft depth in Pit #2. Boulder was split open with the blade of the backhoe showing an unusually thick, dark reddish brown weathering rind around the outside. Right: micaceous cemented conglomeratic sandstone boulder with a dark weathering rind, from 8 ft depth in North Process Pond, Pit #1.

Two unusual features observed in materials extracted from the excavated pits include: 1) dark weathering rinds on cemented micaceous sandstone clasts of the Ringold Formation, and 2) clumps of dark organic(?) -rich material in the sediment matrix. The weathering rinds (Figure 12) appear to be composed of an iron and/or manganese oxide. This type of weathering rind was observed only on cemented Ringold sandstone clasts. The weathering rind must have developed *in situ* since the Pleistocene, because of the loose, powdery nature of this surface, which would have been destroyed during flood transport.

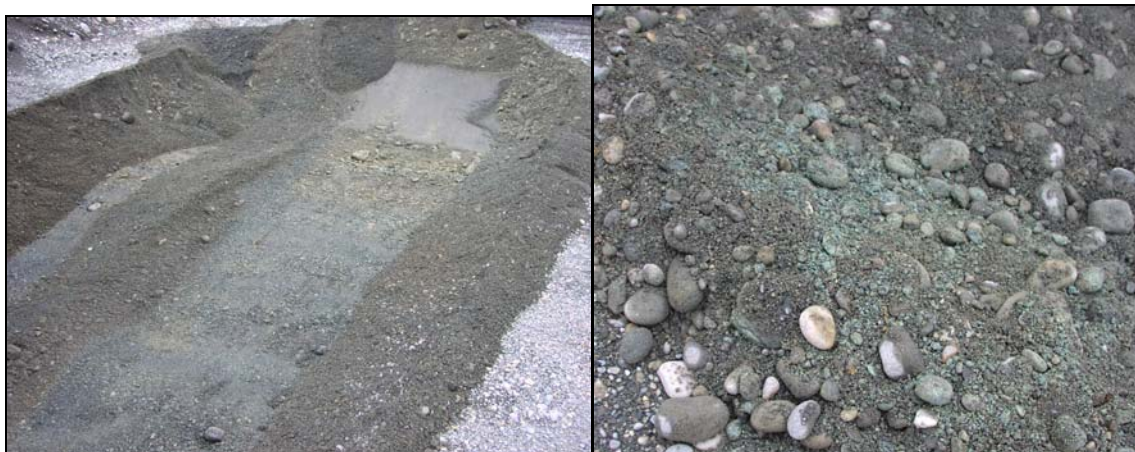
Figure 20. Near-surface contamination encountered at north pond, pit #2. Radioactive contamination appears to be associated with green-colored mineralization only observed in the upper few feet in this excavation.

In Pit #2 radioactive contamination was found, associated with a greenish-colored mineral observed at and just below the surface (Figure 20). The mineralization was described by one on-site worker, with many years of clean-up experience in the 300 Area Process Ponds, as copper uranyl phosphate. The contamination was not found below a few feet of the surface.
