THE REUSE OF MONASTIC MATERIALS IN POST-DISSOLUTION CONTEXTS AT
THORNTON ABBEY

in partial fulfillment of the requirements for the degree of
Bachelor of Arts

University of Wisconsin-La Crosse
2013

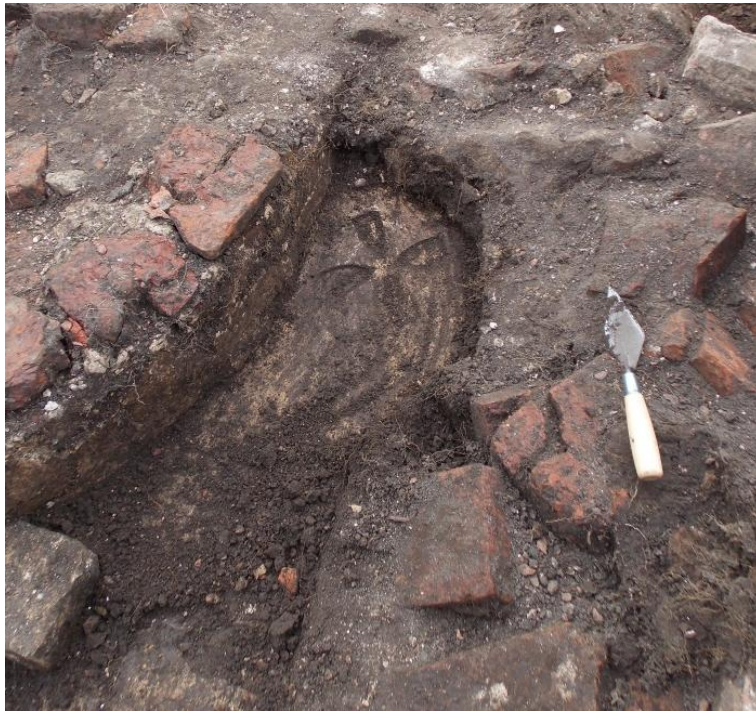
Figure 1. An example of a piece of monastic stone as a flagstone in a post-dissolution building at Thornton Abbey.

During the course of the excavation, other types of reuse emerged. A gravestone was found reused as a flagstone (Figure 1) in Trench E, which had an almost identical, cruciform symbol as some of the gravestones in the church area. Once again, historical sources state that flagstones

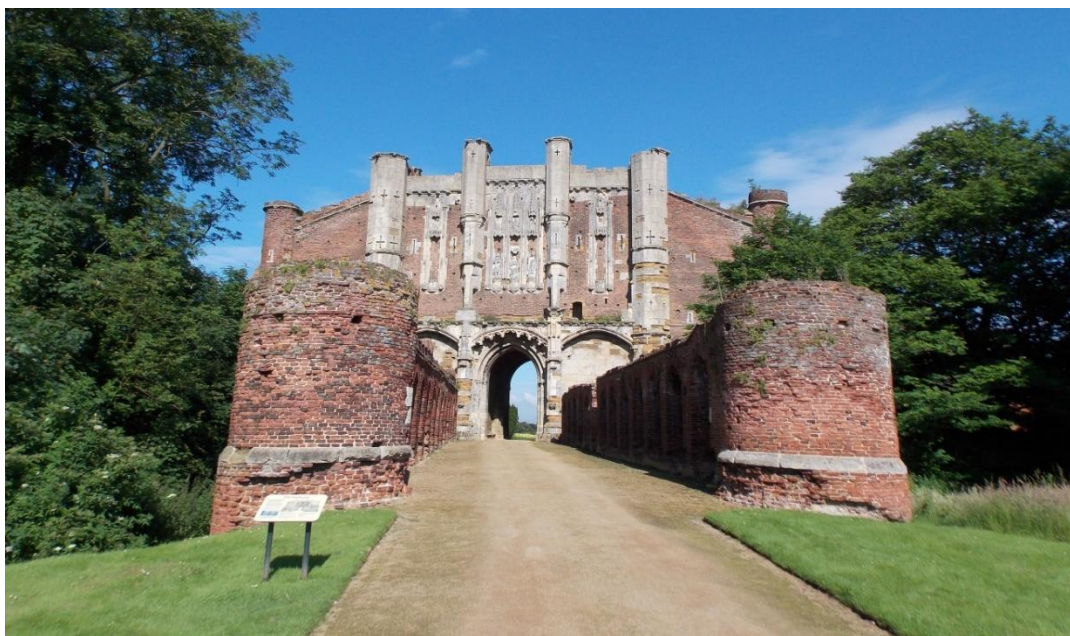
Figure 3. Thornton Abbey Gatehouse from the front, dated to mid-fourteenth century. The Barbican extends outward from the entrance of the Gatehouse, a later addition.

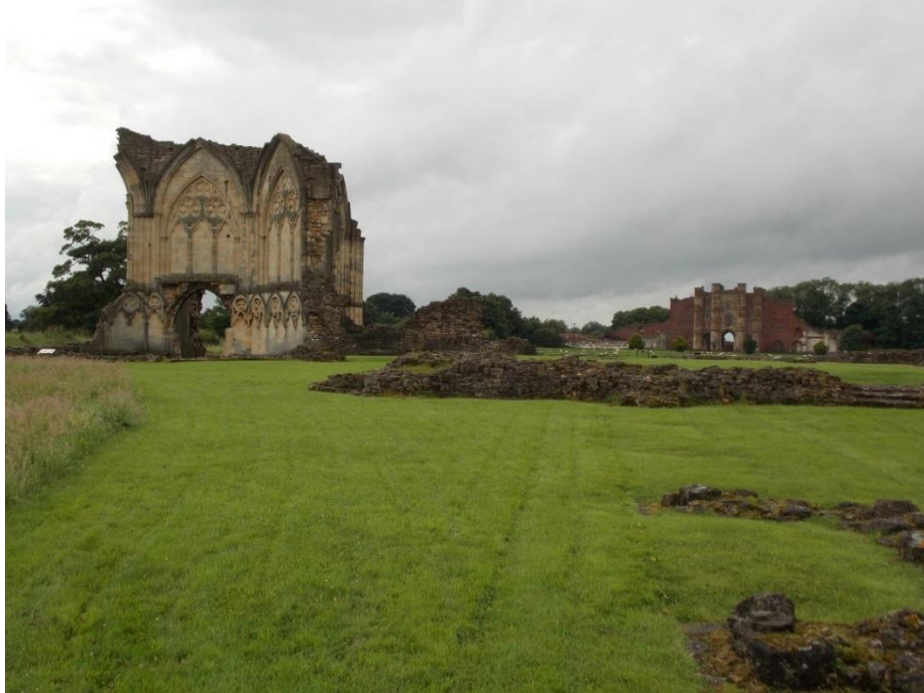
Figure 4. Above are the ruins of the church in the foreground, with the back of the Gatehouse in the background.

An important aspect of the church ruins is the rebuilt brick work. Fifteenth century brick work was laid over parts of the church, blocking over some monastic features. In some cases, the later brickwork had to be removed from the doorways of the monastic structure later on (Clapham and Reynolds 2011:8-12).

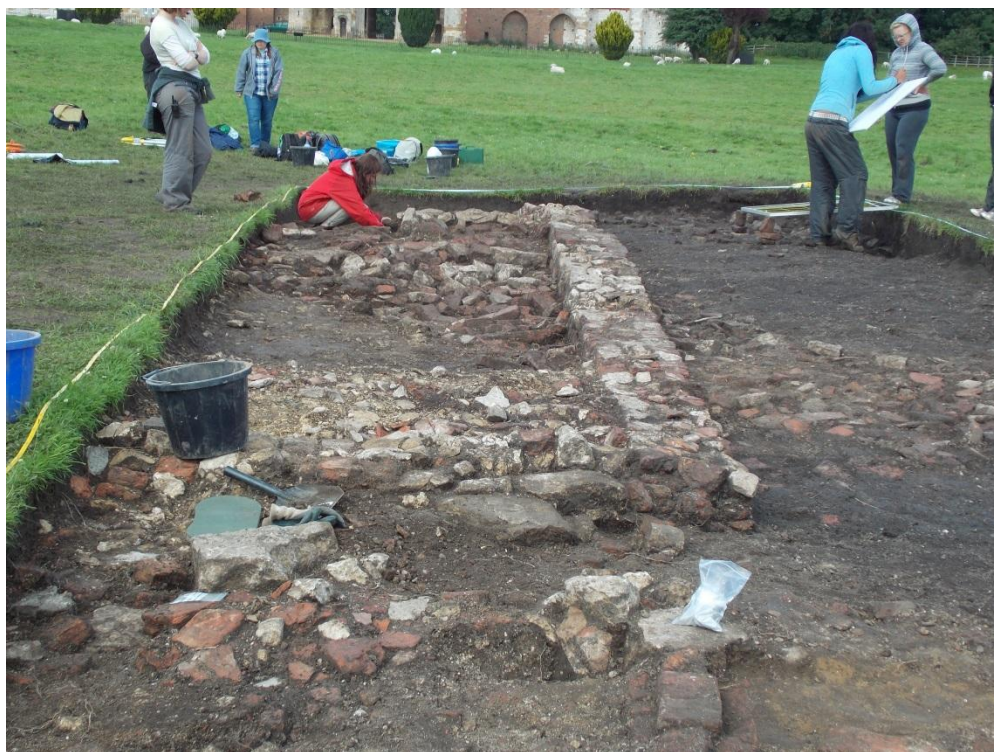
Figure 5. Trench E, pictured wall of post-dissolution building

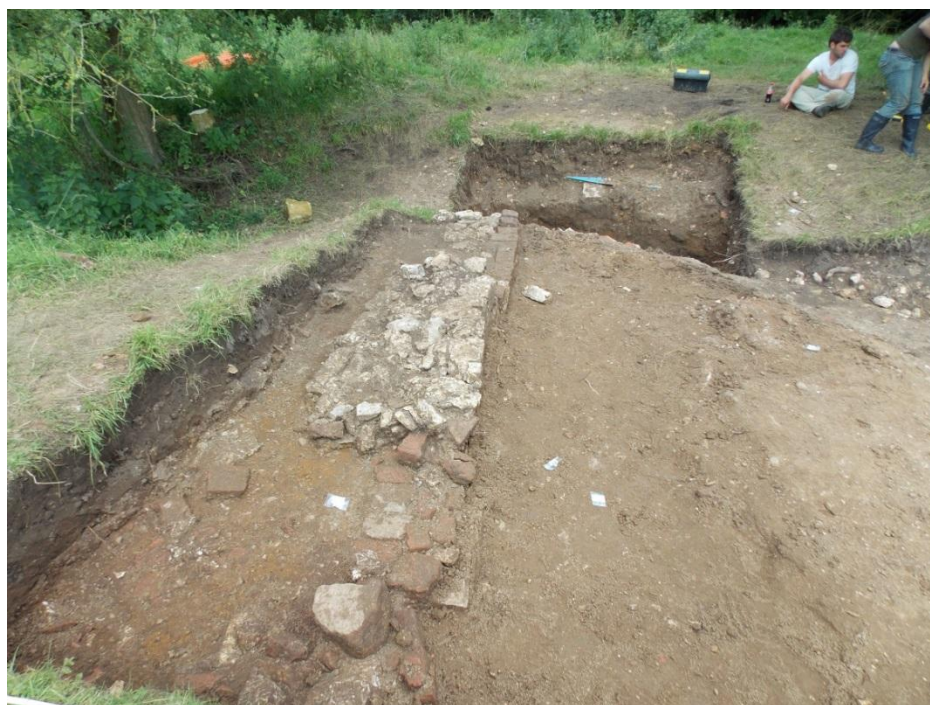
Figure 6. Trench C, pictured is the interior wall of an unfinished building.

During the summers of 2011 and 2012, the University of Sheffield conducted excavations at Thornton Abbey under the direction of Dr. Hugh Willmott. During both summers, the area was substantially surveyed, identifying underground earthworks, and key areas of the site were excavated. During 2012, several trenches were opened, and the trenches that yielded the majority of bricks are as follows; a trench was opened over a post- dissolution building (Trench E; see Figure 5) and another trench opened over the foundation cuts for a house that had never been built (Trench C; see Figure 6)

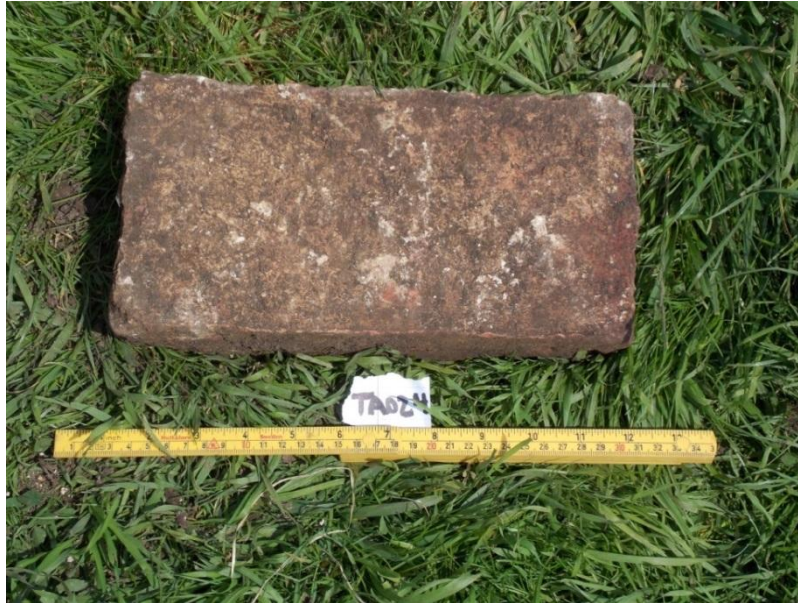
Figure 7. An example of a brick measured, identified, and photographed.

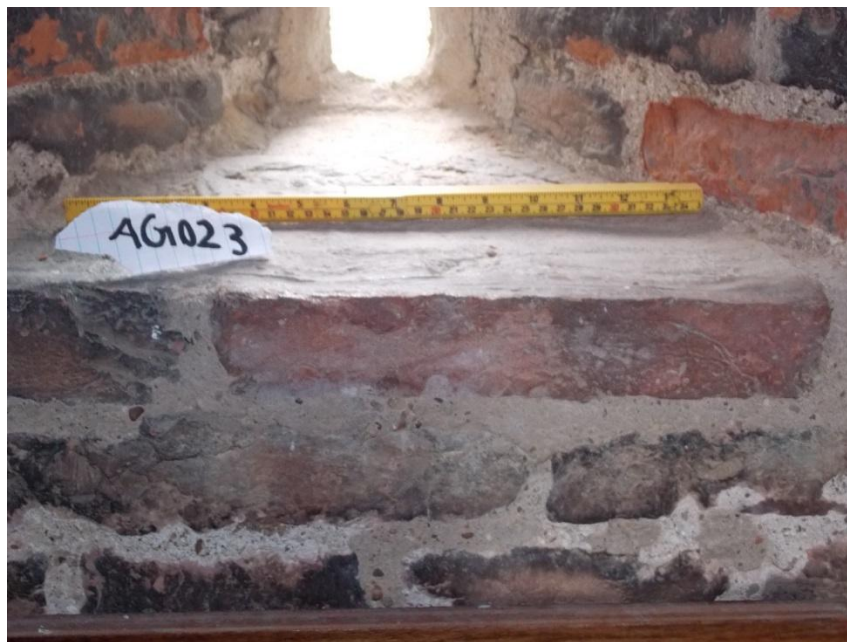
Figure 8. An example of a brick measured from the inside of the Abbey Gatehouse.

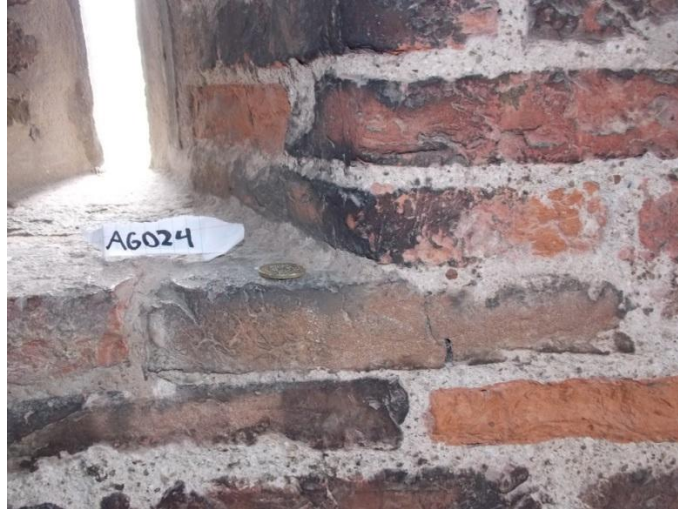
Figure 12. Above the brick marked with a coin, bricks cut to fit into a window overlook are pictured.

The skewing of the measurements on the Gatehouse could be a result of differential use of the bricks in and outside the building. While the bricks on the Barbican were all placed, and used in a more uniform fashion (see Figure 3), the bricks from the Gatehouse were taken from the interior and exterior, randomly selected throughout the building. The bricks were used in various locations and were likely cut to fit in the bonds. Throughout the building there were obvious examples of cut bricks usually near corners, over doorways, and the end of walls, and it is inevitable that some of the sample may have contained bricks that were less obviously cut.

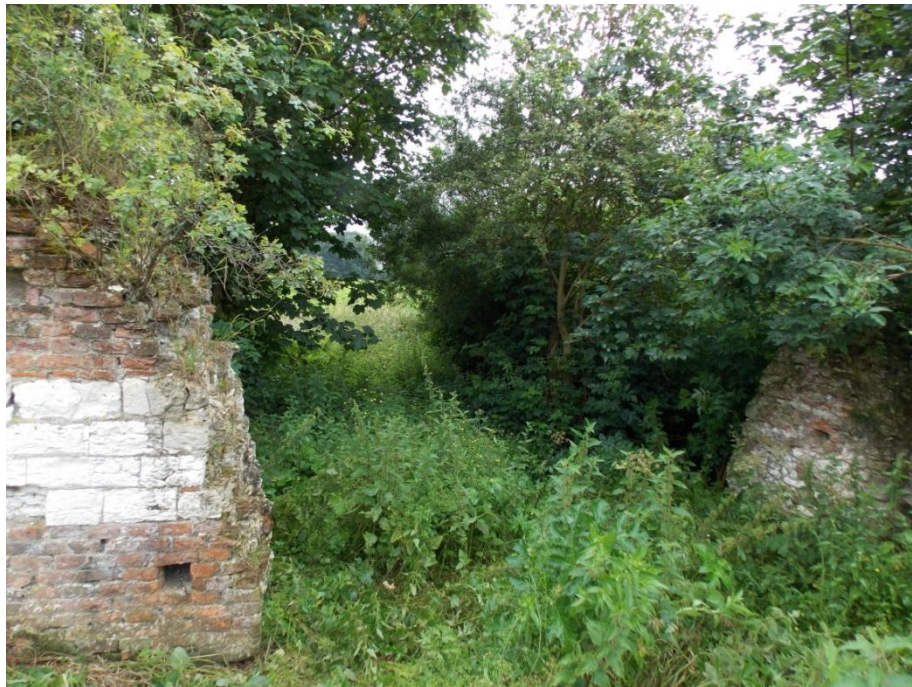
Figure 21. The South Gatehouse.

Beyond the Gatehouse, there were other sources of brick that either had or could have been reused in the building of later structures, in spite of a lack of standing brick structures on the immediate site. The mill and the mill leat both had fragments and full bricks, largely discarded among an abundance of faunal bone observed along the leat path. In addition, the highly decayed south Gatehouse is found far from the excavations, and could have likely been utilized for building source (Figure 23).
