English and Irish Medieval Fortified Ecclesiastical Structures and the Bishop's Manor in
Kilteasheen, Ireland.

A SENIOR THESIS SUBMITTED IN PARTIAL FULFILLMENT OF THE
REQUIREMENTS FOR THE DEGREE OF BACHELOR OF ARTS IN
ARCHAEOLOGICAL STUDIES
UNIVERSITY OF WISCONSIN-LA CROSSE

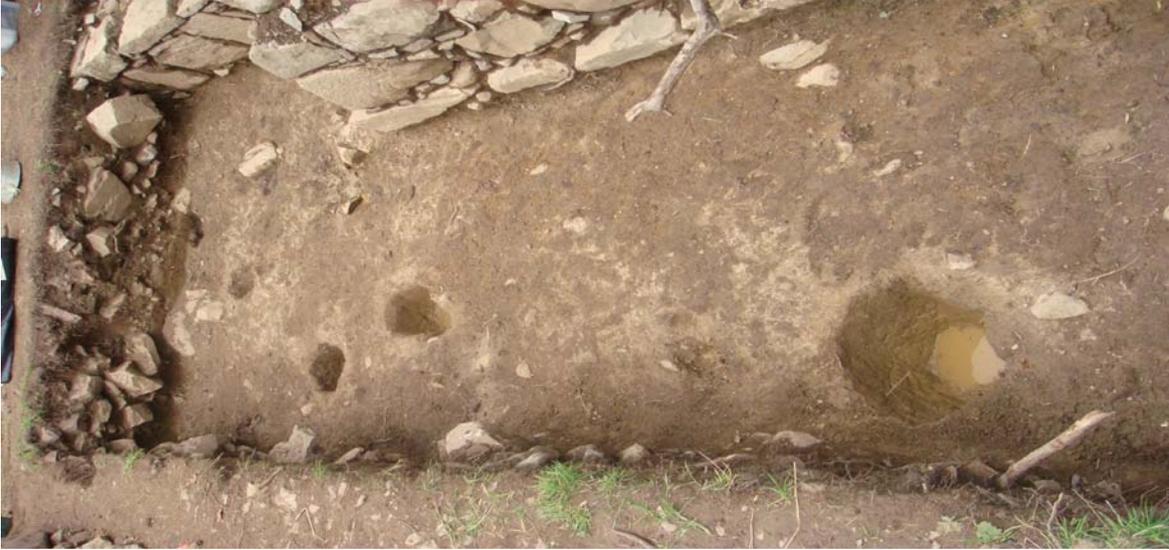
Figure 5: Photo of the post holes in Cutting I at the Bishop's Manor.

When excavating the Bishop's Manor in Cutting I it was uncovered a series of five post holes situated in the north/north-west corner of the wall. The post holes F471, F483, F485, F487, F489, consisted of a sub-circular cut. "Its edges were constructed at a very sharp angle on all sides with the sides sloping vertically to a flat base with U-Shaped profile" (Read and Finan 2008). The post holes can be seen in the Figure 5 in Cutting I at the Bishop's Manor. They all had small packing stone fill in the post-pits which projected above the surface of the cut. The post-pits possibly represent the remains of a scaffolding platform which was used in the construction west gable wall of the hall-house. This information shows archaeologists the construction techniques the stone masons used in building the Bishop's Manor. The scaffolding displays a knowledge of building stone structures which is evidence of English influence in early Irish stone fortified structures.

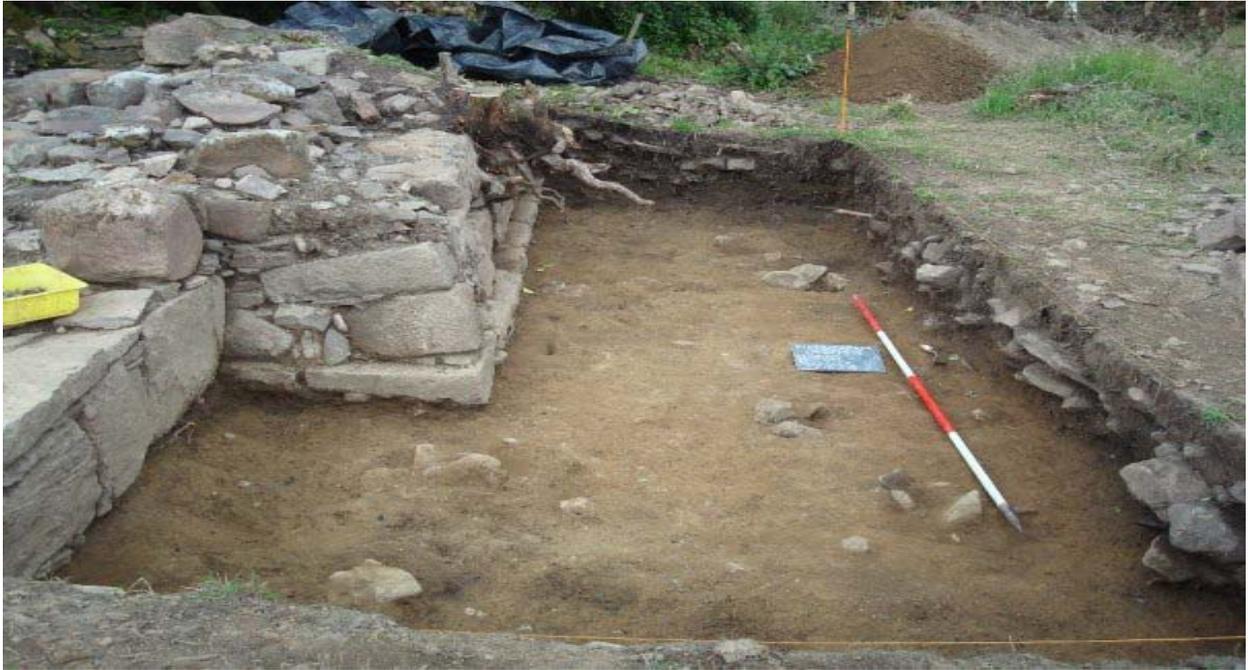
Other features that are important in looking for English influences in the Bishop's Manor are the evidence of base-battering and the plinth. Base-battering is when at the base of a stone defensive structure is widened for extra durability and has an inward inclination of the exterior face of a wall. The way base-battering worked was in case of siege weapons like battering rams striking the walls was to deflect it upward lessening the force of the blow. An example of base-battering can be seen in Figure 6. A plinth is a continuous use of stone slabs that are at the base of a structure that act as support and trim around the building.

Figure 6: Cutting I the exterior wall of the Bishop's Manor showing signs of base-battering and a plinth.

stairway. Also notice in Figure 12 that the plinth does not follow the fore-building but remains at the base of the main structure along with the lack of base-battering on the fore-building. Another thing discovered with the fore-building which supports that it was used as a ground entrance instead of a tower is a possible doorway that can be seen in Figure 13 in the bulk of Cutting I. A theory is that the O'Conors feared that the Bishop's Manor would fall into the hands of the enemy so they destroyed the hall-house, but under the control of the Anglo-Normans they added the fore-building to the structure to allow for an easier way into the building by having a ground entrance. The fore-building needs further excavation in order to find its true purpose and discover if it possibly has a ground entrance with a staircase that leads to the first floor.

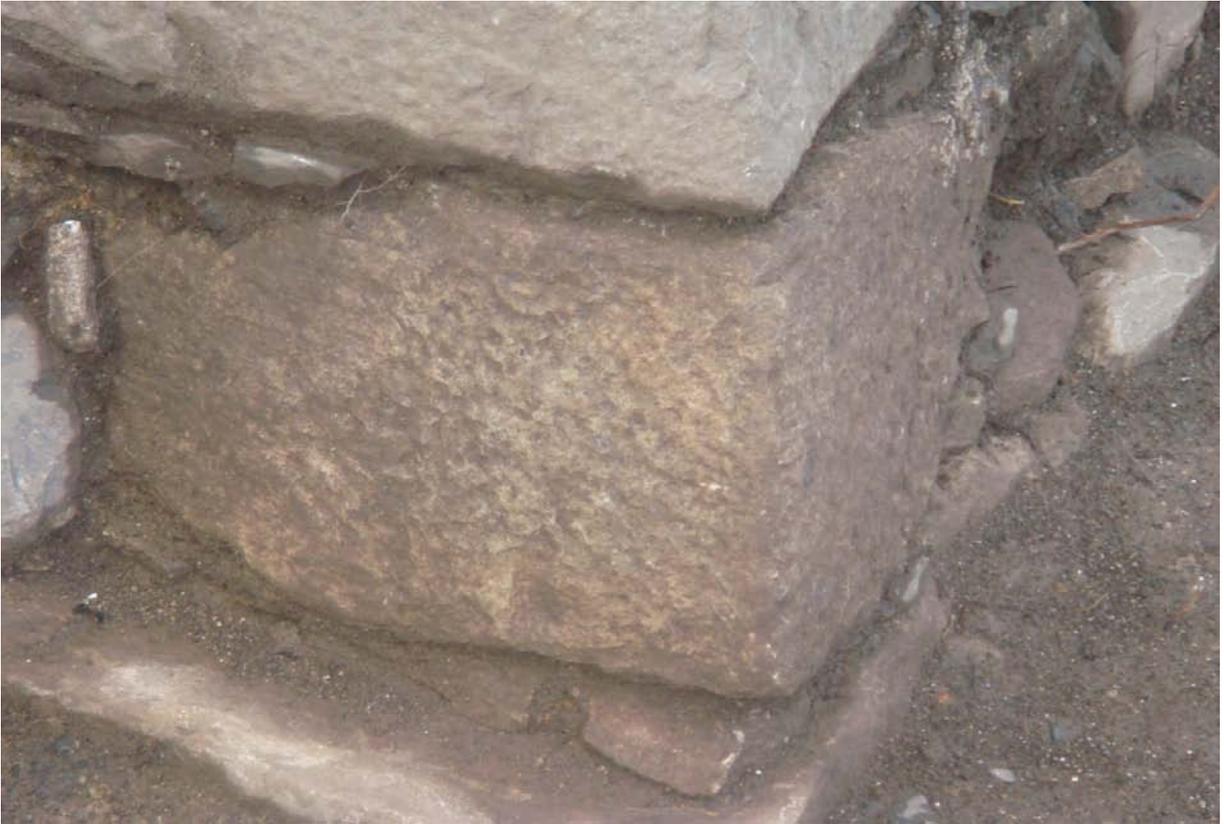
One of the key features at the Bishop's Manor is the corner stone of the north-west corner of the structure. This corner stone is unique because it has an unusual dressing which seems to show a finishing which did not spread to western Ireland until the 14th century. "The north-west corner also contains a stone with what may be rough punched dressing. Not normally associated with buildings in the west prior to the 14th century this may be an anomaly (punched dressing is associated with 13th century buildings at Kells and other ecclesiastical sites in Leinster) or it may be a later addition" (Read and Finan 2008). This is not a good example of punch dressing, but as of now this has been the only corner of the structure that has been excavated. In a close up in Figure 7, it shows in detail the punched dressing used on the north-west corner stone of the Bishop's Manor. To get an even clearer look of what the punch dressing looks like see

Figure 7: The north-west corner stone of the Bishop's Manor that displays a rough punched dressing as a finish on the stone.

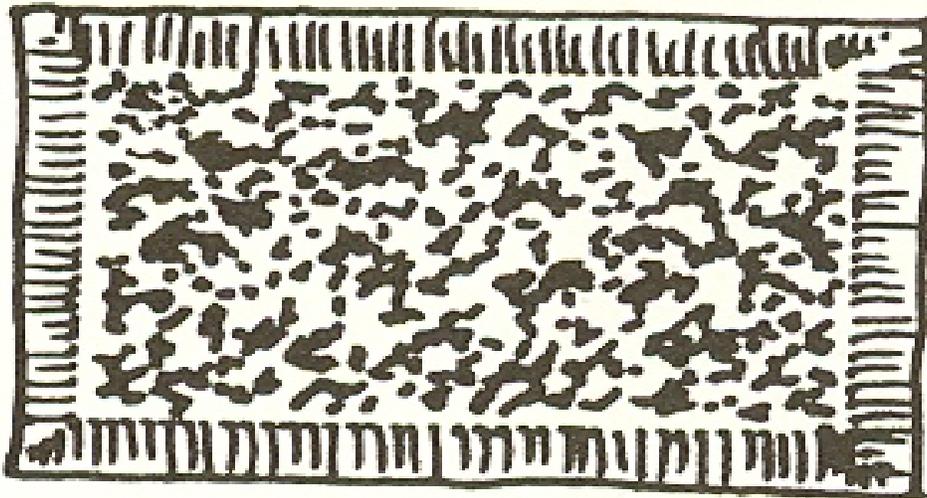
Figure 8: Example of rough punched dressing. (McAfee 1997: 94).

Figures 8 and 9. When looking at the Kells Priory in Kilkenny Co. it also displays use of masons using finishes on corner stones. It has punched dressing like that found at the Bishop's Manor, but it also displays another type of finish which dates to the twelfth century. "The first and more prevalent type is a pale-grey to white, medium to coarse-grained, quartz-rich sandstone. Some of the stones display diagonal axed tooling, where the fine sedimentary layering in the sandstone stands proud due to differential weathering" (T. Fanning & M. Clyne 2007: 66). An example of this can be found in Figure 9 of the axe tooling in diagonal lines. This technique is used on relatively soft stone like limestone or sandstone. "The broad axe marks indicate a method of taking a face out of twist other than using drafted margins" (McAfee 1997: 95). By looking at the tooling techniques used by stone masons on these two stone structures it allows archaeologists to date both structures along with looking at the spread of architectural designs from culture to culture.

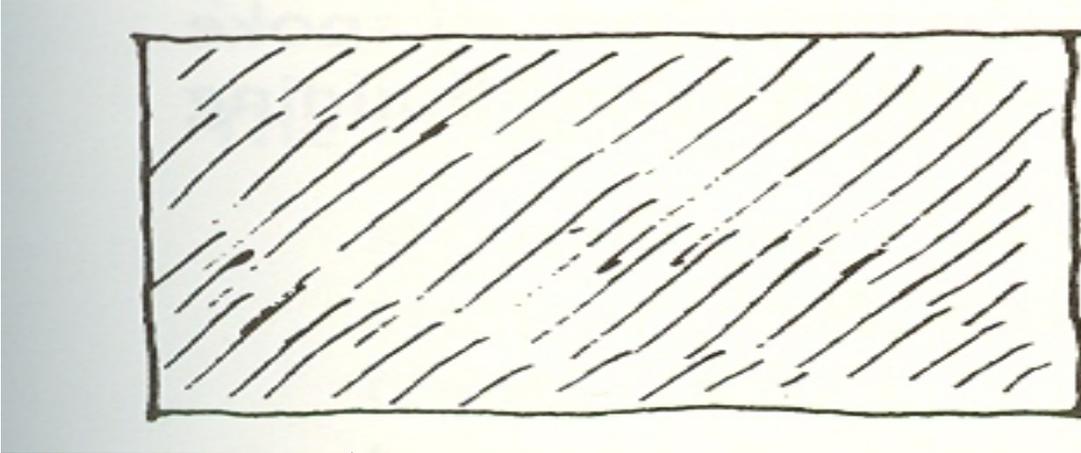
Figure 9: Example of c. 12th century work with axe marks finishing. (McAfee 1997: 95)

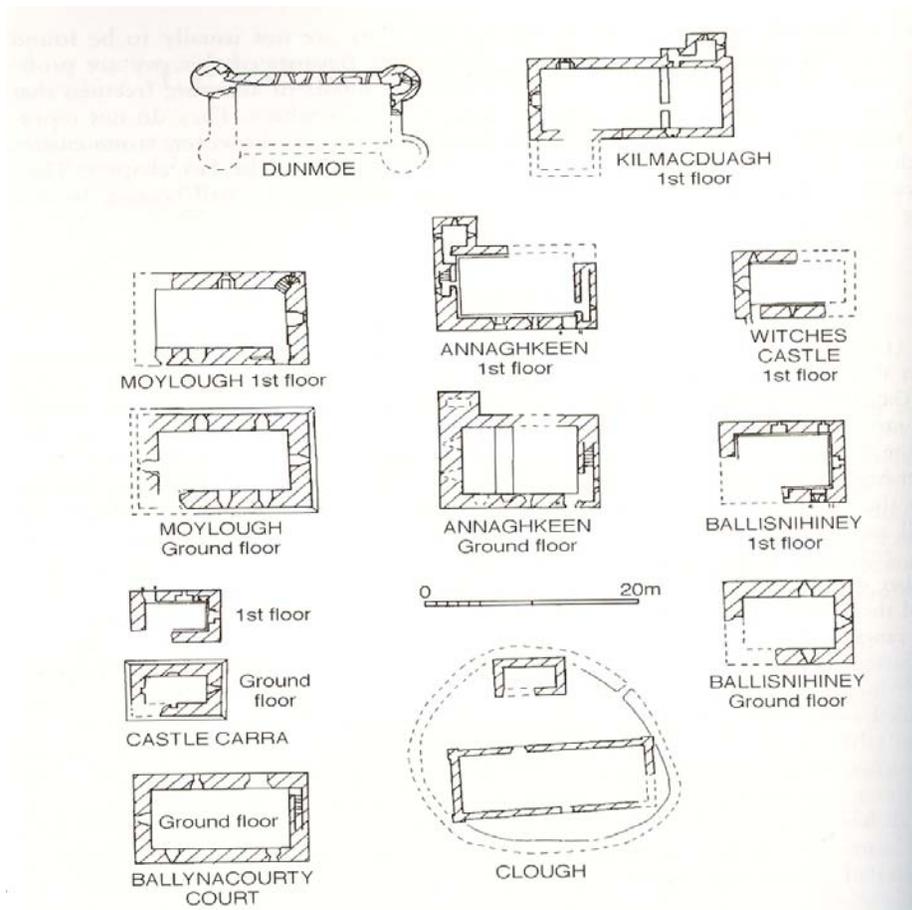
Figure 10: Plans of hall-houses. (McNeill 1997: 150).

One of the more interesting and unexpected finds of the summer 2008 field school was the remains of what appears to be a fore-building. In Figure 11 is a photograph of the north-south wall of the fore-building. The fore-building had substantial amount of wall collapse which made it at first hard to identify, but after removing the collapse a perpendicular wall was exposed coming from the hall-house. “The projecting west wall of the fore-building runs the full width of the cutting i.e. 2m north-south with a returning north face exposed 1.84m north of the external north face of the hall-house. The returning right-angled north wall of the fore-building oriented east-west runs the full length of the cutting on its east side but is less intact towards its north-eastern end” (Read and Finan 2008). The fore-building is interesting because it does not seem to fit the rest of the original hall-house both in its design and the raw materials. By looking at the original design of the Bishop’s Manor it looked like the hall-house Ballisnhiney in Figure 10, but with the discovery of the fore-building the Bishop’s Manor now looks like the hall-house Annaghkeen in Figure 10.

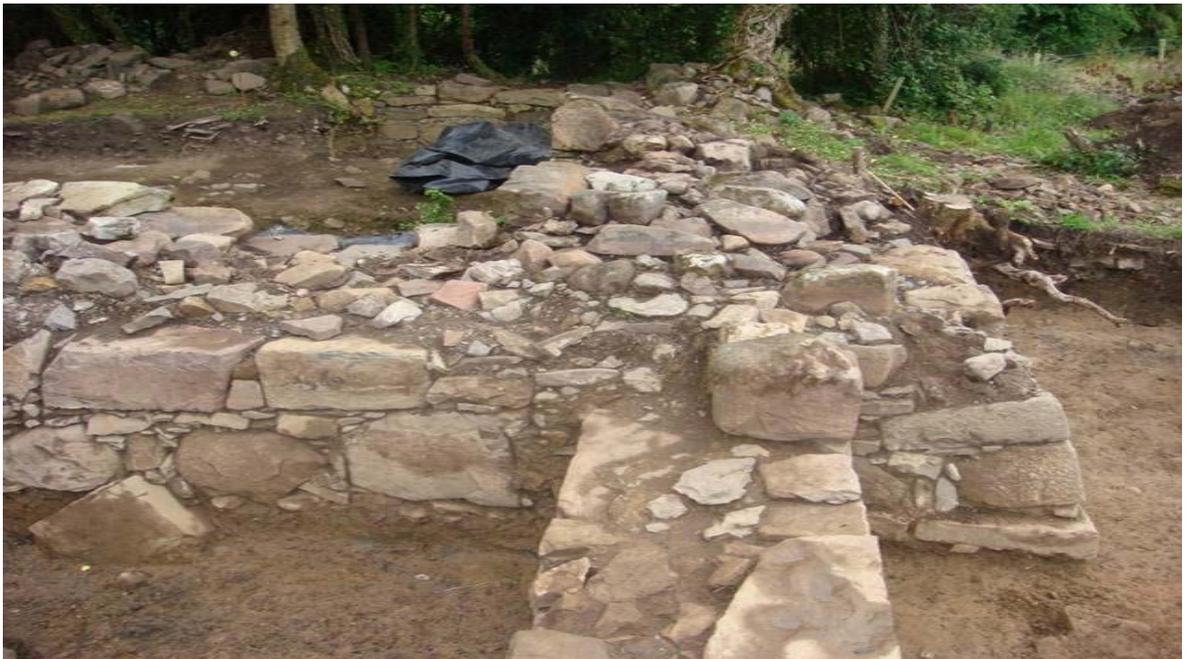
Figure 11: The fore-building and north main wall.

Dr. Christopher Read believes that the fore-building is a later structure that was added on to the Bishop’s Manor after its construction in A.D. 1253. “The differences in the construction and material fabric between both internal wall faces of the fore-building may argue that the north wall represents a later phase of construction than the west of the fore-building” (Read and Finan 2008). The fore-building could have a possible stairway on the ground floor of the Bishop’s Manor that allowed for a ground entrance which would exclude the Bishop’s Manor as a hall-house. Hall-houses have their entrances on the first floor of the structure in order to narrow the accessibility to enter or leave the manor thus making it a more defensible location with a small number of men. In Figures 11 and 12 the photographs show the fore-building that might have had a possible

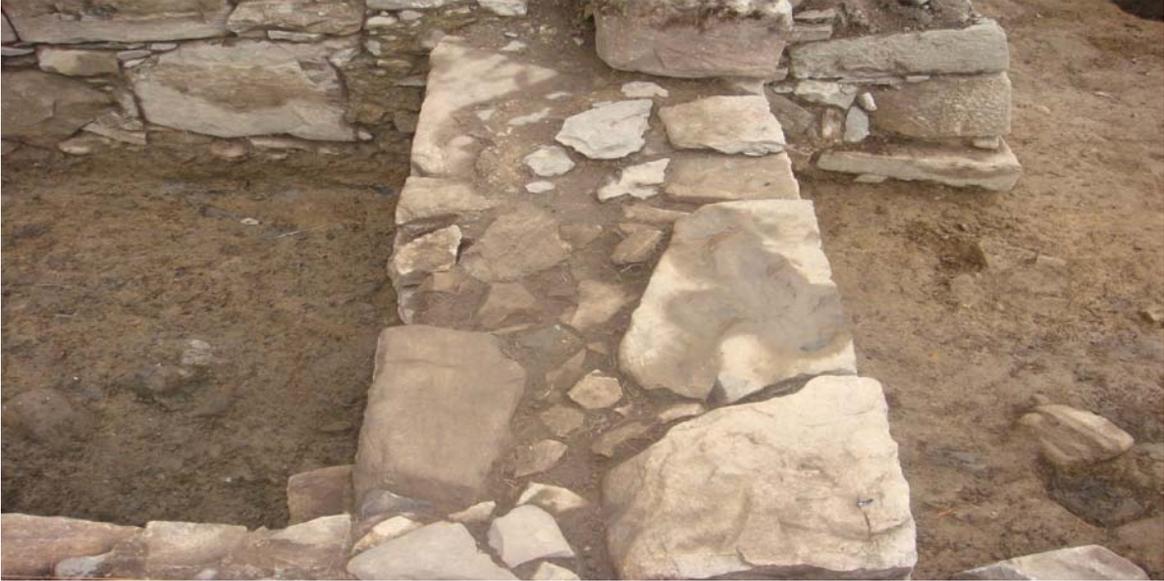
Figure 12: The fore-building close up with no base-battering or plinth.

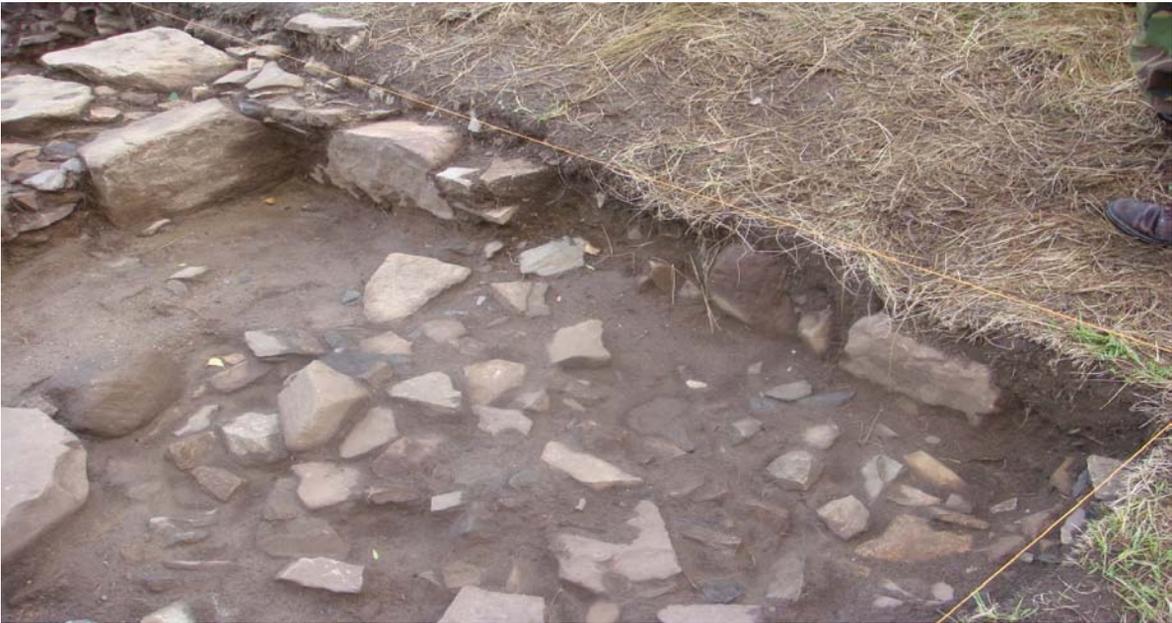
Figure 13: The fore-building at the Bishop's Manor with a possible ground entrance.
