## BRIEF REPORT

## Reports of Two Broken Nexplanon® Rods

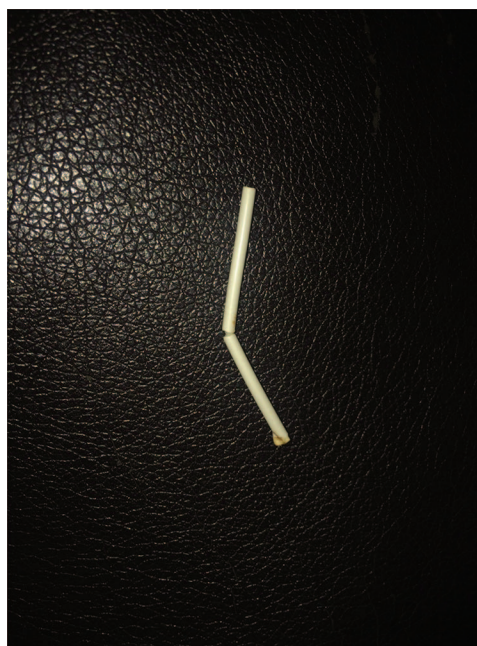
This report will describe 2 cases of damaged Nexplanon® rods. In the first case, an 18-year-old female with an unremarkable history presented for Nexplanon removal. The rod had been placed 8 months earlier. The patient sustained local blunt trauma to the implant during a softball game. She subsequently noticed that the device was bent. Several weeks later, the patient experienced vaginal bleeding resembling a normal period. This was the first vaginal bleeding she had noted following the Nexplanon insertion aside from light spotting. The Nexplanon was readily palpated, but it was centrally concave on examination with the 2 opposite ends tenting at the skin surface when pressed in the center (please see Figure 1). The patient opted for removal and reinsertion through a shared decision-making process. The Nexplanon was removed according to manufacturer guidelines. A urine pregnancy test on the day of removal was negative. The Nexplanon rod was noted to have broken at the midpoint of the

Figure 1. Damaged Nexplanon® removed from case 1.

device. A new Nexplanon was then inserted at the same site. The procedure was tolerated well without complications. The incident was reported to Merck by telephone (1-866-342-5683).
