# Analysis of Possible Causes of Fukushima Disaster

Abid Hossain Khan, Syam Hasan, M. A. R. Sarkar

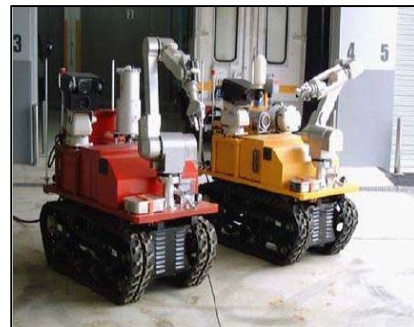
Fig. 4 MoniRobo-A and B [8]

NUSTEC developed MoniRobo-A and MoniRobo-B; robots that could monitor the exterior of a building in which an accident had occurred JAERI, now the Japan Atomic Energy Agency (JAEA), developed two REmote Surveillance Squad (RESQ)-A robots that were anticipated to be able to acquire initial information, such as beta and gamma dose level

Before Fukushima disaster, NUSTEC had kept MoniRobo-A and MoniRobo-B maintained. JAEA had stored RESQ-A, RESQ-B and RESQ-C but had not maintained them after 2006. These robots were not able to work as a result of some failures. The vendor that had co-operated when the robots were developed, was requested to repair RESQ-A, RESQ-B and RESQ-C, but the vender refused the request because the engineer who had involved had since left, with the result that necessary information had been lost. During Fukushima disaster, NUSTEC sent MoniRobo-A to J-Village, which became the base for the emergency response to Fukushima Daiichi accident. However, it was not deployed because it was considered to be too heavy and could damage cables and hoses that were temporarily setup for electric power supply and water supply [8].

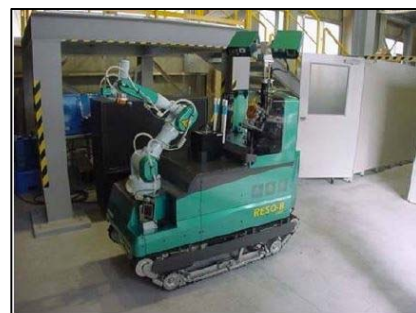
Fig. 6 RESQ-B [8]

data and neutron data, a REAQ-B robot that was to acquire detailed information, a RESQ-C that was to acquire samples, and a Radiation proof roBOT (RaBOT) that could be resistant to radiation. These robots were planned to monitor the insides of buildings, when accidents have occurred in the buildings, so RESQ-B, RESQ-C and RaBOT were equipped with arms that could deal with opening door handles. MSTC developed an operation assistance robot SMERT-K for quick reconnaissance, an operation assistance robot SMERT-M which could carry SMERT-K and run over rubble, a light operation robot SWAN, an operation robot MARS-A, a heavy transporter robot MARS-T, and an anti-high radiation robot MENHIR [8].

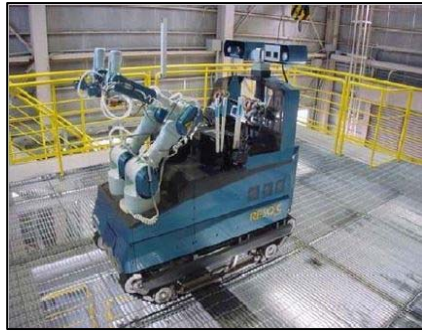
Fig. 7 RESQ-C [8]

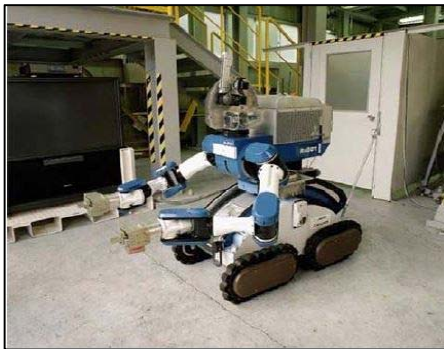
Fig. 8 RaBOT [8]

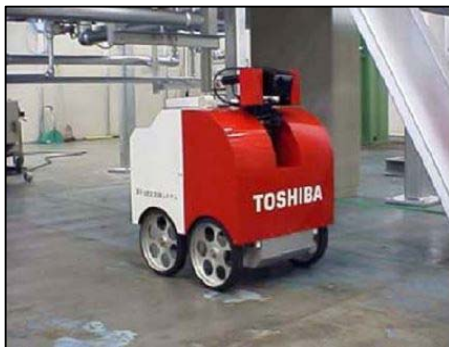
Fig. 9 SMERT-K [8]
