# An Extension–Distraction Injury of the Thoracic Spine with Traumatic Partial Correction of Thoracic Kyphosis

**Study Design** The study is a case report.

**Objective** The authors aim to report an unusual injury pattern in a patient previously treated for thoracic kyphoscoliosis.

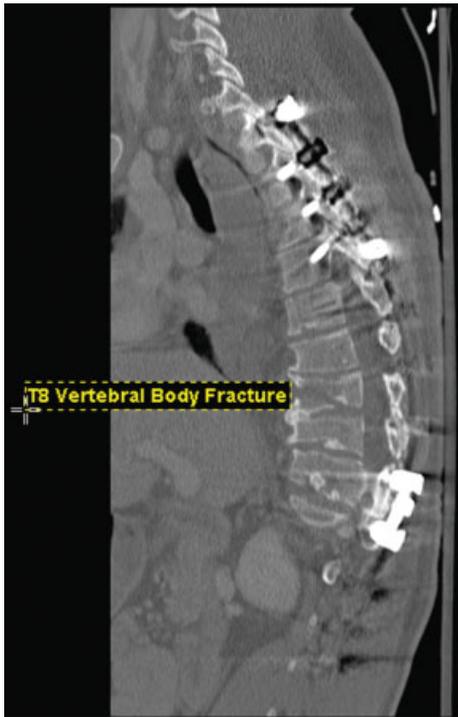
**Fig. 1** Sagittal spine computed tomographic image obtained immediately after the MVA demonstrates T8 vertebral body fracture involving the superior and inferior endplate.

One year later the patient, an unrestrained driver who was ejected from the vehicle, sustained an extension-distracton injury with T8 vertebral body fracture seen on CT imaging (►Fig. 1). He also sustained a right subtrochanteric femur fracture, left clavicle fracture, and left fibular fracture. There was no neurologic deficit postinjury.

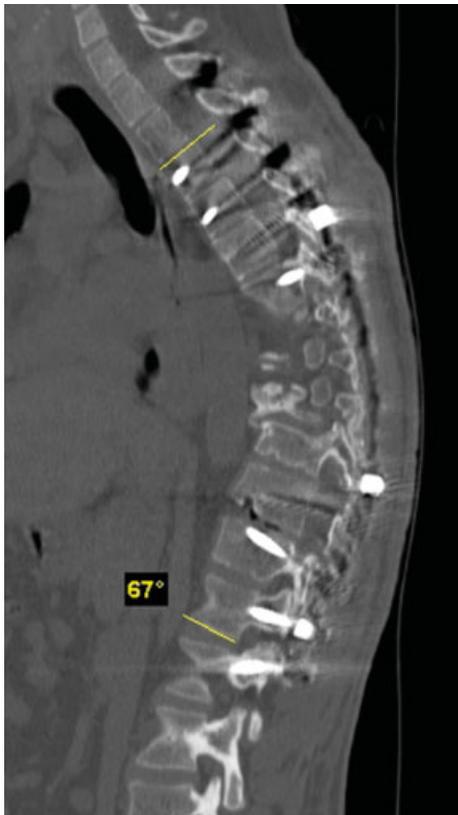
**Fig. 2** Cobb angle measurement (superior endplate T3 to inferior endplate T12) on sagittal spine computed tomographic image obtained 3 months postsurgery but prior to MVA demonstrates a residual thoracic kyphosis of 67 degrees.

Initial postoperative sagittal CT images demonstrate a 67-degree residual thoracic kyphosis (►Fig. 2) compared with the post-motor vehicle accident (MVA) sagittal CT images, which reveal a 54-degree thoracic kyphosis (►Fig. 3) and a 13-degree improvement in sagittal alignment. The measurement of the

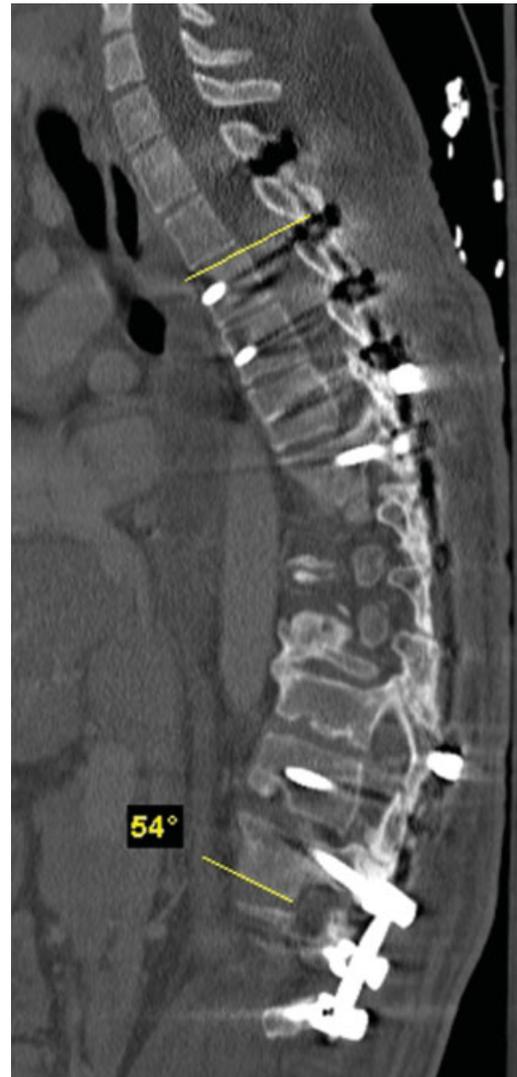
**Fig. 3** Cobb angle measurement (superior endplate T3 to inferior endplate T12) on sagittal spine computed tomographic image obtained immediately after the MVA demonstrates a partial correction of thoracic kyphosis to 54 degrees (previously 67 degrees).

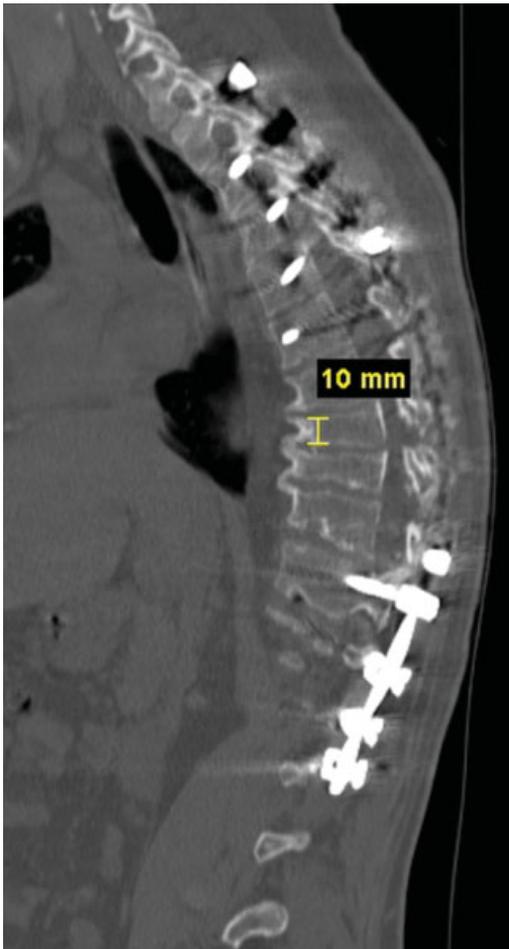
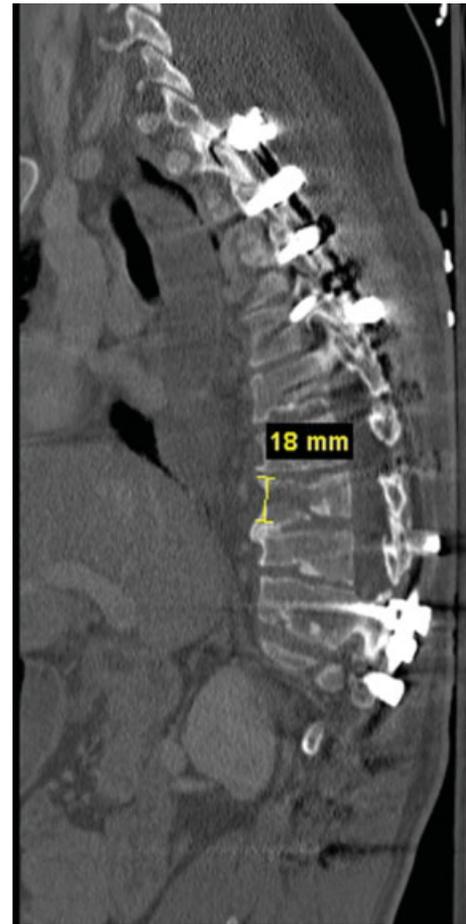
**Fig. 4** Measurement of the anterior T8 vertebral body pre-MVA.

**Fig. 5** Measurement of the anterior T8 vertebral body post-MVA.

anterior height of T8 vertebral body reveals an increase in height from 10 to 18 mm, an increase of 80% (►Figs. 4 and 5).

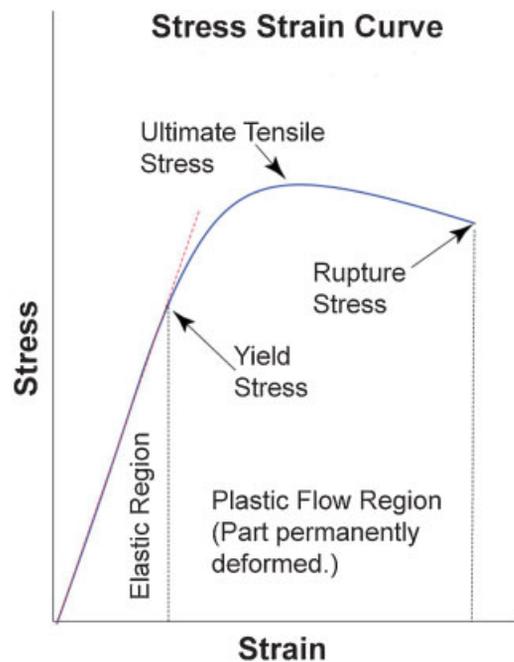
**Fig. 6** Stress versus strain curve. Titanium alloy, which is capable of bone-screw integration, can provide greater deformation at the same in vivo load without system (construct) breakdown.

When bone-screw integration is combined with the plastic attributes of Ni-Ti, greater deformation at the same in vivo load without construct breakdown can be predicted.<sup>6</sup> Ni-Ti alloy would appear to demonstrate biomechanical advantages of plastic deformation and bone integration that rivals stiffer alloys, such as cobalt and stainless steel, as demonstrated in this case.<sup>13,14</sup>

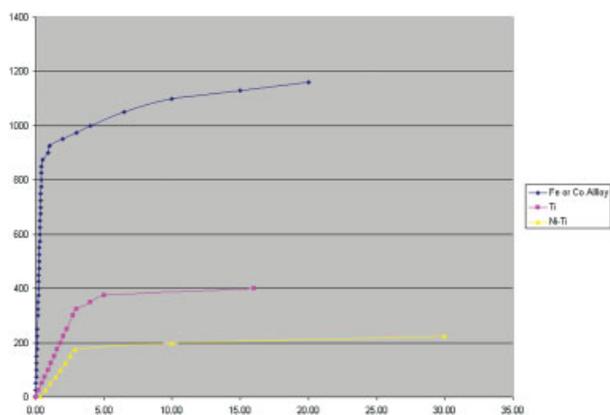
**Fig. 7** Schematics of stress versus strain of metallic implants (EL, elastic limit). The initial segments of the curves up to the EL show the elastic modulus (linear portion) is lowest for Ni-Ti and highest for cobalt and stainless steel alloys. Thus, for any applied elastic stress (load), the strain (deformation) is highest for Ni-Ti. Also, Ni-Ti, in addition to being superelastic, also exhibits pseudoplasticity, which is reflected as increased strain (deformation) without significant increase in stress (load) as represented by the horizontal portion of the curve for Ni-Ti. Co, Fe, and Ti-Al-V alloys exhibit neither superelasticity nor pseudoplasticity.

Under the conditions where the bone-screw interface is osseous, integrated with mature bone as with Ni-Ti, and remains integrated during loading, the highest capacity for strain (deformation) without mechanical failure resides with Ni-Ti. The induced deformation beyond the elastic limit for Ni-Ti is permanent, and in this case, the rod assumed a new and permanent contour, maintaining the spine in a corrected position.
