# A Rare Complication Following Breast Implant Surgery: Capsular Contracture with a Cutaneous Silicone Fistula after Breast Reconstruction with Silicone Gel Implants

Cutaneous silicone fistula · Capsular contracture ·  
Silicone breast implant · MRI

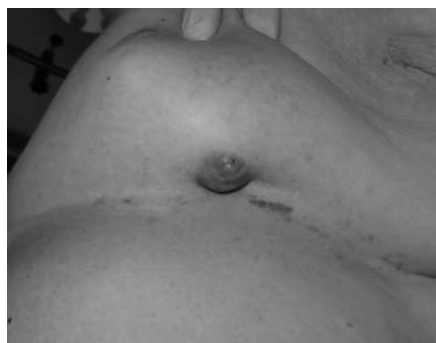
Upon inspection, we found a bilateral mildly deformed breast with implants slightly cranialised and compressed. In the left inframammary fold, a  $4 \times 3 \times 2$  cm bruised area with a central fistula was detected (fig. 1). Following mild pressure applied to the left breast, a viscous discharge coming from the fistula was exposed. There were no signs of acute infection, nevertheless the area around the bruise appeared inflamed. No enlarged lymph nodes were palpable. Standard blood tests were within the normal range.

**Fig. 1.** Transcutaneous silicone fistula of the breast.

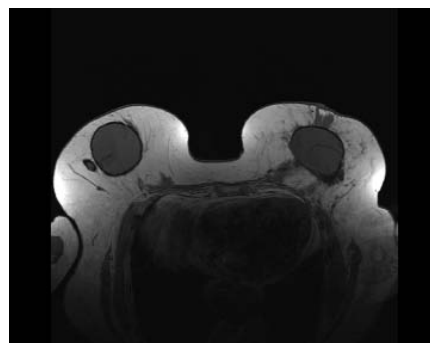
Upon magnetic resonance imaging (MRI), the right breast appeared completely normal, there were no specific findings, especially no signs of implant rupture or dislocation. Around the left implant, especially dorsally, larger quantities of a hypointense material, most likely representing silicone gel leaking from the prosthesis, were detected. The residues of the left implant appeared significantly smaller than the contralateral side. Following intravenous injection of contrast medium, an enhancement in the surrounding tissue was detected, compatible with an inflammatory reaction. No suspicious lymph nodes or malignancies were detected. In the lower part of the left breast, a fistula was clearly detectable. The fistula from the implant pocket to the external part of the inframammary fold was filled with the same hypointense material leaking from the prosthesis and representing silicone gel (fig. 2).

**Fig. 2.** MRI scan of cutaneous silicone fistula.

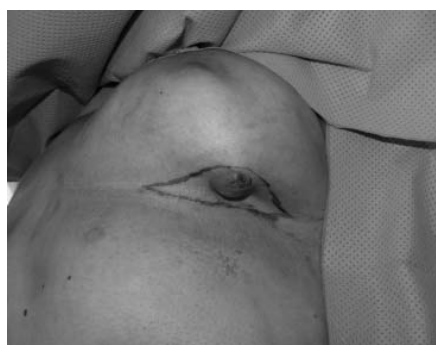
**Fig. 3.** Excisional pattern.

The patient underwent surgery with excision of the cutaneous fistula in the left inframammary fold, followed by removal of both implants including the fibrous capsule (fig. 3). The patient did not wish further reconstruction or mastopexy. The implant pocket was irrigated extensively with high-pressure irrigation. The tissue was sent off for histological examination which confirmed the clinical findings (fig. 4).

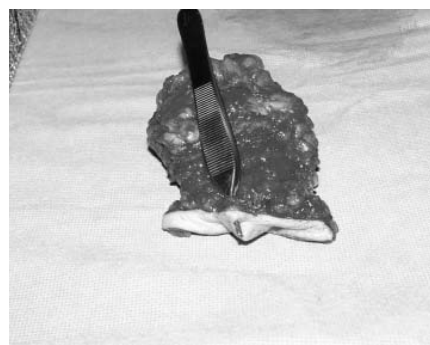
**Fig. 4.** Fistula from the implant pocket through to the inframammary fold.

In our case, silicone penetrated through the subcutaneous tissue and skin via a cutaneous fistula. By definition, a fistula is a permanent abnormal passageway between two organs in the body or between an organ or cavity and the exterior of the body. Whether this fistula was initiated by a trauma or a tissue reaction to the silicone gel, remains unclear. In the past, a closed capsulotomy used to be a common procedure for the treatment of capsular contracture. Silicone rupture is a known complication of closed capsulotomy [11]. Increased pressure during this procedure could have been one reason for the development of unphysiological ducts within the tissue.
