## DAMAGE CAUSED BY TYPHOON-INDUCED LAHAR FLOWS FROM MAYON VOLCANO, PHILIPPINES

ROLANDO P. ORENSE<sup>i)</sup> and MAKOTO IKEDA<sup>ii)</sup>

Severe rainfall associated with the passage of super-typhoon “Reming” on November 30, 2006 triggered lahar flows, landslides and flash floods on the south-eastern quadrant of Mayon Volcano, resulting in extensive damage to life and property. Among the affected areas, the towns of Guinobatan, Camalig and Daraga suffered the most damage, with numerous houses, roads and other infrastructures either buried or swept away by the flowing lahar and rampaging floodwaters. This paper outlines the observations from the reconnaissance work conducted at the affected sites following the disaster, with emphasis on the hydro-geological aspects of the disaster and their impact on civil engineering structures and other infrastructures. Moreover, the properties of the lahar samples obtained near Mayon Volcano were analyzed and compared with the lahar deposits from Mt. Pinatubo.

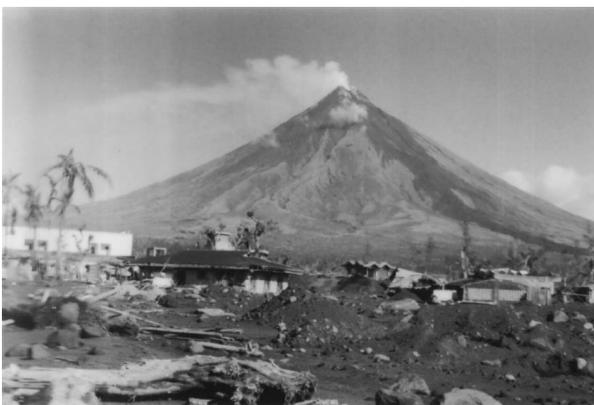
Fig. 2. A view of Mayon Volcano and the buried villages and rice fields at its foot

Mayon Volcano (*see* Fig. 2), a strato-volcano known for its almost perfect cone, has a height of 2,462 m and has a base circumference of 62.8 km (Albay Province website, [www.albay.gov.ph](http://www.albay.gov.ph)). Famous for its extraordinary symmetry, Mayon is also one of the most active volcanoes. Mayon has erupted 49 times since the first documented activity in 1616. Thus, its symmetric cone was actually formed through alternate pyroclastic and lava flows. The upper slopes of Mayon are steep, reaching up to 35–45°. Punongbayan and Ruelo (1985) have shown that lavas are the dominant content of Mayon edifice only from the summit to the 500 m elevation. Pyroclastic flows characteristically occur during each major episode. Some pyroclastic flow materials accumulate between 2000 m and 500 m, principally in flank gullies, but the principal zone of pyroclastic flow deposition is between 500 m and 300 m. From 300 m to 200 m, pyroclastic flow and lahar deposits are roughly equal in abundance; and below 200 m, lahars are almost exclu-

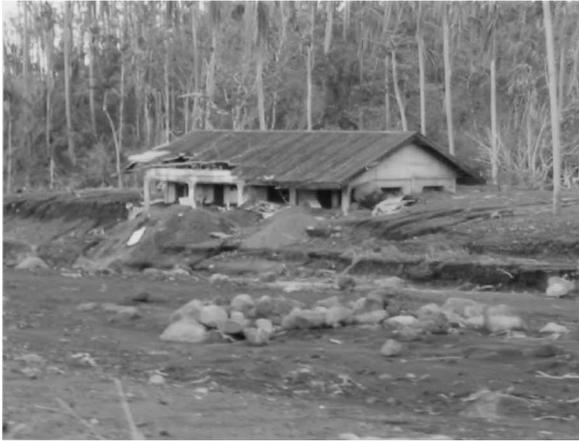
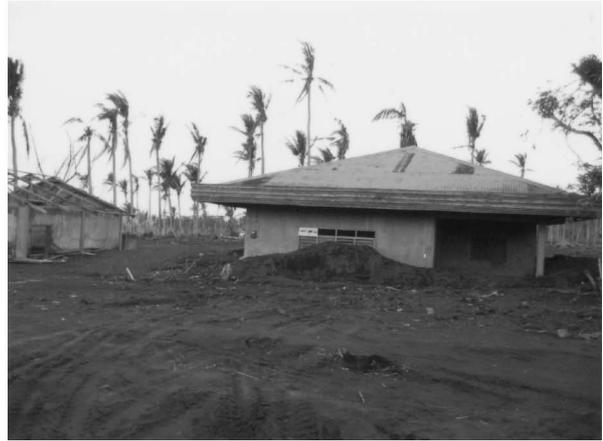
The town of Guinobatan is considered the hardest hit municipality in Albay, with Barangay Maipon almost fully covered with lahar. Numerous houses in the area became uninhabitable as they were buried by about 2–3 m thick lahar deposits (*see* Fig. 7). Large boulders, some with diameter greater than 1 m, were strewn all over the area. Trees and houses disappeared, and the area became a virtual wasteland. Before the typhoon struck, the Department of Public Works and Highways (DPWH) performed dredging operation in the nearby Maninila River. Residents claimed that as a result of this operation, Maipon became a catch basin of mudflows and

Fig. 7. Houses in Barangay Maipon buried by lahar

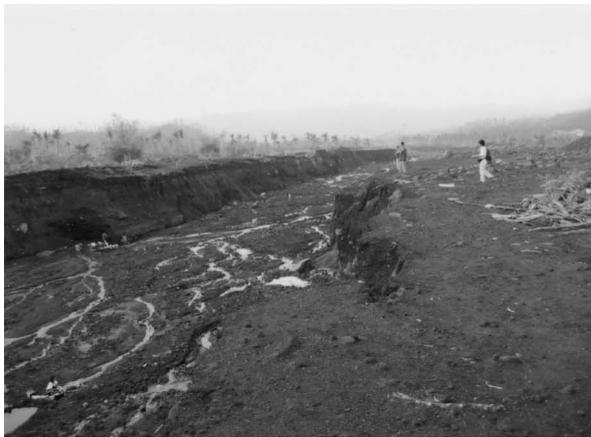
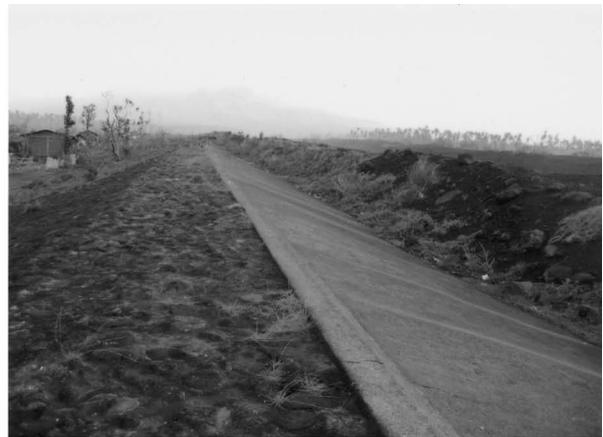
Fig. 8. Large channel created by the flowing lahar in Masarawag River is shown on the left photo. Photo on the right shows the river dike which successfully prevented the lahar from damaging residential houses on the west side of the dike

In Barangay Masarawag located further north of Maipon, a large channel, measuring 50 m wide and 10m deep, was formed by the moving lahar as it flowed from the volcano toward the downslope direction, demonstrating its erosive nature (see Fig. 8). The pre-typhoon river was located about 20 m to the west of this channel. Apparently, the initial lahar flows filled up the river channel and the subsequent flows sought alternate paths. Fortunately, the lahar eroded only rice fields and coconut plantations in this area and spared several houses located to the west of the former river channel which were guarded by a 2 m-high dike, which is also shown in the figure. During the site visit, many residents were seen inside the said channel, now the site of a new river formed, unmindful of the instability posed by the vertical channel walls.

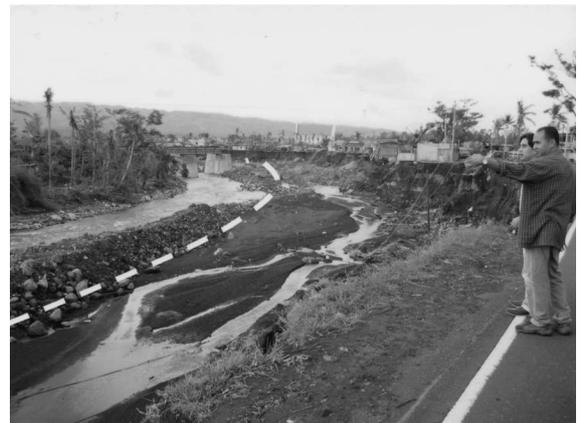
Another site of heavy damage caused by rampaging floodwaters was Barangay Travesia. In this area, a large chunk of the bank adjacent to San Francisco River was scoured by the floodwater and debris, carrying with them numerous houses built along the bank (see Fig. 9). In the

Fig. 9. Scoured river bank in Barangay Travesia, Guinobatan Town. The dotted line on the photo indicates the former location of the river bank. The collapsed rail track can be seen at the background

same location, at least 4 piers of the Philippine National Railways (PNR) rail track which crossed the river were lost as their foundations were scoured, resulting in collapse of the track girders.

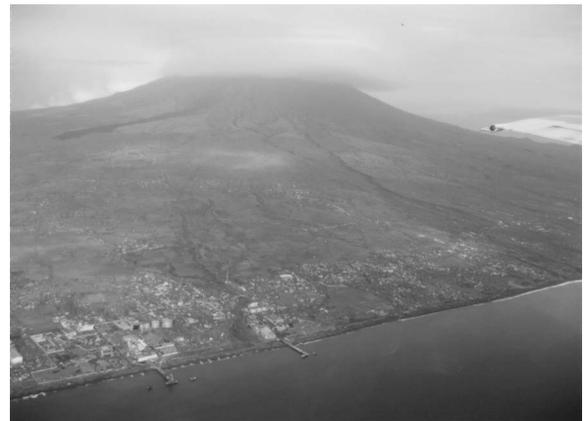
Legazpi City, the capital of Albay Province and the center of its commercial and trade activities, was not spared from damage due to typhoon Reming. Ricefields between Lingnon Hills and Mayon Volcano were littered with scars of eroded channels. The eastern side of the city, especially in Barangay Padang, was also covered by lahar flows (*see Fig. 11*). Evacuees interviewed mentioned that the event transpired very fast. The whole barangay was devastated and wiped out by the lahar flow and several people were injured by boulders and roofing materials. Residents now call the place “black desert”, referring to the color of the volcanic debris.

**Fig. 11.** Aerial view of the lahar flows in Barangay Padang. Note on the left side of the volcano slope the trace of lava flow from the August 2006 eruption

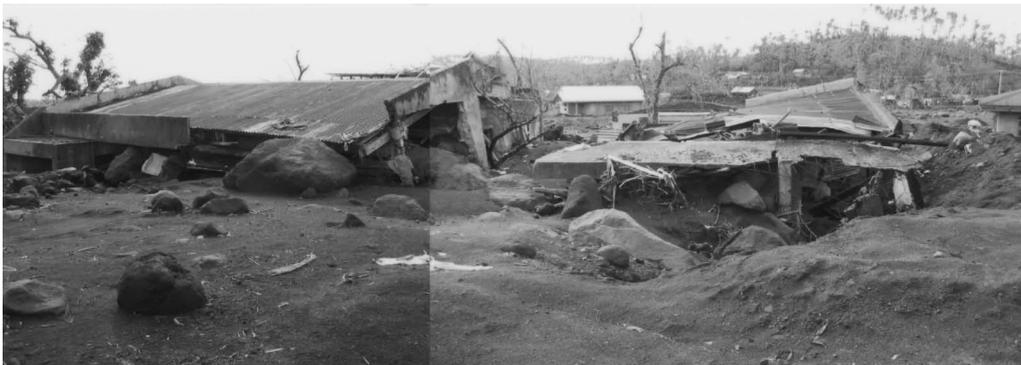
One of the worst-hit areas in Daraga was the area adjacent to Cagsawa Ruins, a popular tourist attraction in the area. The February 1814 eruption of Mayon Volcano buried Cagsawa Church, leaving only its belfry protruding on the surface. In the present case, the site of the ruins was not damaged because it was located in a higher ground. The river forked into two, with the Ruins in the middle, destroying almost all structures along the way. The debris-choked river channels overflowed their banks, flooded most of the houses built on the side and buried others with several meters of lahar (*see Fig. 10*). The floods and lahar forced residents to run to the roofs of their houses and emergency workers had to rescue them from the roof tops.

**Fig. 10.** Buried houses in Cagsawa
