## CHAPTER 91

### PROPOSED "IMPROVEMENT" OF KAIMU BEACH, HAWAII

By Doak C. Cox, Frans Gerritsen, and Theodore T. Lee\*

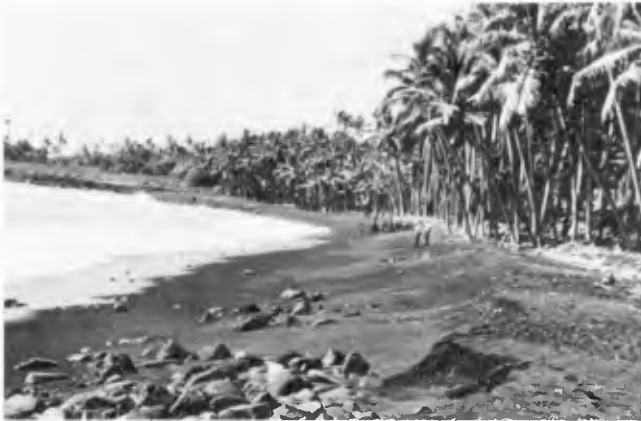
Fig. 1 Photograph of Kaimu Beach in 1968 (Corps of Engineers)

Kaimu beach (fig. 1) is a pocket beach in the Puna District on the southeast coast of the island of Hawaii (fig. 2). Although no more than about a quarter mile in length (fig. 3), the beach would be considered important simply because of the scarcity of beaches on that island and especially in that district. It is in fact famous, but primarily because of the jet black color of its sand. It has been a visitor attraction longer than there has been a recognized tourist industry in Hawaii. However, the beach has long been retreating--indeed measures to control the erosion of its sand were considered as early as the 1910's or 1920's. This paper relates primarily to proposals for its "improvement" dating from 1966 when the Mayor of the County of Hawaii requested the Corps of Engineers to investigate possibilities for its restoration and preservation.

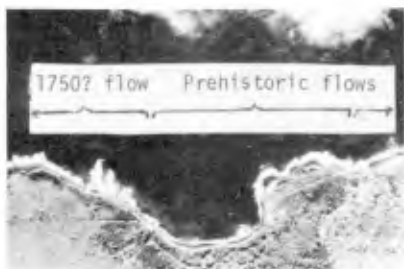
Fig. 4 Aerial photograph of Kaimu in 1959 (U.S. Navy)

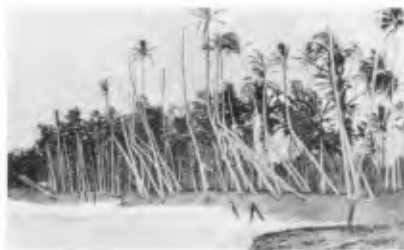
Fig. 5 Photograph of Kaimu Beach in 1880's (Alexander Agassiz)

Evidence of the subsidence of Kaimu beach, possibly combined with retreat, was reported as early as the 1870's by Nordhoff (1874) in the form of coconut tree stumps sticking up out of the surf. Photographic evidence of coconut trees being toppled into the water in the 1880's was published by Agassiz (1889) (Fig. 5). Similar photographs have been taken at numerous times since (figs. 6-8); and rough or precise estimates of the rates of retreat may be made by comparisons of shoreline maps dating from 1892 to 1968 and from beach profile surveys made in 1968 and subsequently (fig. 10). By the mid-1960's a rock ledge was exposed near the middle of the beach, and by the mid-1970's this ledge formed a conspicuous promontory (fig. 7).

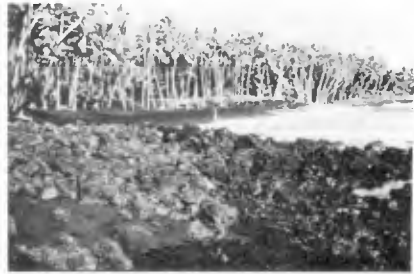
Fig. 8 Kaimu beach in 1973  
(Rick Scudder)
