PROTOTYPE TESTING OF DOLOSSE TO DESTRUCTION

T. Terao¹, K. Terauchi², S. Ushida³
N. Shiraishi⁴, K. Kobayashi⁵, H. Gahara⁶

ABSTRACT

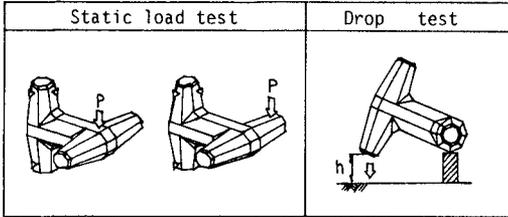
Figure 1 Test Method

Assuming the load conditions, two different types of tests were performed. The static load test was performed to simulate the condition of a dead load of units caused by settlement, and the drop test was instigated to simulate the impact resulting from rocking under wave action. Fig. 1 shows the test methods.

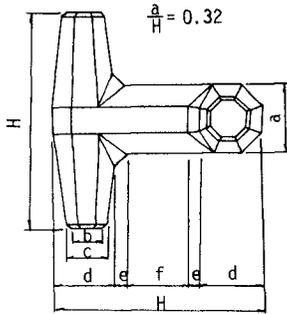
Weight (g)	H	a	b	c	d	e	f
4	2239	716	386	458	669	125	651
0.4	1036	332	178	212	310	58	302
0.04	482	154	82	98	144	27	140

Figure 2 Geometry of units

4t reinforced and 4t, 0.4t and 0.04t unreinforced units were used in these tests. The waist ratio was constant at 0.32. Table 1 shows the test program, Fig. 2 shows the geometry of units, and Table 2 shows the mix proportions of concrete. Tensile strength test results of steel bars and bar arrangement drawing are given in Table 3 and Fig. 3, respectively.

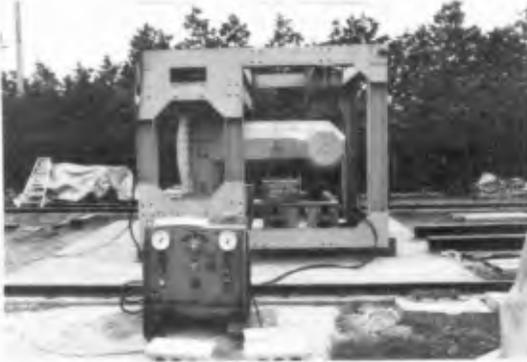
Photograph 1: The situation of the static load test

In the static load test, the vertical fluke of the unit was fixed by a support equipment. There were two different loading conditions. One was imposed on the mid point of the horizontal fluke and the other was on the tip point. A hydraulic jack was used for loading. Photo. 1 shows the

situation of the static load test.

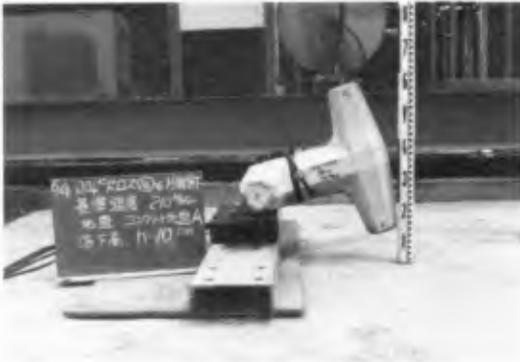
Photograph 2: The situation of the drop test

In the case of the drop test, the horizontal fluke was supported in a way to keep the stem level. Then, the vertical fluke was lifted up to a predetermined height and dropped onto a concrete slab of 1 meter thickness by use of a quick release device. Drop height started at 2 cm and increased every 2 cm. Some of the drop test units were provided with load cells at the bottom of the vertical fluke to measure the impact load. Photo. 2 shows the situation of the drop test.

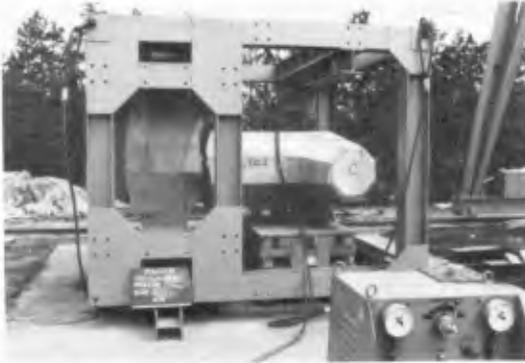
Photograph 3: The breakage of Dolos (Static load test)

Stress concentrated on the corner between the chamfer and the stem due to the bending force. Cracks occurred at this point. Photo. 3 shows the breakage of Dolos. From the results of unreinforced units shown in Table 4, it is considered that the ultimate imposed load which caused cracks increased slightly as the compressive strength of concrete increased. Fig. 4 shows the relationship between the concrete surface stress and static load.

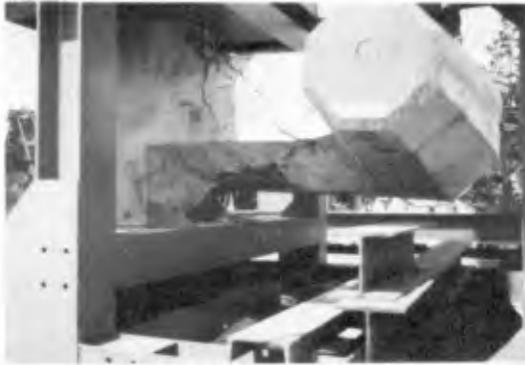
Photograph 4: The cracks of the stem (Static load test)

progressed toward the stem at 45° . Ultimate breakage was identified as shear rupture due to bending and torsion forces. Photo. 4 shows the cracks of the stem. Fig. 7 shows the stress distribution of the reinforcing bar. From the result of the relationship between the reinforcing bar and static load shown in Fig. 8, the stem and chamfer bars placed at the corner section ultimately yielded at about 170 KN.

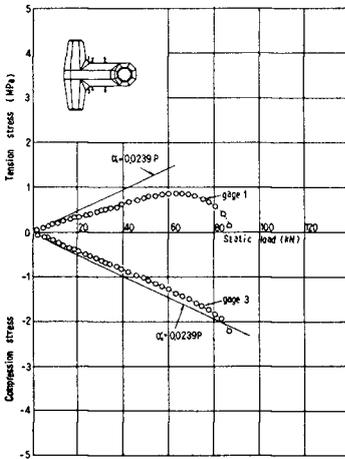
Figure 4 Relationship between concrete surface stress and static load

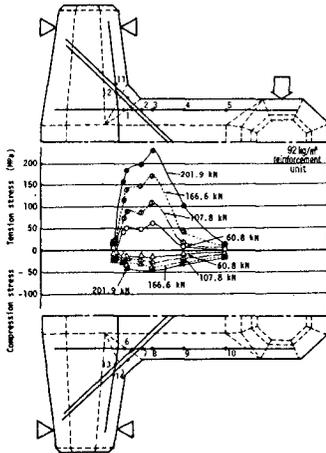
Figure 5 STRESS DISTRIBUTION OF REINFORCEMENT
(Imposed on the mid point of the horizontal fluke)

In the case of reinforced units, cracks appeared in that corner under the static load which was almost as large as the results of unreinforced units. Fig. 5 and 6 show the stress distribution of the reinforcing bar using the units with the chamfer reinforced and unreinforced, respectively. Stress concentrated on the corner revealing themselves as corresponding cracks.

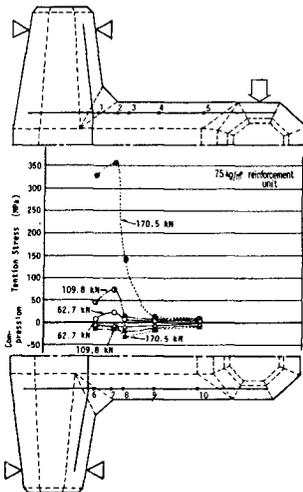
Figure 6 STRESS DISTRIBUTION OF REINFORCEMENT
(Imposed on the mid point of the horizontal fluke)

In the case where the chamfer was not reinforced, the reinforcing bars placed at the stem yielded under a smaller imposed load compared to that of the reinforced chamfer. It is apparent that reinforcement of the chamfer is effective.

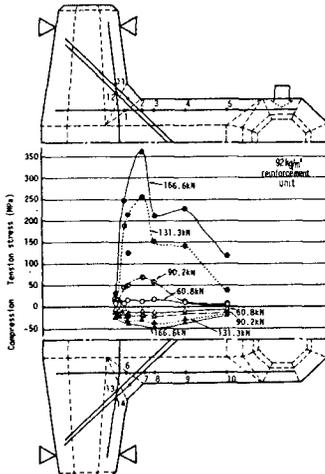
Figure 7 STRESS DISTRIBUTION OF REINFORCEMENT
(Imposed of the tie point of the horizontal fluke)

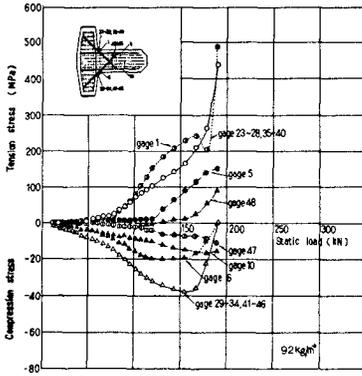
Figure 8 Relationship between reinforcing bar stress and static load

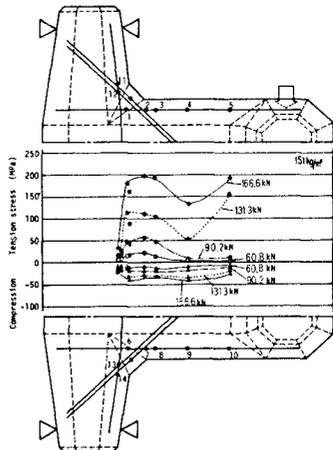
Figure 9 STRESS DISTRIBUTION OF REINFORCEMENT
(imposed on the tip point of the horizontal fluke)

While in the case of 151 kg/m^3 unit, cracks appeared in the corner with a small imposed load, and thereafter new cracks occurred and progressed in the stem at 45° . Ultimate breakage was identified as shear rupture due to torsion force. Fig. 9 and 10 show the stress distribution of the reinforcing and static load, respectively.

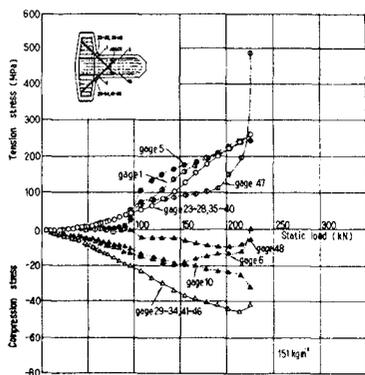
Figure 10 Relationship between reinforcing bar stress and static load

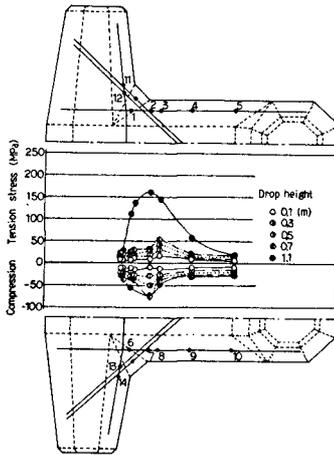
Figure 11 Stress distribution of reinforcement (Drop test)

In the case of the reinforced units, stress concentrated on the corner and cracks occurred at this point, too. But the units didn't separate into two pieces. The stress distribution of the reinforcing bar is shown in Fig. 11.

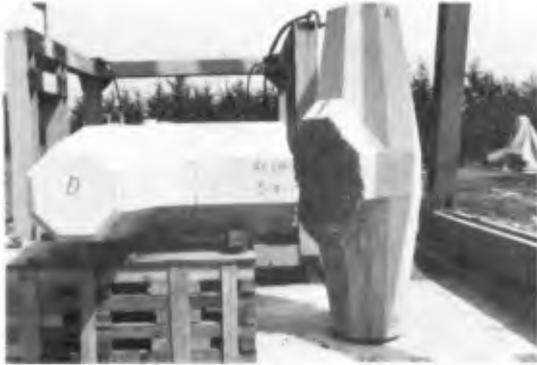
Photograph 5: The breakage of Dolos (Drop test)

From the results of unreinforced units shown in Table 5, it is considered that the drop height which crack occurs is almost constant independent of the weight of the units and concrete strength. Photo. 5 shows the broken unit.

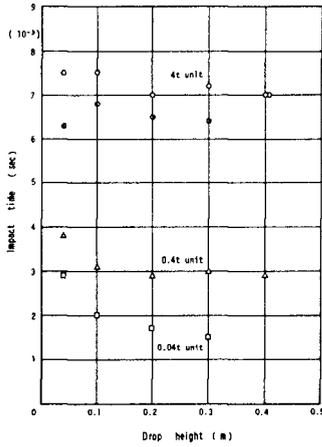
Figure 12 Relationship between impact time and drop height

Impact load and impact time were also measured by using load cells. Fig. 12 shows the relationship between the impact time of the load and the drop height. Fig. 13 shows the relationship between the impact time of the load and the weight of the unit. From these results, it can be assumed that the impact time of the load is almost constant independent of the drop height while using the same weight of the unit, and the ratio of the impact times is almost equal to the ratio of their characteristic length i.e. Dolosse height.

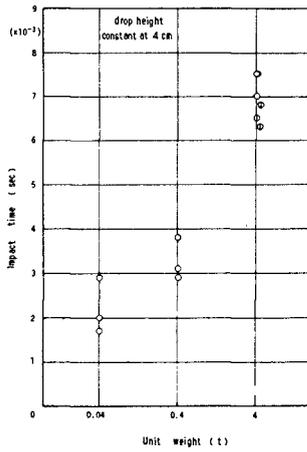
Figure 13 Relationship between impact time and unit weight

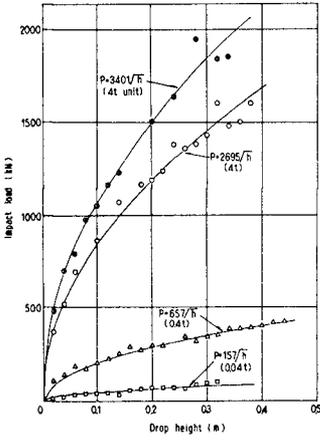
Figure 14 Relationship between impact load and drop height

From the results of the relationship between the maximum impact load and drop height shown in Fig. 14, it is considered that the impact load is proportional to the square root of the drop height and the ratio of the impact loads is equal to the square of the ratio of their characteristic lengths under conditions of the same drop height.

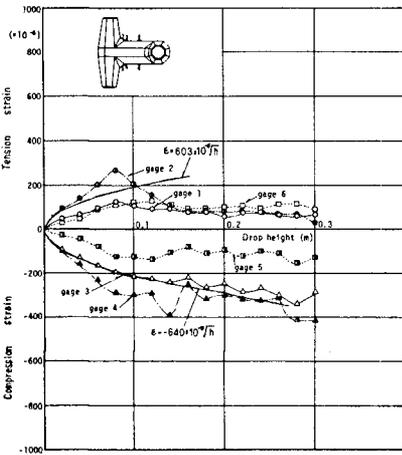
Figure 15 Relationship between concrete surface strain and drop height

As the ratio of the concrete surface strain is almost equal to the square of the reciprocal of the ratio of their characteristic lengths under conditions of the same impact

load, the maximum strain on the concrete surface is proportional to the square root of the drop height as shown in Fig. 15. This results in the stress of the concrete surface being constant independent of the weight of the unit under conditions of the same drop height.
