# ANALYSIS ON PERFORMANCE OF THE EMERGENCY NOURISHMENT PROJECT AT WEST BEACH OF BEIDAIHE, CHINA

*Keywords: beach erosion, emergency nourishment project, shoreline change, Beidaihe*

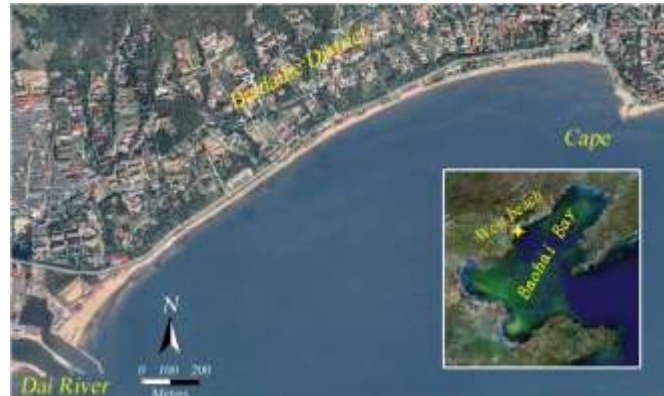
Figure 1. West Beach in Beidaihe, Bohai Bay, China.

West Beach in Beidaihe locates in a famous tourist resort in the south of Qinhuangdao, northeast of Dai river, with several famous and scenic bathing places lying on (Fig. 1). It is characterized by

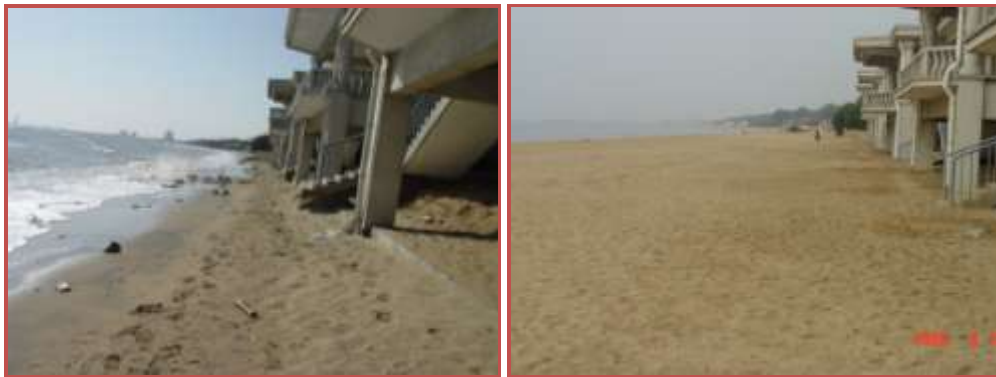
Obviously, the beach after the project is now wide enough to bath and relax with the comparison of the beach's appearance before and after the beach nourishment in Fig. 5. And those coastal buildings which were washed directly by the waves are protected by the artificial sandy beach.

Figure 5. Comparison of the beach's appearances before (left) and after (right) the beach nourishment.
