Determining the site effects of 23 October 2011 earthquake (Van province, Turkey) on the rural areas using HVSR microtremor method

İSMAIL AKKAYA^{1,*}, ALI ÖZVAN², MÜCİP TAPAN^{3,4} and M ALPER ŞENGÜL⁵

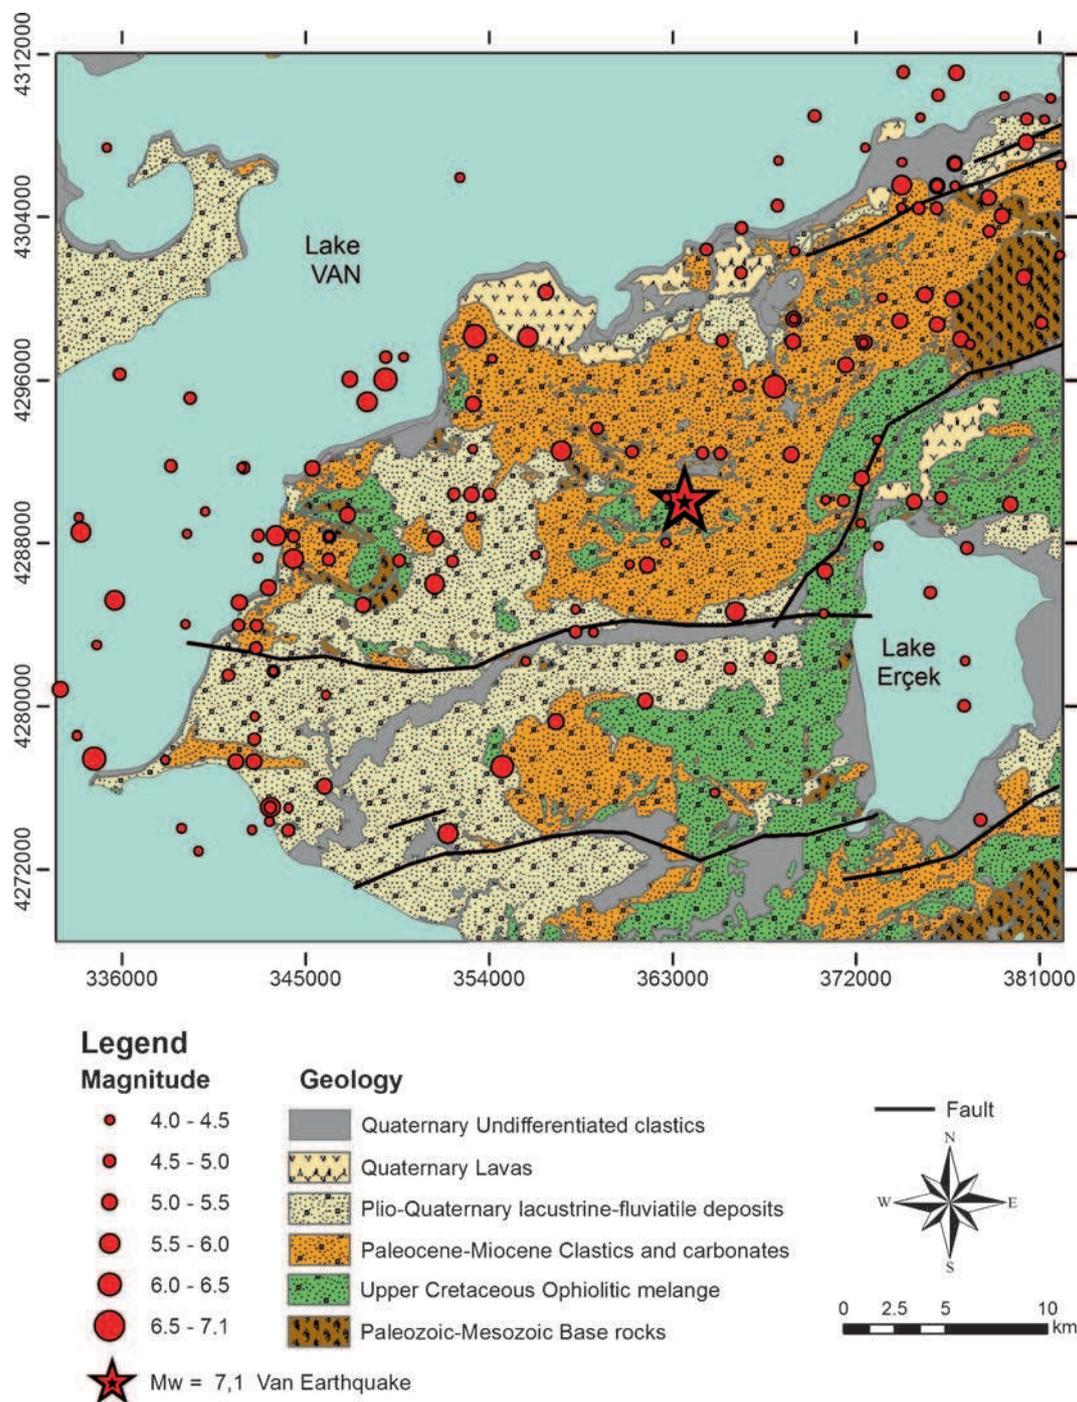
Figure 2. Geological map of the study area (modified from MTA 2008).

Many different types of rocks, from Paleozoic period to the current period have been found around Lake Van basin (figure 2). The basin generally consists of Oligocene–Lower Miocene aged marine sediments called Van Formation (MTA 2007). Bitlis massive metamorphic rocks are mainly observed on the surface from southern to the eastern part of the basin (Ternek 1953; Ketin 1977; Yılmaz *et al.* 1981; Göncüoğlu and Turhan 1984). Volcanoclastic deposits are found around Nemrut and Süphan volcanoes located in the western side of the region. In addition, lavas extending from Etrüsk and Tendürek volcanoes are found in the northern and northeastern parts of the region (Güner 1984; Yılmaz *et al.* 1987). Clastic ophiolitic units are derived from Yüksekova Complex and settled on Upper Cretaceous–Paleocene, while sedimentary rocks are observed in the southern and southeastern parts of the basin (Acarlar *et al.* 1991). Lacustrine sediments and fluvial deposits from Pliocene period outcrop in the eastern and northeastern parts of the basin.

The villages included in this study are generally located on Quaternary-aged terrestrial sediments composed of Van Formation (composed of Oligocene–Lower Miocene aged sandstone, conglomerate, siltstone, claystone, calcarenite rock types), Adilcevaz limestone (composed of Lower Miocene reef limestone), Aktaş Formation (composed of Middle Miocene conglomerate), Kurtdeği Formation (composed of Upper Miocene aged Yağlık basalt, Upper Miocene aged gypsum, sandstone, conglomerate, siltstone, claystone and Miocene-aged rock formations), respectively (MTA

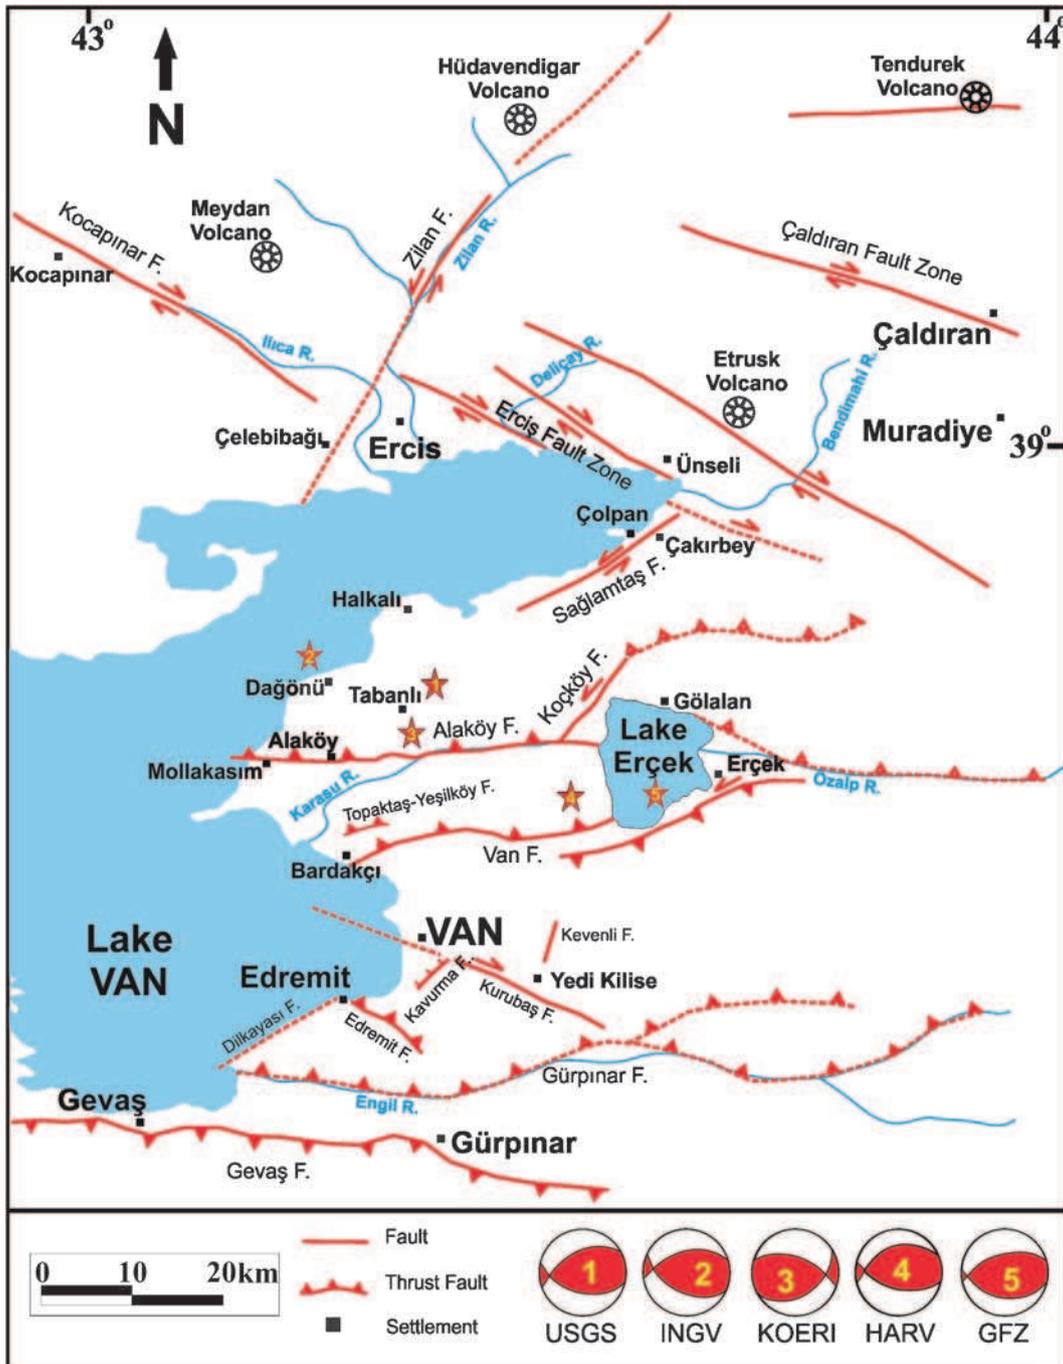
Figure 3. Major active faults in eastern part of Lake Van and epicenter of the main shock that occurred on October 23, 2011. Beachballs are showing focal mechanism solutions of different institutions. TF: thrust fault, RL: right-lateral strike slip fault, LL: left-lateral strike slip fault, NF: normal fault. Ruptured faults of 23 October 2011 are Van and Topaktaş faults (modified from Poyraz *et al.* 2011).

Fault plane solutions, which were obtained by various institutions, display that the earthquake is activated by thrust fault mechanism (figure 3). According to the Disaster and Emergency Management Presidency of Turkey (AFAD), approximately 12,000 aftershocks between the magnitude values of 2.0 and 5.0 were recorded in this region (AFAD 2011).

Lake Van and its surrounding area comprise seismically-active fault systems (strike-slip fault, normal fault and reverse fault) with diverse magnitudes and properties (Aksoy and Tatar 1990; Koçyiğit *et al.* 2001; Akkaya and Köse 2002; Çiftci *et al.* 2004; Özvan *et al.* 2005). These fault systems are as follows: Çaldıran fault zone, Erciş fault zone, Süphan fault zone, Muş fault zone, Güzelsu fault zone, Başkale fault zone, Van fault zone, Özalp fault zone, Gevaş fault zone and other individual faults (Bulanık fault, Malazgirt fault, Kuşcu fault, Çakırbey fault, Alabayır fault, Erçek fault, etc.) (Koçyiğit *et al.* 2001). Özalp and Gevaş fault zones are in the form of E–W trending reverse fault; whereas Çaldıran and Erciş faults are in the form of NW–SE trending right lateral strike-slip fault zones; whereas Süphan and Başkale fault zones are in the form of NE-trending left lateral strike-slip fault zones, respectively (Koçyiğit *et al.* 2001) (figure 3). Van earthquake that occurred on

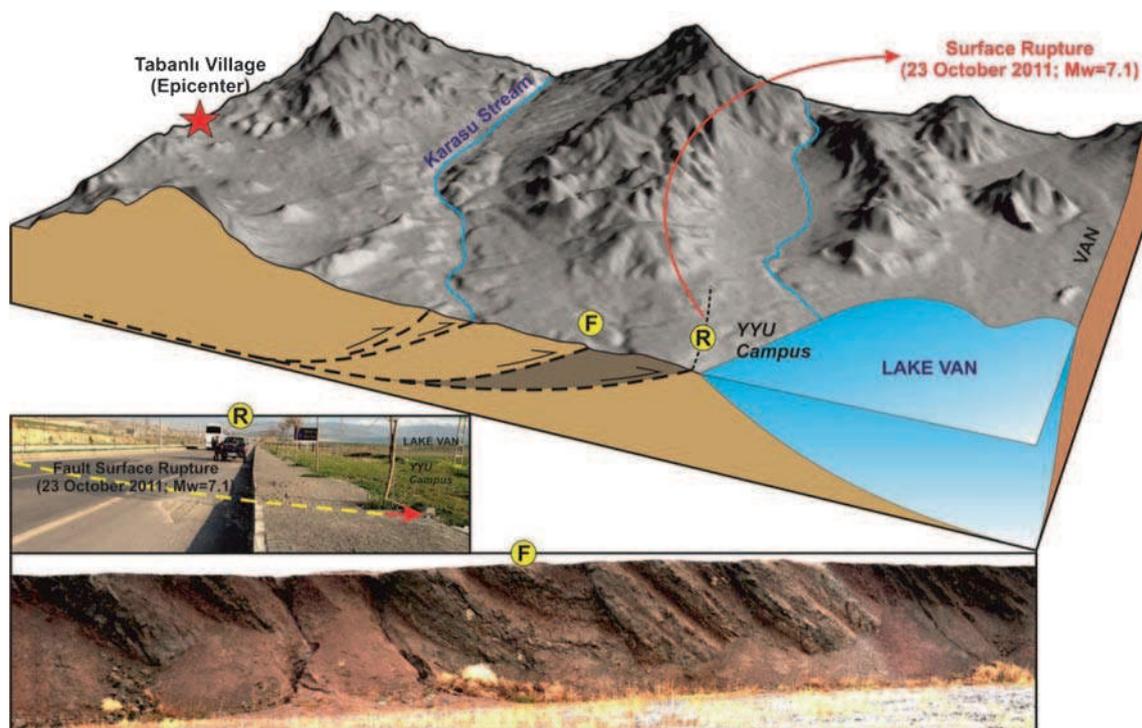
Figure 4. Block diagram showing main thrust zones in the region and ruptured faults after Van earthquake (R: surface rupture, F: Van Thrust Fault).

October 23, 2011 was recorded to be the most destructive earthquake resulting from the movement of reverse faults in Turkey (Koçyiğit *et al.* 2011). Earthquake-induced surface fault rupture and block diagram can be seen in figure 4. Especially after 2000, the region had relatively higher seismic activities.

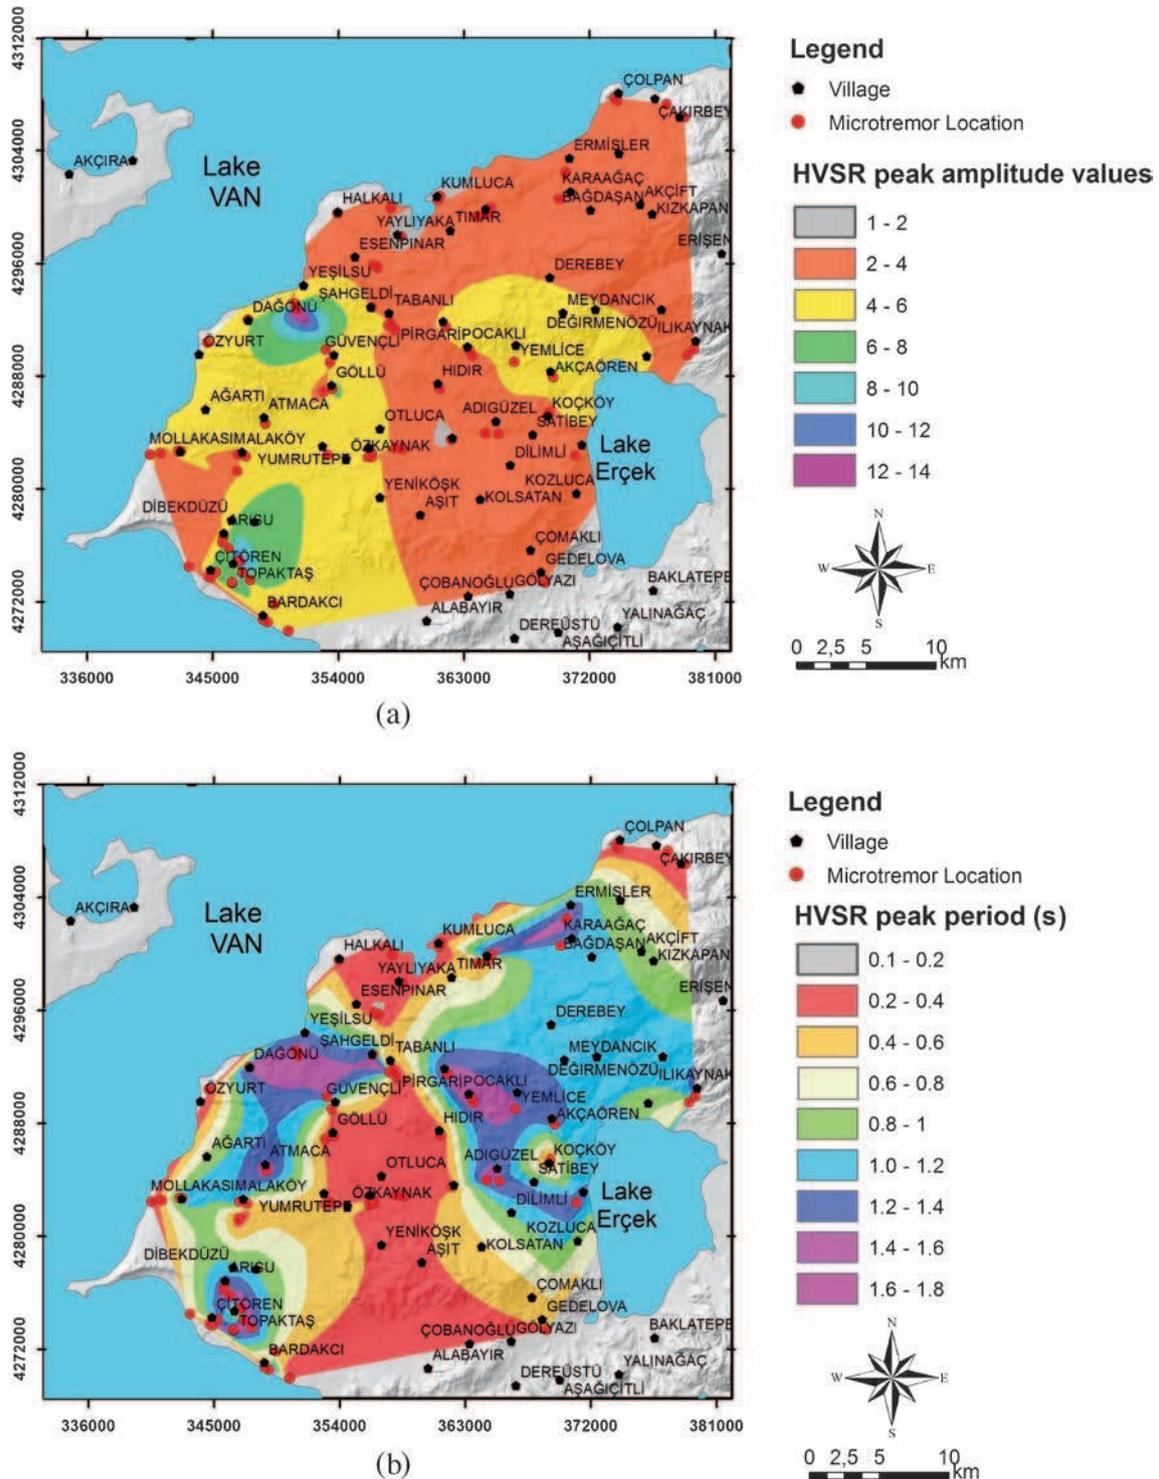
Figure 5. HVSR measurements obtained from the records of HVSR peak amplitude values (a) and HVSR peak period values (b).

period values and HVSR peak amplitude values were obtained by using the Nakamura method (figure 5, table 1). With the evaluation of the spectral curves obtained through the analysis, HVSR peak period and the corresponding increased rate in HVSR peak amplitude are determined (figure 6). The Geopsy software packages prepared by the SESAME were used in order to process the data obtained.

HVSR method is applied to 80 microtremor measurements to provide information related to site response of the study area (figure 5). HVSR peak period values were found to be between 0.2 and 1.6 s and HVSR peak amplitude values were found between 4 and 10, respectively, in the villages that were severely damaged by the earthquake. HVSR peak period values of 0.1 s and HVSR peak amplitude values of 1.5–2 were obtained from the microtremor measurements, which were conducted in the villages that have minor damages caused by the earthquake (Çolpan, Çakırbey, Halkalı, Karaağaç, Sağlantaş, Yaylıyaka). This location over the rock area shows quite smaller peaks at lower periods.

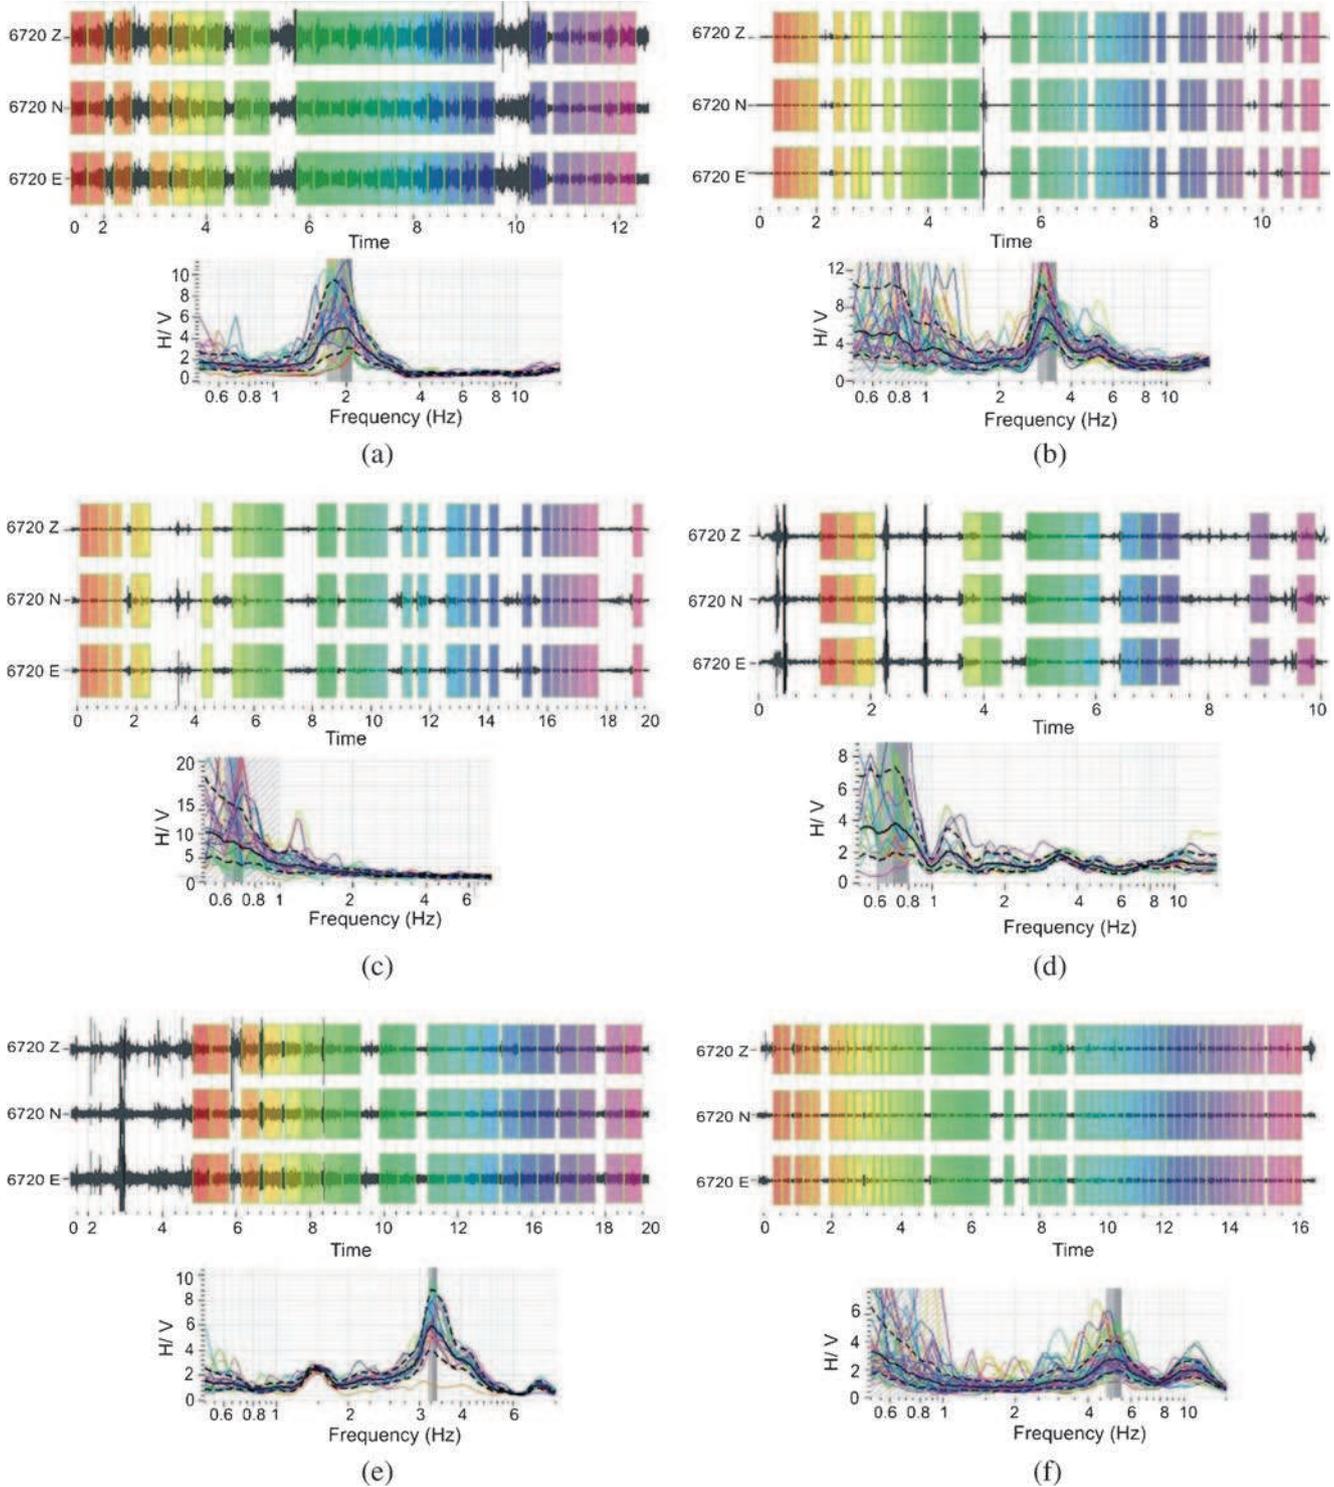
Figure 6. Interpretation of data obtained from the microtremor measurements in the study area; in the figure, there are two dotted lines above and below which is standard deviation for all values of the ratio of the resulting spectra. The line in the middle is the average value of the FFT analysis of the HVSR value, while the thin line is colourful curves HVSR of each window ((a) Bardakçı, (b) Göllü, (c) Dağönü, (d) Adıgüzel, (e) Timar (Gedikbulak), (f) Çolpan).

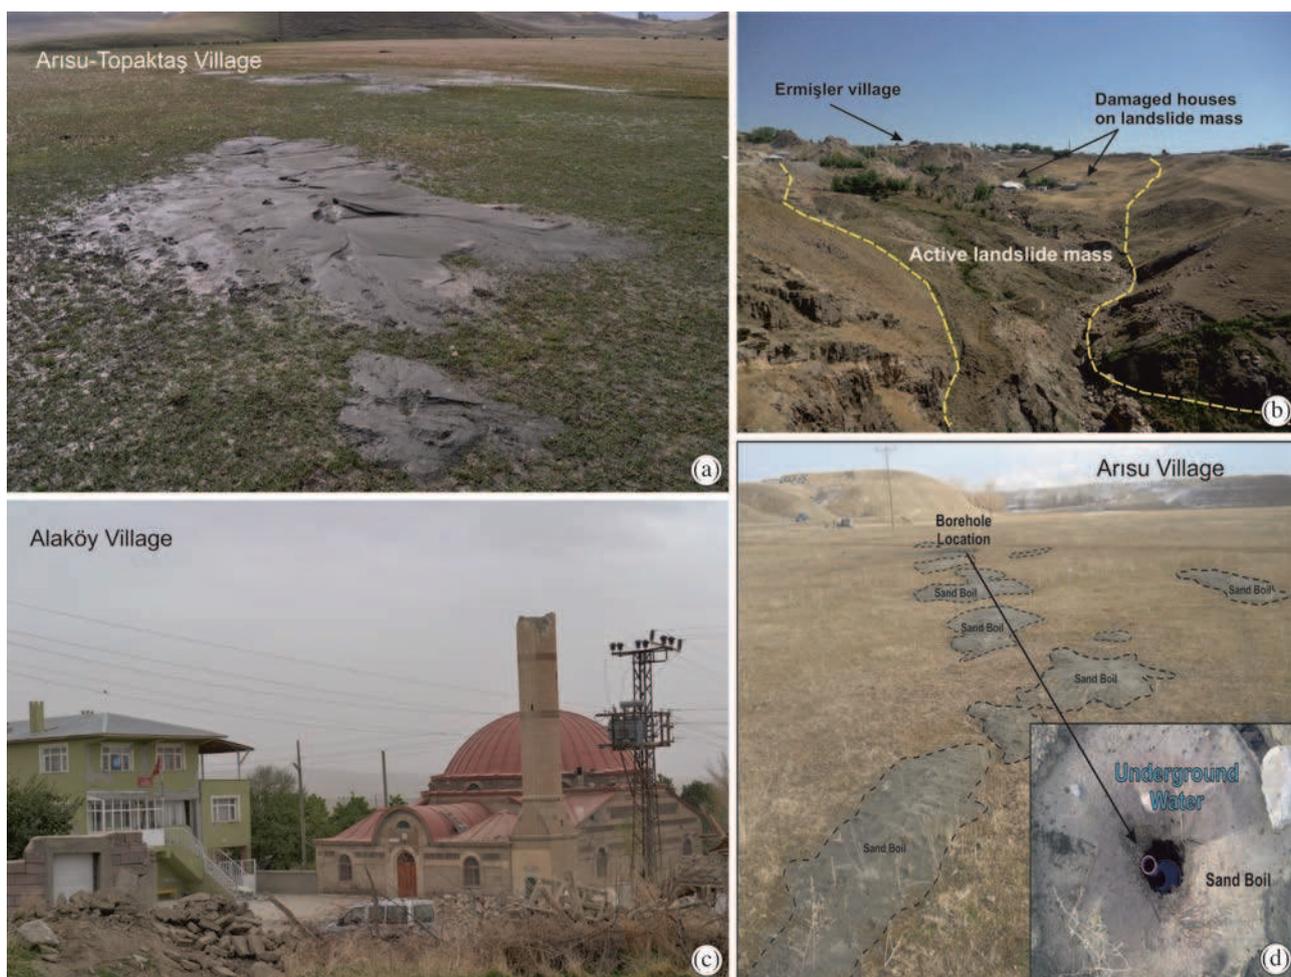
Figure 7. Earthquake-induced damages in the study area; (a) liquefaction, (b) landslide, (c) hillside effect, and (d) underground water effect.

The level of damage in the villages that are settled on lacustrine and stream sediments (Arısu, Mollakasım, Alaköy, Bardakçı, Topaktaş, Özkaynak, Gülsünler, Kasımoğlu, Satıbey, Koçköy, Yumrutepe, Atmaca, Göllü, Güveçli, Tabanlı, Dağönü, Şahgeldi, Yeşilsu, Ocaklı, Pirgarip, Hıdır and Aşağıgölalan) has verified that the damage correlates well with comparatively high HVSR peak period values and HVSR peak amplitude values that were in the range of 1.0–1.6 s and 6–9, respectively. The probability of liquefaction (Akın *et al.* 2013) has increased in these villages (Arısu and Topaktaş villages) due to the shallow groundwater level and the sandy soil layer.

Other severely damaged villages (Çitören, Arısu, Mollakasım, Alaköy, Yumrutepe, Atmaca, Göllü, Güveçli, Tabanlı, Dağönü, Şahgeldi, Yeşilsu, Ocaklı, Pirgarip, Hıdır, Aşağıgölalan, Esenpınar, Sağlantaş, Çakırbey) were located on the Oligocene–Miocene aged deposits. The values of mid-range HVSR peak period, obtained in these villages, are compatible with geological characteristics of the region (0.4–0.8 s). High HVSR peak period and HVSR peak amplitude values were obtained, correlating with occurrence of liquefaction, in the villages of Bardakçı, Topaktaş, Özkaynak, Gülsünler, Kasımoğlu, Satıbey and Koçköy (figure 7a).

The results of this study are compared with the results of the final damage assessment report prepared by Governorship of Van and the relation between the damage levels to the buildings and the regional tectonics, local geological and geophysical conditions are given in table 1. The results of this study are almost consistent with the results of the final damage assessment report prepared by Governorship of Van. However, it should be noted that the housing units severely damaged in villages located in volcanic areas, were constructed on locally found alluvial/lacustrine deposits (i.e., Halkalı, Yaylıyaka, Kumluca, Çolpan and Esenpınar villages). The damages in Satıbey, Ermişler and Özkaynak villages are mainly because of the landslides (figure 7b).

It was found that hillside effect, which is the translation of the body waves into surface waves in the edges of the basin, increased the amplitude value. The increase in the amplitude consequently resulted in higher levels of damages in housing units in Alaköy and Dağönü villages (figure 7c). Arısu and Güveçli villages are highly damaged due to underground water (figure 7d). Structural damages, which are related to the local soil conditions and the geological properties, are given in figure 8.

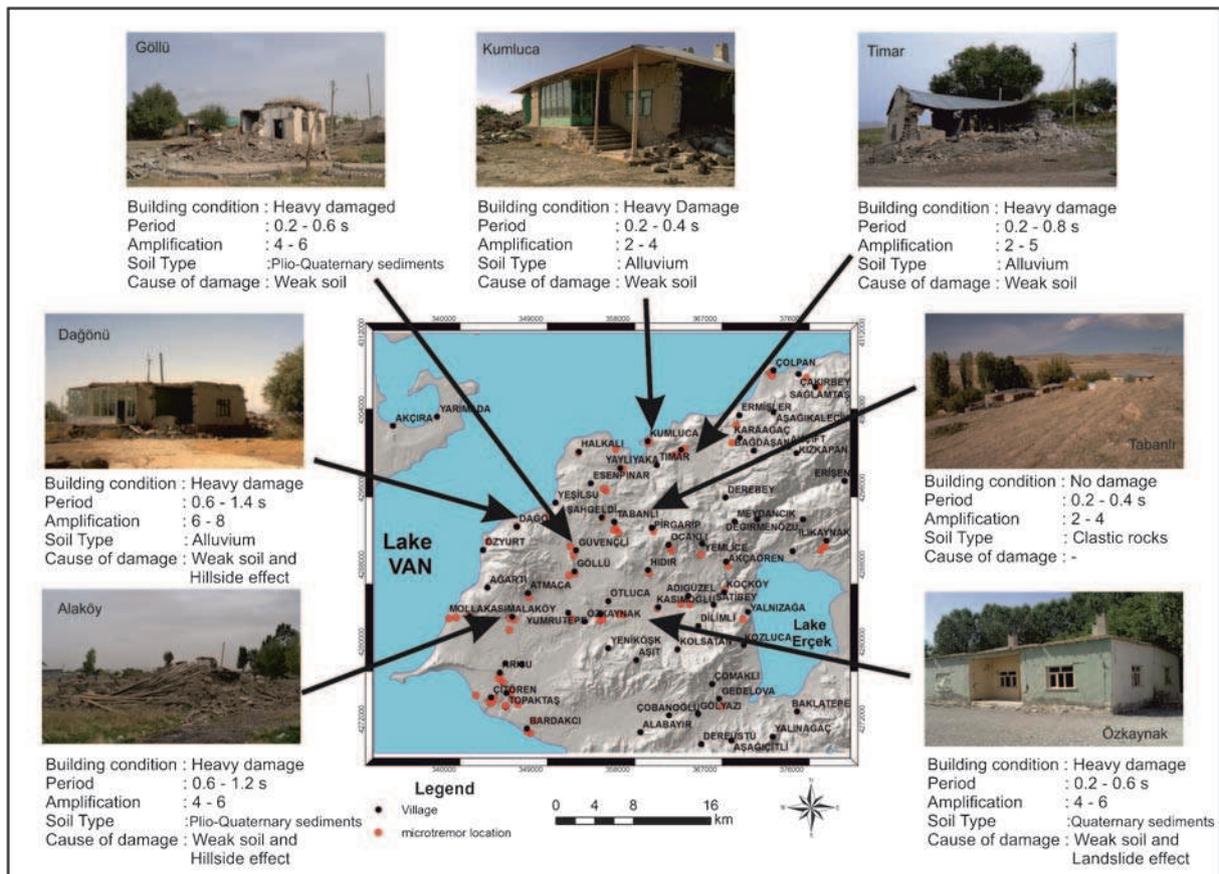
Figure 8. Different types of earthquake-induced structural damages in investigated villages.

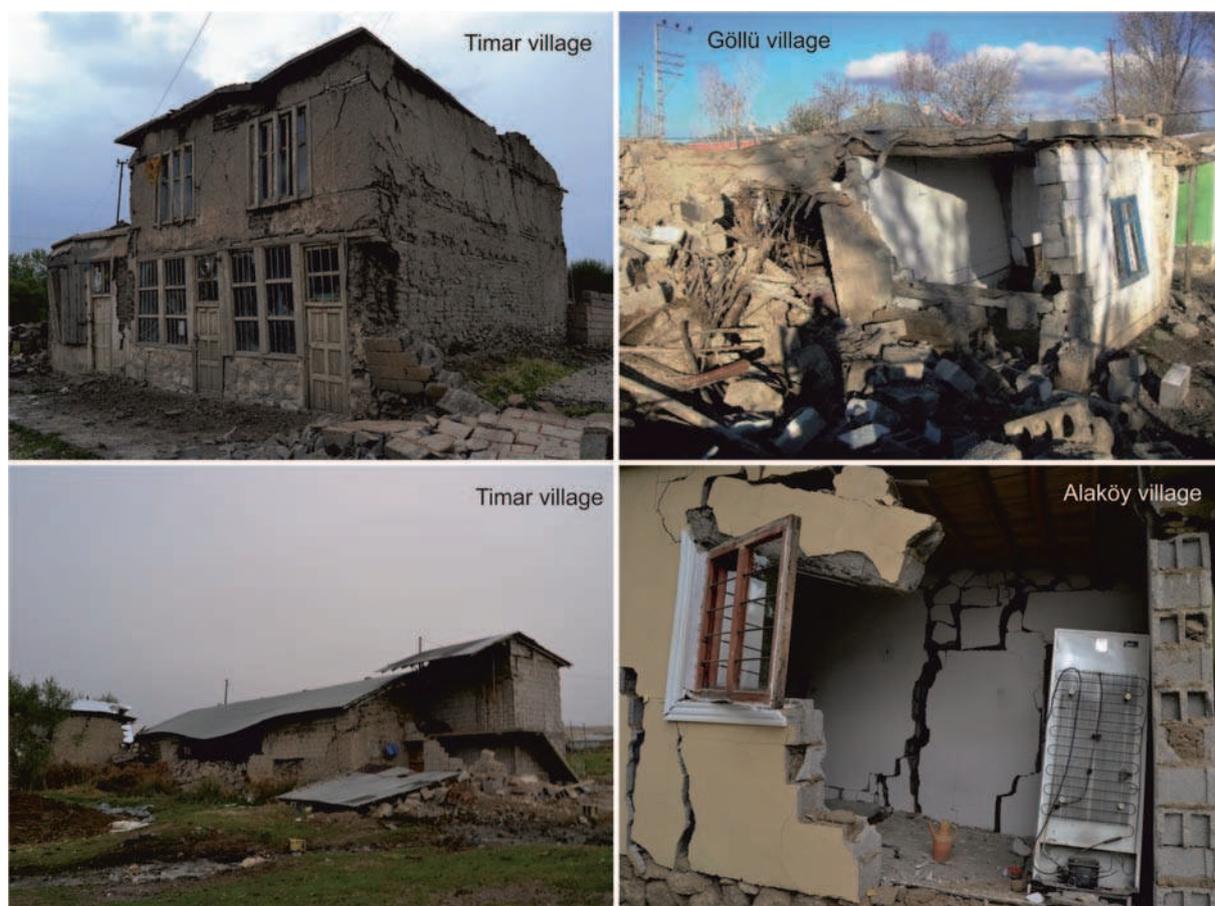
Figure 9. Damages to unreinforced masonry buildings on weak soils in the study area.

The structural damages were severe and widespread in villages located on soft soils. A great majority of the existing housing units are unreinforced masonry buildings in these villages. The walls of relatively older housing units are mostly constructed with adobe blocks and mud mortar, whereas the newer units are constructed with light-weight concrete blocks and cement mortar (Tapan *et al.* 2013). There are also many housing units built with combination of these two different types of blocks, sometimes together with wooden structural materials (Tapan *et al.* 2013).

The roofs of these housing units, particularly for relatively older ones, are built by woodwork and covered with a thick layer of clay for heat insulation. Although construction practice of all housing units are similar in the region, damages to the housing units located on strong soils such as rock units were relatively less than the damages of housing units located on weak soils (figure 9).
