PRODUCT QUALITY ASSESSMENT – MEASUREMENT AND ANALYSIS OF SURFACE TOPOGRAPHY

This paper concerns the issues of measurement techniques, analysis and assessment of the machined surface geometric structure. The aim of this work was to show the application of surface analysis in diagnosing the causes of discrepancies occurring in the manufacturing process, which may result from ill-matched (poorly fitting) process parameters. An appropriate system of control and interpretation of results may allow early reaction to unfavorable trends (for example blunting of the tool) and prevention of undesirable defects.

The subject of research was a waste basket used in the construction of retaining sewer systems. In this paper, the quality of the waste basket as well as its manufacturing process were analyzed and assessed. The research was carried out with the use of three measurement stands, i.e. optical microscopy (OM), scanning electron microscopy (SEM) and white light interferometer (WLI).

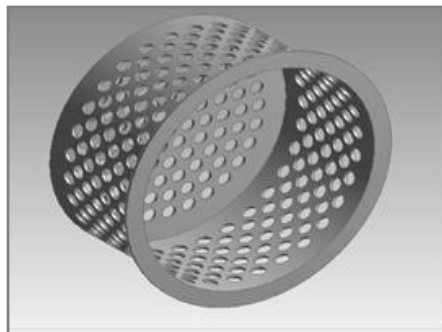
Fig. 1. The studied element – a waste basket.

The subject of the present analysis is a waste basket (a strainer – Figure 1) which is applied to sewage (drainage) systems with the view of filtering solids from industrial wastewater.

The filtered pollutants can considerably influence the surface of the strainer. Taking into consideration the materials used in the production of this component, it is the pollutants made of glass that most heavily expose it to damage, scratching the component and causing it to break or crumble; whereas pollutants made of other elements, e.g. steel, ceramic, or cast iron, affect it to a lesser degree.

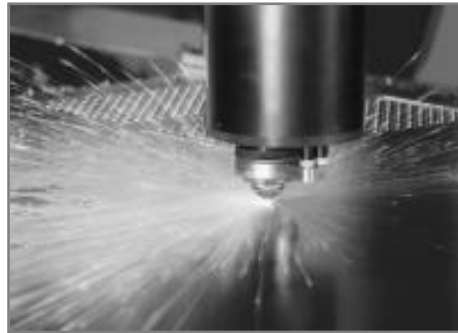
Fig. 3. Cutting bores with a laser cutter

In the beginning stage of the production process, bores are made with the use of a laser cutter (the two-way one) – Figure 3.

Next, flat discs are cut and passed to machining stands. Here, semi-products are processed with the use of drawing processes, which aim at achieving a correct construction of the component. The last stage of the process is to deliver the fully formed products to the storage point. Yet, cutting bores with a laser cutter is said to be the most important part of the whole technological process. Defects emerging on the surface geometric structure are linked to this very stage.

Costly attempts made to correct the movement of the laser cutter head failed to bring any improvement with regard to the manufacturing quality. It turned out that damages emerging on the surfaces of waste baskets and all discrepancies did originate from the power of the beam incorrectly adapted. It was noticed that once the power of the beam had been changed during the process of cutting bores, growths started to appear on the edges of the bores cut in the waste basket.

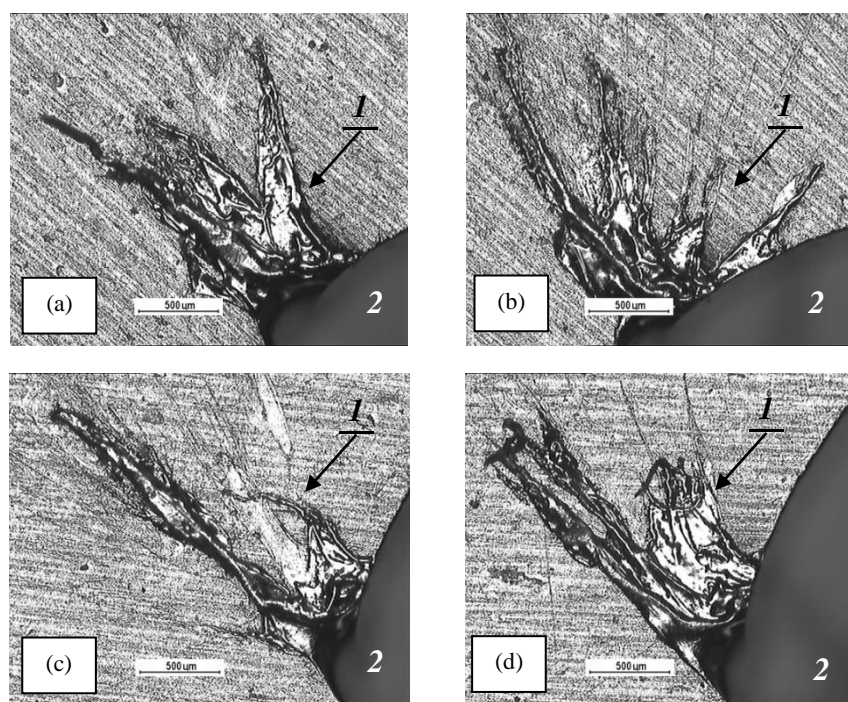
The pattern and repetition of the size and type of damages was observed on the analyzed surfaces. The research results were subject to quantitative (measuring of damages) and qualitative analysis (visualizing of damages) with the use of three measuring stands and professional metrological software. The research which was conducted with the use of the non-contact measuring methods shows that the biggest discrepancy appears near the bores. The shape of the damages is irregular. The maximum size of the damage (irregularity, or so called growth) reaches 0,5 μ m. The common characteristic of all the irregularities is their accumulation near the bores. Yet, the further from the bore growths are distributed, the less deformed the shape is. At first glance, the damages looked like scratches, or cavities in the surface. Only after 3D visualization had been used, the real nature of the damages was revealed. Selected damages are depicted in the pictures below: Figure 4 (the results achieved with the use of optical microscopy OM), Figure 5 (the results achieved with the use of scanning electron microscopy SEM) and Figure 6 (the results achieved with the use of the white light interferometer WLI).

Fig. 4. The results achieved with the use of OM (total system magnifications x50)
1- damage (partially melted material), 2- bore.

It is possible to eliminate the damages done and identified, if additional machining techniques are applied, for example sand blasting, thanks to which the undesirable irregularities could be removed. However the whole surface of the product would have to be flattened at the same time, which would increase the susceptibility to corrosion. On the other hand, application of other techniques would increase the cost of both the manufacturing process and final product. Another possibility is to reduce the laser cutting speed. However, doing that would decrease the efficiency of the process. Then, the problem might be solved if the power of the beam were stabilized. But, it seems that it would not change the efficiency of the process, while requiring beam guidance and trajectory corrections. Continuous monitoring of laser parameters would be necessary, with regard to the type and thickness of the cutting material. The process parameters can only be set experimentally through repeated topographical analysis with variable sample parameters. This gives satisfactory effects by reducing growth which is the main factor influencing the final shape, size, and product quality.

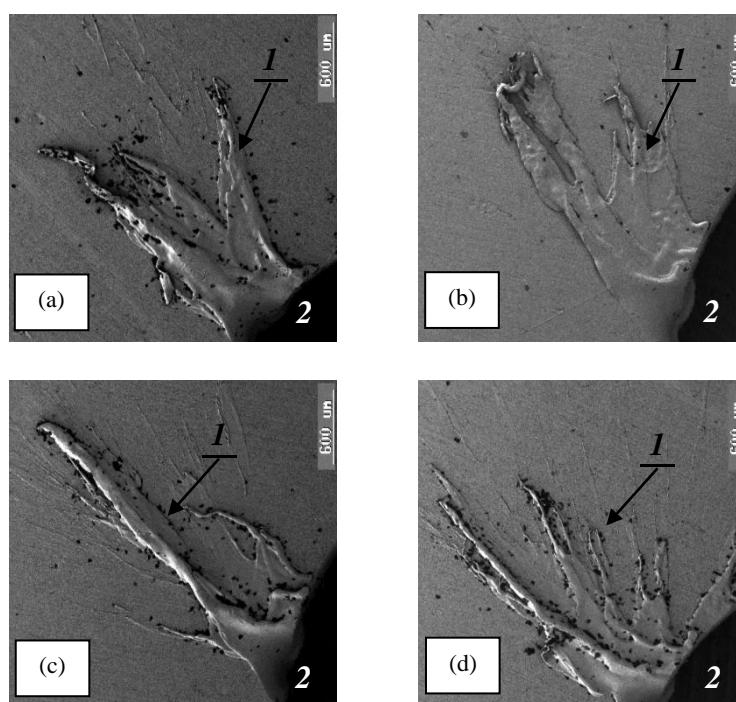
Fig. 5. The results achieved with the use of SEM (total system magnifications x40)
1- damage (partially melted material), 2- bore.

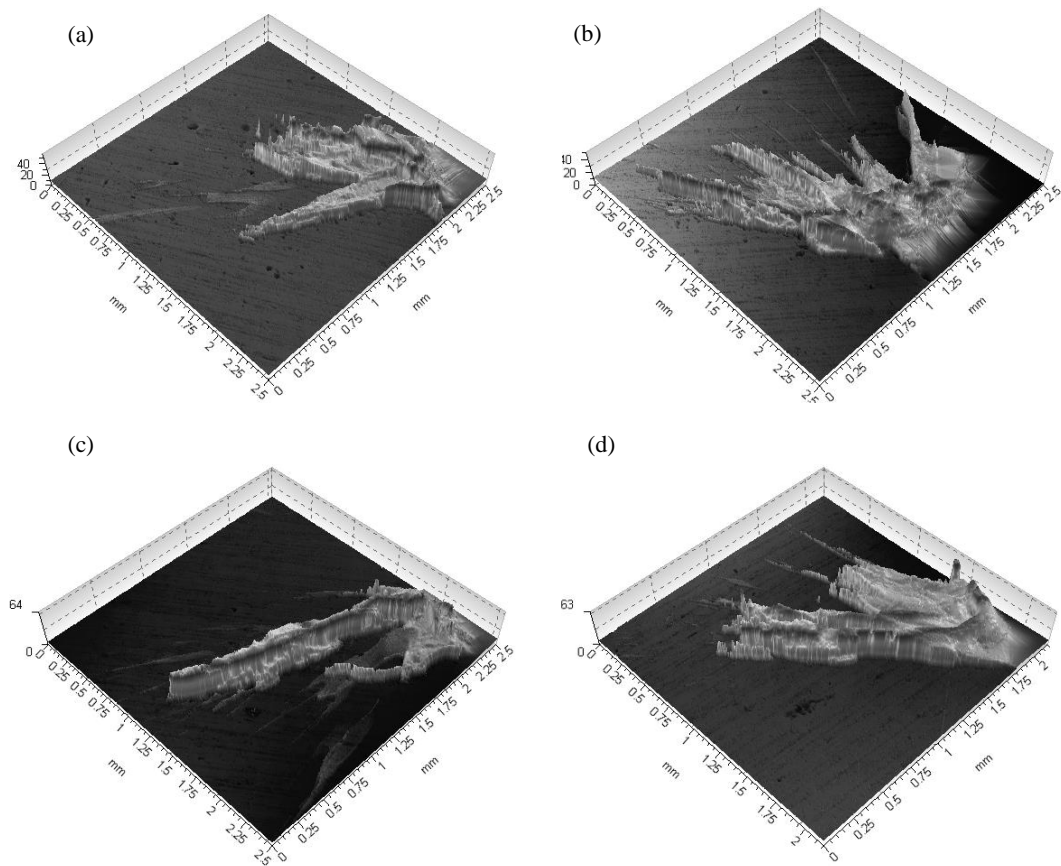
Fig. 6. The results achieved with the use of the WLI – damages (partially melted material).

The analysis shows that the existing discrepancies take about 30% of the examined surface around the bore. The damages have an irregular character. The section through the profile (Figure 7) very clearly shows the changes in amplitude.

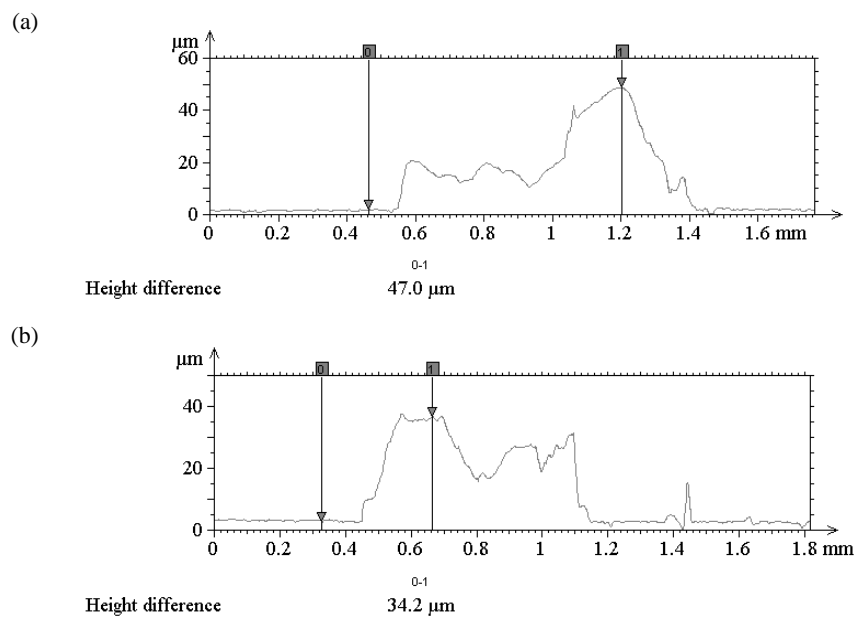
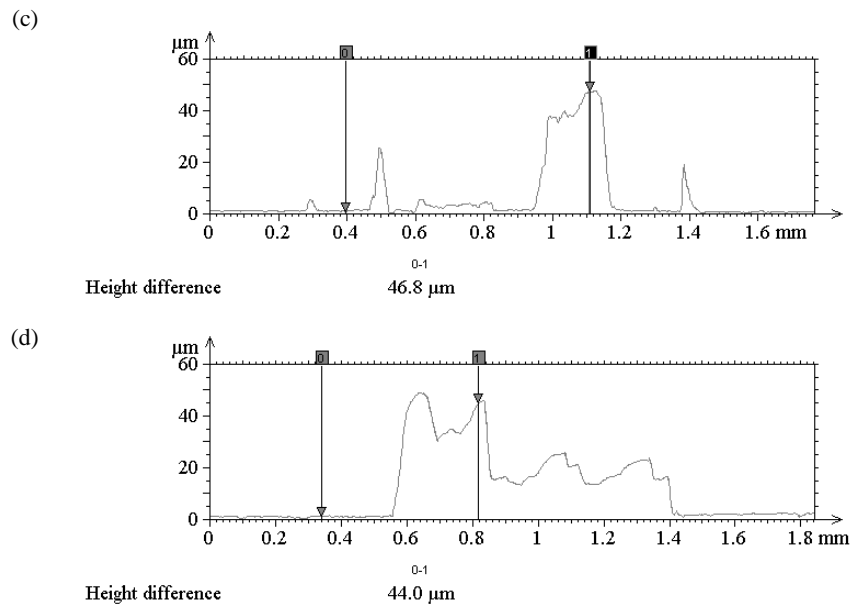
Fig. 7. The profiles of selected surface damages (partially melted material).

As far as the discussed issue is concerned, another solution would involve the modification of the manufacturing process of baskets. From the viewpoint of operation, laser cutting appears to be an expensive technology. Cutting thousands of small bores in short intervals will result in many quick and sudden movements of the laser head. The inertia forces arising in this way will certainly speed up the wear of power trains and guiding systems, lowering the precision of cutting. Given that the manufacturer has a *power* press, it would be reasonable to consider equipping it with punches for cutting bores and implementing the whole process with a single device.

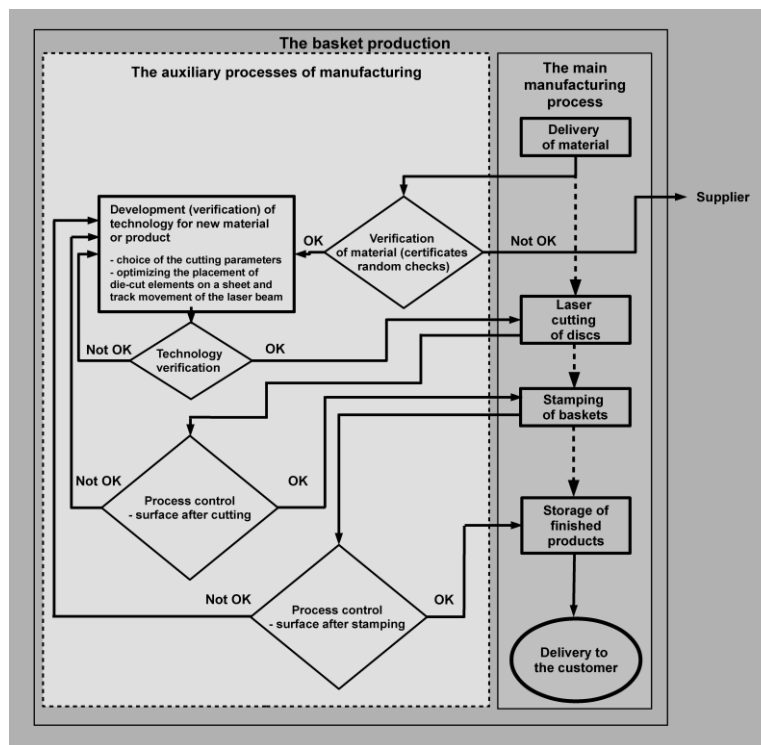
Fig. 9. Scheme of the support and control systems.

Yet, it seems undeniable that if the support and control systems are effectively implemented, the technological process will be easily controlled, loss of stability will be immediately handled, and defects will be prevented from ever occurring - Figure 9 presents a scheme of the support and control systems.
