## Preservation Practice between Identity and Social Issues: The Case of Gayantou Ethnic Village in Yongzhou, China

To cite this article: Francesco Augelli *et al* 2019 *IOP Conf. Ser.: Mater. Sci. Eng.* **471** 112050

# Preservation Practice between Identity and Social Issues: The Case of Gayantou Ethnic Village in Yongzhou, China

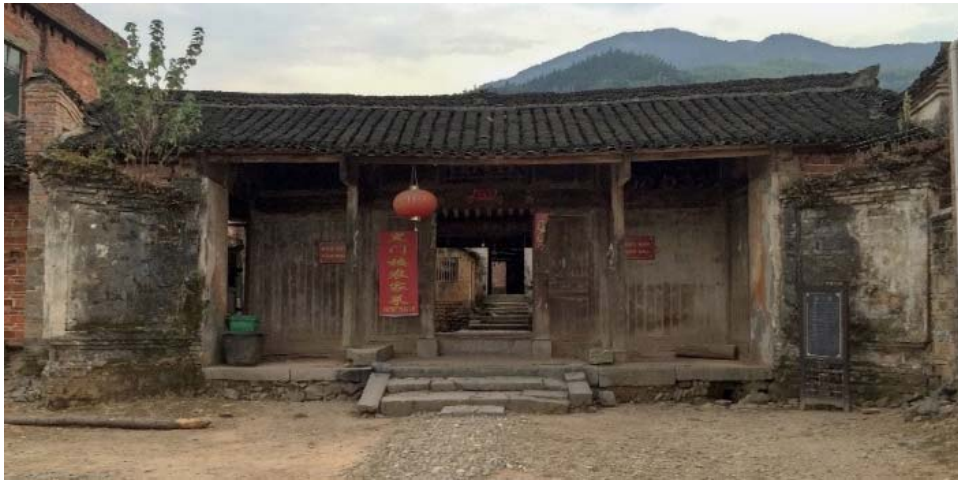
**Figure 2.** Main façade of the Black Gate Mansion. August, 2016.

Zhou Ziji, the eldest son of Zhou Xisheng in 1638, built the mansion (Figure 2). Zhou Ziji wanted to show respect for his father's house, the Red Gate Mansion, so he decided to paint it black. The style and the ornaments of the building are similar to those of the Red Gate Mansion, but unlike it, its courtyards are wider and more ventilated, its structure is composed differently and it incorporates a garden in the back. The building occupies about 2,500 square meters. The Black Gate Mansion complex consists of a series of buildings arranged along a central axis. The oldest rooms are southernmost rear part - firstly home, then place of ancestry veneration - while the more recent environments were gradually built to the south.

The present study takes the main pavilion as example in order to deepen some aspects on material and structural deterioration. The main pavilion is the space in which host reception took; it was both a place of representation and of distribution to the rest of the mansion. It is about 12,50 meters wide and 9 meters deep and it is covered by a double-pitched roof. The smaller sides consist of two mixed- masonry walls 40 cm. thick and with a maximum height around 7 meters.

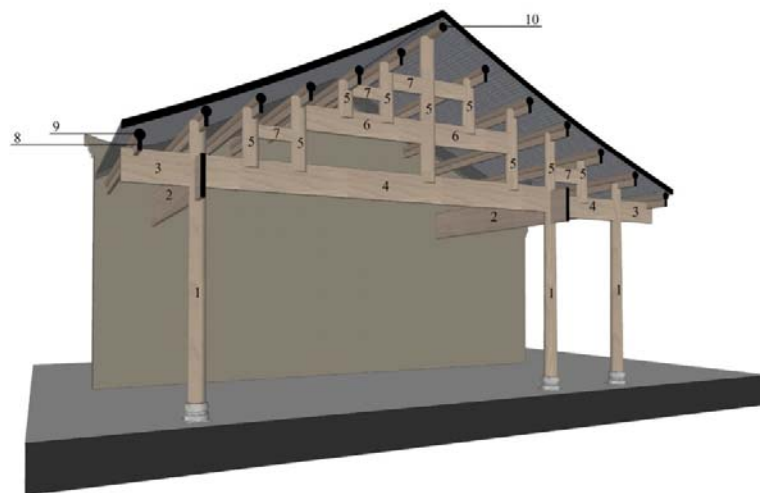
The structure typology of the pavilion is Tingtang [1]. This typology is characterized by a repetition of frames (*liangjia* in Chinese) made of columns of different heights occasionally extending up to the roof supports. In formal terms, this typology is distinguished by having an exposed roof structure. (Figure 3)

**Figure 3.** Diagram of a wooden frame (1. Columns, 2. Crossbeams, 3. Cantilever beams, 4. Beams, 5. Posts, 6. Secondary beams, 7. Secondary crossbeams, 8. Joists, 9. Purlins, 10. Ridge purli)

The connection between timber elements takes place with the use of mortise and tenon joints or with the use of wooden wedges. The only exceptions are the ends of the perpendicular crossbeams, which are simply

The pavilion also features special connectors that we will call *set squares*. These fan-shaped beautifully carved wooden elements are stuck on the top of the columns or the posts. These transfer the load of purlins to the underlying beams or cantilever beams. In this hypothesis set squares would help to keep the cantilever beam horizontally in place just as the main beam, otherwise it would naturally tend to rotate downwards.

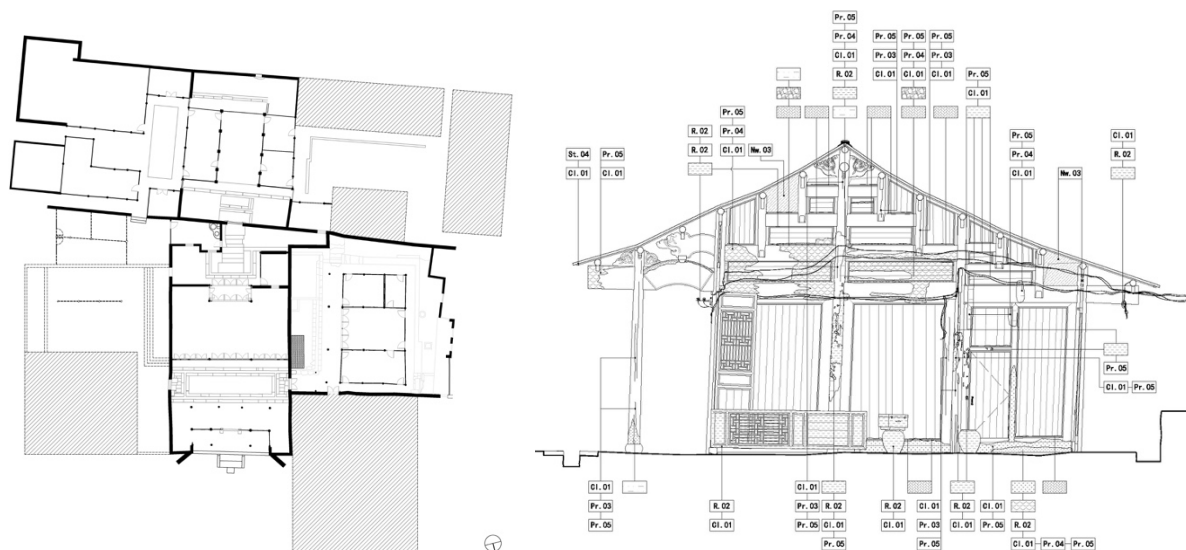
A geometric survey was carried out on a simple traditional way with precise and adequate techniques, in order to give students a valuable graphic basis to represent on data regarding material and deterioration survey. Students were able to learn a fast and low-cost, yet correct methodology concerning direct data acquisition, an essential phase prior a conservation and reuse project proposal. (Figure 4 and 5)

**Figure 4-5.** Floor plan and section plane of the Black Door Mansion.
