Qualitative and Quantitative Assessment of Scaffolding Used in Polish Cities: Focus on Safety

To cite this article: Robert Bucon *et al* 2019 *IOP Conf. Ser.: Mater. Sci. Eng.* **471** 112059

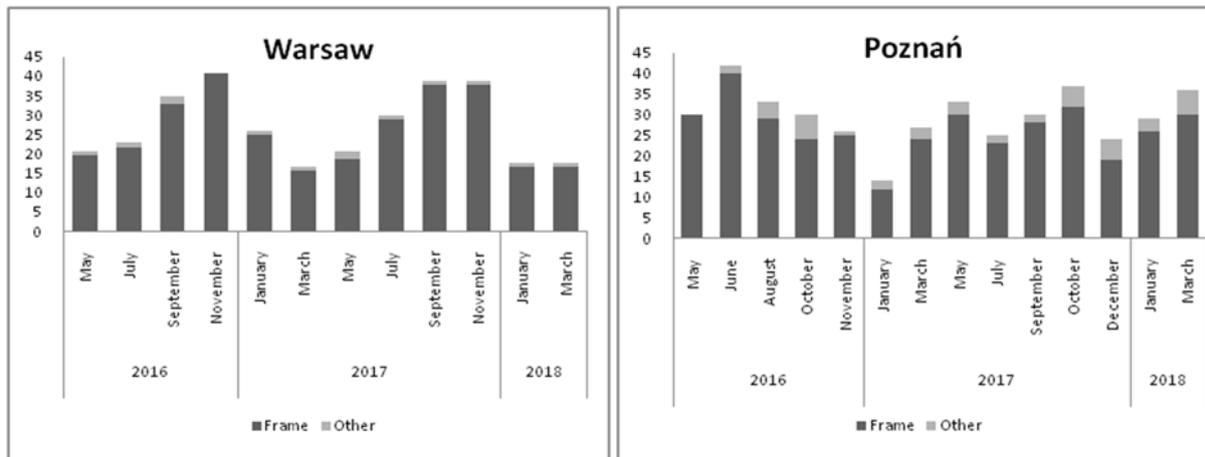
Figure 1. Number of scaffoldings according to type observed in city centres of Warsaw and Poznań

The seasonal differences in the number of scaffoldings (figure 1) expressed in absolute numbers look similar: within 3 km² of Warsaw centre, the smallest number of scaffoldings was 17, and the greatest – 41. In Poznań, these figures were 14 and 42, respectively, but in a larger area (3,74 km²). The seasonal trend was quite clear in Warsaw: the number of scaffoldings grew from spring until November (when contractors strive to complete the works before wet and cold winter and end of the fiscal year). In Poznań, where winters are milder, the drop in the number of scaffoldings towards the end of the year was not that obvious, and the construction season seemed to start and finish earlier. However, the data have not been collected long enough to allow for generalizations in this respect.

In both cities, simple frame scaffoldings were the most popular type: on average, 96% of all scaffoldings in Warsaw, and 89% in Poznań. Modular systems seem to be the second choice in Poznań – in some periods over one fifth of scaffoldings were of this type (figure 1).

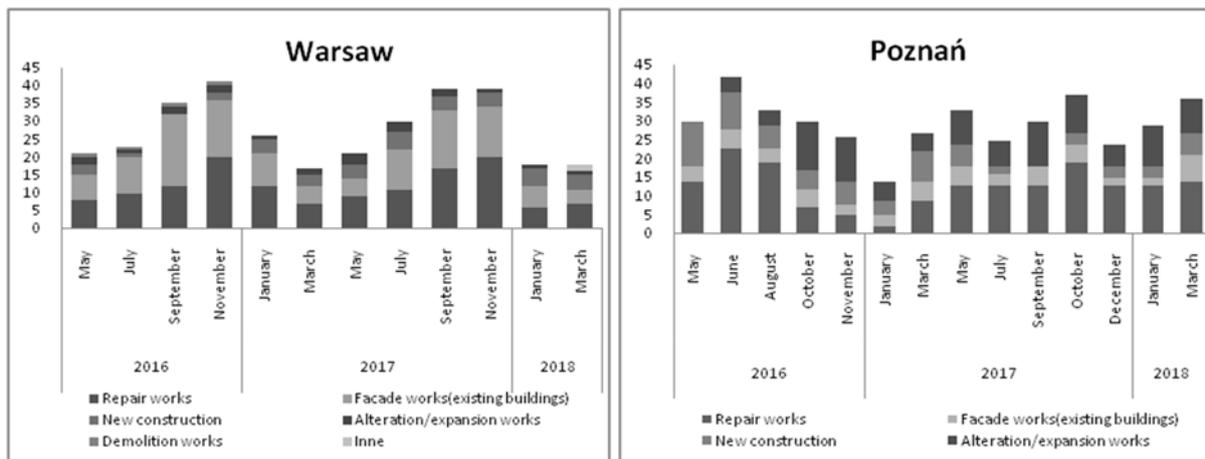
Figure 2. Number of scaffoldings according to the type of works served in city centres of Warsaw and Poznań

As for the type of works served by the scaffoldings (figure 2), the majority of observed cases were related with repairs of the existing assets. A considerable number of heavy alteration/expansion works was observed in Poznań (25% of cases), whereas in Warsaw such ventures occurred less frequently (6%). Nearly 12% of Warsaw centre scaffoldings observed during the whole period of analysis served new construction. In Poznań, where some post-industrial plots have been recently reclaimed for construction, the share of scaffoldings accompanying erection of new buildings was greater, and reached nearly 18%.

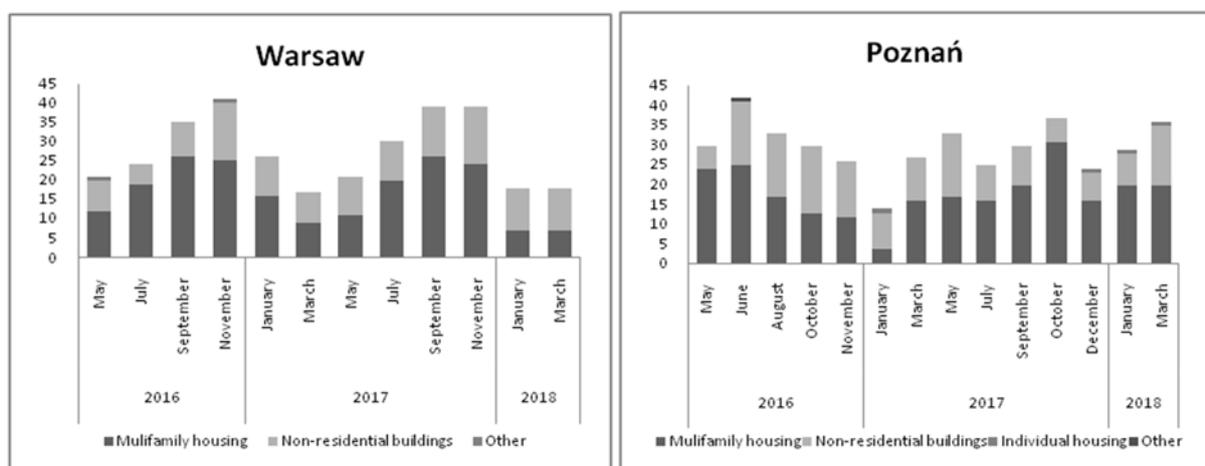
Figure 3. Number of scaffoldings according to the type of buildings served in city centres of Warsaw and Poznań

The works were conducted mostly in multifamily residential buildings (62% in Warsaw, 61% in Poznań). Due to the character of development, the Poznań central area encompasses some single family buildings (or rather urban villas), and 1% of scaffoldings were used there; whereas in Warsaw no such buildings were present in the test area. The remaining scaffoldings served works in non-residential buildings (figure 3).

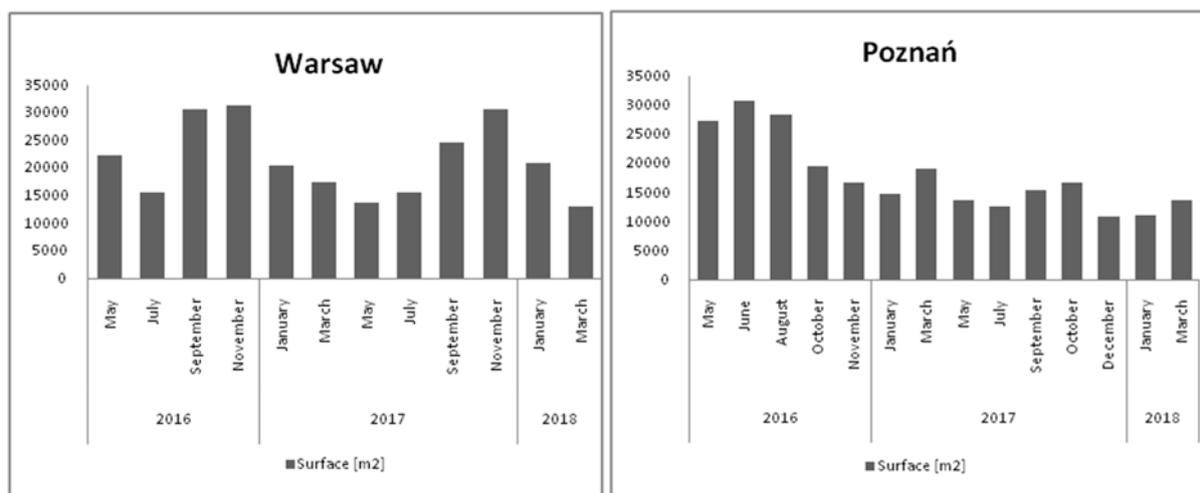
Figure 4. Total area of scaffolding in city centres of Warsaw and Poznań

So far, the difference between the central areas of Warsaw and Poznań in terms of purpose and intensity of scaffolding use seems minimal. However, if one compares fluctuations of the total scaffolded area (figure 4), the discrepancies become visible. Of course, the period of data collection is too short to generalize, but the area of scaffoldings in Warsaw seems to fluctuate with some regularity and according to the same pattern as the number of scaffoldings: surprisingly small number and small areas of scaffolding in late spring and summer, the peaks in late autumn (November). As for Poznań centre, the total area of scaffolding seems to drop from June 2016 (the effect of two large office projects being completed between May and October 2016), and the relationship between the number and the area of scaffolding is less clear.

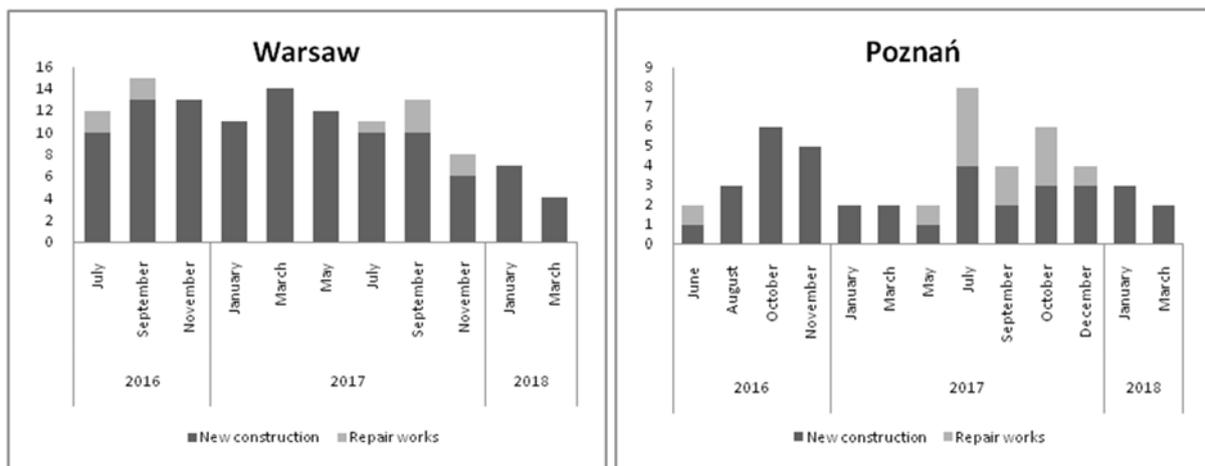
Figure 5. Number of scaffoldings according to the type of works served in new residential districts of Warsaw and Poznań

The total number of scaffoldings in Warsaw fluctuated between 4 and 15, whereas in Poznań – between 2 and 8 (figure 5). Interestingly, the number of scaffoldings in Warsaw did not vary significantly between winter and summer months. In Poznań, changes in the number of scaffoldings

were considerable. This can be explained by the character of works (figures 5 and 6). In Warsaw, these predominantly consisted in construction of new large housing blocks (95.8%), so the works took a long time; it was not economical to dismantle scaffoldings for winter even if weather did not allow to continue works. In Poznań, the share of scaffoldings for new construction was smaller (73.5%), and the remaining ones served repairs, so they were needed for short-term works (less than 2 months). Thus greater changes in scaffolding numbers over time (figure 5).

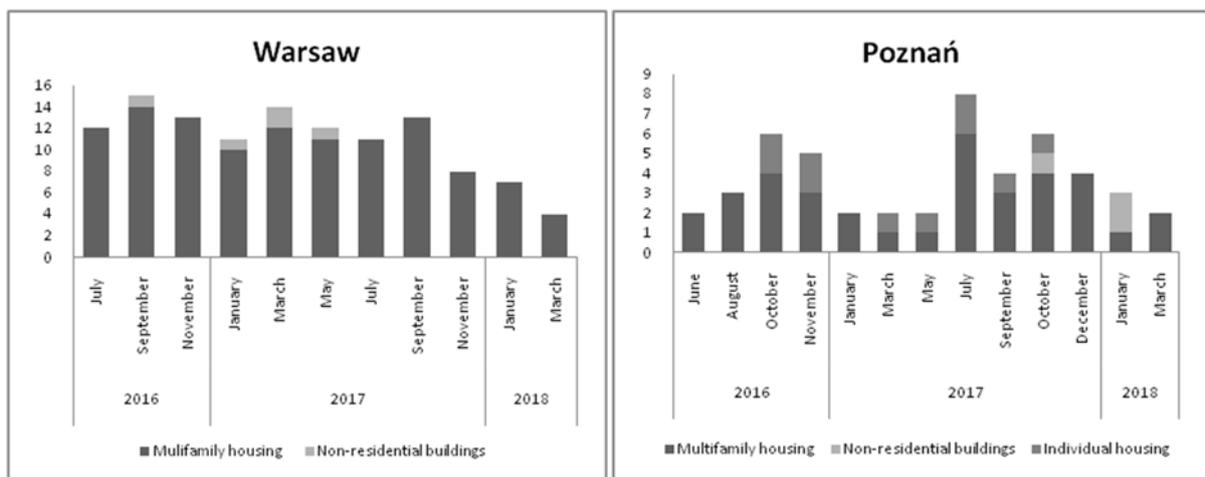
Figure 6. Number of scaffoldings according to the type of buildings served in new residential districts of Warsaw and Poznań

The area in Warsaw (Wilanów) covers 2.83 km². Its counterpart in Poznań (Naramowice) is slightly smaller, of 2.5 km²; its function is also less uniform, as it contains small areas of single family houses and areas occupied by small industrial establishments. This is reflected in the distribution of scaffoldings according to the types of buildings served (figure 6).

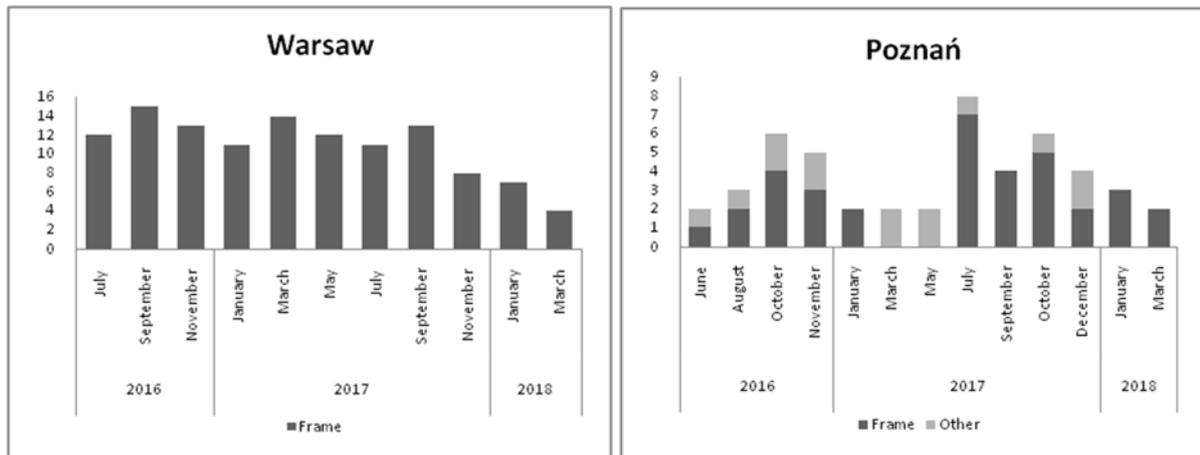
Figure 7. Number of scaffoldings according to type observed in new residential districts of Warsaw and Poznań

As illustrated by figure 7, only frame scaffoldings were used in the Warsaw residential district under observation. In Poznań, frame scaffoldings were dominant, but other types were also present (modular, mobile towers, Warsaw towers and combinations of these).

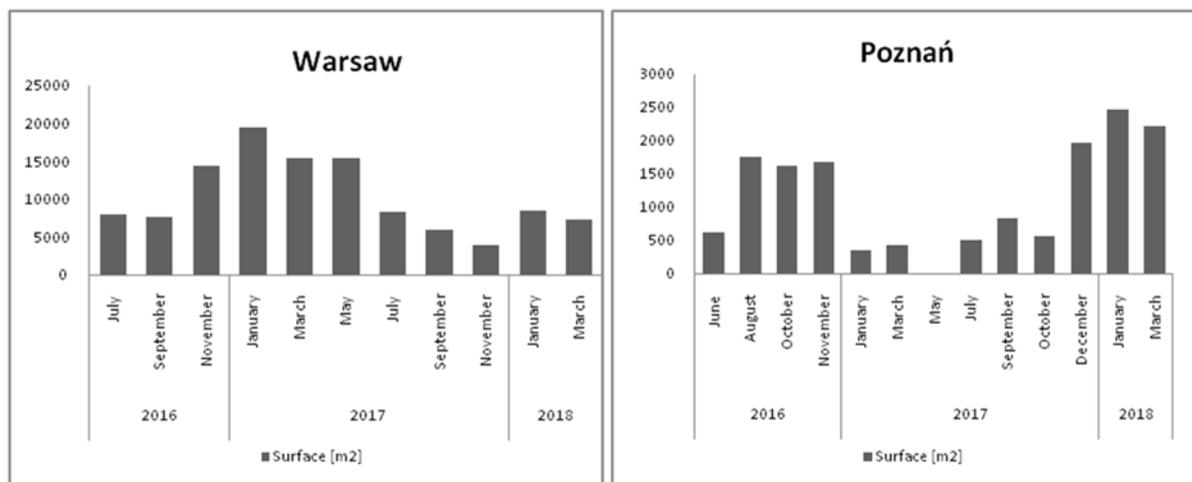
Figure 8. Total area of scaffoldings in new residential districts of Warsaw and Poznań

However, the greatest difference between the Warsaw and Poznań districts lies in the total area of scaffolding (figure 8). As big projects were conducted in Warsaw, the total scaffolding area fluctuated between 4,095 and 15,530 m², whereas in Poznań - between 24 and 2,465 m². The average size of a Warsaw scaffolding was 1027 m², with only 361 m² in Poznań. Big scaffoldings (above 200 m²) consisted 98.5% of Warsaw, and 93.3% of Poznań samples, and they all were related with new

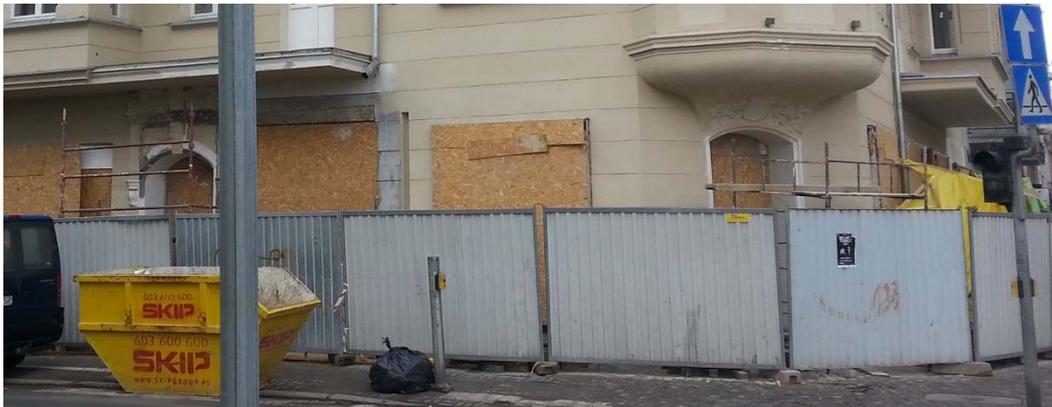
Figure 9. Makeshift platforms with missing elements covered with loose planks, main street in Poznań Old Town, 2018

- Small scaffoldings (individual housing, small scale repairs) frequently rely on combination of elements of systems scaffoldings and are often incomplete and dangerous to use. Interestingly, “bad scaffoldings” do not appear only in remote suburbs: they can be spotted even in prominent areas of the cities (figure 9).

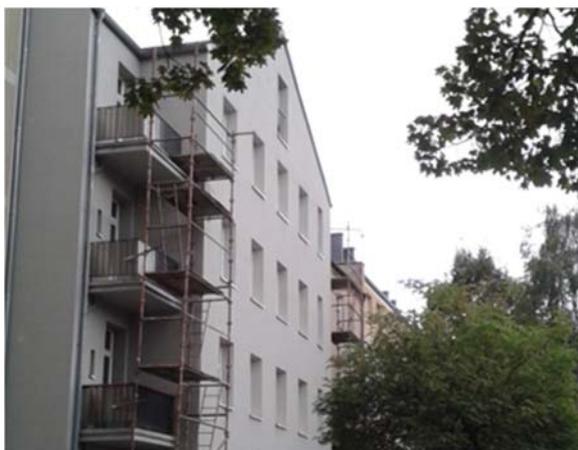
Figure 10. Small modular scaffolding – missing mid-rails and toeboards, Poznań centre, 2016

The method of data collection does not enable the researchers to check condition of the scaffoldings in detail. However, some deficiencies can be seen even from a distance. From the point of safety, the worst scaffoldings are those smallest, erected “just for a while” and used in repair works or as platforms for structural works. They are often not properly supported, with missing elements (figure 10). The Warsaw tower type scaffolding (according to accident statistics, notorious for being misused) almost disappeared from the building sites in the centres – no construction works were observed to rely completely on them. However, with their loose planks serving as platforms and no guardrails, they still lurk from the shadows even in seemingly well managed sites, as the one spotted at a large office project in Poznań (figure 11).

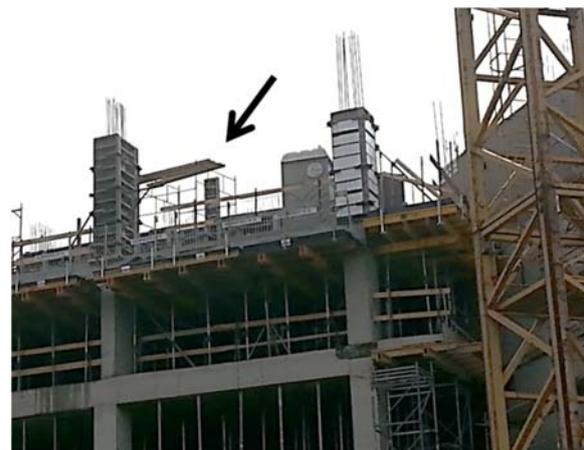
Figure 11. Incomplete Warsaw tower type scaffolding as a platform for concrete placers 15 metres above the ground, Poznań centre, 2018
