# Restoring Minarets as A Dominant Part of Urban Landscape Restoration of Stone and Wooden Minarets in Bosnia and Herzegovina - Materials, Structure and Urban Form

**Abstract.** In a post conflict zone, restoration of monuments is not only a scientific or technical matter but also a highly symbolic and emotional act of reclaiming culture, identity and urban form. In Bosnia and Herzegovina minarets are shaped by local building traditions and materials, influenced by the ottoman classical minaret format. Most of the prominent mosques have stone minarets, especially in regions abundant with suitable stone and craftsmanship. Wooden minarets were usually built alongside local neighbourhood mosques and they defined city image due to their frequent occurrence in most parts of the urban core. Restoration of these two types of minarets is significantly different mainly due to the nature of the material itself. Interventions on stone minarets were carried out through reconstruction and re-composition of elements, based on documentation about the structure. Stone remains were actually the prime source of information for geometry and breadth of the minaret body and for the complex structural

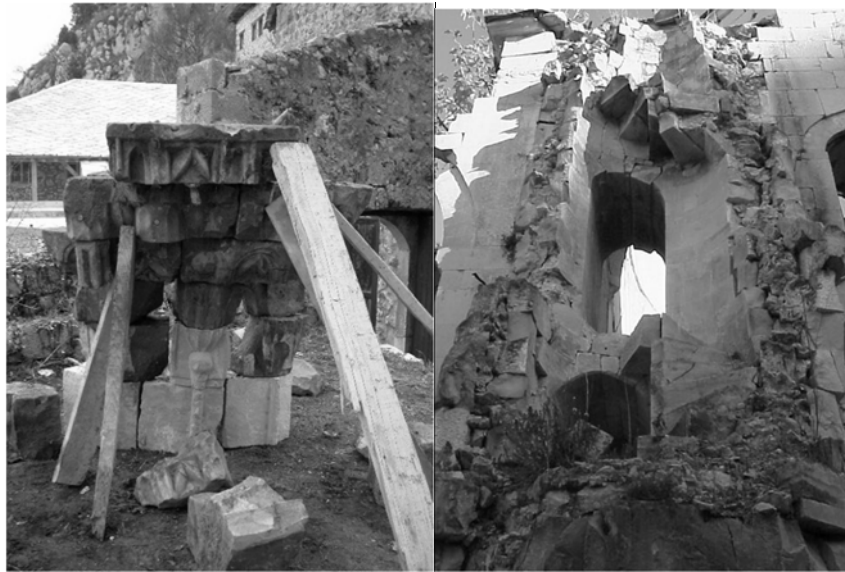
**Figure 4.** Počitelj mosque minaret, detail of the serefet and destruction of entire minaret.  
(Source: authors archive, 2002.)

Destruction of the minaret was so severe that only first five rows and several blocks from the base were preserved in situ, and the rest of the minaret body was cut out of new stones (Fig.4). There were only a few decorative and one cornice piece from the top of the base so the decoration had to be reproduced based on photographs and documents, and the remaining segments. The transition and the shaft were most damaged since it was the focus of the explosion, only few blocks were reused in the shaft.

Sherefet (the “balcony”) on the other hand had a lot of pieces surviving that helped to figure out the complex richly decorated element that was not documented in great detail previously. (Fig.4). Most of the surviving segments were from the upper shaft, and them were reused during reconstruction.
