## Disappearance of the Limestone Architectural Heritage in Central Poland - Trends and Challenges

To cite this article: Marcin Goraczko and Aleksandra Goraczko 2019 *IOP Conf. Ser.: Mater. Sci. Eng.* **471** 082021

# Disappearance of the Limestone Architectural Heritage in Central Poland - Trends and Challenges

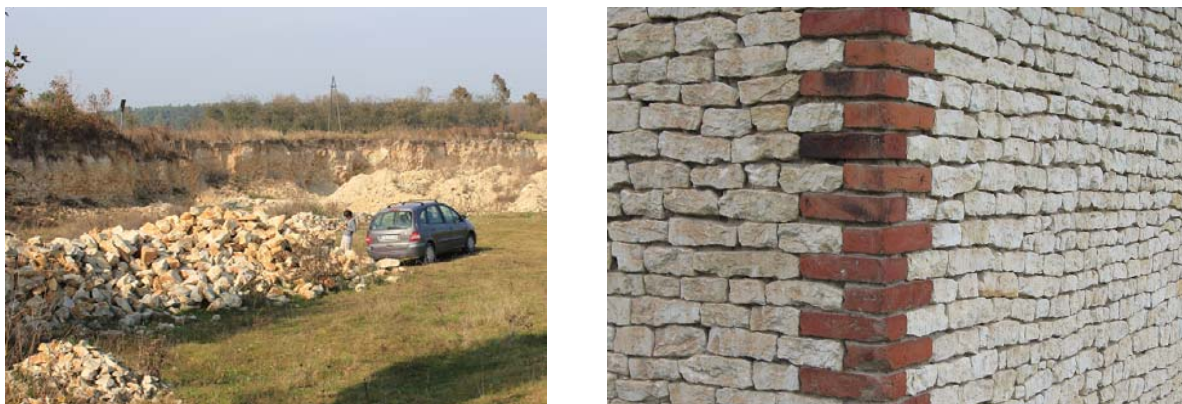
**Figure 2.** Quarry in Rożniatów (present condition) and typical method of using limestone in traditional rural architecture.

Limestone quarry in Różniatów, which at least for several decades has been the main local source of construction material in Koło Basin remains operational to this day. Under the current ownership however, the mining operations are conducted only at seldom. Within the last 10 years, the limestone mined here was used for constructing merely a couple of structures - two farmhouses in an ethnographical museum (figure 8a), several merchant pavilions in the communal marketplace (figure 8b), utility buildings at the football field - all located in Uniejów and a fire depot in Ostrowsko, a village near to Uniejów. All of these investments were funded by the local authorities of Uniejów, within whose administrative borders the quarry is located [5]. The situation is not any better when it comes to the use of the material by private investors. It is sporadically used in the modern projects for

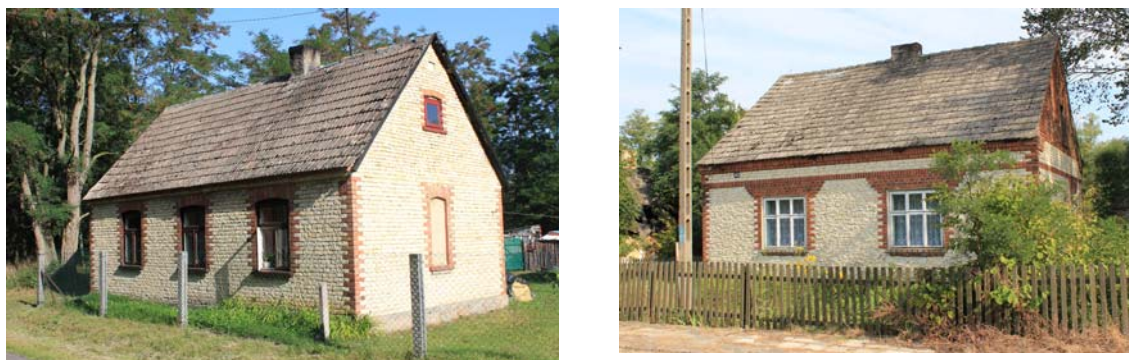
**Figure 3.** Examples of traditional structures erected using limestone

In the years 2011-2017, the authors conducted a survey of a 1200km<sup>2</sup> area, identifying over 2,300 buildings erected using limestone as the primary construction material (figure 3). The range of objects included houses, homesteads, barns, churches, manors, mills and other rural buildings. The estimated number of these buildings might have been even over 3,000. During the survey it was possible to notice that the number of limestone buildings is diminishing with each passing year. This article represents the first attempt of a systematic assessment of this process, identification of the main obstacles in maintaining these objects of architectural heritage. We hope that it might lead to determining the chances for preserving the traditional rural architecture in the present and the future conditions of modern transformation.

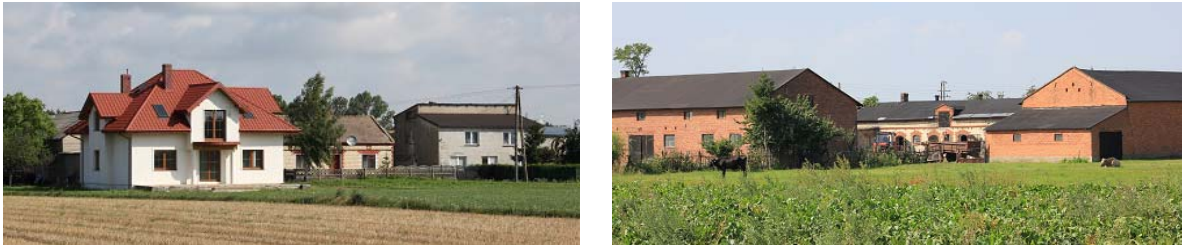
**Figure 4.** Cases of superseding of the limestone structures from the local landscape

Attempting to determine the causes for the advancing diminishing of the traditional rural architecture in Koło Basin (figure 4), it is necessary to examine separately the residential structures from the agricultural structures, even whereas they belong to the same households.

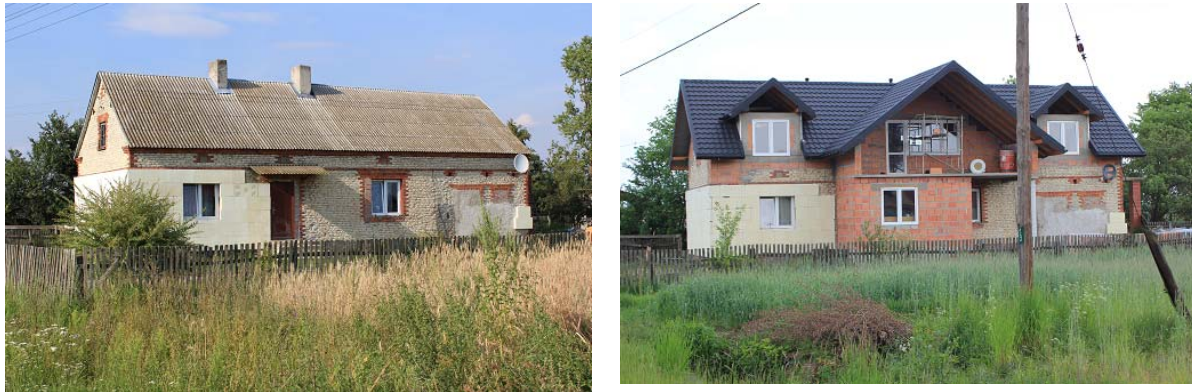
**Figure 6.** Example of traditional limestone structure undergoing thermo-renovation between 2012-2016

In the traditional process of erecting walls using limestone, the rule was that the material was to be visible from the outside. Therefore, the stone was meticulously cut and elements of the wall were decorated using ceramic brick. Nowadays though, the walls are being covered by layers of thermal-insulation (figure 6). The main reason for that action is lowering the heating costs. It's worth noting, that the owners are gladly deciding to improve the thermal characteristics of the houses, as such investments are supported by various institutions, programs and funds, through direct subsidies, favourable loans or tax relieves. Once insulated, the walls are then plastered and covered with paint. Most commonly, these actions are done with a purpose of differing the house from the other ones in the neighbourhood. This way of redevelopment does indeed preserve the original structures, losing however their main characteristic - the exposition of the natural stone construction. A better chance in preserving the original structures might be seen in their adaptation to the role of summer houses, to be used seasonally by the population of the nearby cities. A similar direction is given by the currently thriving rural tourism, which by definition ought to be related to the cultural heritage of the given region, especially architecturally [3]. Both of these directions in the region are currently merely marginally developed, involving several, out of hundreds, of limestone houses.

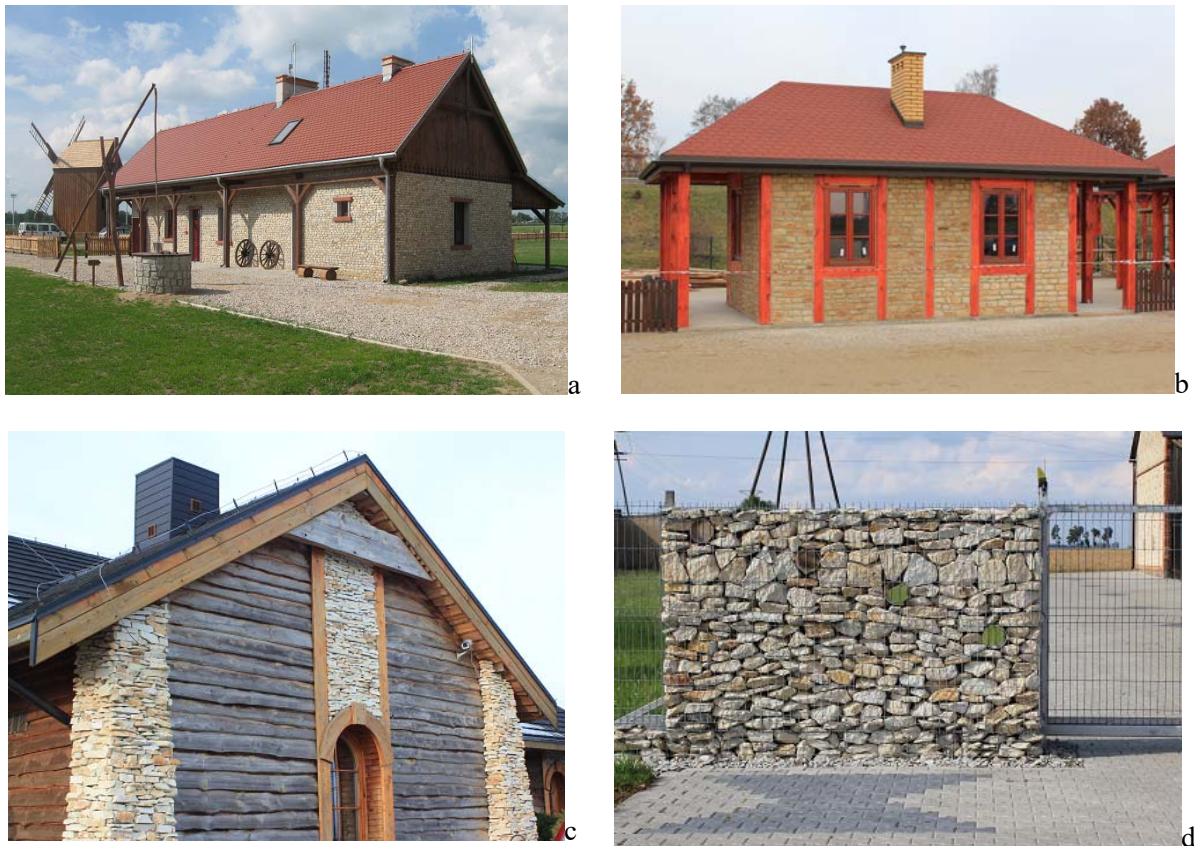
**Figure 8.** Rare examples of the modern use of the traditional stone material

decoration purposes or minor construction utilization (figure 8c, 8d). It should be noted that during its period of popularity, the local limestone was a relatively cheap material - both to mine and to process. Nowadays it is being considered an expensive or even luxurious material. This might be the reason why most investors opt for the use of industrially-produced imitations of a natural stone.
