## Determination of The Physical and Mechanical Properties of the Materials Used in The Northern City Walls of Historical Sinop Castle

To cite this article: Ruya Kilic Demircan *et al* 2019 *IOP Conf. Ser.: Mater. Sci. Eng.* **471** 082039

# Determination of The Physical and Mechanical Properties of the Materials Used in The Northern City Walls of Historical Sinop Castle

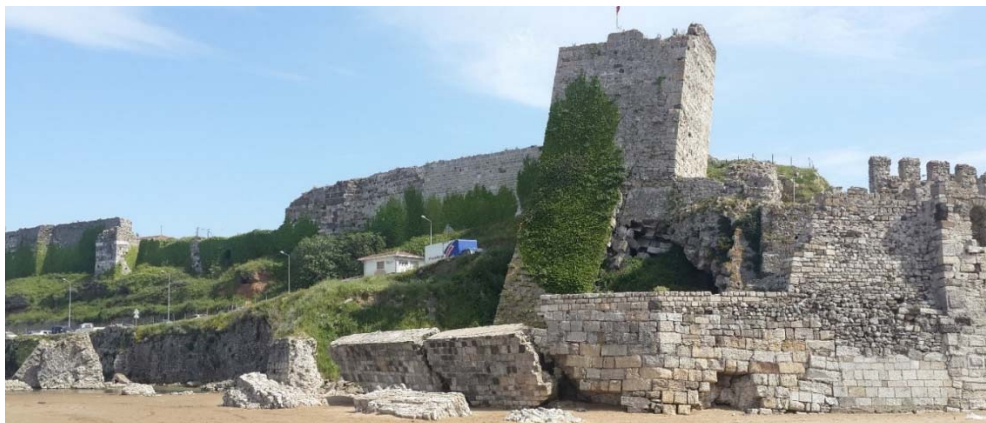
**Figure 2.** North Baileys of Sinop Castle (Kumkapı Site)

The best locations for sample collection were found as a result of the survey of Sinop Castle. The definitive parameter of the location selection for sample collection was that the samples were collected from intact original stone and mortar material which was not exposed to the deforming effects of the sea water as the castle was built on sea level. The masonry samples were collected from the outer facade, backfill and inner facade of the walls. Masonry samples were collected in accordance with the standards using hammer and chisel.

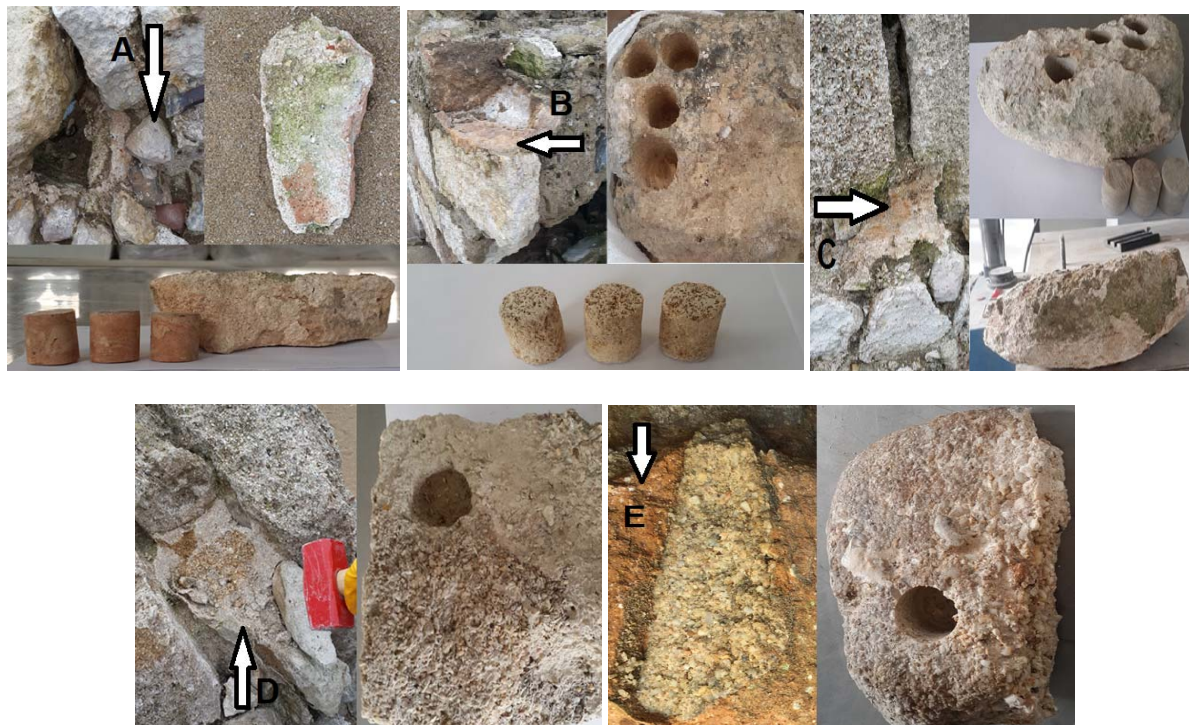
**Figure 3.** Stone Samples

Stone samples were collected from three different points, namely, the outer facade, the inner facade facing the large bastion and the backfill. The samples were then subjected to physical and mechanical (strength tests) analyses.

Stone Sample A was collected from the backfill; Stone Sample B was collected from the outer façade; and Stone Sample C was collected from the inner facade of the castle. Stone Sample D, on the other hand, was collected from the outer facade, however, as it was of petrified clay and silt material, it was not possible to collect a borehole sample. The sample was dissolved during the borehole sampling as soon as it was subjected to sea water. Stone Sample E was collected from the backfill. Stone Sample E was of sand, clay and silt material. This sample was also dissolved during the borehole sampling as soon as it was subjected to sea water. The sampling locations, samples and the borehole samples are listed below (Figure 3).

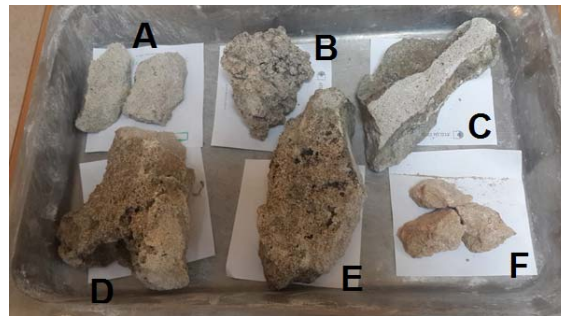
**Figure 4.** Samples of Mortars

Mortar samples were collected from three different points, namely, the outer facade, the inner facade facing the large bastion and the backfill. Sample of mortars were taken in Figure 4. The samples were subjected to physical analyses and data was obtained. As it was not possible to obtain borehole samples, it was impossible to perform mechanical analyses.

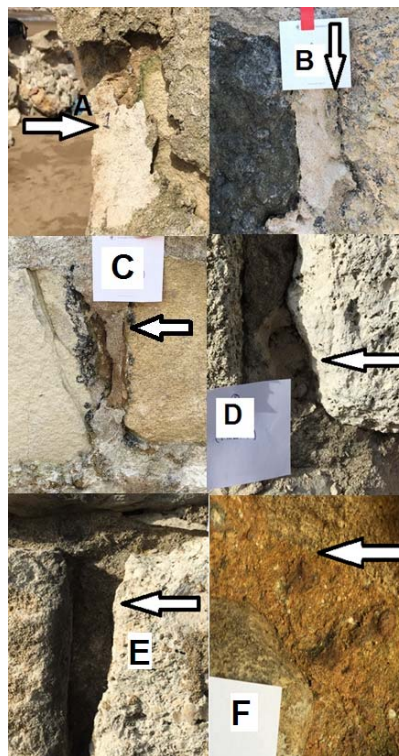
**Figure 5.** Samples of mortars which were received their locations

HA, HB, and HC mortar samples were collected from the outer facade which is exposed to sea water; while HD and HE mortar samples were collected from the inner facade; and HF mortar sample was collected from the backfill. Sampling locations are shown below in Figure 5.

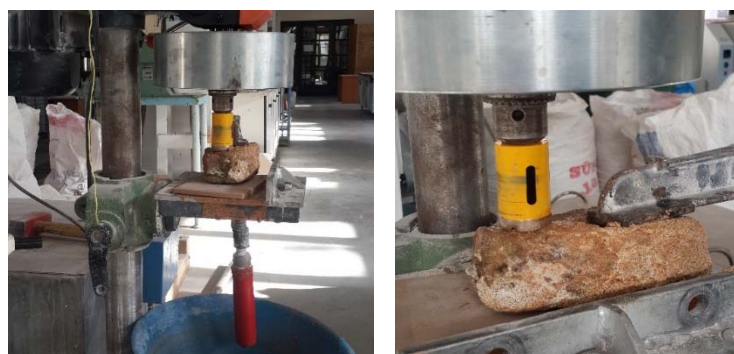
**Figure 6.** Coring from stone sample

Borehole samples were taken from stone and mortar materials in order to determine the compressive stress. Due to unfavourable conditions present at the locations for borehole sampling, samples were not collected on-site. Stone and mortar samples were dislocated and transported to the city of Ankara. Borehole drill bit was custom designed to accommodate the size of the samples (2.75 in diameter).

Borehole samples were taken from stone materials in order to determine the compressive stress. A custom borehole drill bit was obtained in accordance with the size of stone samples. Stone samples obtained were tested using a uniaxial compression test device with three repetitions and the mean values were found (Fig.6-7). The following diagrams illustrate the compressive strength findings.

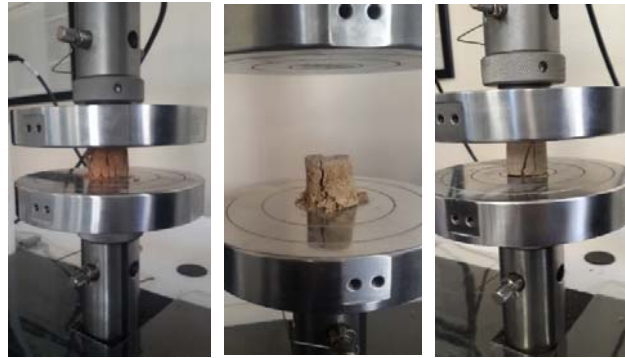
**Figure 7.** Uniaxial compression test of stone samples A, B, C respectively

Although it was possible to obtain borehole samples from stone samples, we were not so lucky with mortar samples. Stone samples obtained in the form of a cylinder were tested in a uniaxial compression test device and the measurements were recorded.

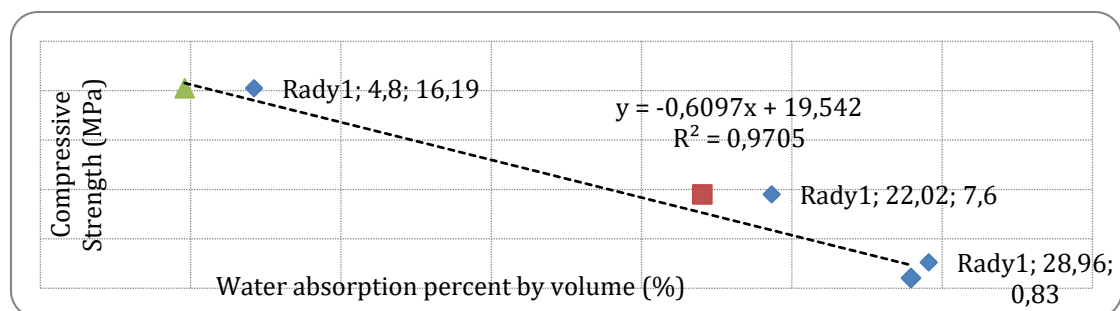
As shown in the table. 2 compressive strength-volumetric water absorption diagram, compressive strength is increased as the water absorption ratio is decreased. In addition, relation with compressive strength –water absorption percent by volume-porosity- apparent density were shown in figure 8-9-10.

**Figure 8.** Relation with compressive strength - water absorption by volume of stone samples

Volumetric water absorption ratios of the stones collected from the outer and inner facade of the wall were in the range of 4.8%-28.96%. True densities of the stones, on the other hand, were in the range of 2.59-2.69 g/cm<sup>3</sup>. Porosity of the stones was in the range of 7.11-31.53%. Physical experiments showed that there are significant differences between the stones used in the outer and inner facade of the wall. A closer look into the compressive strength of stones showed that compressive strength increases with decreasing porosity. Compressive strength of the stones increases with increasing apparent density. Based on the structure of the stones being sampled, compressive strength readings were above 15 MPa. It was observed that the properties of sedimentary rocks degrade when they are exposed to water. It was found that the findings of this study were similar to those reported in recent literature. In general, water absorption increases and compressive strength decreases with increasing porosity.

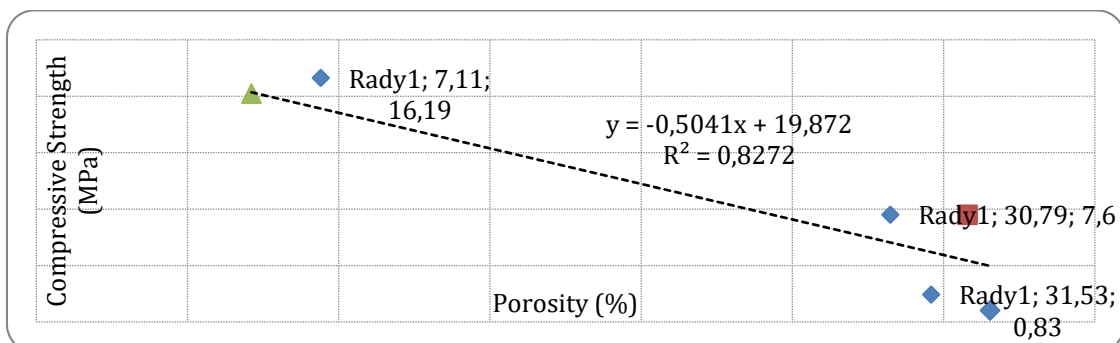
**Figure 9.** Relation with compressive strength - porosity of stone sample

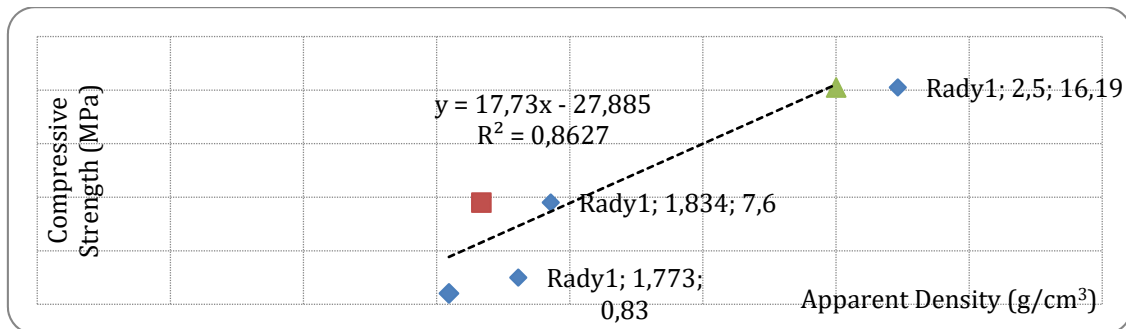
**Figure 10.** Relation with compressive strength – Apparent density of stone sample
