## Protection of Authenticity in the Process of Historic Sacral Site Adaptation. Contemporary Interior Decoration in Renovation Design

To cite this article: Barbara Pierscionek 2019 *IOP Conf. Ser.: Mater. Sci. Eng.* **471** 082050

Barbara Pierscionek <sup>1</sup>

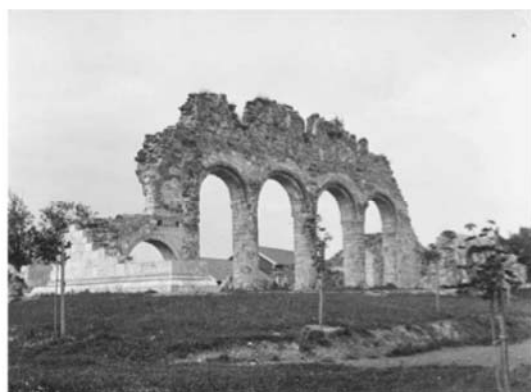
**Figure 1.** The Fragment of the Hamar Cathedral Ruins before renovation (photograph by E. Cisek)

**The Hamar Cathedral relics**, that currently constitute a part of the *Hedmarksmuseet* Museum, exemplify contemporary creation of ruins. The Cathedral was originally erected in the Roman style and at the beginning of the 13th Century it was reconstructed according to the Gothic style. At that time it was one of the two largest Roman Cathedrals in Norway (apart from the Cathedral in Oslo)<sup>1</sup>. It was destroyed by the Sweden Military Forces during the First Northern War in 1567. In 1998 the preserved arcades (Figure 1) were covered by the glass and steel construction designed by Architect Kjell Lund, that was to serve the encapsulation purposes and provide for continuation of archaeological studies in that area (Figure 2).

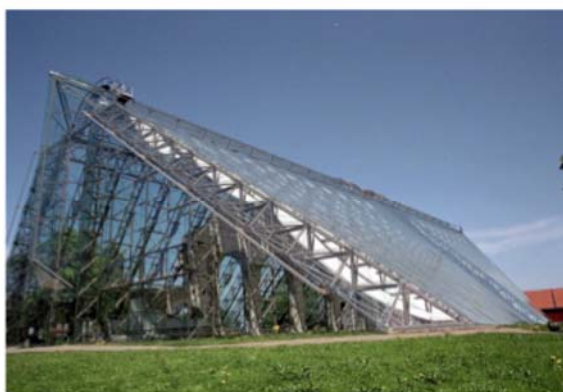
**Figure 2.** The Hamar Cathedral after renovation (photograph by E. Cisek)

The Architect's major concept was to create cohesion of the interior with the surroundings, making the impression of the cathedral interior continuity<sup>2</sup>. That was the reason for concealing the steel construction elements that could contrast with the surroundings. The advanced and constantly monitored heat distribution system provided for optimal conditions for visitors and efficient maintenance, inter alia: prevention of wall cracking in result of low ambient temperature as well as the Cathedral relics desiccation<sup>3</sup>.

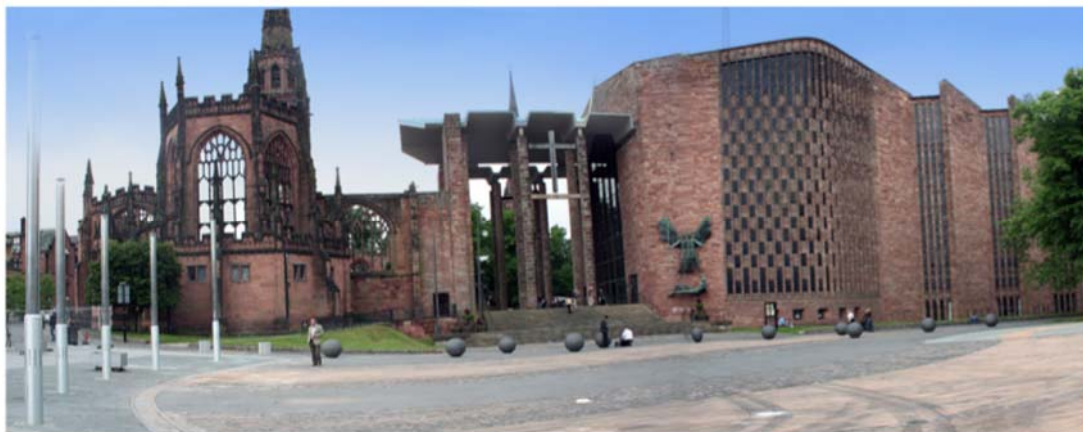
**Figure 3.** St Michael's Cathedral in Coventry. The Medieval fragment is on the left-hand side, and the contemporary fragment - on the right-hand side

**St Michael's Cathedral in Coventry**, that is the Anglican Cathedral erected at the turn of the 14th and the 15th century and destroyed in 1940 during the German bombing offensive, is another example of post-war renovation measures. The outer walls, the crypt, and the 90 metre tower were the only fragments to have remained intact. The Cathedral has never been reconstructed and its ruins have become the symbol of the German bombing offensives in England during the World War II. Inside the ruins, the blackened wooden cross was placed by the fire fighters, after the fire in 1949. After the war, in the 50s a new modernistic cathedral designed by Sir Basil Spence was erected next to the ruins. That design was selected out of over two hundred designs that were competing in the contest (Figure 3).

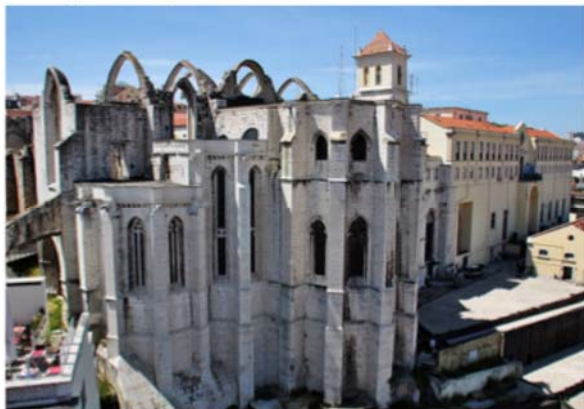
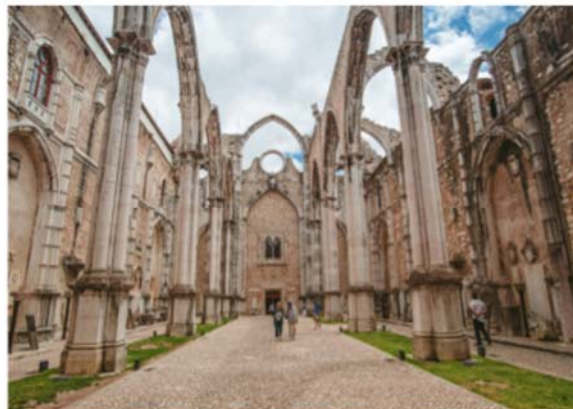
**Figure 4.** The Church of Carmelitas in Lisboa (photograph by B. Pierścioneck)

**Figure 5.** The Interior of the Church preserved in the form of sustainable ruins, the current state of the ruins (photograph by B. Pierścioneck)

The Convent and Church of Carmelitas (Convento do Carmo and **Igreja do Carmo**, Figure 4, 5) was one of the sacral sites destroyed at that time. That was a fairly significant building since the Convent Library kept approximately 5000 tomes in its custody. After the tragic earthquake during the reign of the Queen D. Maria I de Portugal, the reconstruction works of the Convent were commenced and later ceased in 1834 in result of the dissolution of Convents. At that time the Convent buildings were taken over by the Army to be administered as the Military Headquarters by the Army. Then it was decided to reconstruct some of the buildings but the Church Igreja do Carmo was neither repaired or restored. In 1864 the Church was transferred to the Association of Portuguese Archaeologists who transformed its ruins into the archaeological museum. Until now the Church has been preserved in the form of sustainable ruins and has been available for sightseeing. The original outer walls, interior pillars and acute arch pillars, stone vault stiffeners are the only fragments to have been preserved whereas the vaults have not actually survived the destruction.

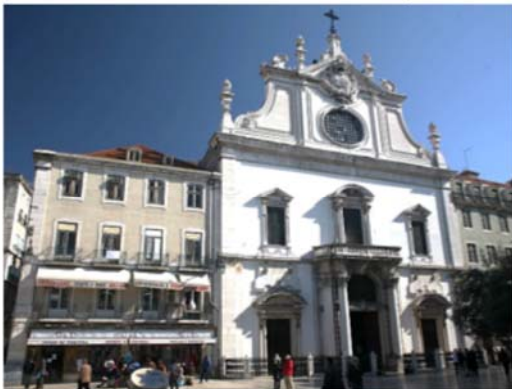
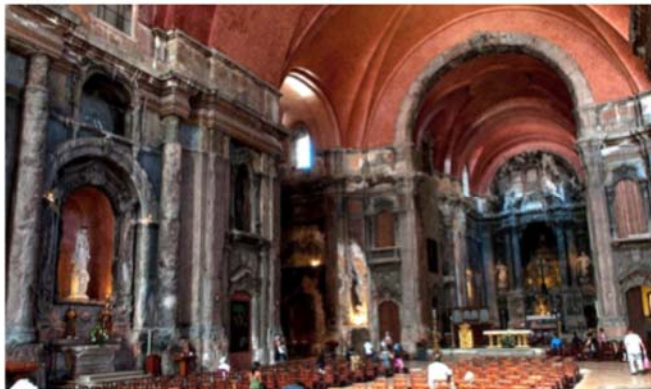
**Figure 6.** St Dominic's Church in Lisboa, the western facade (photograph by B. Pierścioneck)

**Figure 7.** The Church Interior after renovation, the current state of the Church (photograph by B. Pierścioneck)

St Dominic's Church (**Igreja de São Domingos**, Il 6, 7) is still another interesting example of renovation in Lisboa. It was erected as a single-aisle church on the Latin cross plan in the middle of the 13th century. It was reconstructed many times and after the aforementioned earthquake in 1755 it was reconstructed as a Baroque church. The fire in 1959 affected the church to the greatest extent as it destroyed its interior. Then the whole of the barrel vault collapsed and the walls were destroyed by the fire. Renovation of the church emphasised the value of the authenticity of the destroyed architectural texture because the church walls were restored to its original shape, the barrel vault was reconstructed and painted red that symbolised the fire that had burnt down the church.

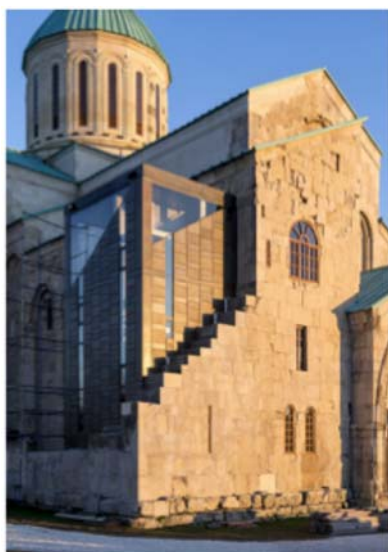
**Figure 8.** The Fragment of the Bagrati Cathedral, the western facade with the built-on elevator shaft, [3]

mainly in the Cathedral Interior. The built-on modern elevator shaft by the entrance, connected with the terrace, is the most controversial element (II.8).

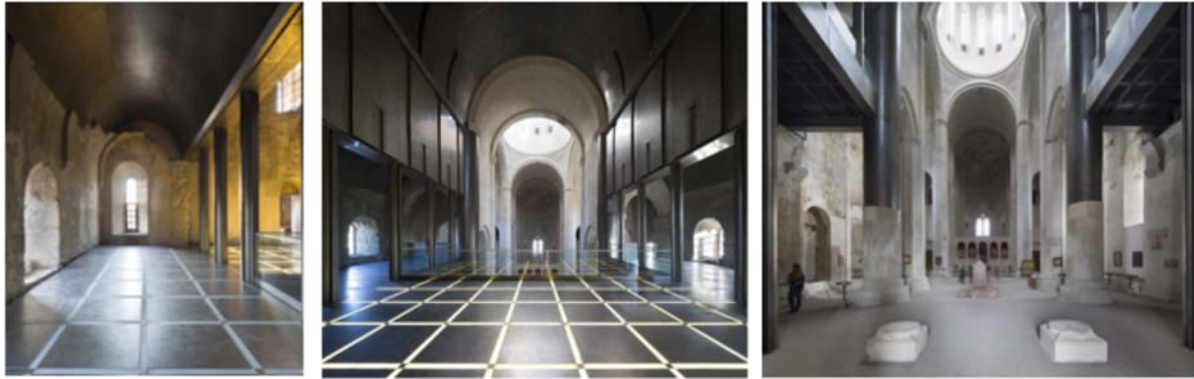
**Figure 10, 11, 12.** The Bagrati Cathedral Interior View after the renovation works, the current state of the Cathedral, [5]
