Moistening of Walls Caused by Damage to Terraces - Research Studies and Numerical Simulations

Jan Slusarek ¹, Pawel Krause ¹, Agnieszka Szymanowska-Gwizdz ¹

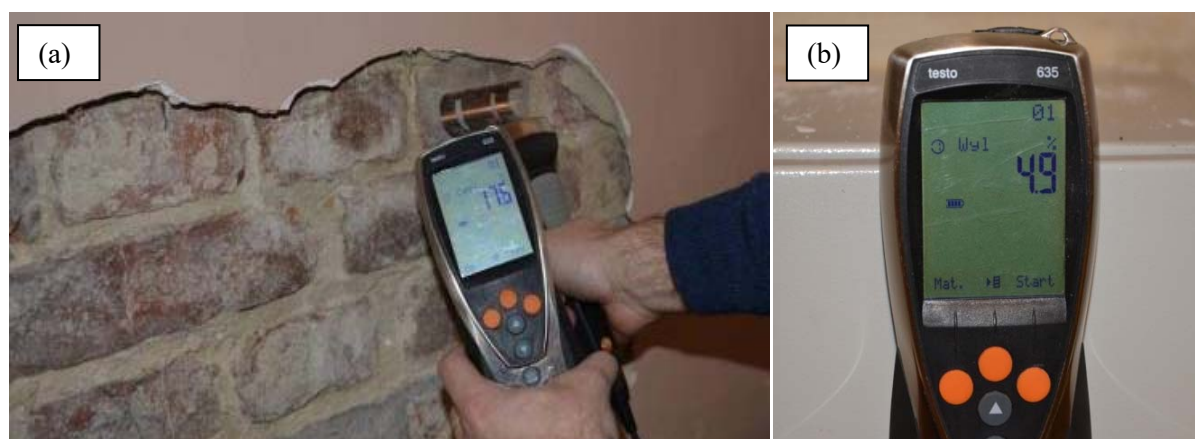
In the public utility building located in Gliwice, built before World War II as a residential object, the renovation of rooms and facades was carried out in the years 2013-14. The works comprised the renovation of three terraces, including new floor surfaces and the installation of flashings. In 2017, due to visible moisture on the internal surfaces of the external walls and on the internal surfaces of upper floors, as well as due to evident surface salt blooming, plaster damage and damage to external coatings, visual inspection and macroscopic examinations were performed to identify the reason for their occurrence. In addition, the research included the measurements of mass humidity of the external wall elements, using non-destructive methods as well as sampling for laboratory tests. As part of the non-destructive tests carried out inside the building, the surface moisture of solid ceramic brick with lime plaster used for the construction of external wall structures was measured. Mass humidity measurements were carried out using the Testo 635-2 measuring instrument with a probe to measure humidity level of the material (Figure 1). The instrument is used for the measurement of temperature, air humidity and humidity balance of the material. In the places where the symptoms of moisture were identified, on a section of the external brick wall of the utility room, a fragment of the wall was exposed and made available (plaster rubble). Humidity measurements were made on the surface of visible bricks, on two levels, i.e. 20cm and 50cm from the floor level. Similar measurements were made in another room within the area of the adjoining terrace, in which the users had removed the moistened internal plaster, replacing it with the repair plaster. On its surface, surface salt blooming was visible in some places as well as traces of strong moisture around it.

Figure 1. Measurement of mass humidity of the brick (a) and (b)

The measurements of mass humidity of the plaster done in the place of strong discoloration and humidity of the external wall yielded the values ranging from 14.3% to 18.6%. After the removal the plaster layer, the measurements of mass humidity of the brick wall were made, yielding the results ranging from 13.9% to 17.5%. Further non-destructive control measurements were made in places located about 1.5 m from the fragment of the moistened wall. Mass humidity of the plaster ranged from 3.1% to 3.9% and mass humidity of the solid brick wall on lime mortar ranged from 4.3 to 5.2%. Mass humidity measurements with the Testo 635-2 measuring instrument with the probe for material moisture measurements yielded the following mean values (from six measurements) in the places of identified moisture:

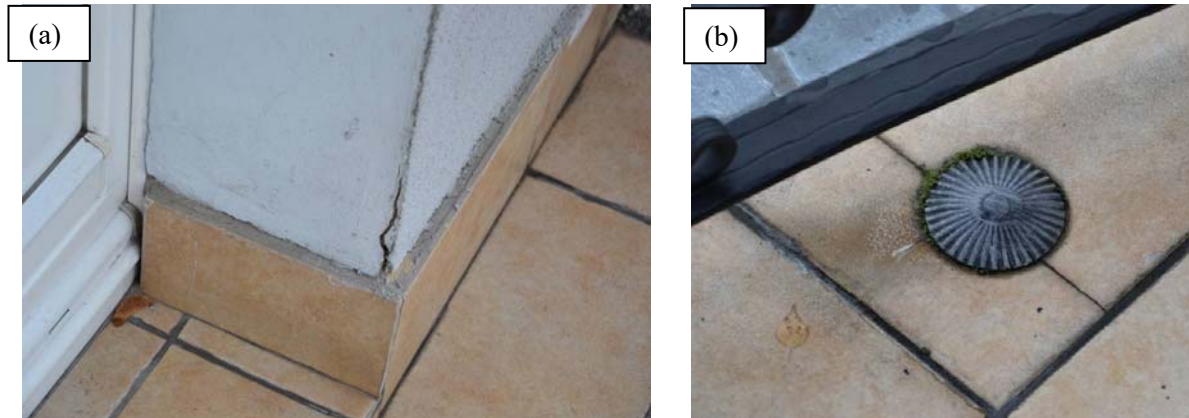
The moistening of external walls located in the immediate vicinity of the presented terraces was caused principally by irregularities involving the surface of bay window. Damage to ceramic tiles, lack of effective waterproofing and inaccurate work execution of flashings, and also leaks in the walls at the contact places with gres plate flooring or with flashings resulted in rainwater penetration into the

interior of the building, bringing about progressive moistening of external walls and the destruction of finishing elements. Additionally, floor surface slopes of the terrace were improper, causing water stagnation (Figure 2,3,4).

Figure 2. Damage within the terrace area above the bay window: (a) Damage to the plaster in the corner, (b) Cracking of the terrace tile

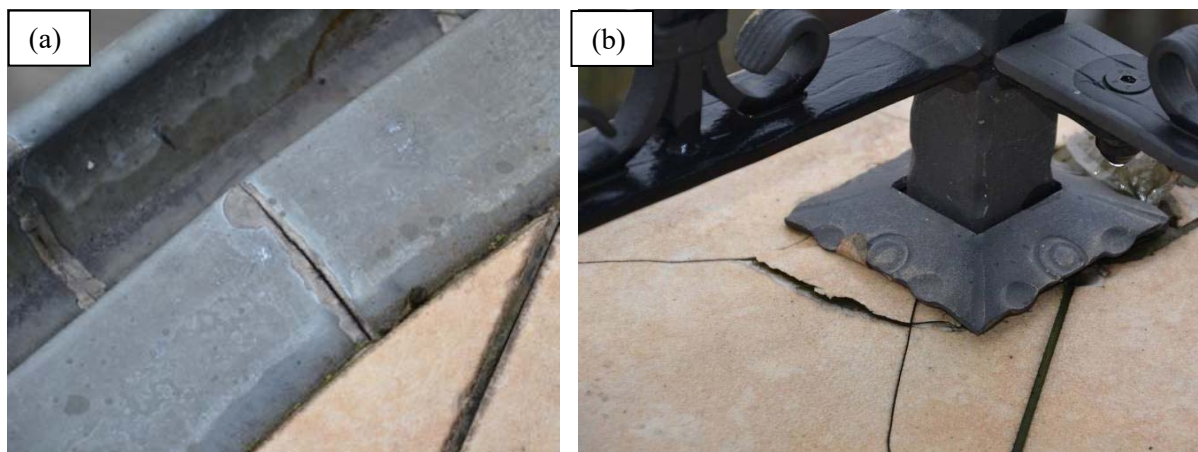
Figure 3. Damage within the terrace area above the bay window: (a) Leaks in flashings, (b) Crack in the terrace tile – mounting place of the balustrade

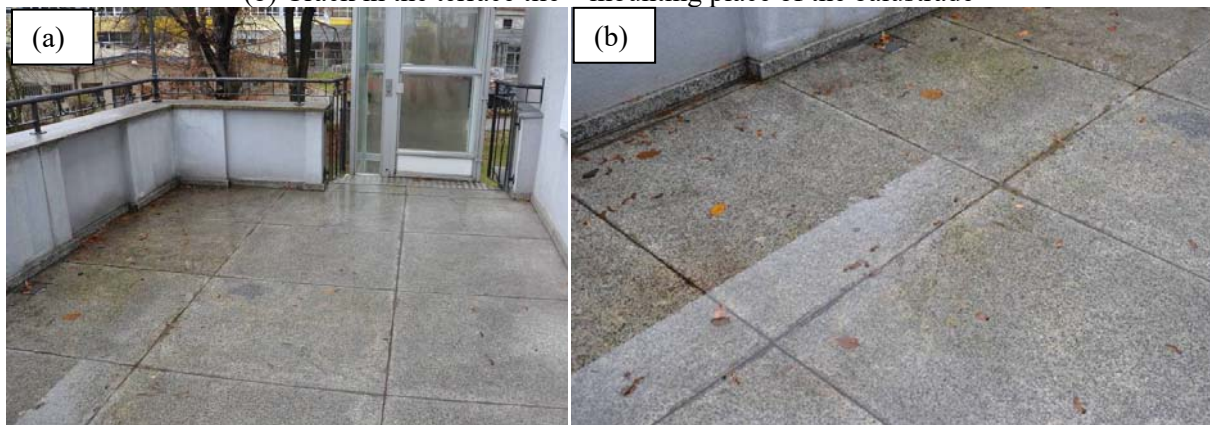
Figure 4. Ground floor terrace: (a) Lack of required floor slopes, (b) Water stagnation

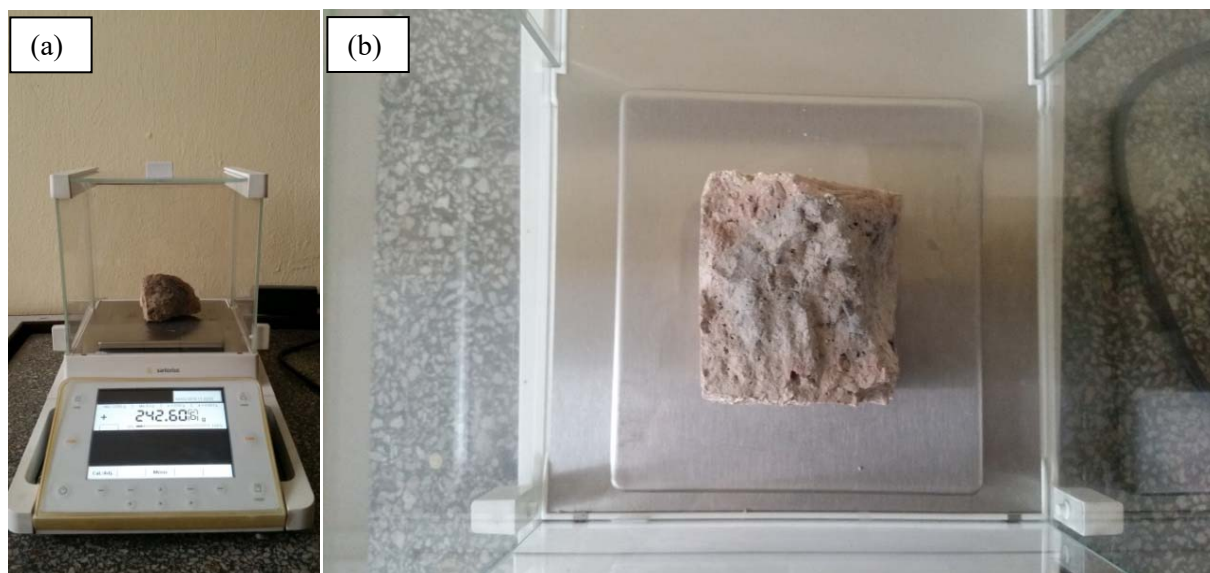
Invasive tests were carried out using the dry oven method. The method consists in taking out a small sample from the material to be tested, weighing it, then drying it up at the temperature of about 105°C until the mass is constant and re-weighing it. In order to collect samples from the inside of the wall, holes are drilled with a 100mm-diameter core drill bit. During the sampling process, special attention was paid to avoid drying the sample with the heat generated during the drilling process. Therefore, a slow-speed impact drill was used. The collected samples were put into sealed containers and delivered to the laboratory. The pictures below present a fragment of the sample of solid ceramic brick collected from the depth of about 20 cm from the surface of the internal plaster along with the applied moisture analyser. In order to obtain the results of mass humidity from the place of identified moisture and from the place outside the moist area, 3 samples of solid brick were collected (Figure 5). The average mass humidity values of the ceramic brick wall in the places of identified moisture amounted to 9.9%. At the distance of about 1.5 m from the moistened fragment, the mass humidity was 3.4%.

Figure 5. Testing of the sample in the moisture analyser (a) and (b)

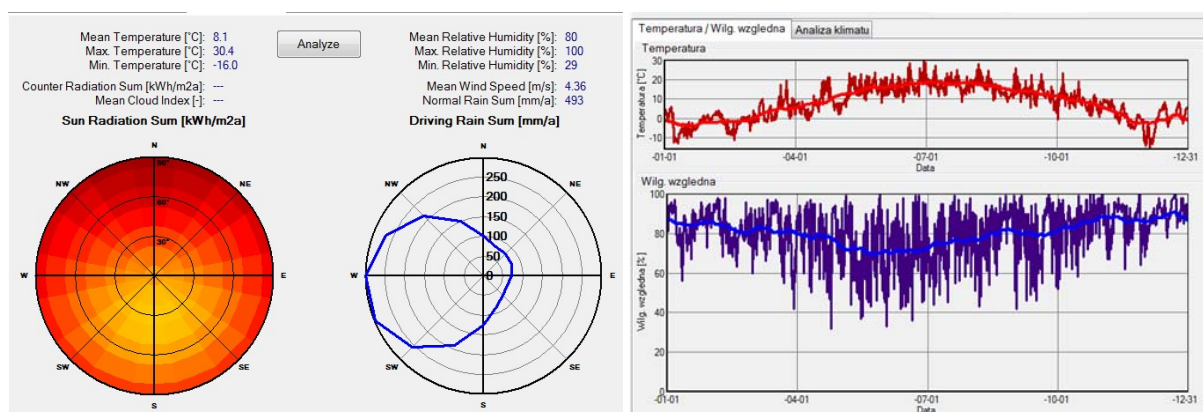
To calculate the changes in moisture, a 38cm thick masonry external wall made of solid bricks was applied along with two-sided lime plaster. In the analysis, practically only materials available from the program's database were applied. In the hygrothermal calculations, the dependence of thermal conductivity of the material and that of the capillary transport coefficient on its moisture was taken into account. This was particularly important in the case of materials used for external envelopes, for which thermal resistance constitutes a significant part of the overall thermal resistance of the envelope. It happens so in the case of an exemplary single-layer solid brick wall. Before the simulation, the data needed for the calculations was defined. The initial mass humidity of a solid brick wall was defined at X% and Y%. The extremely high initial moisture content in the material brings about the increase of its thermal conductivity. It depends on the amount of moisture and structure type of the material. Other material data including porosity, density, specific heat was based on the data contained in the WUFI 2D database. The outdoor climate was simulated based on the climate data for the city of Warsaw. The calculation was made for the envelope located on the west side of the building, due to the large unfavourable amount of precipitation (Figure 6). With respect to the indoor climate, the calculation variants were limited to dry rooms utilized in a regular way with conditions similar to those of typical calculation conditions, i.e. it was assumed that for normal conditions, the temperature was changing in a sinusoidal manner from 18°C in winter to 24°C in summer and relative humidity of the air changing from 55% in winter to 65% in summer.

Figure 6. External climate for the city of Warsaw, based on the WUFI 2D program: (a) and (b)

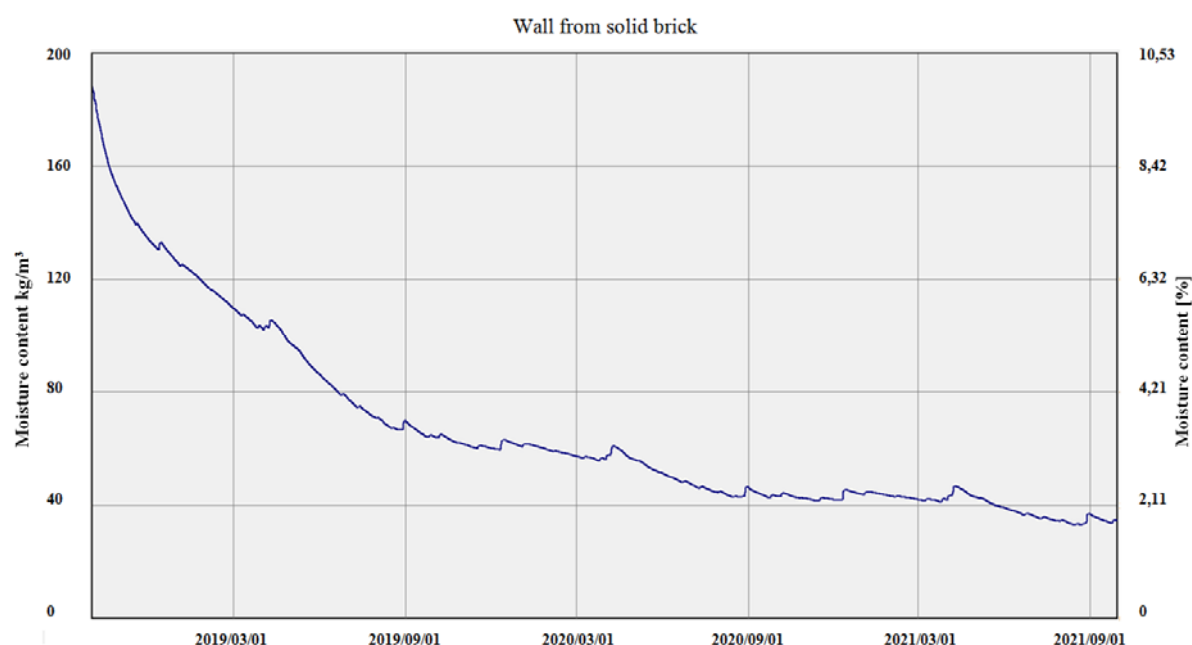
The results of the one-dimensional modelling calculations obtained in the WUFI program are presented in the graphical form. The content of moisture in the present model for the moistened wall over the period of 3 years is presented in Figure 7. The mass humidity of the brick in the analysed period decreased from 188.1 kg/m^3 to 34.4 kg/m^3 . The largest decrease to the value of approx. 3.6% (the decrease of humidity by approx. 6.3%) was recorded in the first 365 days. In the following year, we could observe a decrease in humidity by another 1.3% to the level of 2.3%. In the third year, the drop in brick moisture did not exceed 0.5%. The mass humidity was 1.8%.

Figure 7. Changes in mass humidity of the solid brick of the initial humidity of 9.9% over the 3-year period, based on the WUFI program

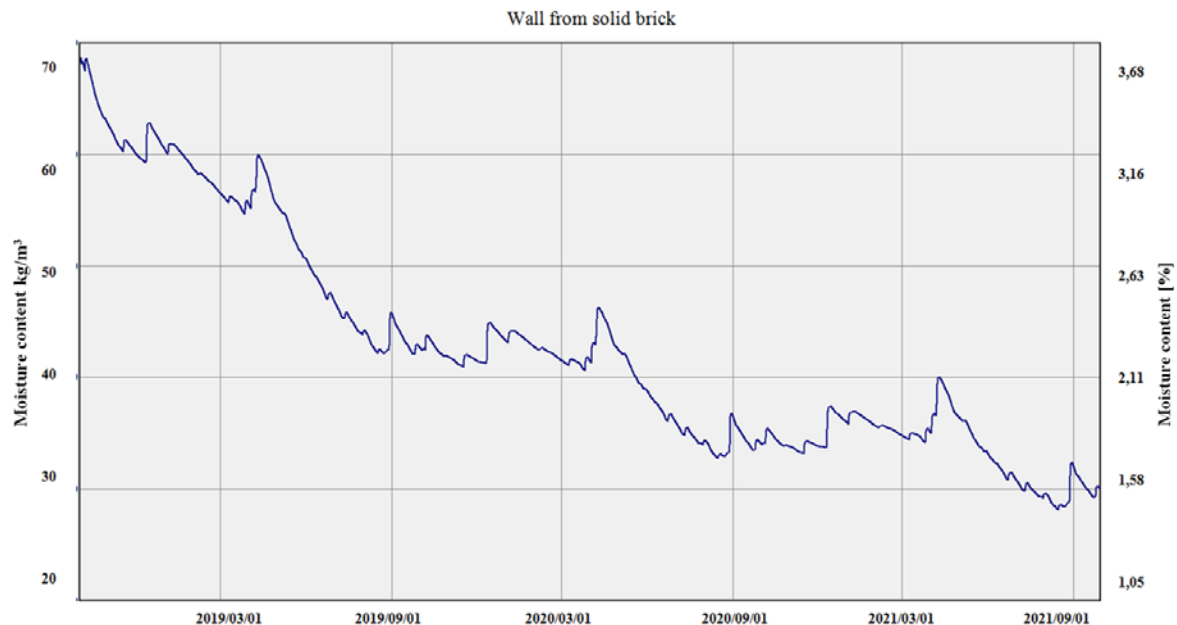
The calculation results involving the change in water content for the solid brick located outside the moisture zone of the external wall are presented in Figure 8. The mass humidity of the brick in the analyzed period decreased from the initial value of 64.6 kg/m^3 to 30.1 kg/m^3 . The largest decrease, the same as for the moistened wall, by about 1.0%, to the value of 2.4%, was recorded in the first 365 days. In the following year, we can observe a decrease in humidity by another 0.5% to the mass humidity of 1.9%. Over the last, third year, the drop in brick humidity did not exceed 0.3%, to the value of 1.68%.

Figure 8. Changes in mass humidity of the solid brick of the initial humidity of 3.4% over the 3-year period, based on the WUFI program
