Urban River Design: A River Restoration Case Study

Denisa Halajova ¹, Peter Halaj ², Viliam Macura ³, Andrej Skrinar ³

Abstract. Human excessive requirements on functions of aquatic ecosystems cause that surface waters often suffer from significant morphological and hydrological alterations. Human induced hydromorphological changes of rivers belong among the most common ecological problems of the water bodies and they appear in all scales of river habitat. These changes have an impact in their ecological status and need to be solved in the near future. Successful sustainable river rehabilitation depends on the identification and understanding of key processes and anthropogenic stressors. These factors enable to estimate a proper longitudinal and lateral riverine system structure including stream habitat improvements at different scales. The article summarizes the basic principles of urban river restoration, that enables to approach to the state of dynamic stability and to increase the „absorbing capacity” of freshwater ecosystem. The authors also provide the background facts and principles of the restoration design of canalized reach of the River Trnavka, which flows through an u

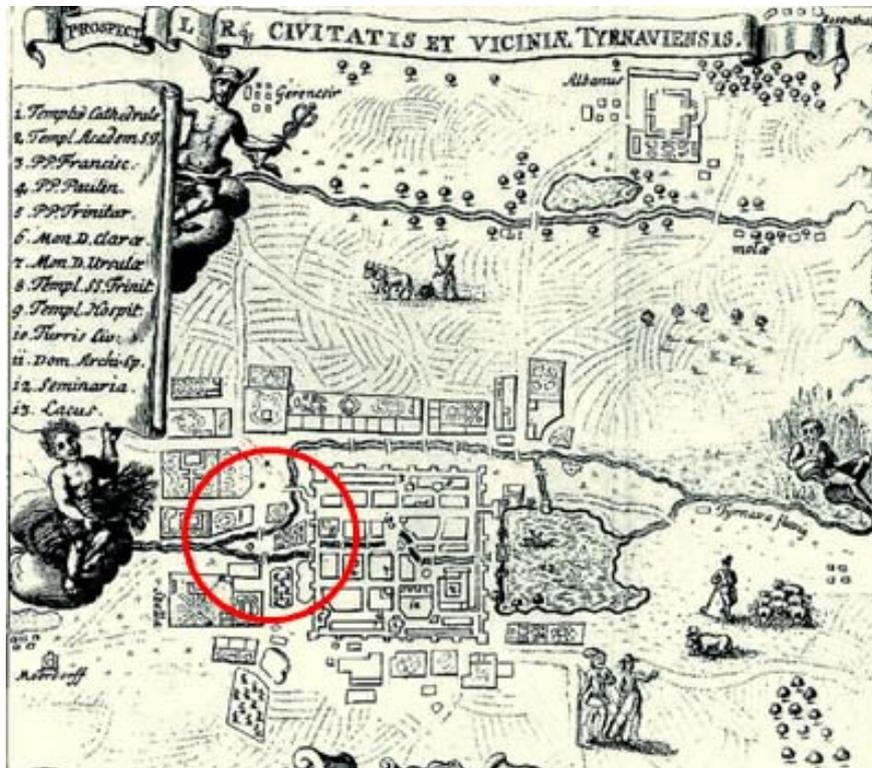
Figure 2. The Trnavka River in 1727 [10]

The Trnavka River is located in central part of the town Trnava in western part of the Slovakia (figure 1). In the 13th century, the Trnavka River flowed around the town and river was a part of the city defensive walls. The Trnavka River painted on the veduta from the 1727 is divided into two branches behind the northern city walls (right side of the Figure 2.). Behind the southern city walls was a junction of both branches next to the area of current Rose Park (circle on the Figure 2). Because of flood threat existence (the great flood occurred in 1909) the Trnava City Council began to plan increasing the level of flood protection. Building of systematic flood control measures started after the First World War and continued during the Second World War. The western branch of the river (originally behind the city walls) was transformed into partially underground closed conduit. The second branch of the river (originally in the city centre) has been completely transformed into underground conduit. One branch of the River was also left in the area of the Rose Park.

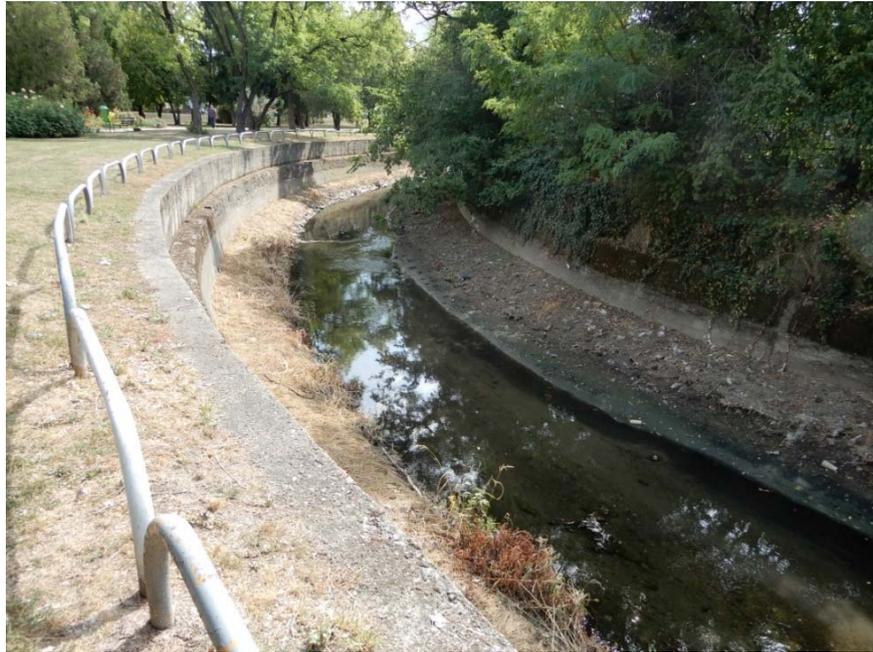
Figure 4. The recent state of the Trnavka River

The current state of the designed reach of the river is presented in Figure 3. The researched reach of the Trnavka River is strongly altered. According to the Water Framework Directive is categorized as a heavily modified water body. It's due to effect of the channel modification and pollution from overflow chamber of town sewage system. The prismatic compound channel has cross section of the trapezoidal shape. The bed width equals to 4.50 m, channel depth is 3.10 m and bankfull width equals 9.50 m. The V-shape low flow cross section is armoured with stones. The bank toe is stabilised by riprap and adjacent floodwalls are made from concrete. The biota of the ecosystem has low diversity and abundance. The chub (*Leuciscus cephalus*) is main representative of ichthyofauna in the river. The chub is considered as tolerant fish species in heavily contaminated river reaches [11]. The control measurement of physical-chemical characteristics of water has shown following values: BOD₅ = 8.5

mg.l⁻¹ , pH = 7.37, conductivity EC = 27 mS.m⁻¹, Dissolved Oxygen concentration= 1 mg.l⁻¹. The results categorized water to the worst the 3rd quality class of physico-chemical parameters.

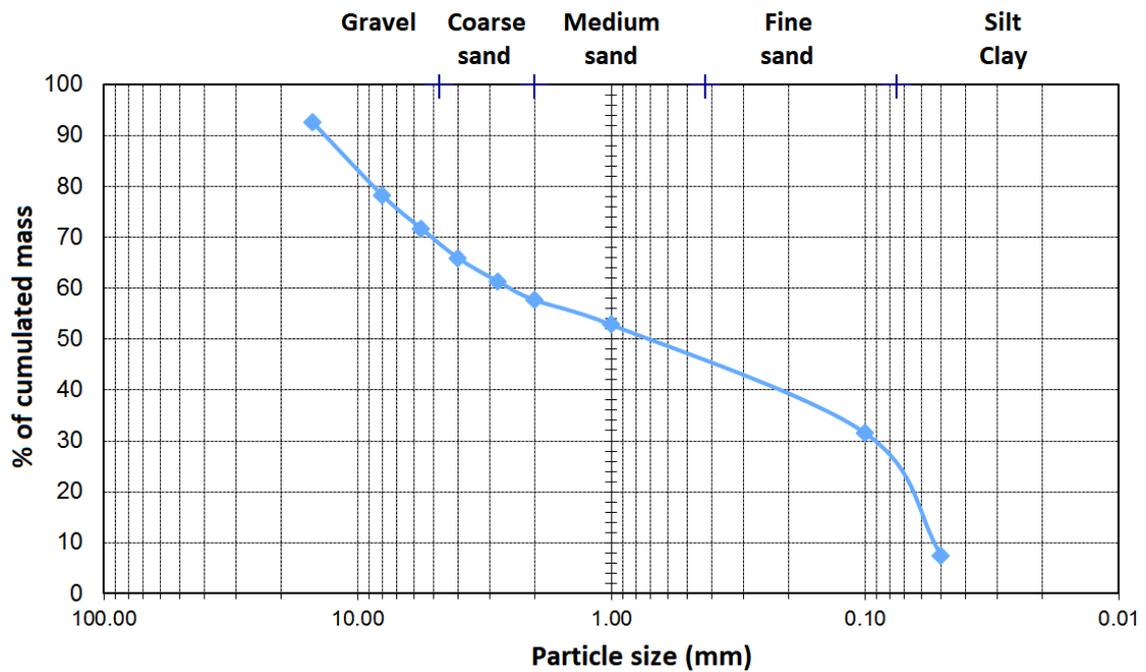
Figure 5. Particle size distribution curve of the sediments

To improve ecological conditions of flow channel we analysed bedload sediments granulometry (Figure 5.) with prevailing representation of fine material (sand, clay and silt). The goal of the low flow channel narrowing was to increase mean velocity that enable transport of fine grained material.

Such way we increase the share of gravel and coarse sand and eliminate accumulation of fine material from overflow chamber of town sewage system. The goal of the increasing of low flow channel sinuosity (Figure 6.) is to improve morphology and material diversity. The cross section modification design is presented in Figure 7. Excavated bed material is substituted with stones to form the toe stabilisation element. Rest of the bed and part of the bank is built from mixture of gravel and sand. The surface is covered by jute geotextile on which the macrophytes. The main goals of the measures are: reduction of water pollution, forming shaded areas, creation a refugia for ichtyofauna, enables the contact with river by pier design (Figure 8.) and increasing an aesthetic level of the riverscape.
