## Study on Initiation and Growth of Fatigue Crack of Pre-corroded 7B04 Aluminium Alloy Specimen

Ang Qian, Xiaoming Tan, De Wang, Mingrui You

Qingdao Branch, Naval Aeronautical University, Qingdao 266041, China

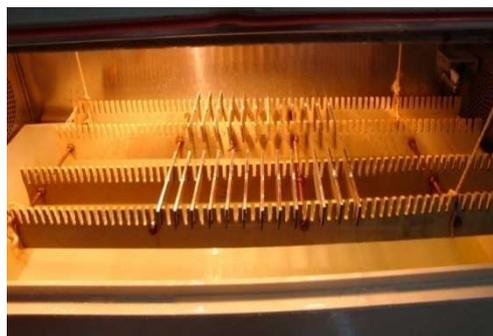
Simulate the aircraft's outfield service environment and conduct accelerated corrosion tests. The method for accelerating the etching solution is as follows: ① using 95 parts of distilled water and 5 parts of NaCl having a purity of 99.9% to prepare a NaCl solution having a concentration of 5%; ② adding an appropriate amount of dilute sulfuric acid to make the pH of the NaCl solution  $4.0 \pm 0.2$ . Before the corrosion test, the parts other than the notch of the test piece are protected with anti-corrosion sealant to remove the influence of other factors on the fatigue crack initiation and expansion behavior. The ZJF-75G periodic infiltration test chamber was used to carry out the equivalent accelerated corrosion test for 0 years to 12 years. The test pieces were divided into 4 groups, and the corresponding corrosion time was 3 years, 6 years, 9 years and 12 years, namely 3a, 6a, 9a, 12a, the number of test pieces in each group is 6. Figure 2 shows the accelerated corrosion test state of the test piece.

**Figure 2.** Accelerated corrosion test state of specimens

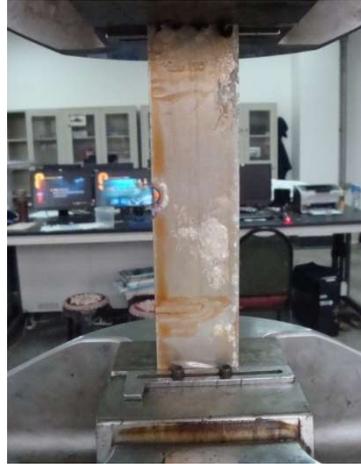
The test piece of the accelerated corrosion 0a, 3a, 6a, 9a, 12a was subjected to a fatigue test using an electro-hydraulic servo fatigue tester Material Test System 810. According to HB 7705-2001 "Test method for fatigue crack growth rate of metallic materials" [7], the metallographic AC paper replica was used to monitor the fatigue crack initiation and expansion at the notch of the test piece. The stress ratio

is  $R=0.06$ , the maximum stress  $\sigma_{max}=98$  MPa, the loading frequency  $f=10$  Hz, and the constant amplitude loading mode is shown in Figure 3.

**Figure 3.** Replicas of specimen
