PAPER • OPEN ACCESS

To cite this article: W W Cong *et al* 2019 *IOP Conf. Ser.: Mater. Sci. Eng.* **504** 012030

An experimental investigation of the composite coating for marine propellers on cavitation characteristics and fouling release property

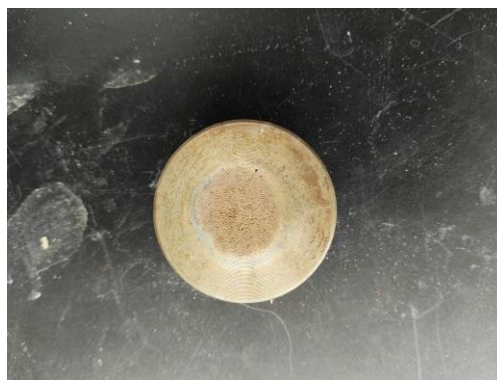
As contrast to composite coating, blank column of copper alloy was eroded by cavitation, the morphology of its surface was showed in figure 1. The cavitation damage was severe and cavities appeared everywhere, and after 600 min, cumulative weight loss reached about 40 mg.

Figure 1. Eroded surface of copper alloy.

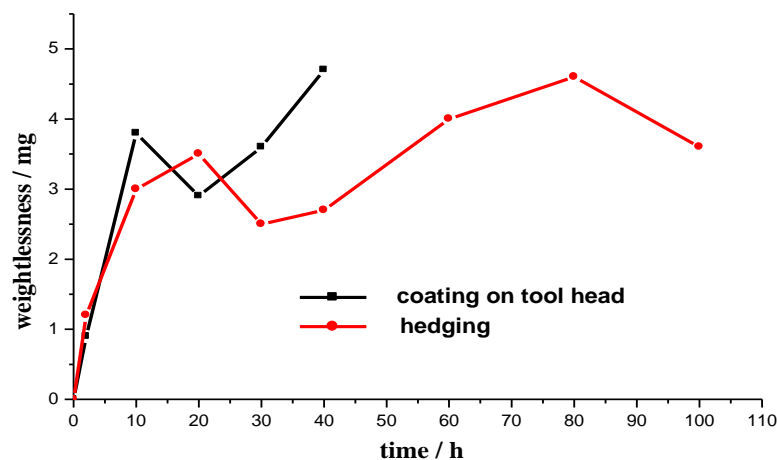
Figure 2. Weightlessness curves of test columns over time.

We could see that the composite coating had obvious weight loss within the first 10 hours from figure 2. Tested column for hedging received moderate growth from 10 to 20 hours and from 30 to 80 hours. After 10 hours, the composite coating kept relatively stable cavitation resistance property, for buffer epoxy coating, silicon tie-coat and fouling release top-coat were all elastomers. Three types of matching coat contributed to reduce the impact generated by cavitation bubble collapse, which establish a barrier from the propeller substrate. While the composite coating tested on tool head had slowly increased between 20 to 40 hours. The uncertainty analysis caused weight increase in both of them. In general, cumulative weight loss of tested columns was all less than 5mg on tool head for 40 h and hedging for 100 h. Also the surface characterizations of composite coating were got before and after the cavitation resistance tests from figure 3.

Cavitation resistance tests were undertaken to study withstanding cavitation shock of composite propeller coating. Weightlessness curves of test columns demonstrated weight loss within 5 mg for two methods; Thrust coefficient and torque coefficient of the composite propeller coating had no influence in hydrodynamic performance; Model propeller kept intact and matched better with good mechanical behavior and cavitation resistance after rotating for 300 h; Characteristics of propeller coating expressed much flatter to SPC Zinc coating which delaying boundary layer transition from laminar to turbulent flow and cavitation bubbles generation. Seawater exposure tests last nearly 3 years; soft fouling such as sponges was easily removed after washing, also, fouling release propeller coating was effective to hard fouling. Generally speaking, cavitation resistance fouling release propeller coating had no toxic anti-fouling compounds and was safe to health of construction workers and marine environment. Also, obvious properties in cavitation resistance and antifouling were given, including remarkable drag reduction. All of these were essential to present high efficiency and extend the service life for propellers.

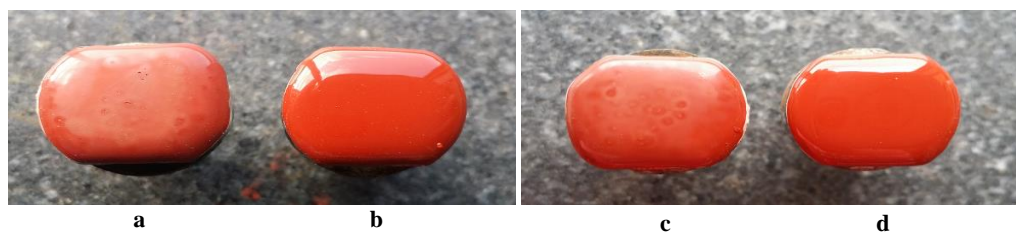
Figure 3. Surface characterizations of composite coating before and after cavitation tests: (a) coating on tool head for 40 h; (b) newly painted columns; (c) Hedging for 100 h; (d) newly painted columns.

The composite coating on tool head for 40 hours received some empty pits, only existed a few tiny breakages, but merely to top-coat. Also it was obvious in the presence of the light loss. For the other tested column hedging for 100 hours, less empty pits were appearing on the surface with no damage and coating film remained relatively intact with slightly loss of light. The visco-elastic fouling release composite coating acted as a damper absorbing the energy of cavitation noise and shock wave as collapse of cavitation bubbles, hence reducing damage of noise level.

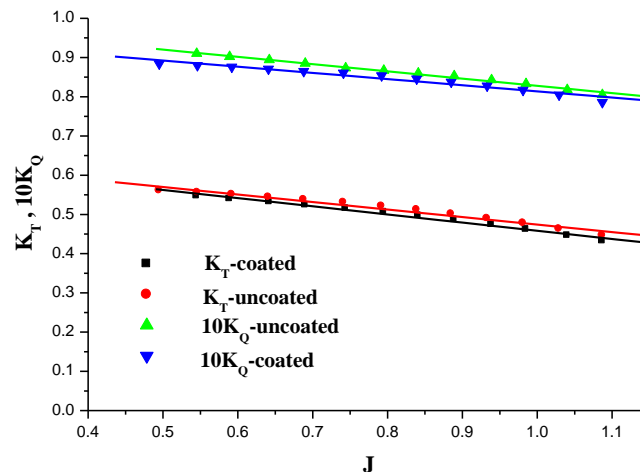
Figure 4. Comparison of open water test results for coated and uncoated cases.

Thrust coefficients of the blades without the composite coating were slightly higher than the coated blades by an average of 0.9%. This was also valid for the torque coefficient, as the blades with composite coating gave an average reduction of 1.6% compared to those uncoated blades. Based on the previous experiment results and present measurements we could conclude that the composite coating does not significantly affect thrust and torque property of the model propeller.

Results of open water test were shown in figure 4 to compare the performance of the propeller blades with the uncoated and coated composite coating. In this figure propeller advance coefficient J , thrust

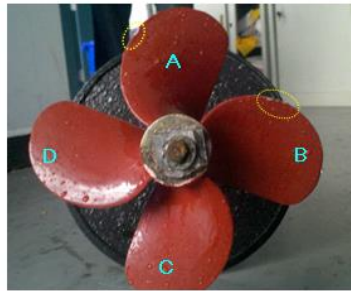
Figure 5. Photography of blade surface for 300 h.

We could see the leading edge of blade A and blade B appear small areas damaged, but matching coating of blade C and blade D kept relatively intact from figure 5. This phenomenon showed 4-layer coating system was matching better with good mechanical behavior and cavitation resistance.

Blade A and blade B employed three layers without buffer epoxy coating compared to other two blades. Model propeller was rotating at the speed of 500 rpm after 300 hours. Seawater and gravel mixed in the cylinder simulated the severe marine environment, collided matching coating to accelerate wear behavior of coatings. Also cavitation performed to destroy matching coating during rotation. Characteristic photography of blade surface was obtained after 300 hours showed in figure 5.

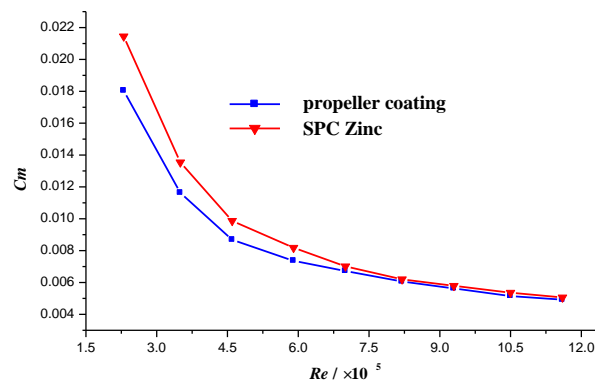
Figure 6. Smooth plate line for 300 h moment coefficients and rotational Reynolds number.

At the lowest Reynolds number, the SPC Zinc coating showed rapid growth in C_m compared to propeller coating. Moment coefficients gradually decreased with the rotational Reynolds numbers grew larger. Moment coefficients gave a rapid decline in the low Reynolds number region while mild fall in high Reynolds number area. Both coatings presented similar downtrend in the second half of the experiment, which was attributed to Reynolds number effect. For the bigger Reynolds number, the weaker viscous effects and the smaller the coefficient of friction. Generally speaking, propeller coating expressed relatively low moment coefficients in all process of the tests compared to SPC Zinc coating and showed obvious drag reduction performance especially in the low Reynolds number region.

Where γ is the kinematic viscosity (m^2/s). The results of the drag reduction tests for the coated surfaces in the unfouled condition were given in figure 6. Variation of moment coefficients C_m with rotational Reynolds number Re between SPC Zinc and Propeller coating were presented for

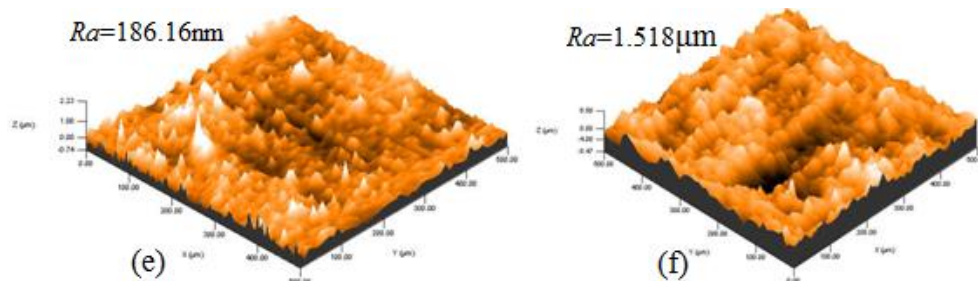
Figure 7. Surface profile of propeller coating (e) and SPC Zinc coating (f).

The main difference between propeller coating and SPC Zinc coating lay in characteristics, as shown in figure 7 for two typical roughness profilograms. The SPC Zinc coating surface gave a spiky closed texture (e, $R_a=1.518 \mu\text{m}$) whereas the fouling release propeller coating (f, $R_a=186.16 \text{ nm}$) displayed a small proportion of short-wavelength roughness. It was thought the rheology of coating is significantly different for fouling release propeller coating and SPC Zinc coating. Today, the growth of the boundary layer contributed the most to cavitation, while roughness of blades accelerated boundary layer transition from laminar to turbulent flow and caused cavitation generating. Smooth surface of fouling release propeller coating not only could reinforce cavitation resistance but also reduce mucus wetting area to coating, at the same time it can effectively reduce the frictional resistance to seawater with excellent drag reduction.

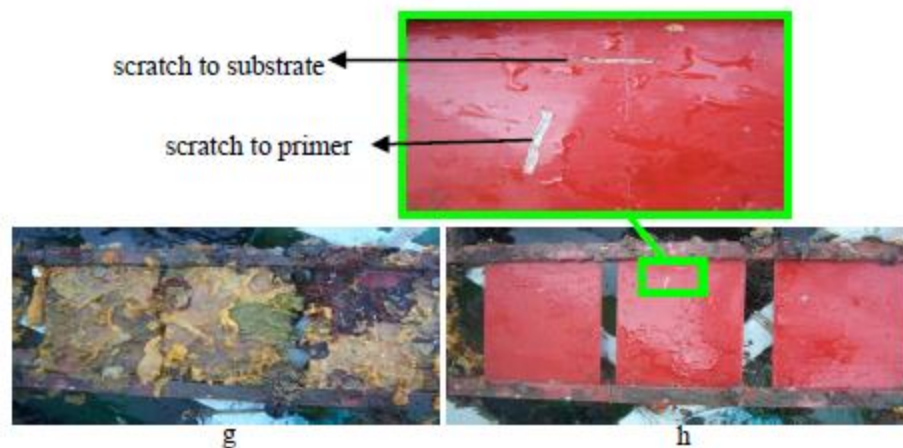
seawater. And photos were taken about growth of marine organisms on testing boards from Figure 8. Large coverage by soft fouling such as sponges was investigated. Some algae occupied half of the third board from Figure 8 (g) Only a few sea squirts were caught in the middle of first two boards in Figure 8 (g). Only two barnacles at the edge of the third block within 20mm should be overlooked for edge effect, while the wooden frames which were used to fasten samples were densely occupied by barnacles.

Figure 8. Photos of matching coating for seawater exposure(g: initial state after 34 months; h: test boards after scouring).

Fouling on test board was easily removed through the scour of seawater; propeller coating was free from adhesion of marine organisms and expressed release from fouling. Water on coating surface gathered to some layers which showed low surface energy properties. Also scratches damage to substrate and primer obtained to investigate anticorrosive property to primer without diffusion phenomenon under matching coating appeared in the enlarged picture.

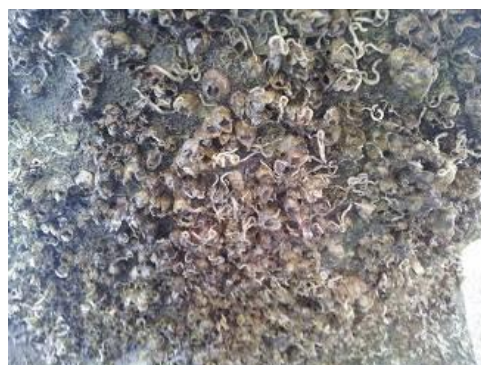
Propeller blades were contaminated with many species of marine organisms at dock as figure 9. after a period of time in service. From the picture, it had been difficult to find out the propeller surface which was full of mature barnacles like craters and white tube worms. Test boards had dense growth of tubeworms with barnacles and calcareous shells brown in color in fouling ratings in the level of 90 [27].

Figure 9. Biofouling on blades of propeller at docking site.

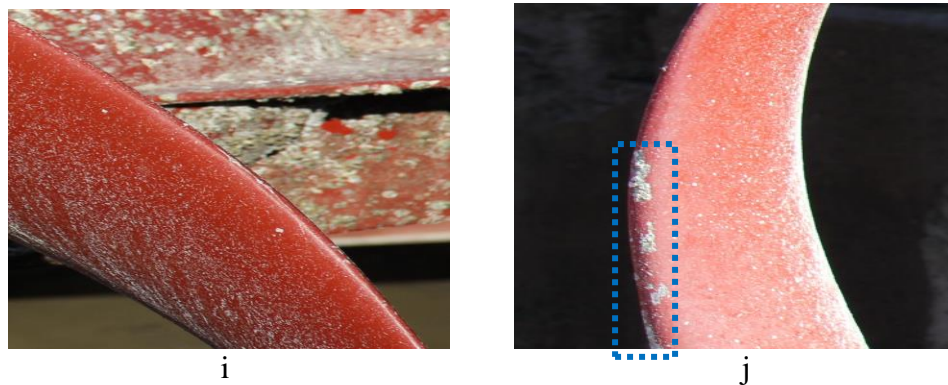
Figure 10. Surface after six months service.

After operating for 6 months, we found matching coating showed integrity overall from the left picture of figure 10. merely small areas damaged in the leading edge (blue dashed box) with no diffusion under the composite coating.

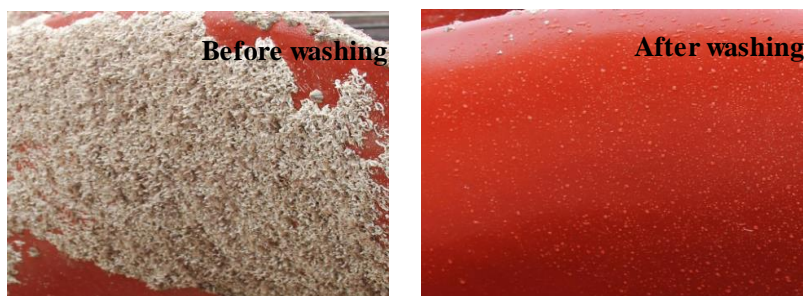
Figure 11. Appearance of the whole blade after sixteen months service.

Characteristics of the whole blade were shown in figure11. After 16 months navigation, some calcarina were adhering on the inside of the blade, while very few were on the central axis of the blade. After washing, the blade was free from any marine organisms. Also detail image on top of the blade after 16 months was given in figure 12. Calcarina was gathering on top of the blade.

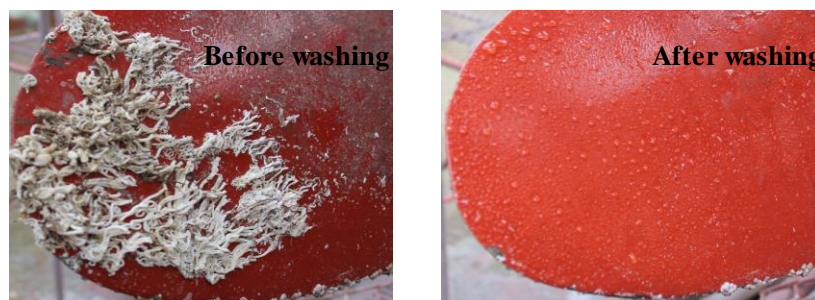
Figure 12. Detail image on top of the blade.

Drop of water like sphere did not spread after washing which exhibit low surface energy. From the

detail, it presented a small regional breakage at the leading edge with water meeting. Also, property of composite coating was keeping track of investigation.
