# The concrete frame strength test is filled with brick against horizontal loads with several types of column beam joints and several types of brick wall connection frames

**J Tarigan<sup>1</sup>, T Sitorus<sup>1</sup> and S Hani<sup>1</sup>**

<sup>1</sup>Department of Civil Engineering, Universitas Sumatera Utara, Indonesia

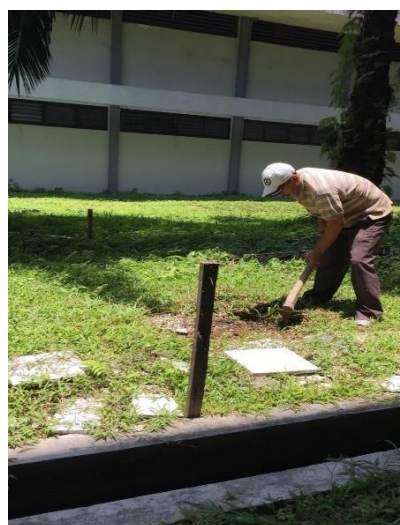
**Figure 4.** The process of digging soil and bowplank work

In the initial stage of constructing the walls, a spread footing foundation was used along the wall. The depth of the foundation was 1 m, and the K-175 concrete was used. After the casting of the foundation was done and the foundation has been dried completely, the next step was reinforcement steel bar work. Rebar installation of the beams and columns used concrete steels with a diameter of 10 mm and confinement bars with a diameter of 8 mm. For the installation of the anchors, reinforcement steel was placed every 20 cm between the stones assembled on the top and side of the wall. The next step was bricklaying. The size of the wall in this study was 2 x 3 m. After the brick walls were built, the process was continued to the installation of rebar for the columns and beams and the installation of the anchors. After the installation of rebar was finished, the next step was the casting of the beams and columns. After 28 days, the brick wall samples were tested. Some processes of preparing the samples can be seen in Figure 4, Figure 5, and Figure 6.

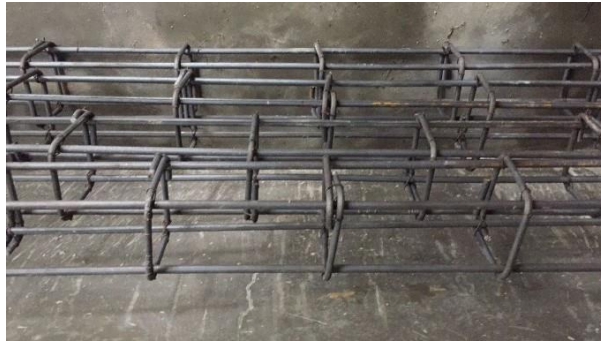
**Figure 5.** Rebar work

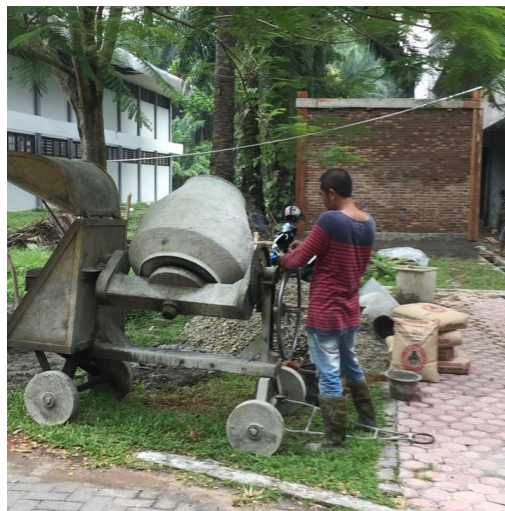
**Figure 6.** The process of casting
