Maintenance management of pavements for expressways in Malaysia

M A Shahid

Principal Pavement Specialist, Opus International (M) Berhad, UEM Edgenta, Kuala Lumpur, Malaysia

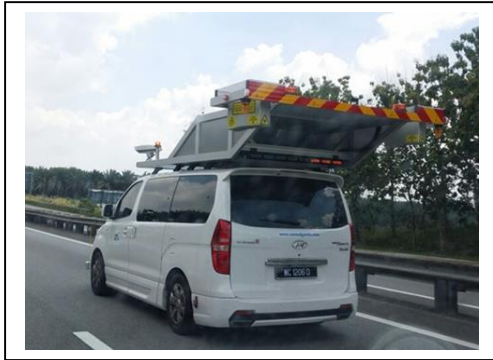
The MLP survey is carried out annually to measure the surface properties which are directly related to the riding quality of pavements (figure 2). The survey is carried out at traffic speed of 70-90 km/hr. The data is recorded for every 25mm spacing and reported at 20m to 100m intervals based on the project requirements. The data is analyzed and processed to determine the following:

- Riding quality in terms of International Roughness Index (IRI) expressed in units of m/km.
- Transverse profile (rutting).
- Surface texture of pavements (macro texture).

Figure 2. Multi Laser Profiler

The FWD and MLP require annual calibration carried out by the manufacturer and a relative or reference calibration prior to the commencement of any survey. The FWD relative calibration involves stacking tower test for deflection sensors. This helps to compare and verify deflection measurements from all deflection sensors. Any sensors with inconsistent readings are removed and replaced prior to commencement of data collection.

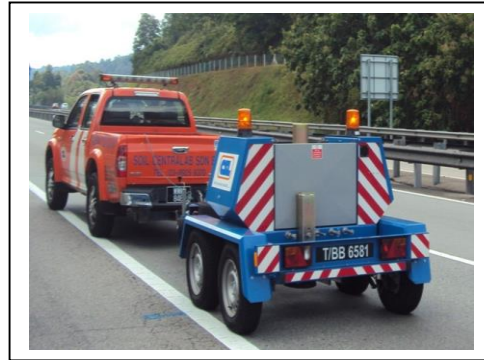
The FWD testing is carried out to determine the structural condition of pavement (figure 3). The testing is carried out along left wheel-path of slow lane and right wheel-path of fast lane. The test spacing is generally 200m for network level PCA depending on the size of road network and 25m to 50m for project level investigation.

The FWD contact pressure is around 0.7 MPa for flexible pavement and 1.0 MPa for rigid pavement which produces a load pulse similar to that from an axle load of heavy vehicle. Pavement and air temperatures are recorded during testing and used in the subsequent analysis. The FWD data is analysed to determine the stiffness moduli of pavement layers and subgrade.

Figure 3. Falling Weight Deflectometer
